APPENDIX C SURVEY FORMS (CONTINUED)

DRAFT
(Information is under FTA review and is subject to change.)

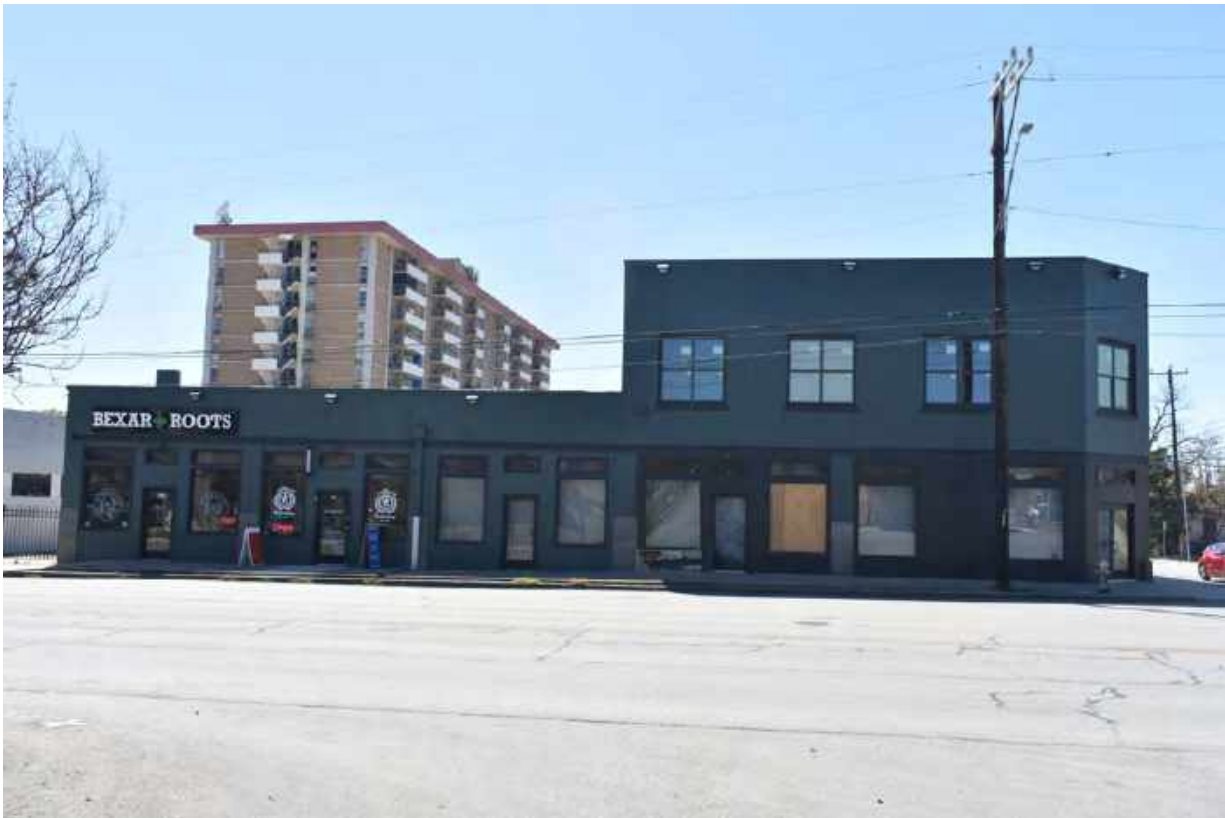
View facing west.

Type:	Exterior materials:	Primary roof type:	Alterations:
Building	stucco	flat	Windows replaced – all visible
Style:	brick	with parapet	Doors replaced
Commercial			Decorative elements removed
Form:	Porch:		Storefront altered/replaced
Rectangular	N/A		Brick/stone painted

The resource is not present on the 1904 Sanborn, but is present on the 1911 Sanborn. The existing resource replaced a single-family residence that had been constructed on the parcel by 1896. A newspaper search reveals that the commercial storefronts were occupied by various business, such as Urban Market (San Antonio Gazette 1907), Nelson Grocery Co. (San Antonio Evening News 1919), a pharmacy called J.D. Nash (La Prensa 1922), Kuhn Paint and Wallpaper Store (San Antonio Express 1955), an artificial limb store called Lux Artificial (San Antonio Express 1957), and a portrait studio called Telecolor of Hollywood (Express and News 1966).

This resource was constructed sometime between 1904 and 1911 and does not represent an early period of development in this area of San Antonio. According to Sanborn maps, most of the parcels in this area were already developed with single-family residences by the late 1890s, including the parcel where the existing resource was later constructed. Therefore, the resource is instead associated with the ongoing trend in development in this neighborhood and has no significant associations linking it to events or trends of historic importance. The resource is also a highly altered example of a Commercial-style building. Because the property’s integrity has been impacted by alterations undertaken after its construction, it no longer embodies the distinctive characteristics that would make it significant as an example of the style and does not demonstrate any innovative, important, or outstanding design features. Additionally, no associations were identified linking it to persons of historic importance. Because the building offers neither a local interpretation of a standard design nor an undocumented construction technique, it has limited potential to yield important information. As a result, it is recommended not eligible for the NRHP under Criterion A,

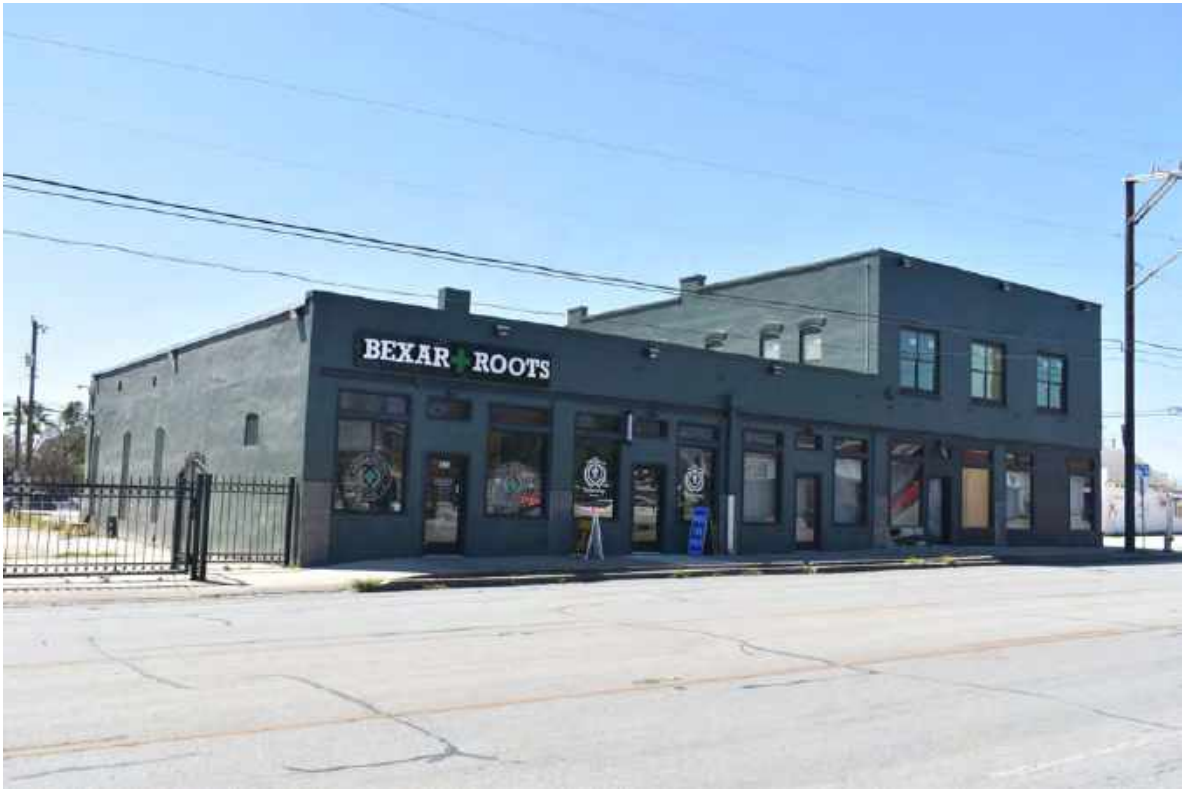
View facing northwest.

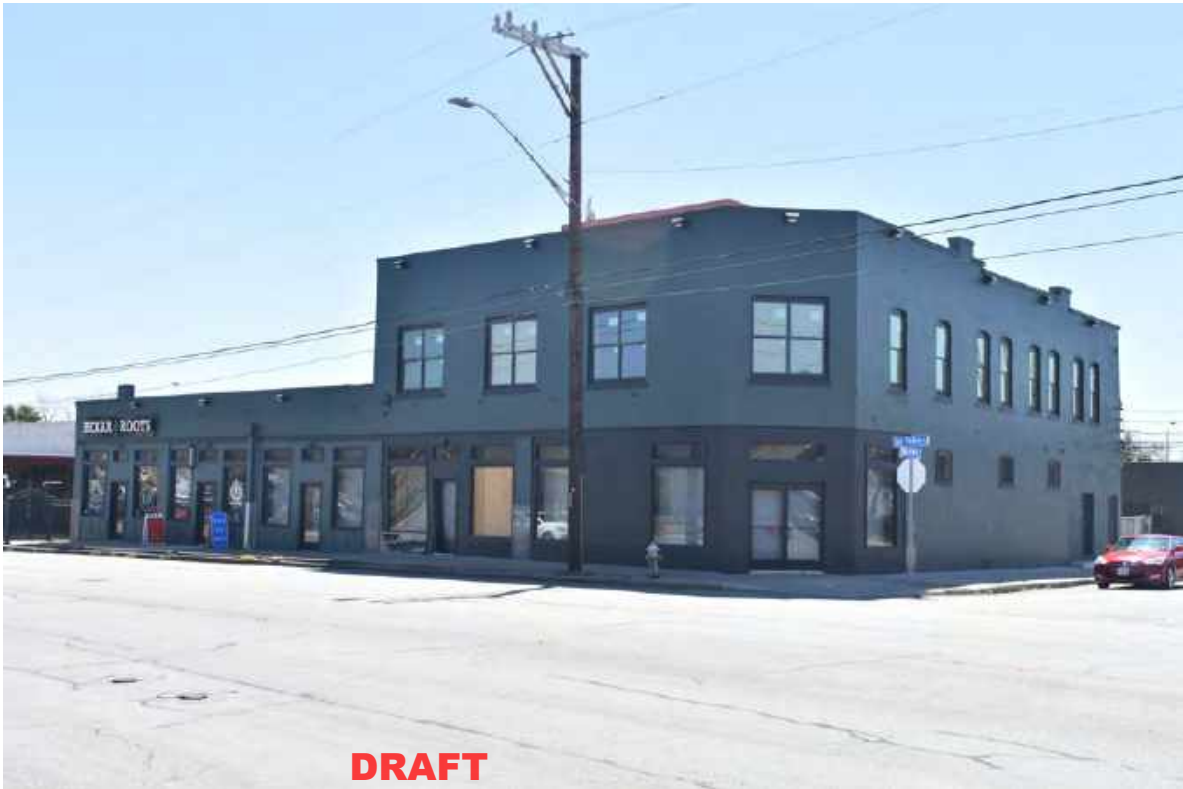
View facing southwest.

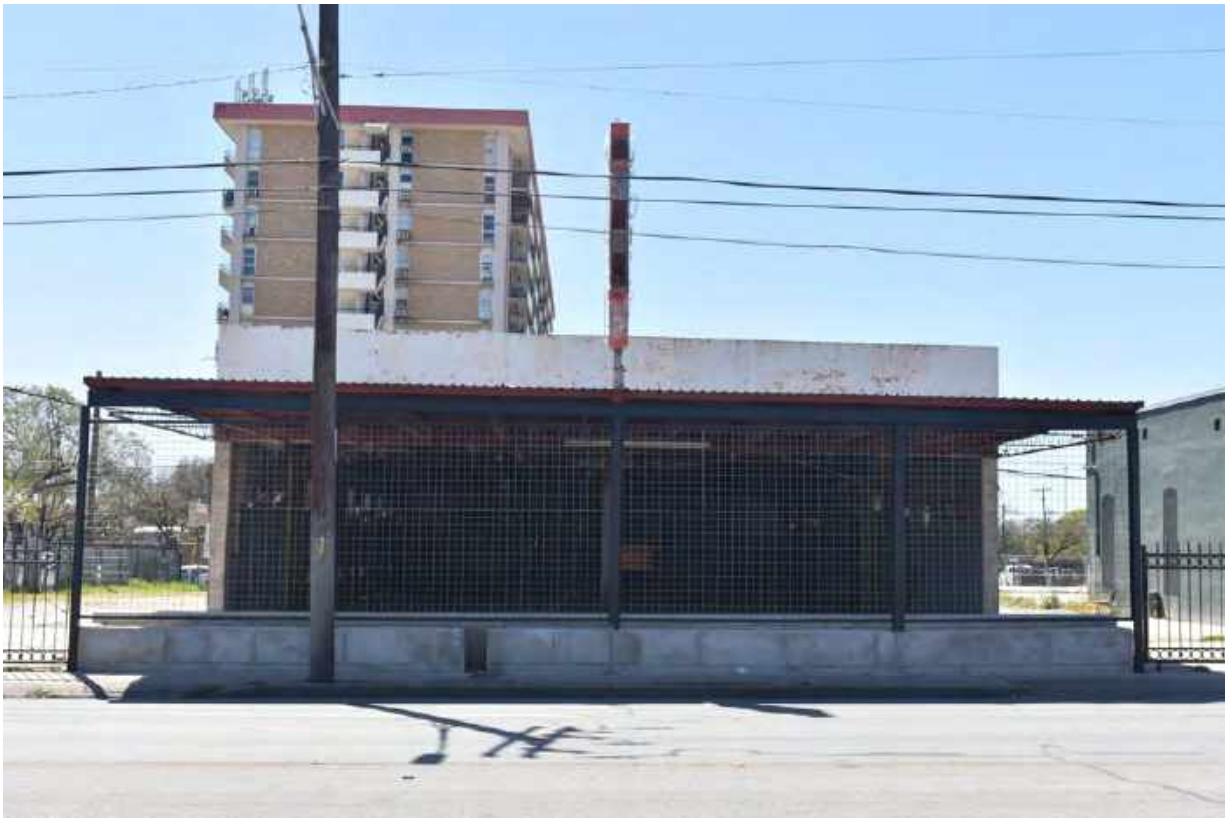
View facing west.

Type: Building	Exterior materials: brick	Primary roof type: flat with parapet	Alterations: Canopy added Storefront altered/replaced
Style: No style			
Form: Rectangular	Porch: full-width projecting

This resource was not found to embody distinctive characteristics of a type, period, or method of construction, represent the work of a master, or possess high artistic value. Additionally, no associations were identified linking it to events or persons of historic importance. Furthermore, integrity has been diminished as outlined above. Because the building offers neither a local interpretation of a standard design nor an undocumented construction technique, it has limited potential to yield important information. As a result, it is recommended not eligible for the NRHP under Criterion A, B, C, or D.

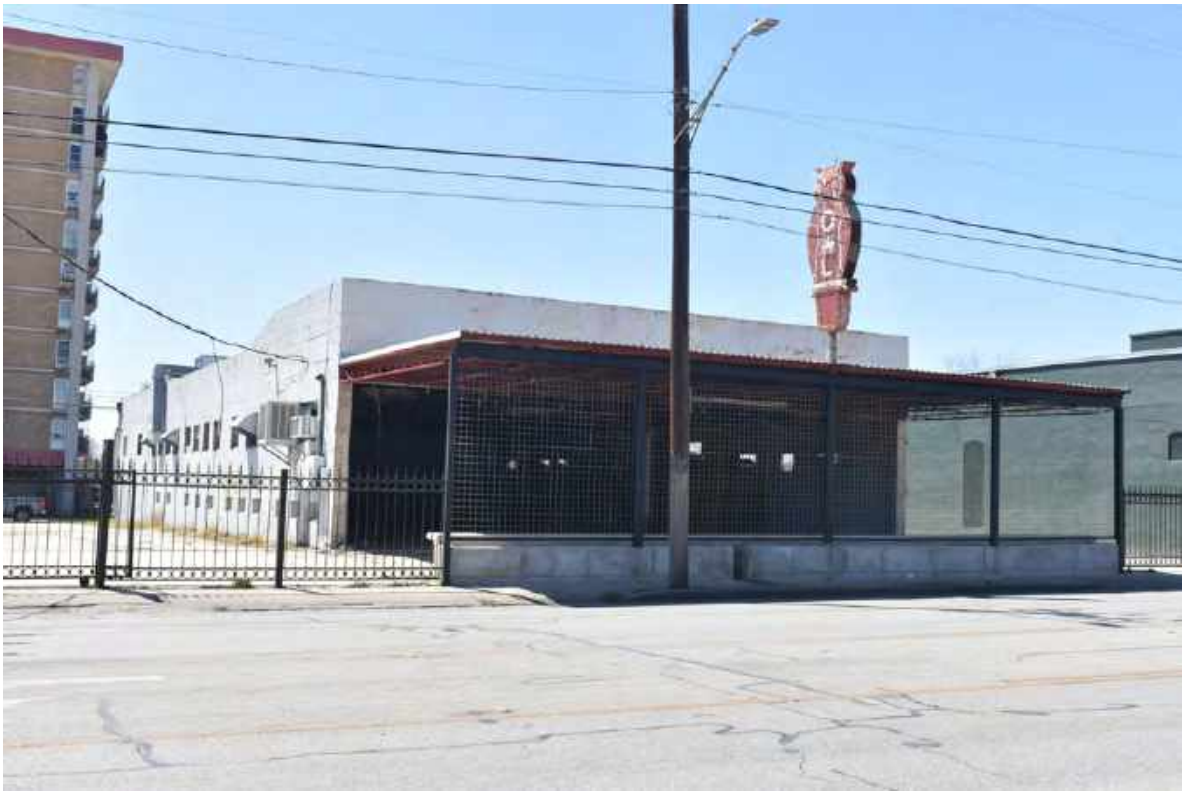
View facing northwest.

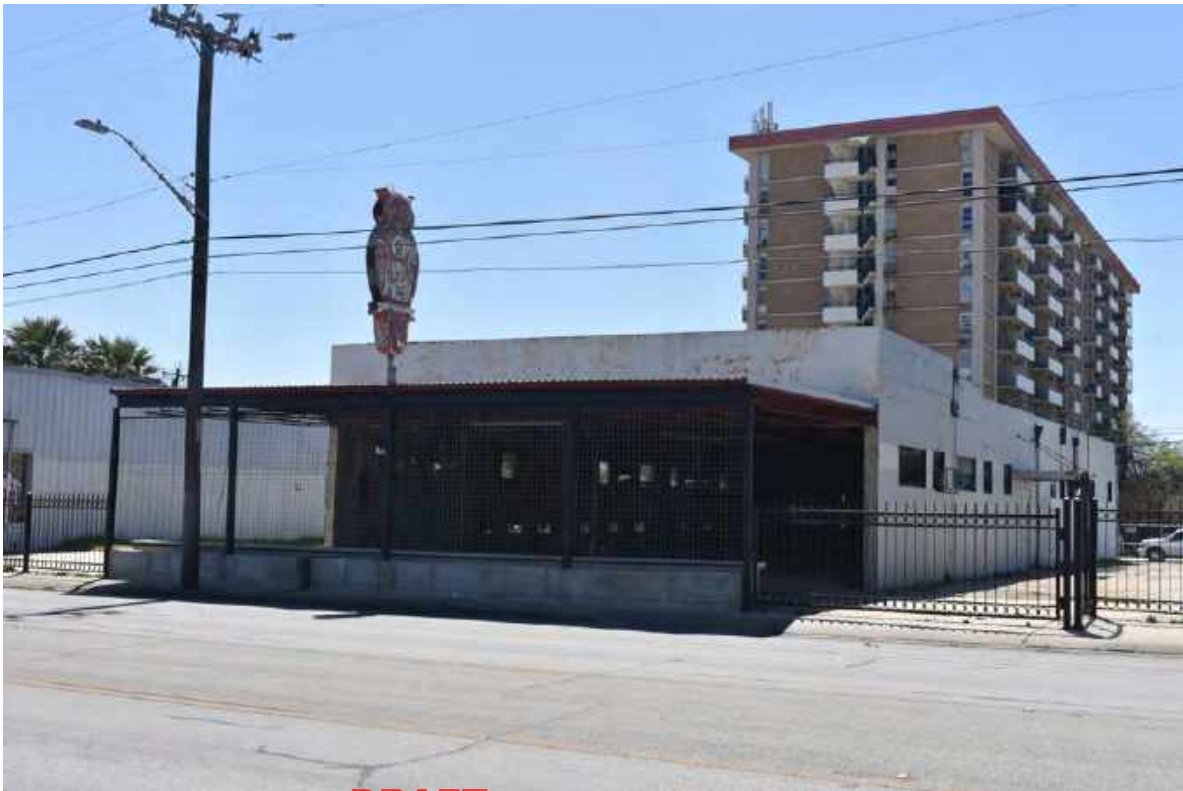
View facing southwest.

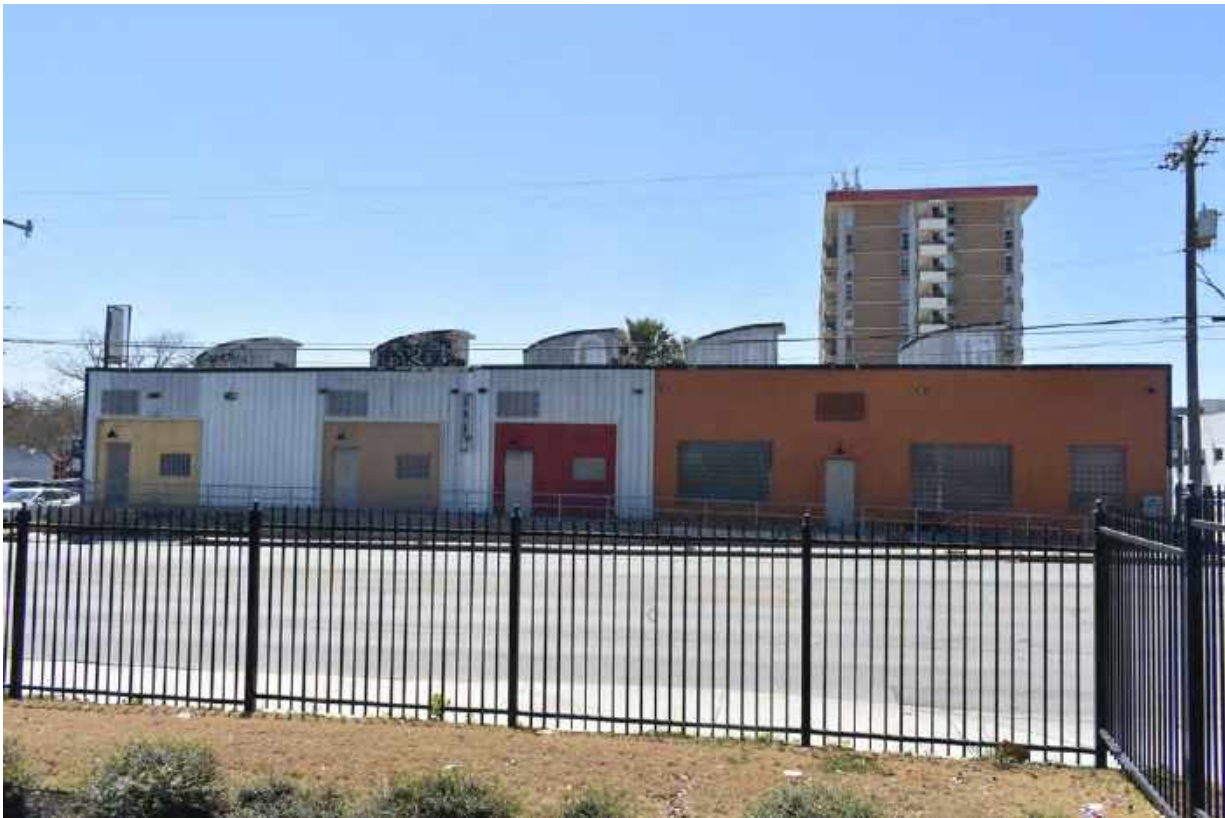
View facing west.

Type: Building	Exterior materials: aluminum siding stucco	Primary roof type: flat	Alterations: Wall cladding replaced - some Window opening(s) altered
Style: No style			
Form: Rectangular	Porch: N/A

Though it possesses integrity, this resource is utilitarian in nature. It was not found to embody distinctive characteristics of a type, period, or method of construction, represent the work of a master, or possess high artistic value. Additionally, no associations were identified linking it to events or persons of historic importance. Because the building offers neither a local interpretation of a standard design nor an undocumented construction technique, it has limited potential to yield important information. As a result, it is recommended not eligible for the NRHP under Criterion A, B, C, or D.

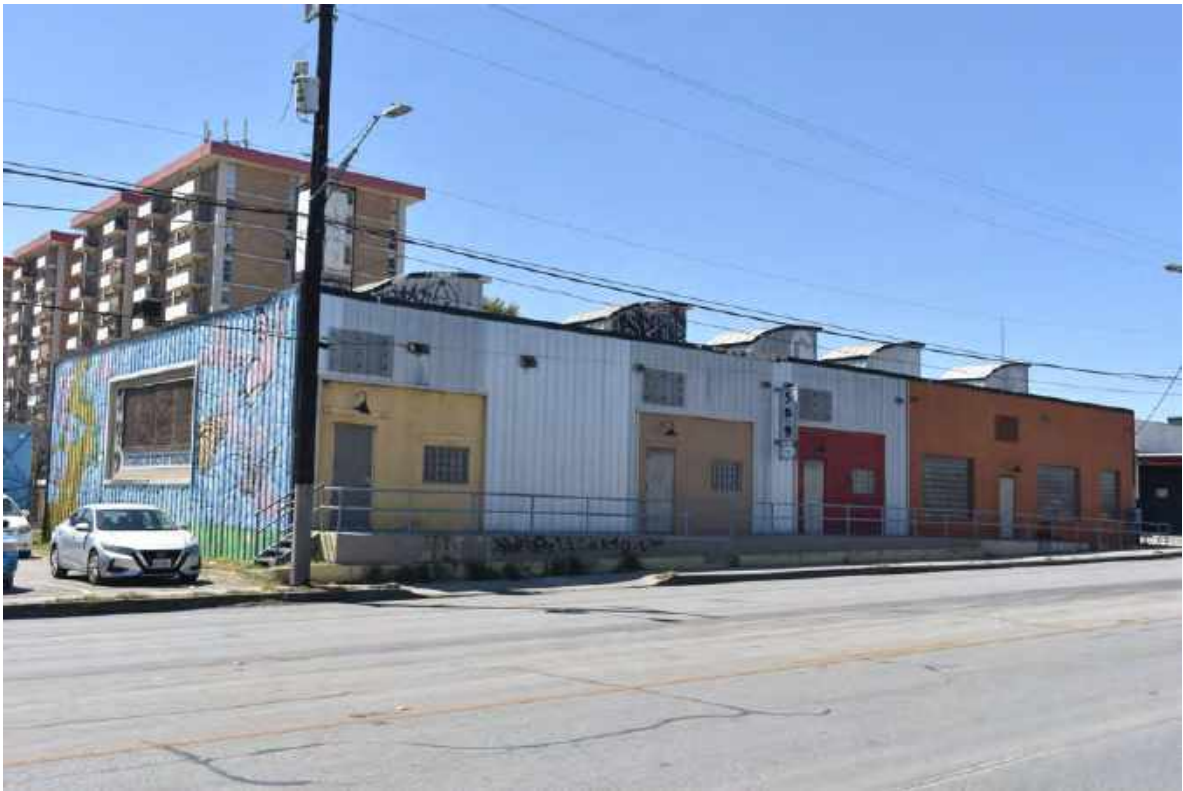
View facing northwest.

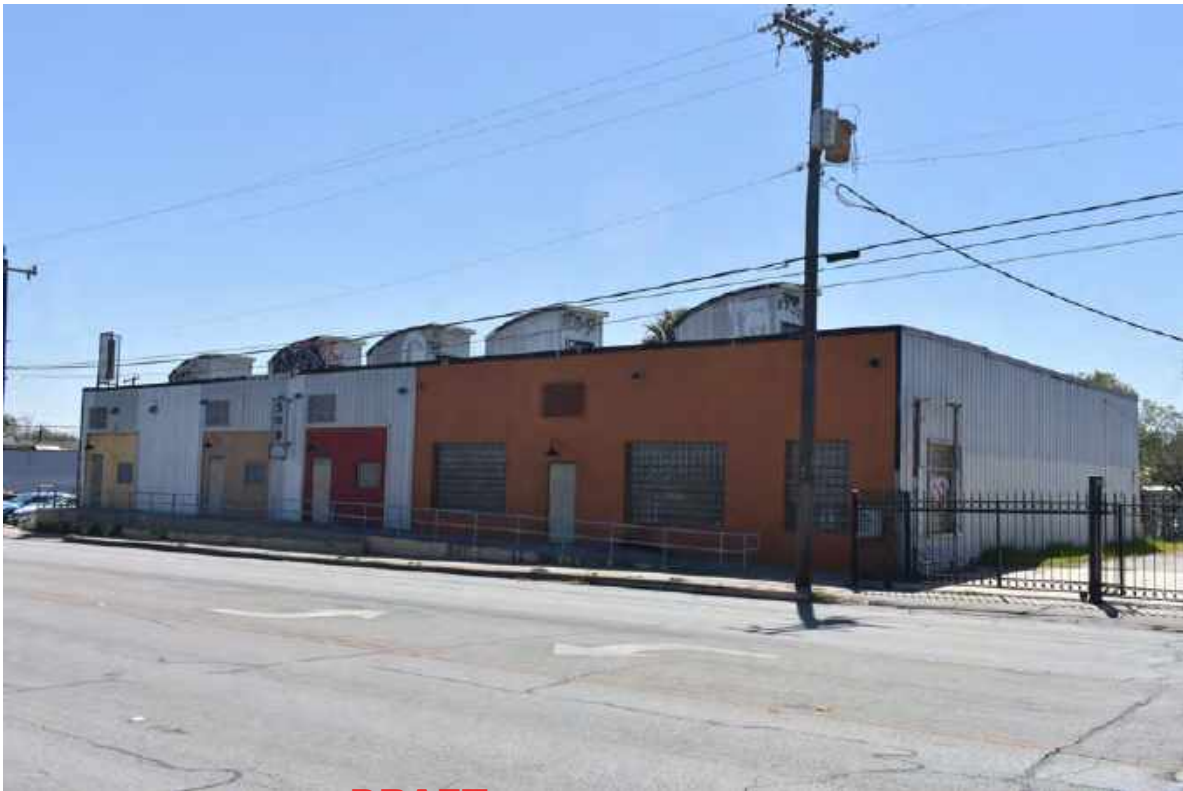
View facing southwest.

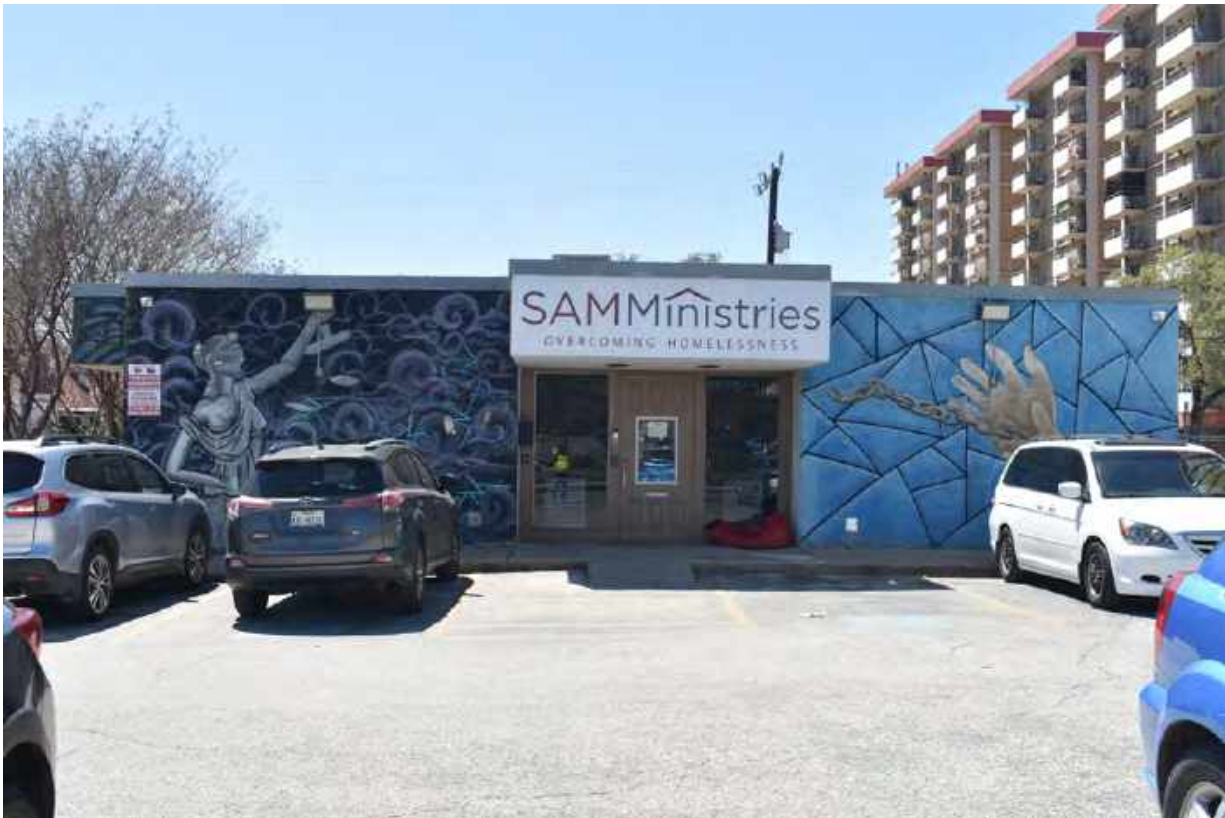
Resource A
(Historic-age);
view facing west.

Type: Building	Exterior materials: concrete	Primary roof type: flat	Alterations: Murals added Porch support(s) replaced Door (primary) opening altered Door (primary) replaced
Style: No style			
Form: Rectangular	Porch: N/A

This resource does not embody distinctive characteristics of a type, period, or method of construction and it does not represent the work of a master or possess high artistic value. Additionally, no associations were identified linking it to persons or events of historic importance. Because the building offers neither a local interpretation of a standard design nor an undocumented construction technique, it has limited potential to yield important information. As a result, it is recommended not eligible for the NRHP under Criterion A, B, C, or D.

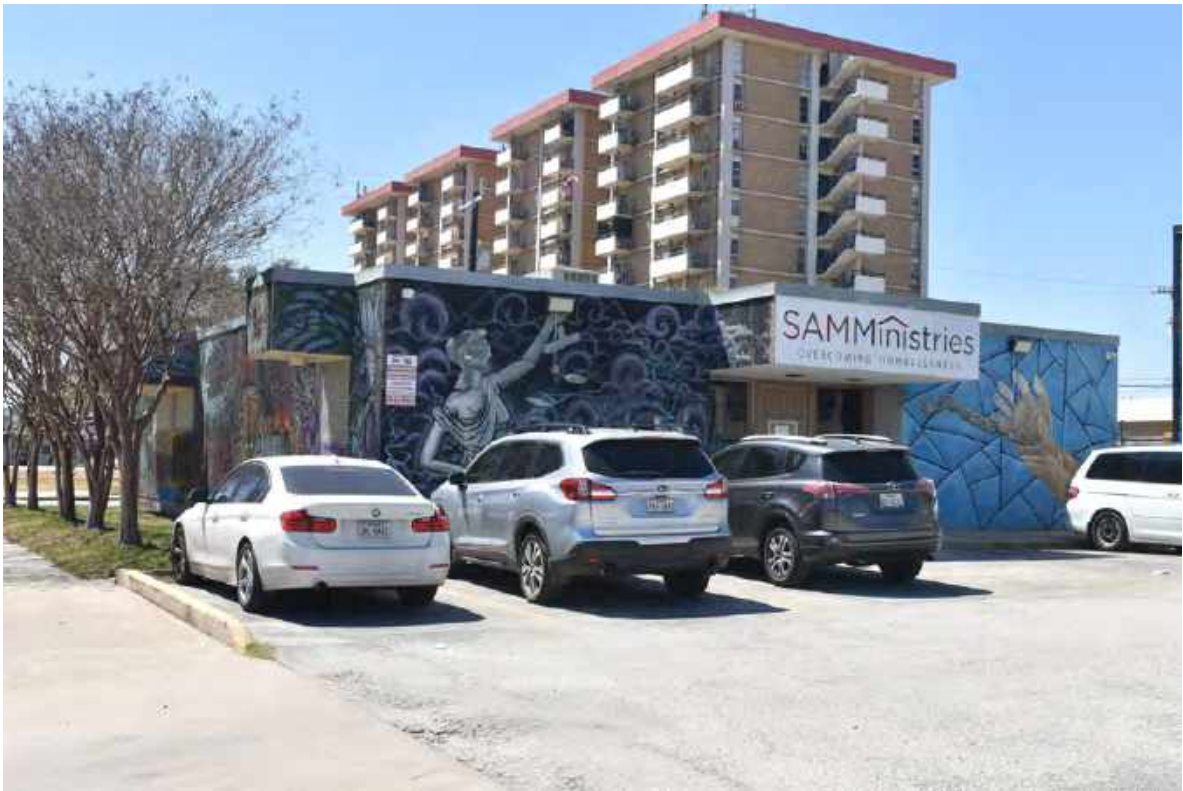
Resource A (Historic-age);
view facing northwest.

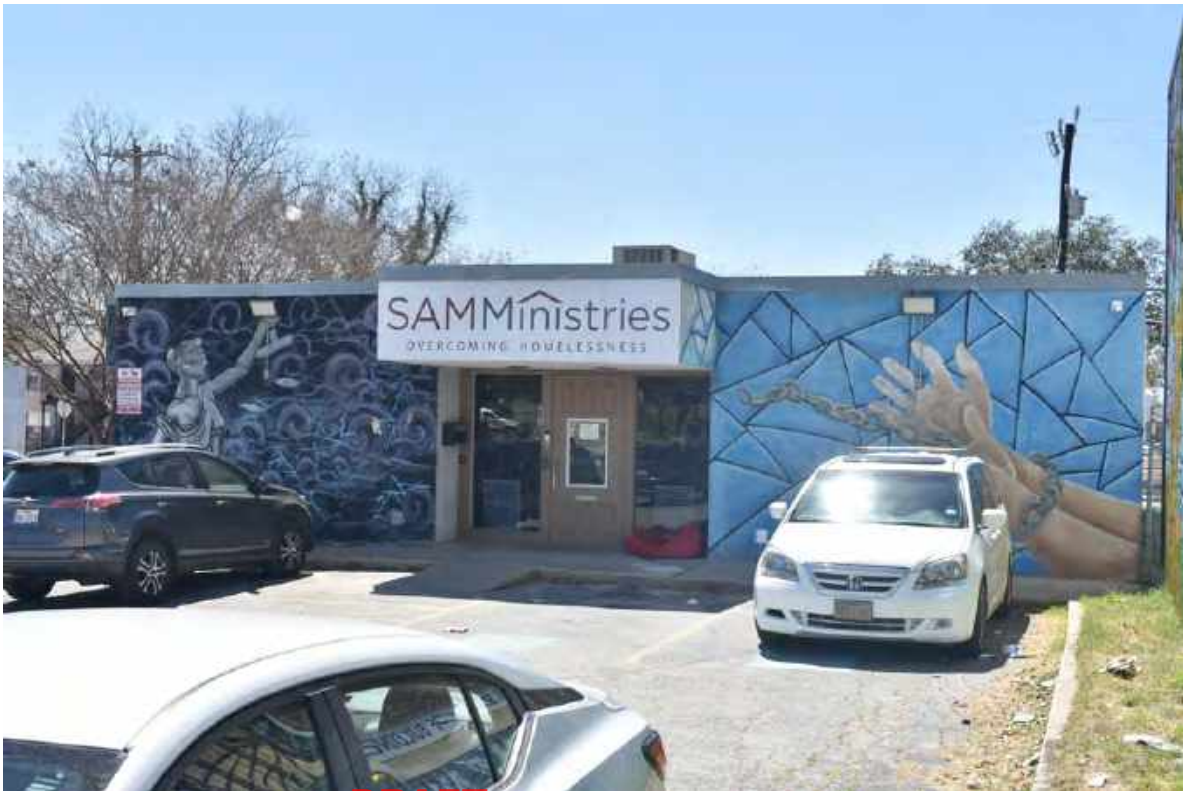
Resource A (Historic-age);
view facing southwest.

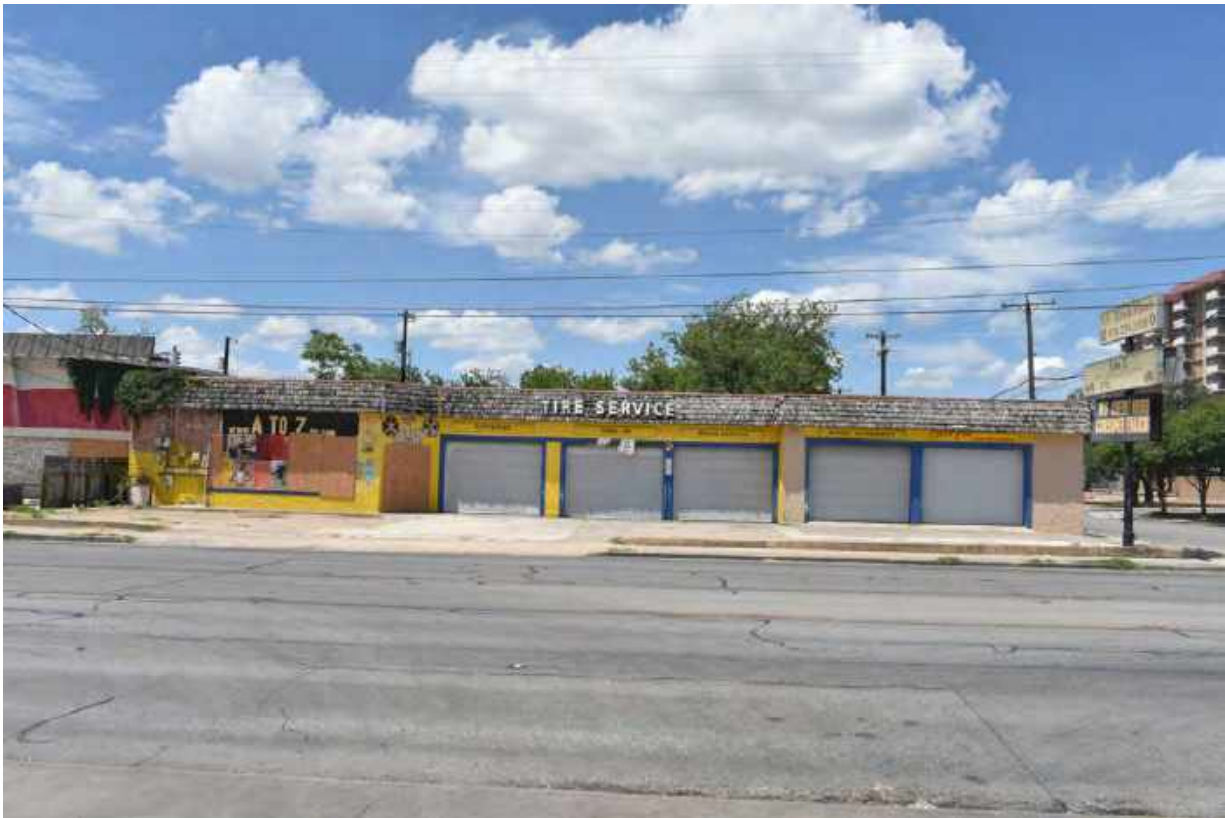
Resource A
(center) and
nonhistoric
Resource B (sign,
right); view facing
west.

Type: Building	Exterior materials: brick	Primary roof type: flat mansard	Alterations: Garage door(s) replaced Window(s) boarded Addition to primary elevation Brick/stone painted Mansard added
Style: No style			
Form: Rectangular	Porch: N/A

This resource is utilitarian in nature. It was not found to embody distinctive characteristics of a type, period, or method of construction, represent the work of a master, or possess high artistic value. Additionally, no associations were identified linking it to events or persons of historic importance. Furthermore, integrity has been diminished as outlined above. Because the building offers neither a local interpretation of a standard design nor an undocumented construction technique, it has limited potential to yield important information. As a result, it is recommended not eligible for the NRHP under Criterion A, B, C, or D.

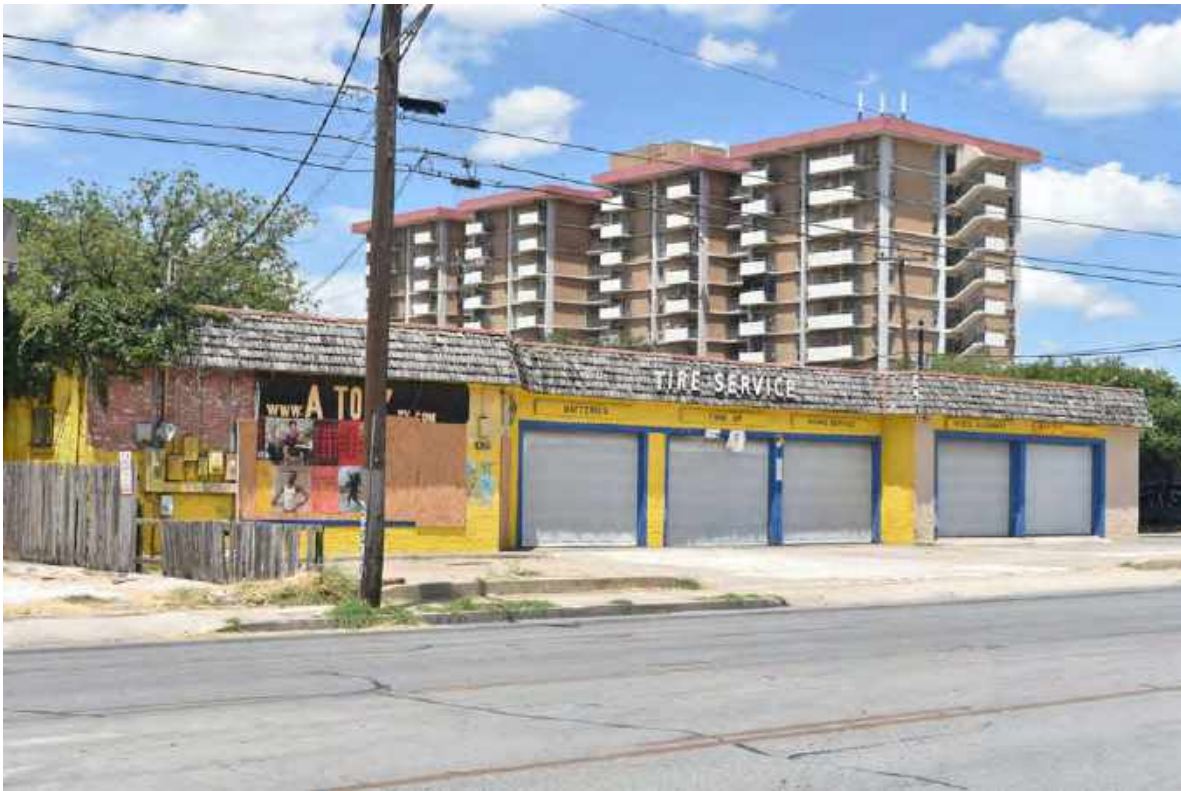
View facing northwest.

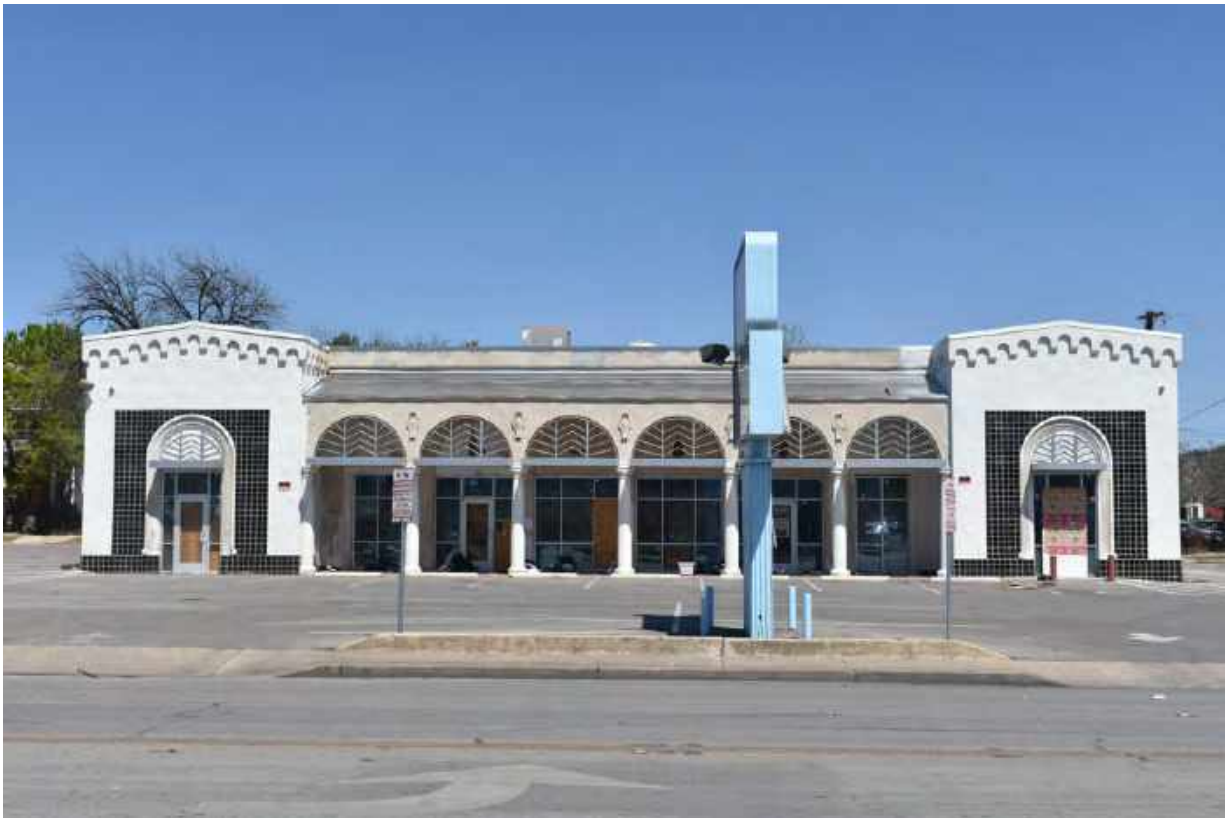
View facing northeast.

Type: Building	Exterior materials: stucco glazed brick/tile/block	Primary roof type: flat with parapet shed	Alterations: Awning(s) added Decorative elements added Storefront altered/replaced Wall cladding replaced - some Window opening(s) infilled Roof replaced w/ incomp. materials
Style: Spanish Colonial Revival			
Form: Rectangular	Porch: partial-width integrated

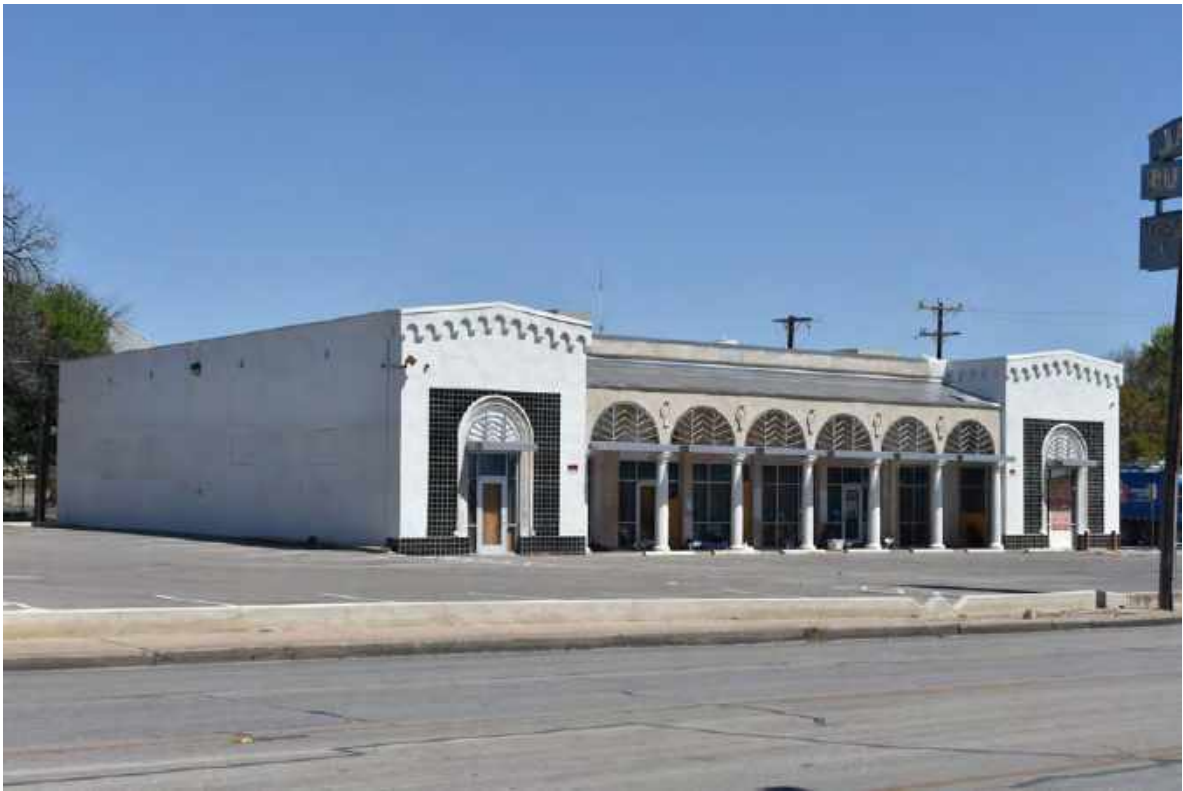
View facing east.

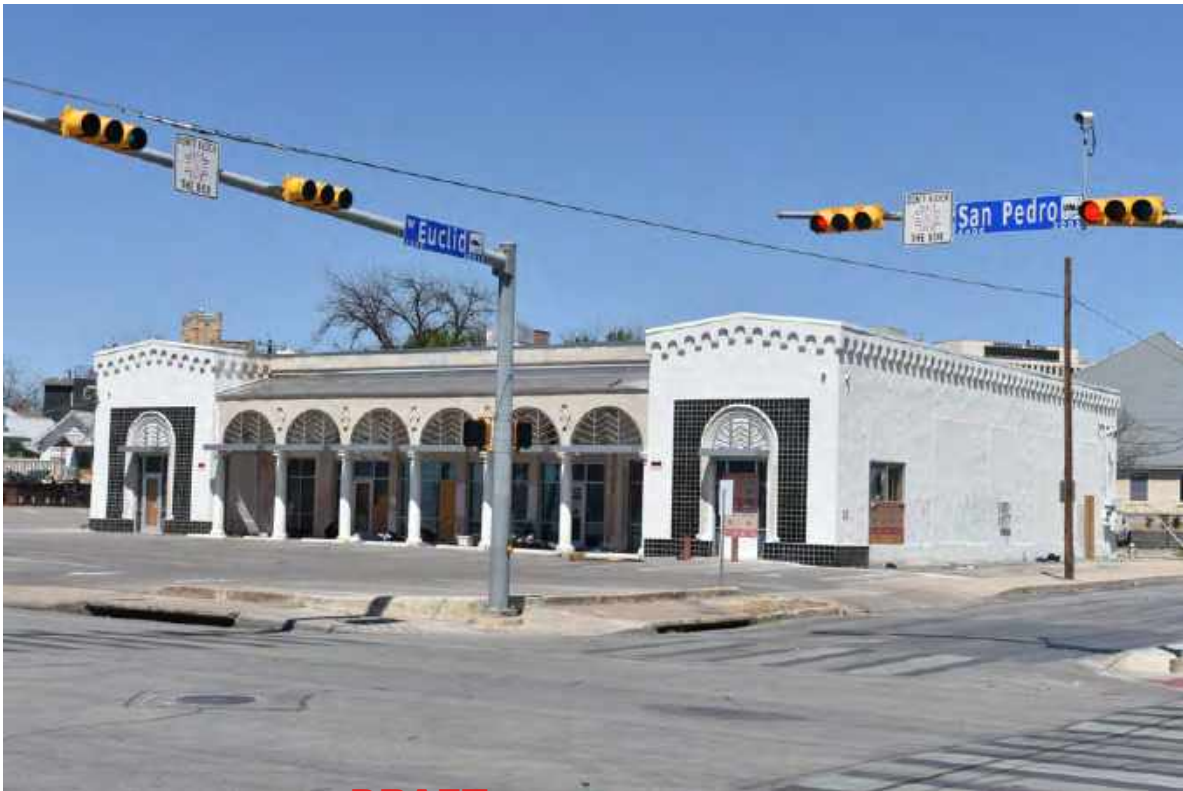
View facing northeast.

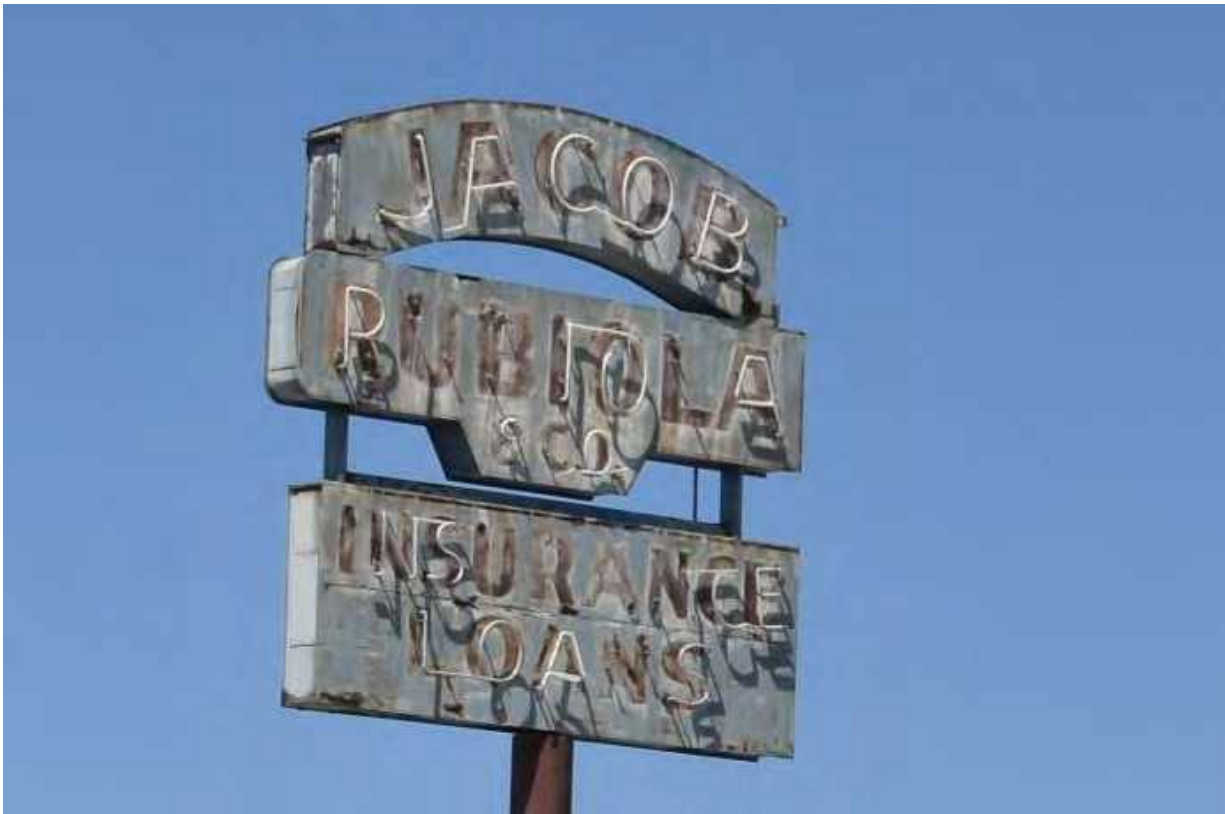
View facing
northeast.

Type: Object	Exterior materials: metal	Primary roof type: N/A	Alterations: Neon missing Deteriorated
Style: No style			
Form: Linear	Porch: N/A

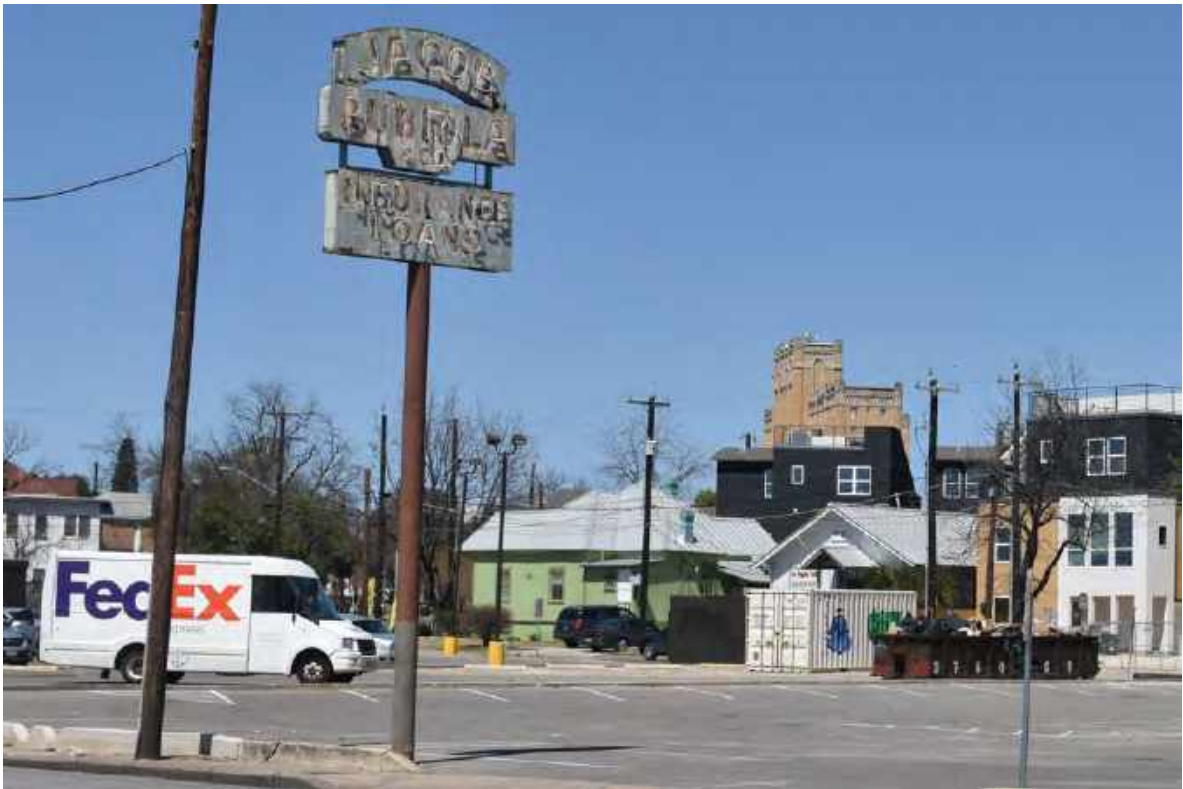
View facing northeast.

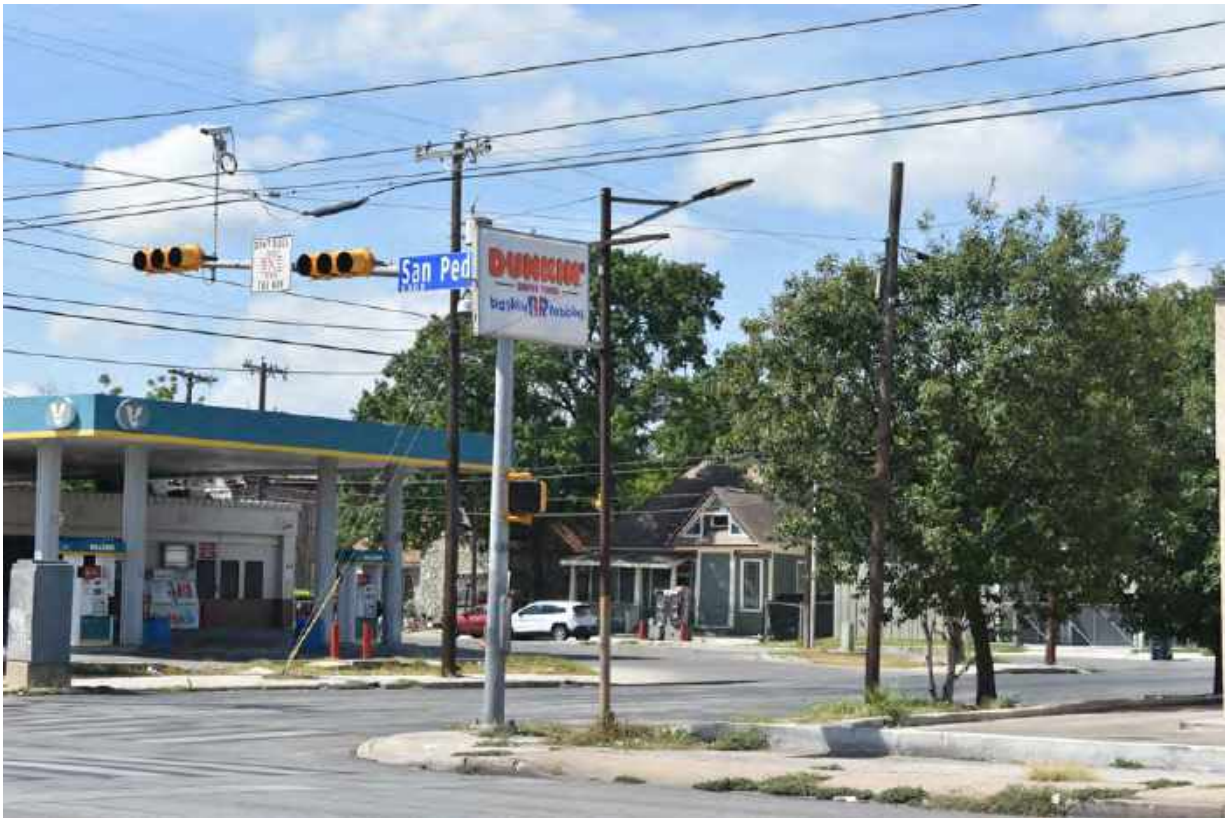
View facing southwest.

Type: Structure	Exterior materials: metal	Primary roof type: N/A	Alterations: Signage replaced
Style: No style			
Form: Linear	Porch: N/A

This resource does not embody distinctive characteristics of a type, period, or method of construction and it does not represent the work of a master or possess high artistic value. Additionally, no associations were identified linking it to persons or events of historic importance. Furthermore, integrity has been diminished as outlined above. Because the building offers neither a local interpretation of a standard design nor an undocumented construction technique, it has limited potential to yield important information. As a result, it is recommended not eligible for the NRHP under Criterion A, B, C, or D.

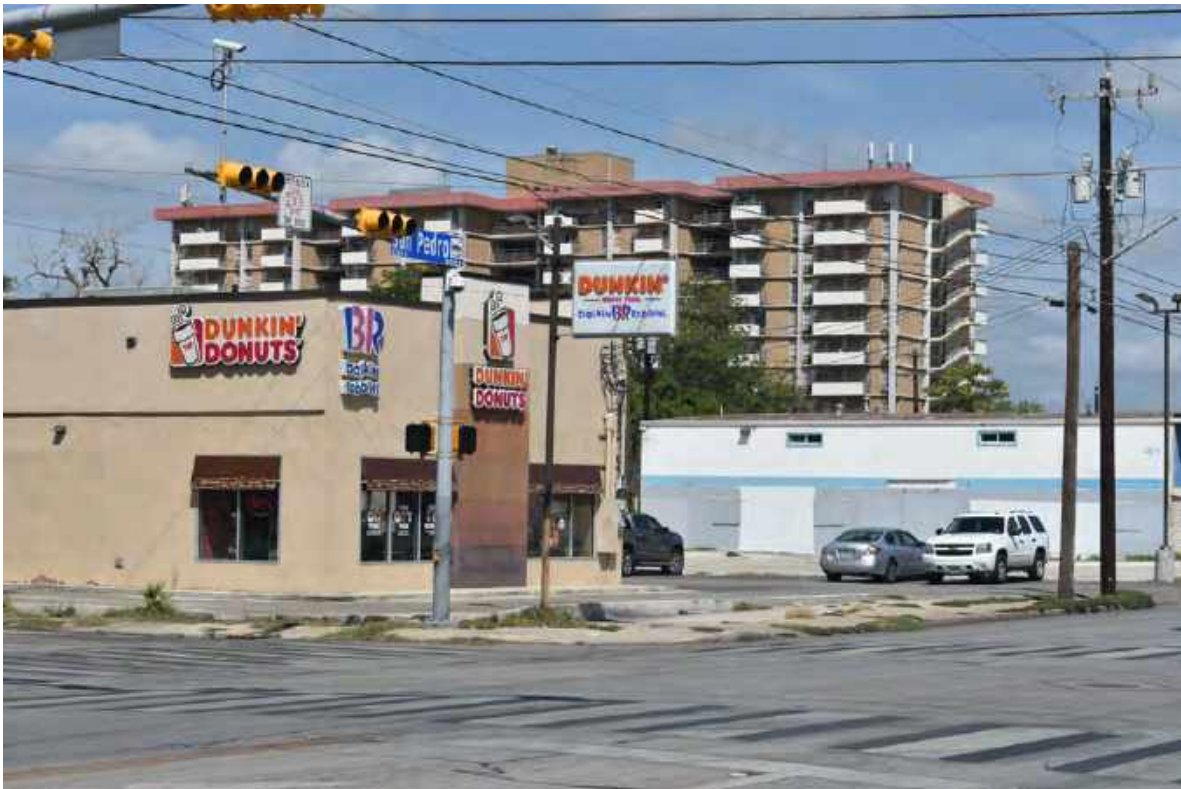
View facing northwest.
