APPENDIX C SURVEY FORMS (CONTINUED)

DRAFT
(Information is under FTA review and is subject to change.)

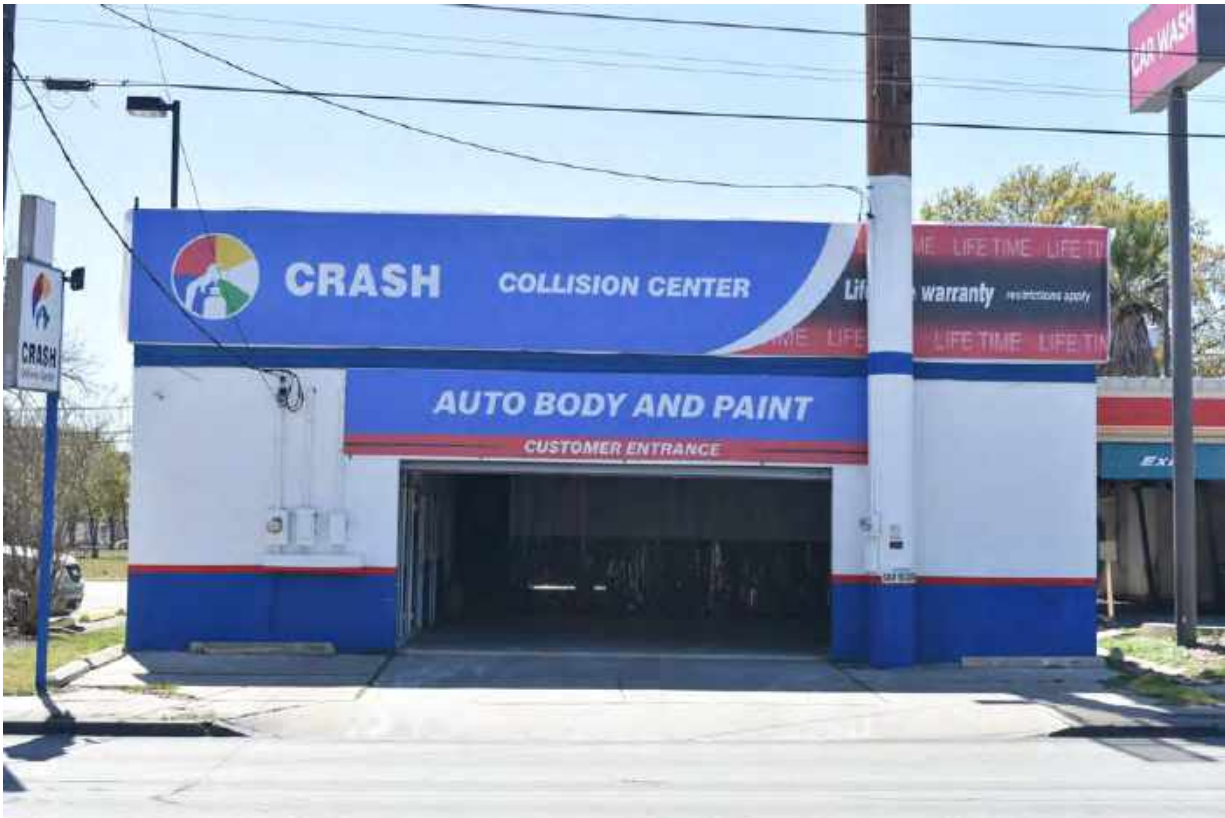
View facing southwest.

Type: Building	Exterior materials: stucco	Primary roof type: gable, front	Alterations: Awning(s) added Garage door(s) replaced Door/entrance enclosed Roofline altered
Style: No style			
Form: Rectangular	Porch: N/A

This resource is utilitarian in nature. It was not found to embody distinctive characteristics of a type, period, or method of construction, represent the work of a master, or possess high artistic value. Additionally, no associations were identified linking it to events or persons of historic importance. Furthermore, integrity has been diminished as outlined above. Because the building offers neither a local interpretation of a standard design nor an undocumented construction technique, it has limited potential to yield important information. As a result, it is recommended not eligible for the NRHP under Criterion A, B, C, or D.

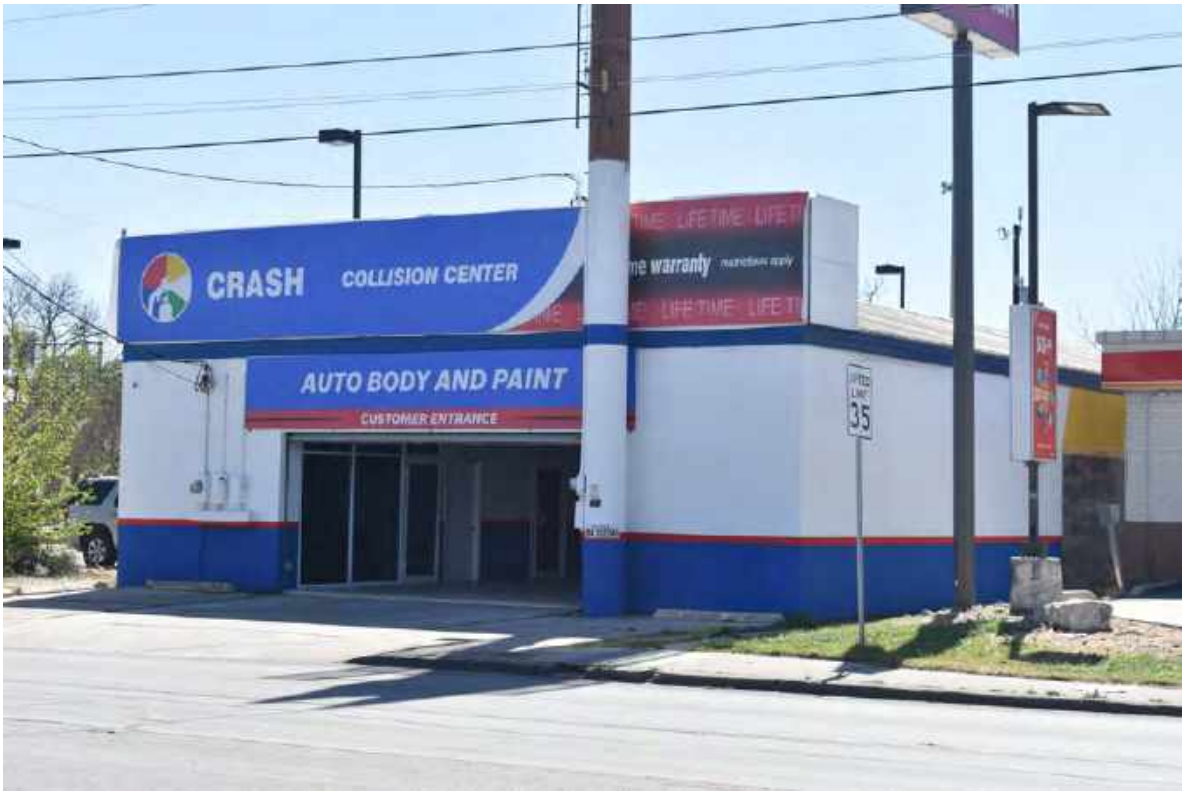
View facing south.

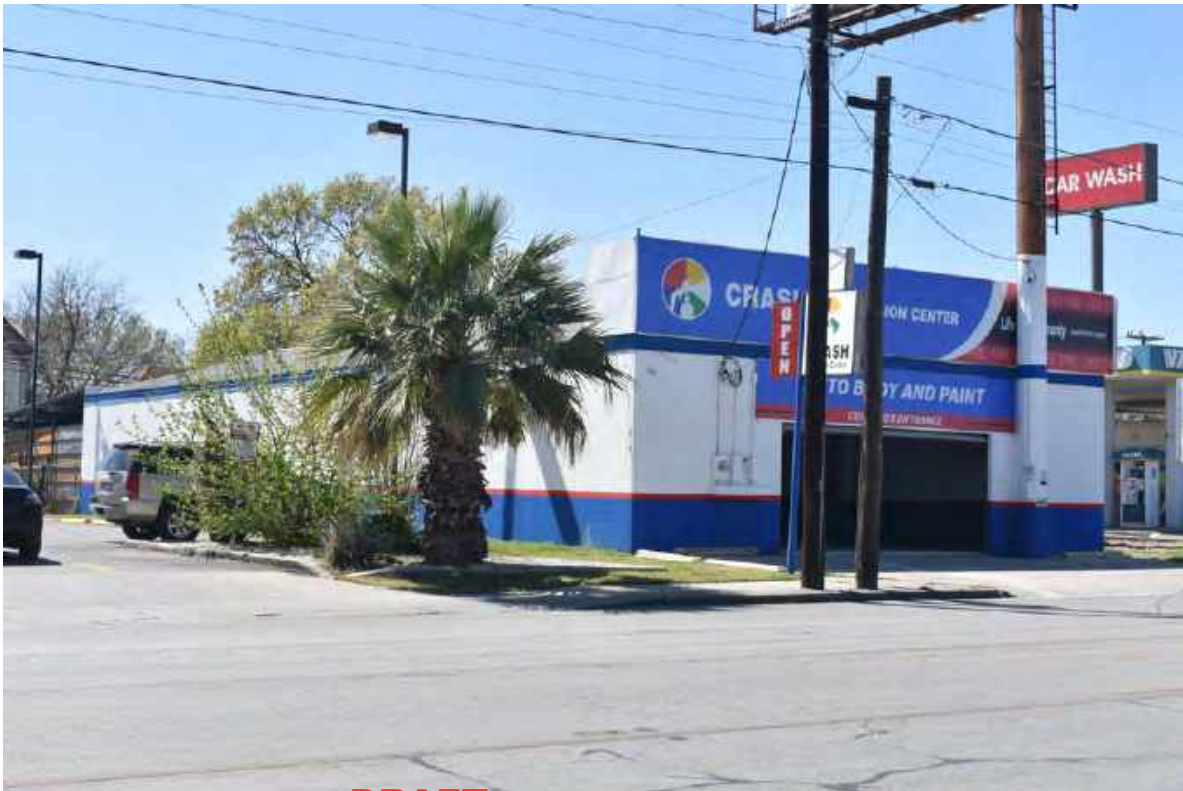
View facing north.

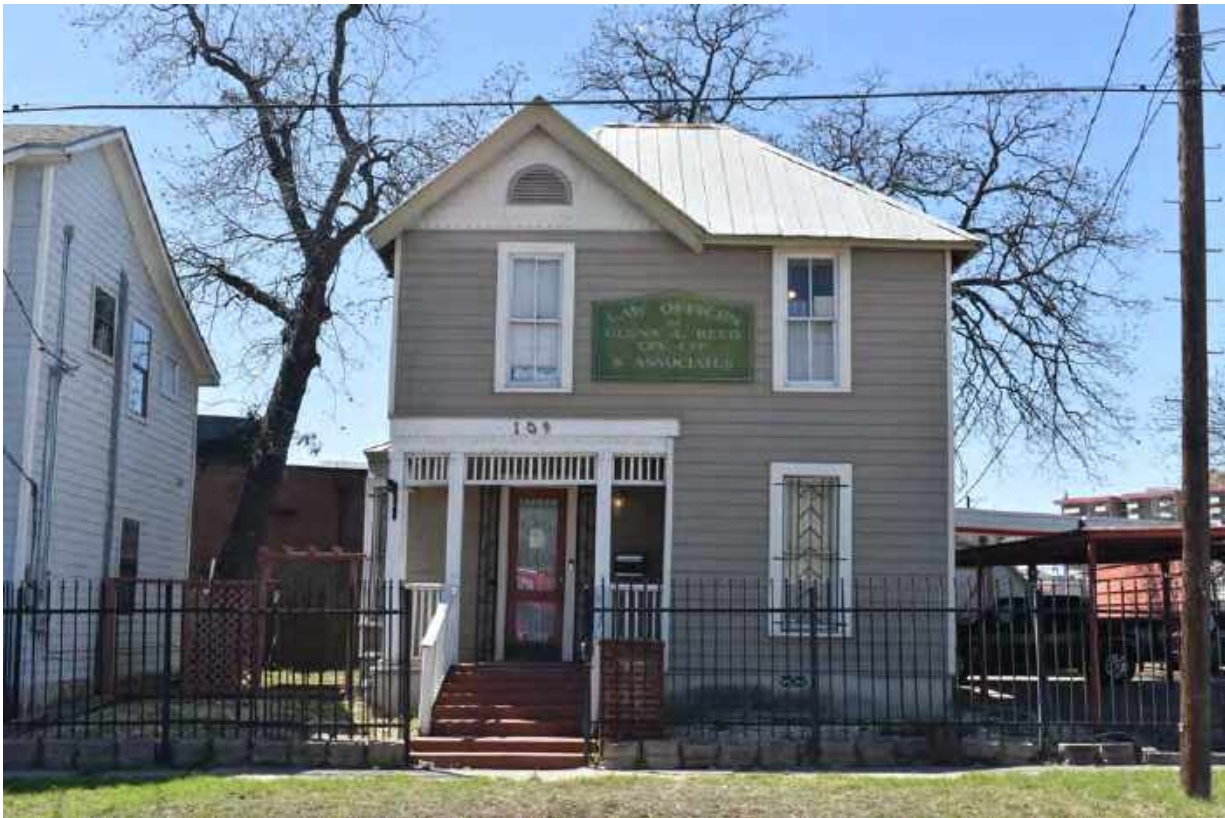
View facing northwest.

Type: Building	Exterior materials: engineered wood siding	Primary roof type: gable-on-hip	Alterations: Roof replaced w/ incomp. materials Addition to rear/side elevation Wall cladding replaced Window frames replaced Paving at front stairs replaced Security bars added
Style: Folk Victorian			
Form: Rectangular	Porch: partial-width integrated

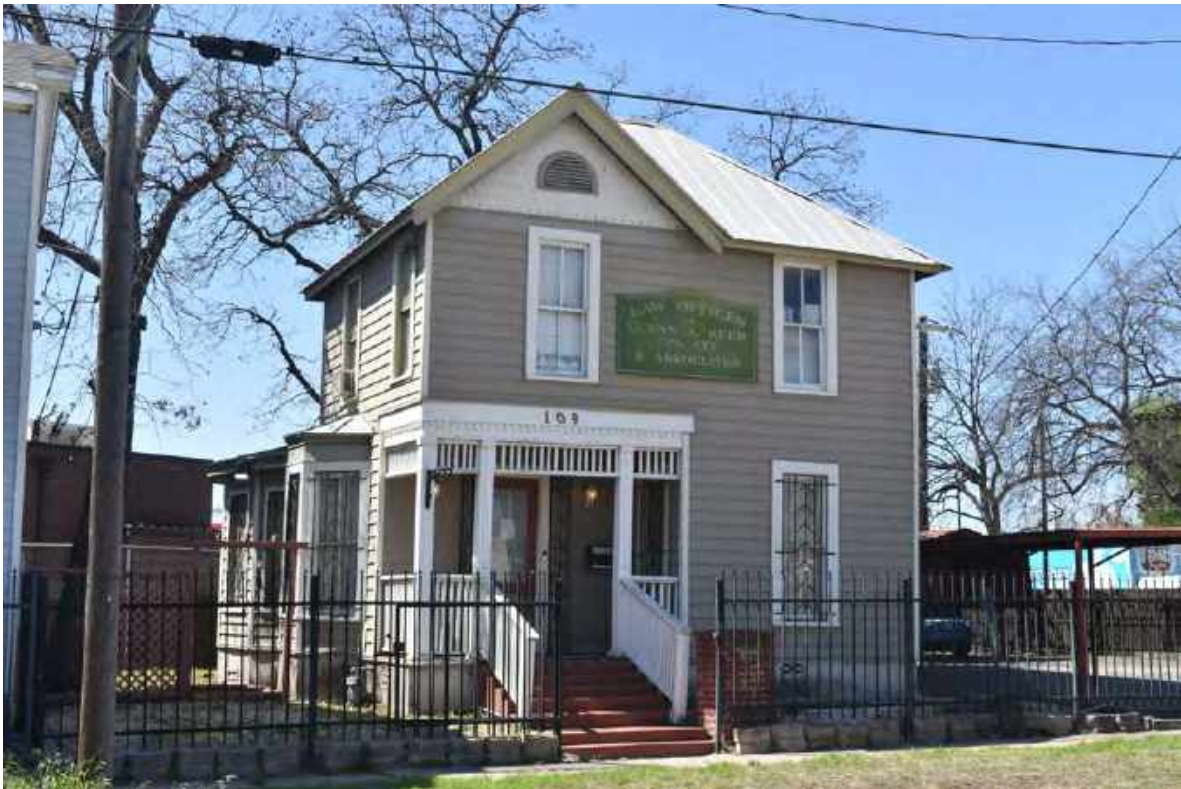
View facing north.

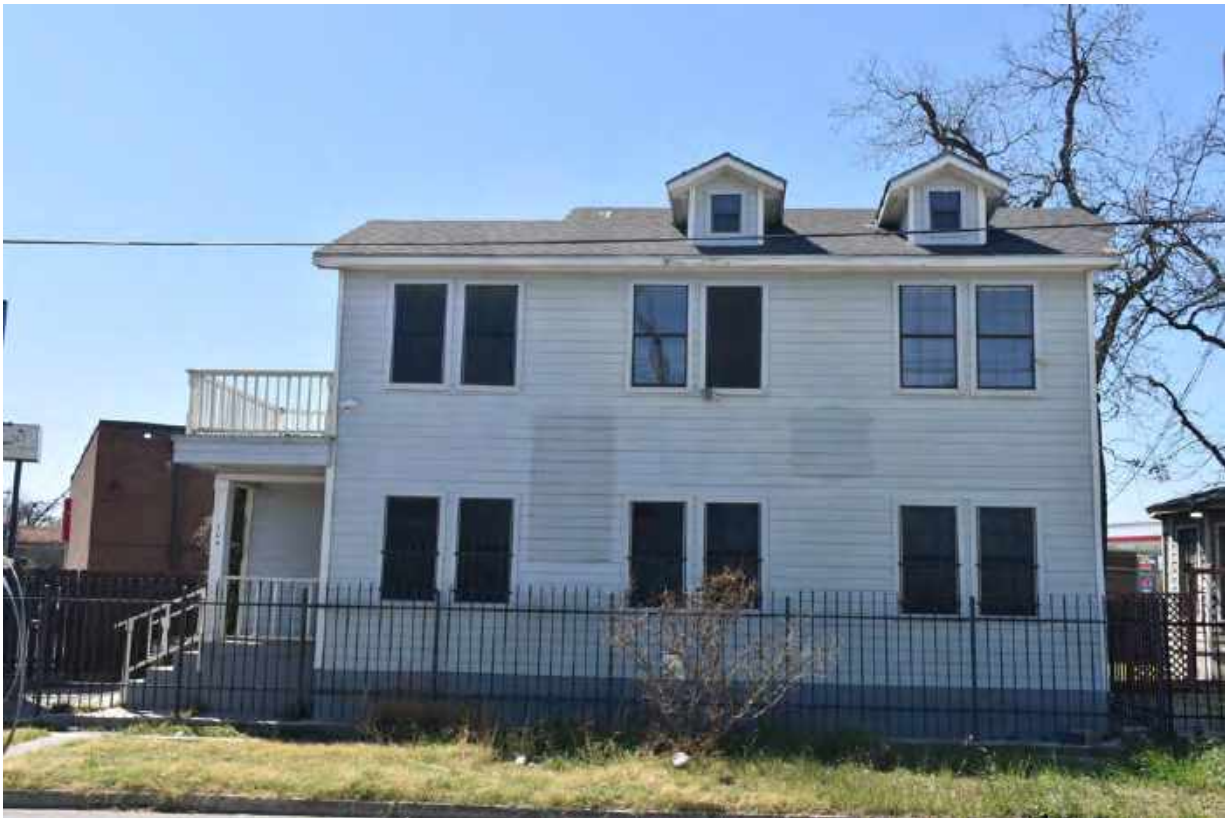
View facing west.

Type: Building	Exterior materials: wood horizontal board	Primary roof type: gable, front	Alterations: Completely modified from its original appearance Addition to primary/side elevation Wall cladding replaced Windows replaced – some Door/entrance enclosed
Style: No style			
Form: Irregular	Porch: partial-width projecting

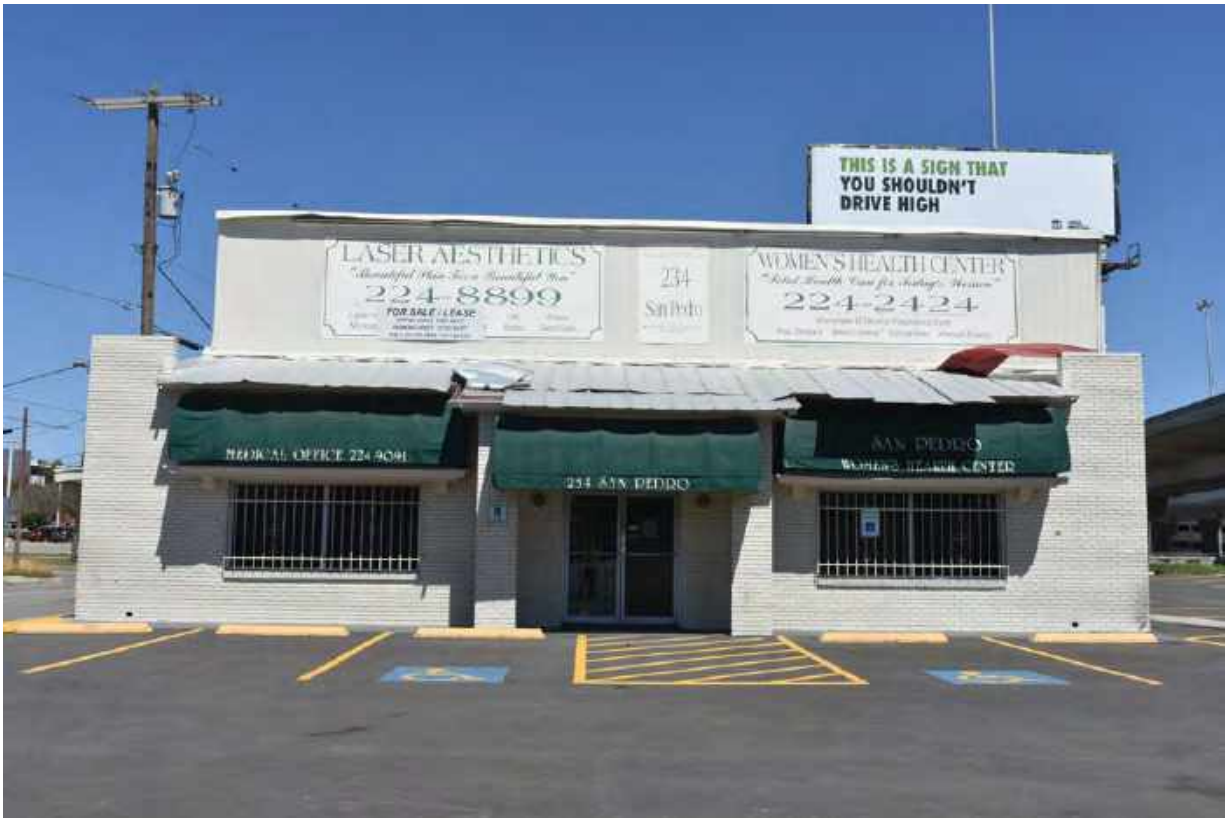
View facing east.

The resource is present on the 1950 Sanborn map. It is noted as being used as an automotive repair shop. The 1950 Sanborn map reveals that the resource was originally located to the rear of a gas station which has since been demolished. The garage appears to have closed in 1967 (San Antonio Express 1967). The resource was then occupied by a typewriter rental company through the 1970s (Express and News 1973). In addition to this historic-age building (Resource A), this parcel has a historic-age standalone sign (Resource B).

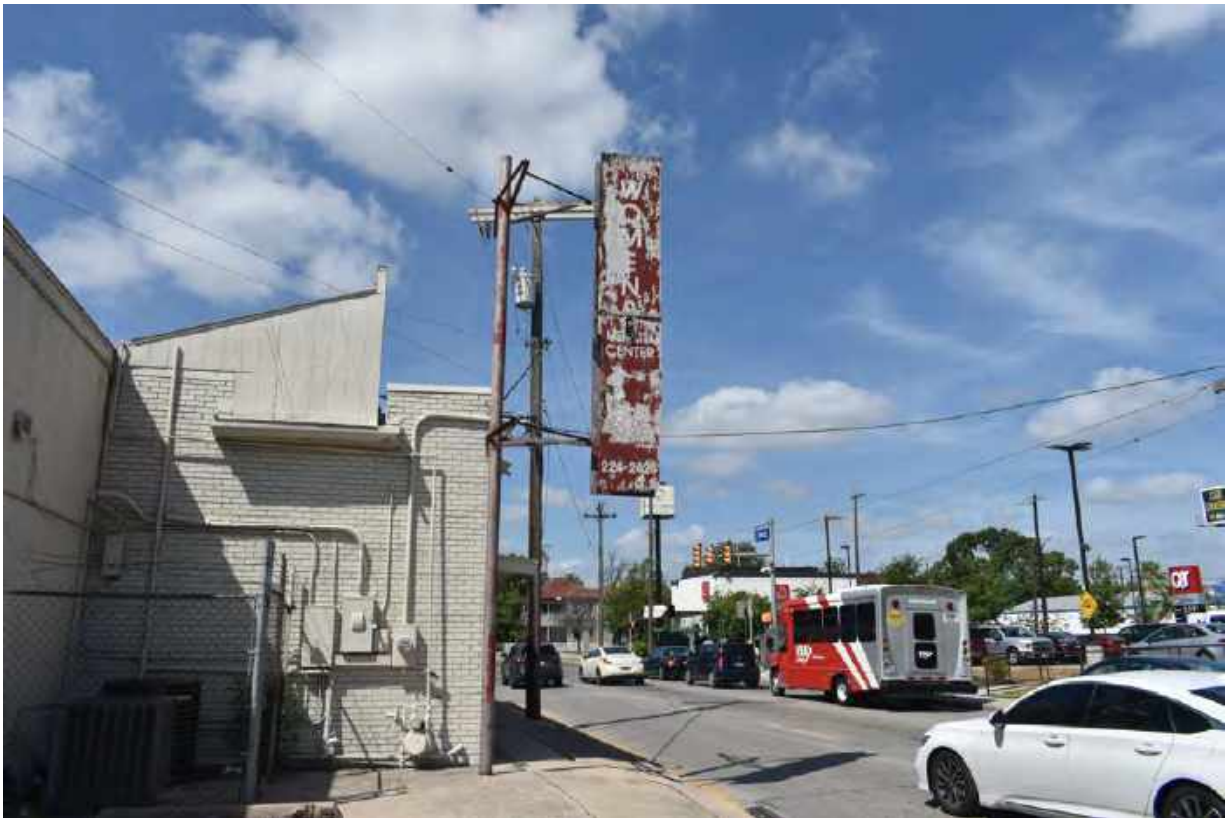
Resource ID: 174B **Parcel ID:** 108900 **Year Built:** ca. 1946 **Year Source:** Estimate

View facing southwest.

This sign does not embody distinctive characteristics of a type, period, or method of construction and it does not represent the work of a master or possess high artistic value. Additionally, no associations were identified linking it to persons or events of historic importance. Because the building offers neither a local interpretation of a standard design nor an undocumented construction technique, it has limited potential to yield important information. As a result, it is recommended not eligible for the NRHP under Criterion A, B, C, or D.

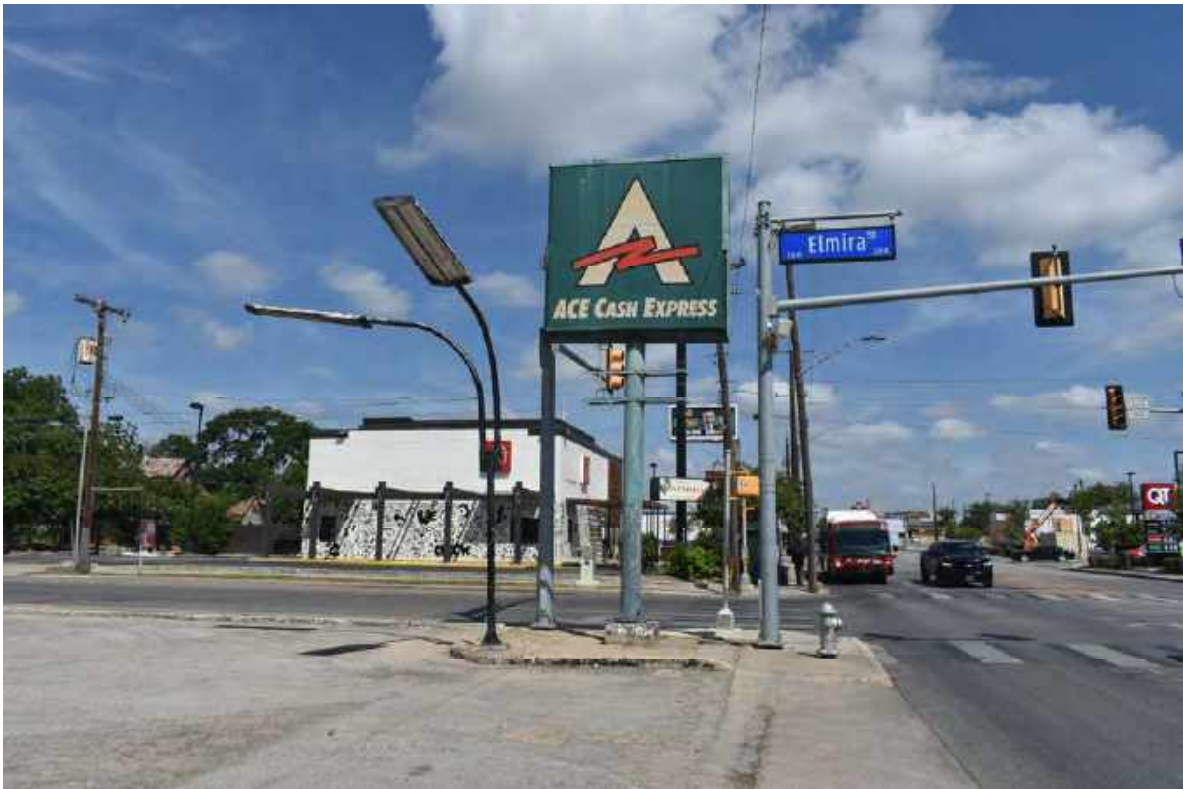
Resource ID: 175A
Parcel ID: 108894 **Address:** 231 SAN PEDRO AVE, SAN ANTONIO, TX 78212

Resource B (left, light posts)
and nonhistoric Resource C
(center, sign); view facing
northwest

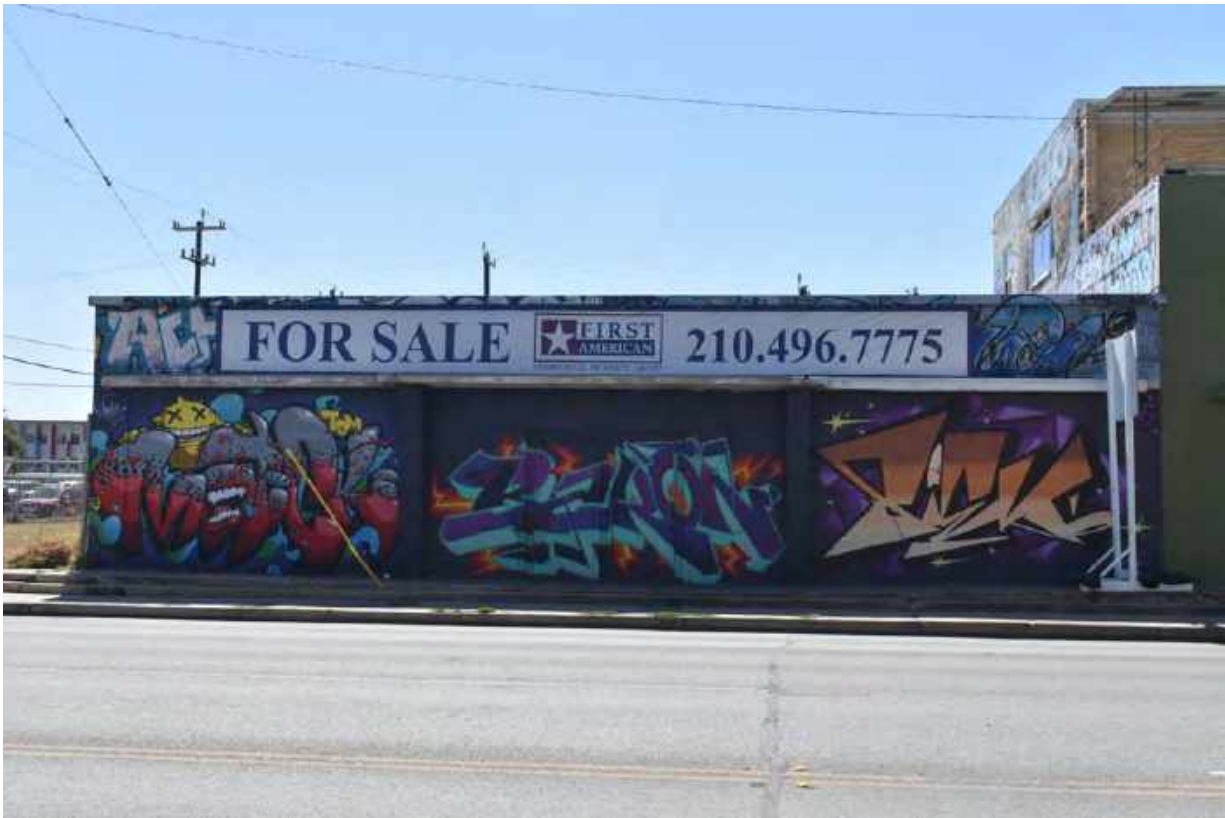
View facing southwest.

Type: Building	Exterior materials: stucco	Primary roof type: flat	Alterations: Door (primary) replaced Brick/stone painted
Style: No style	brick glass block		
Form: Rectangular	Porch: N/A

Though it possesses integrity, this resource is utilitarian in nature. It was not found to embody distinctive characteristics of a type, period, or method of construction, represent the work of a master, or possess high artistic value. Additionally, no associations were identified linking it to events or persons of historic importance. Because the building offers neither a local interpretation of a standard design nor an undocumented construction technique, it has limited potential to yield important information. As a result, it is recommended not eligible for the NRHP under Criterion A, B, C, or D.

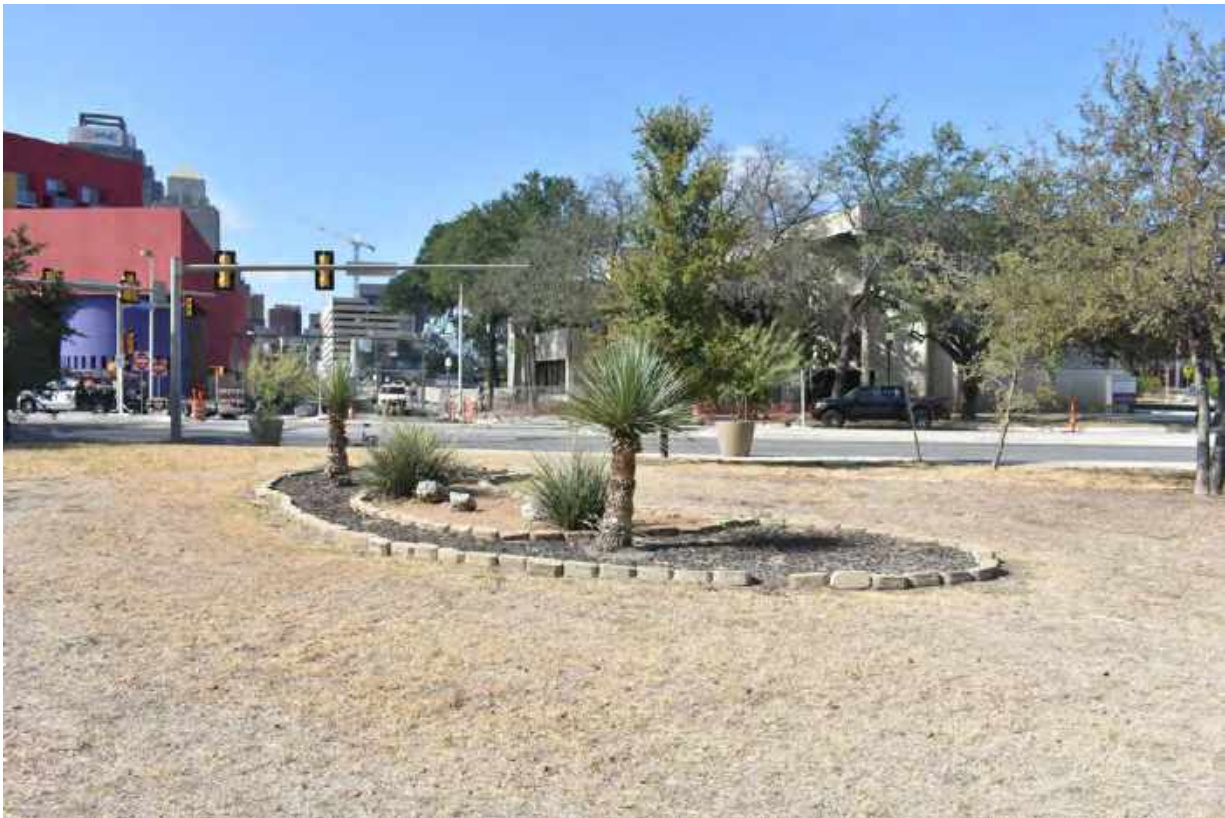
View facing south.

Alterations:
Park bench missing

Romana Plaza Park was named after Romana Avenue, which was renamed Navarro Street at an unknown date. Sanborn Insurance maps indicate the park has been city property since at least 1911 when police and fire stations were located on the north end (1911-1952). From the 1950s until the early 1970s the park was bisected by Soledad Street that terminated at Camden street. The park has a kidney shaped landscape feature, and its single park bench is missing.

This resource does not embody distinctive characteristics of a type, period, or method of construction and it does not represent the work of a master or possess high artistic value. Additionally, no associations were identified linking it to persons or events of historic importance. Furthermore, integrity has been diminished due to missing lawn furniture. Because the building offers neither a local interpretation of a standard design nor an undocumented construction technique, it has limited potential to yield important information. As a result, it is recommended not eligible for the NRHP under Criterion A, B, C, or D.

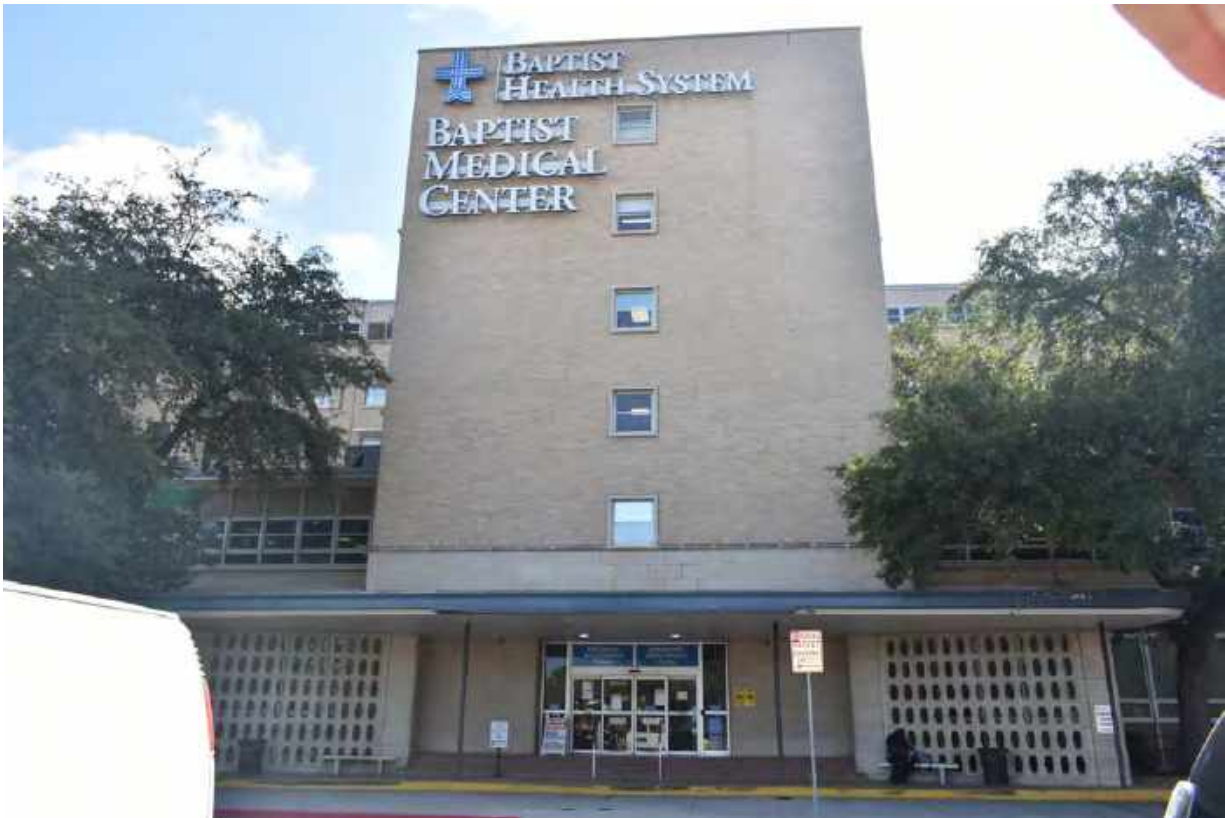
View of main entrance; view facing northeast

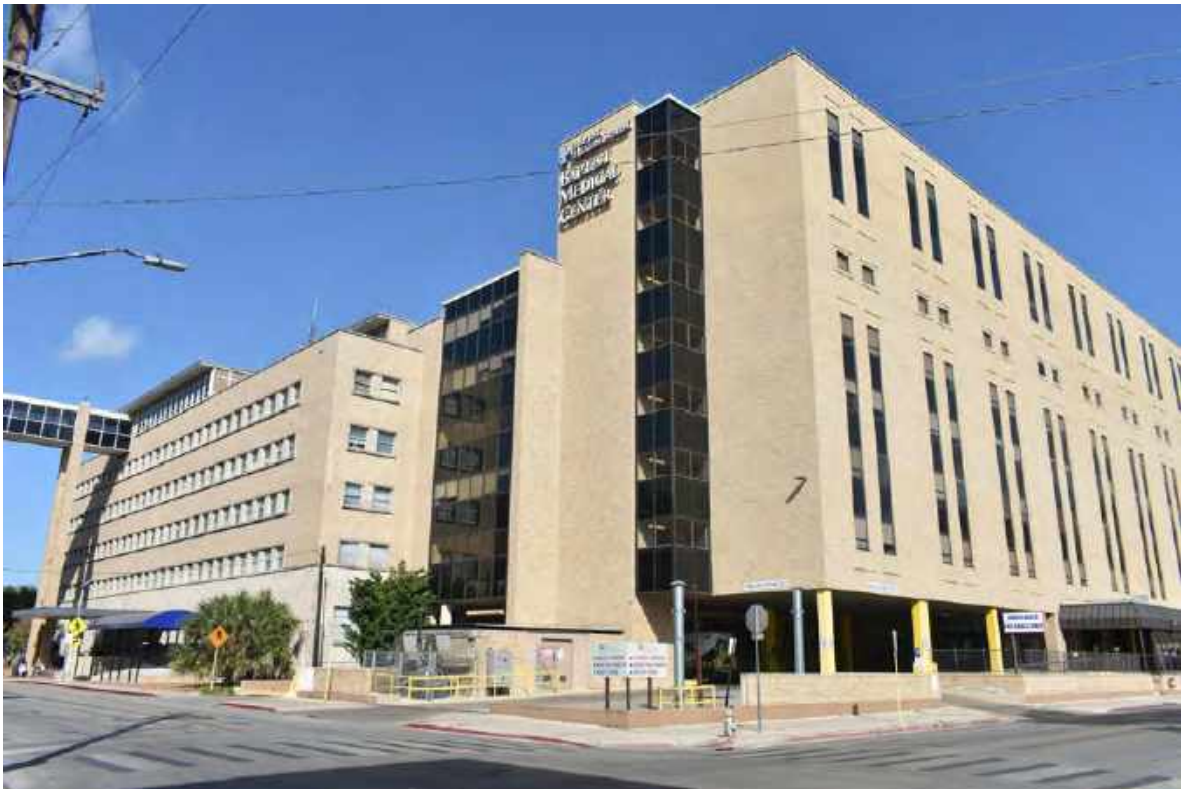
Resource ID: 178
Parcel ID: 108998 **Address:** 111 DALLAS ST, SAN ANTONIO, TX 78205

View of original unit (left) and
ca. 1980 addition (right); view
facing west

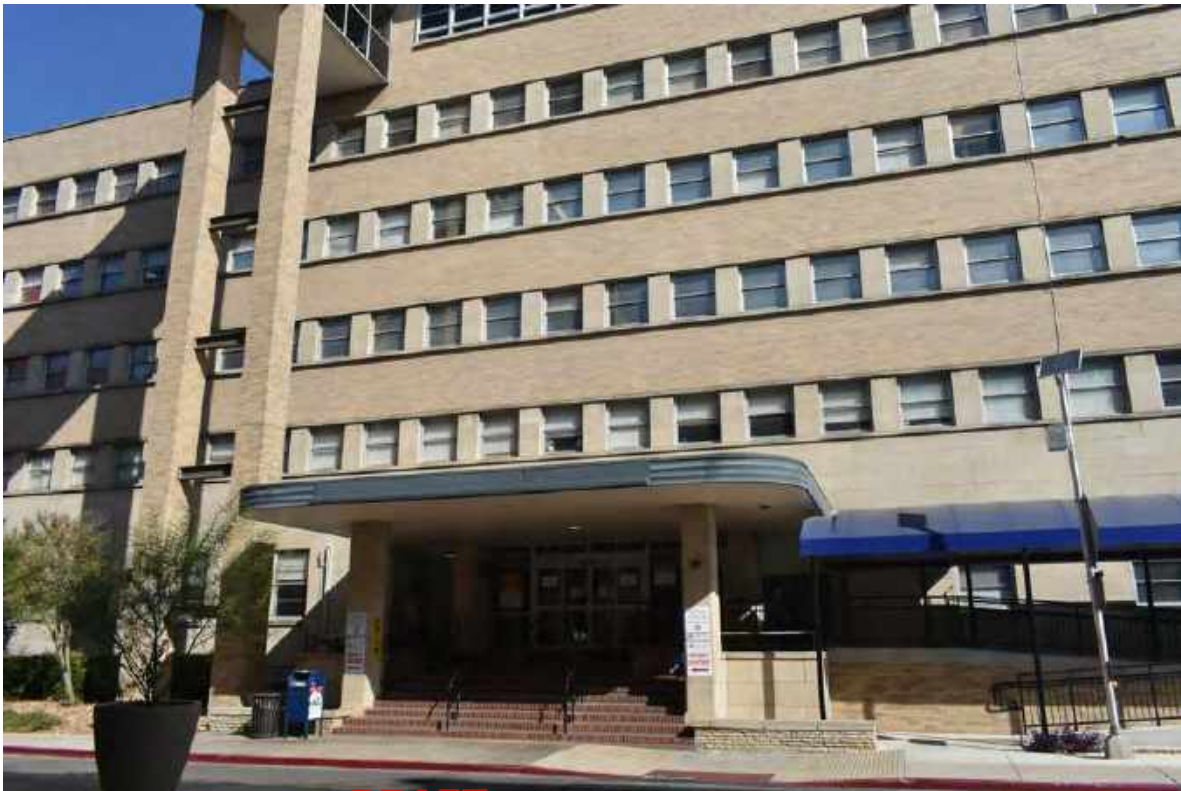
Detail of former main
entrance on 1949 building;
view facing northwest

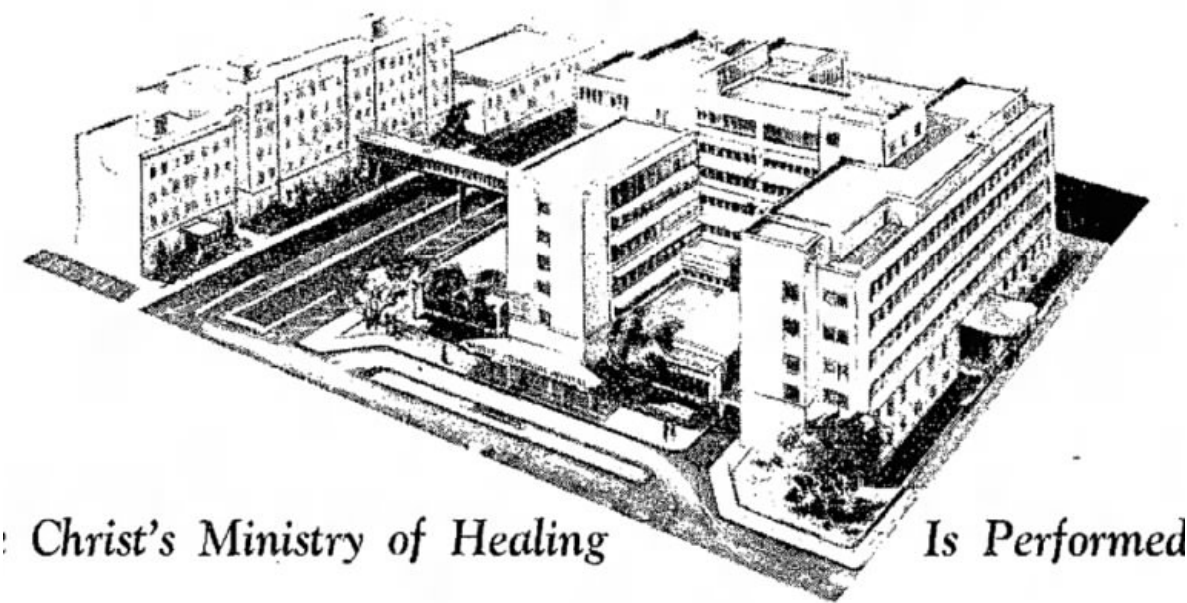
Image of 1962 addition
(center) in relation to 1949
building (right) and original
facility (left); San Antonio
Express and News, February
11, 1962, p. 75

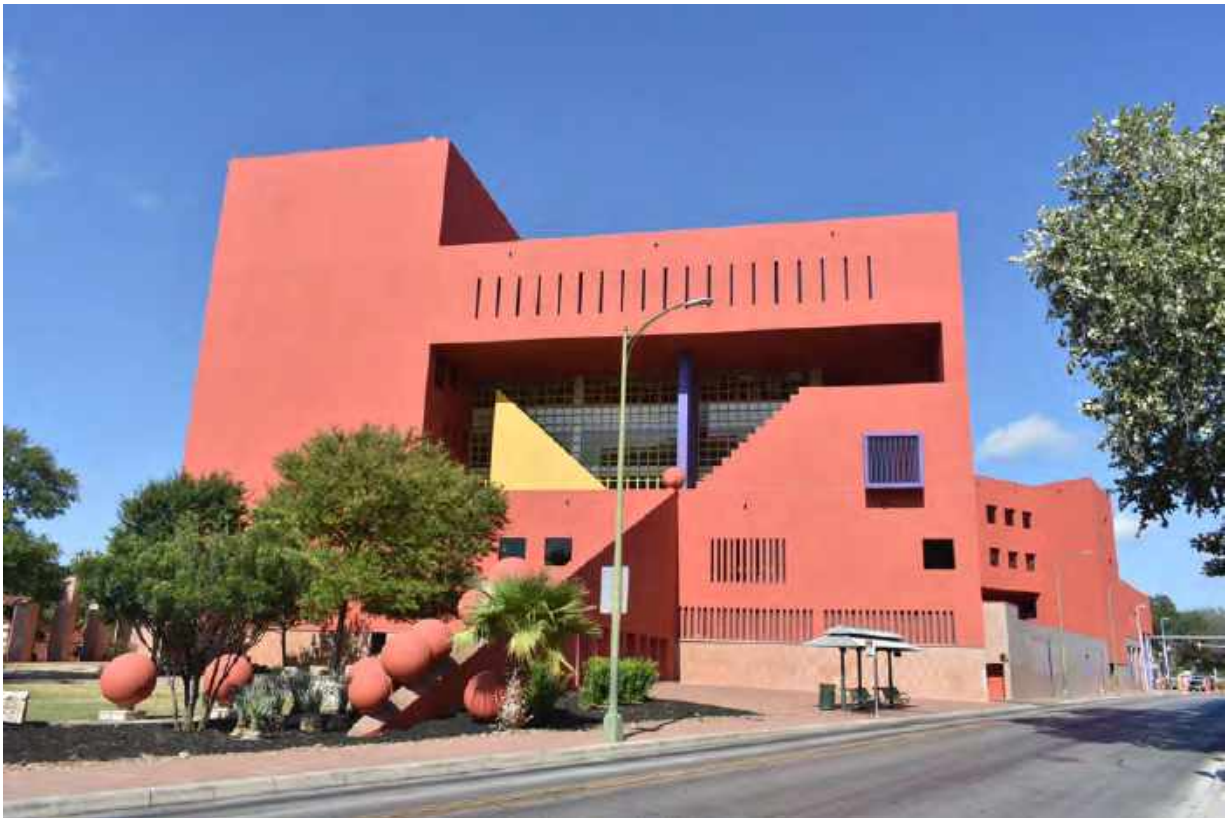
View facing west

As an extravagant interpretation of Mexican Modernist architecture and the work of internationally renowned master architect Legorreta, the 1995 library is recommended eligible for the NRHP under Criterion C, in the area of Architecture. It is eligible at the local level of significance. The building exudes Legorreta’s vibrant architectural ethos—a synthesis of space, mass, form, color, shadow, and light that created remarkable functional spaces. Since the building is less than 50 years old, it also meets Criterion Consideration G. Legorreta’s work has been analyzed in peer-reviewed articles since at least 1987, providing historical perspective. This is his only San Antonio work; his other Texas projects are limited to a Fort Worth museum, a Corpus Christi museum expansion, and in Dallas, the Latino Cultural Center and part of a shopping complex. His other only other library project in the United States is in Chula Vista, California. These comparative buildings have similar significance and historical associations, however, as one of Legorreta’s most exuberant designs, the San Antonio library is a dazzling portrayal of his work. Resource 180B, the library’s parking deck, was constructed before the library and refashioned. It is recommended non-contributing. The parcel polygon is the recommended NRHP boundary.

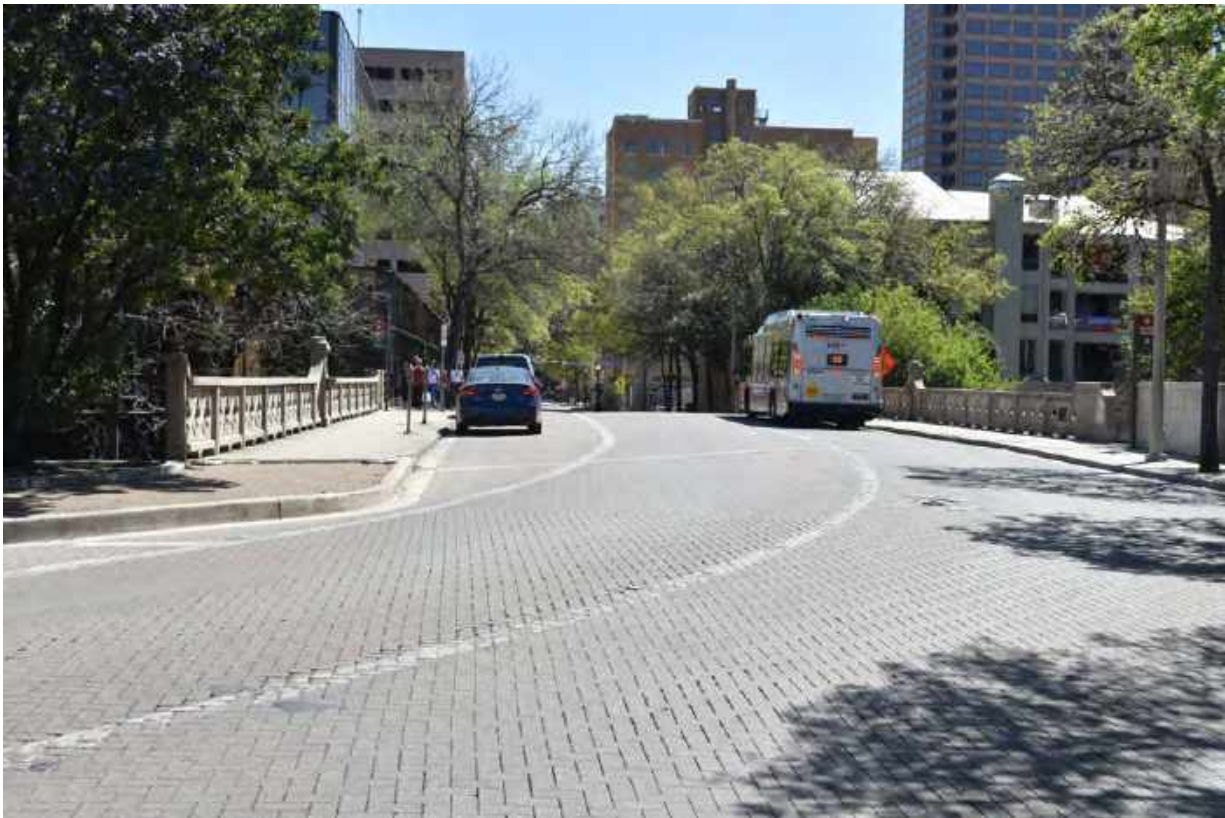
View facing south.

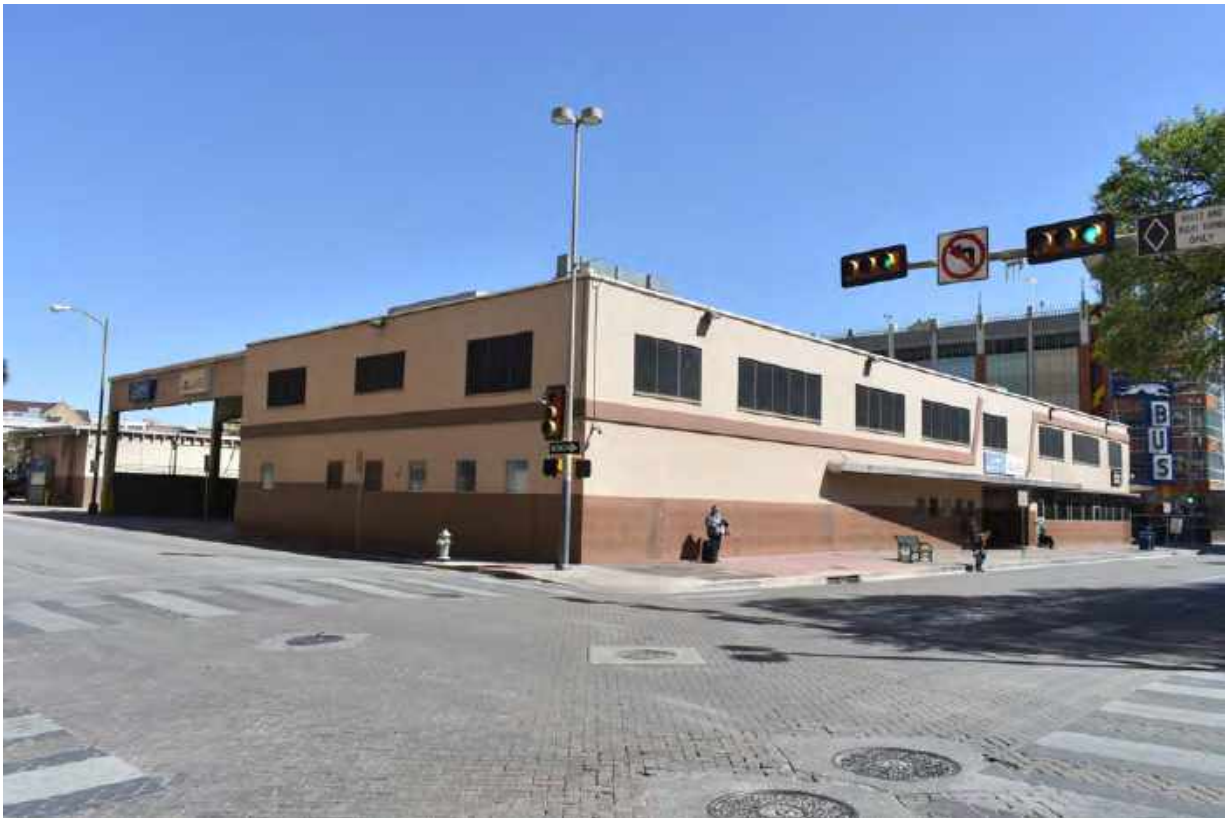
View facing
southeast

Type: Building	Exterior materials: stucco	Primary roof type: flat	Alterations: Storefront altered/replaced
Style: Commercial	concrete/cinder block		Signage replaced
Form: Rectangular	concrete		String course added
	Porch: partial-width		Window opening(s) infilled
	integrated		Windows replaced – some

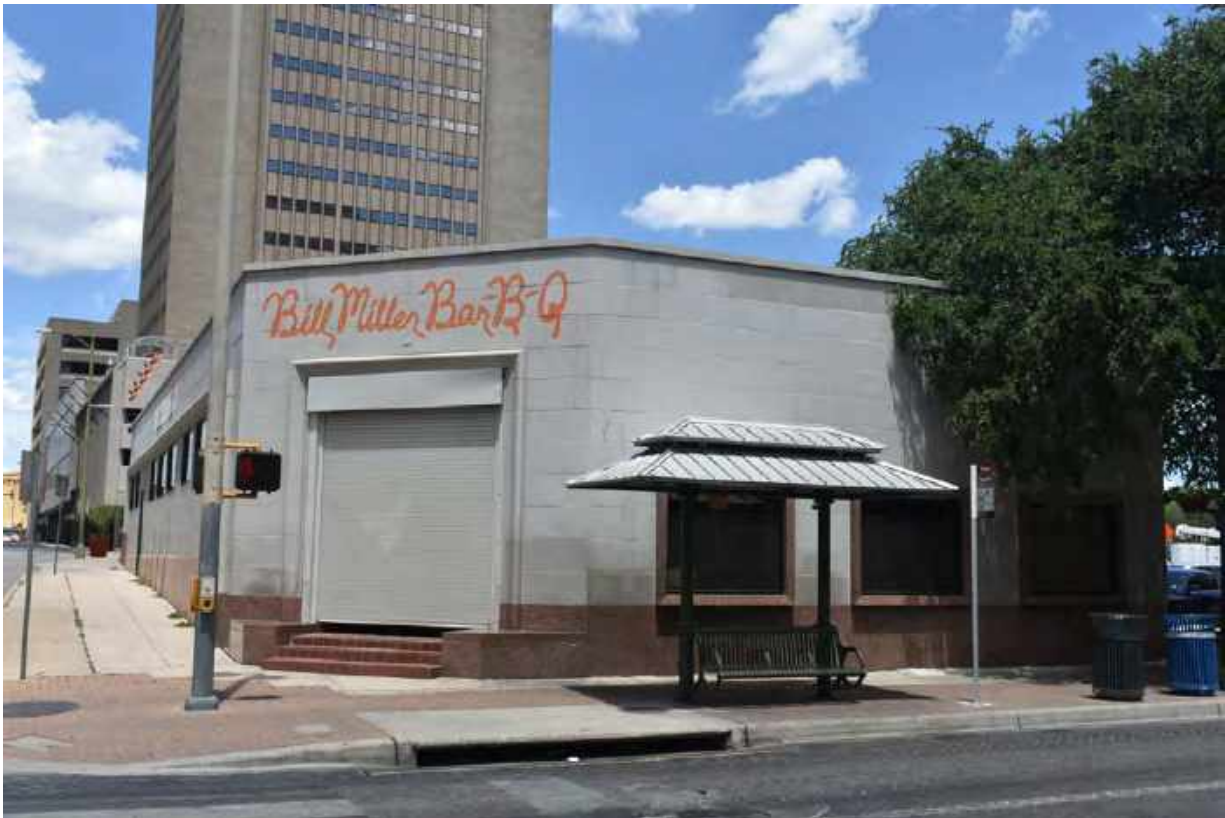
View facing north.

Type: Building	Exterior materials: stone	Primary roof type: flat	Alterations: Awning(s) added
Style: Commercial	brick	with parapet	Drive-through enclosed
Form: Irregular	Porch: none		Signage removed/added
			Storefront altered/replaced
			Windows replaced – all visible
			Brick/stone painted

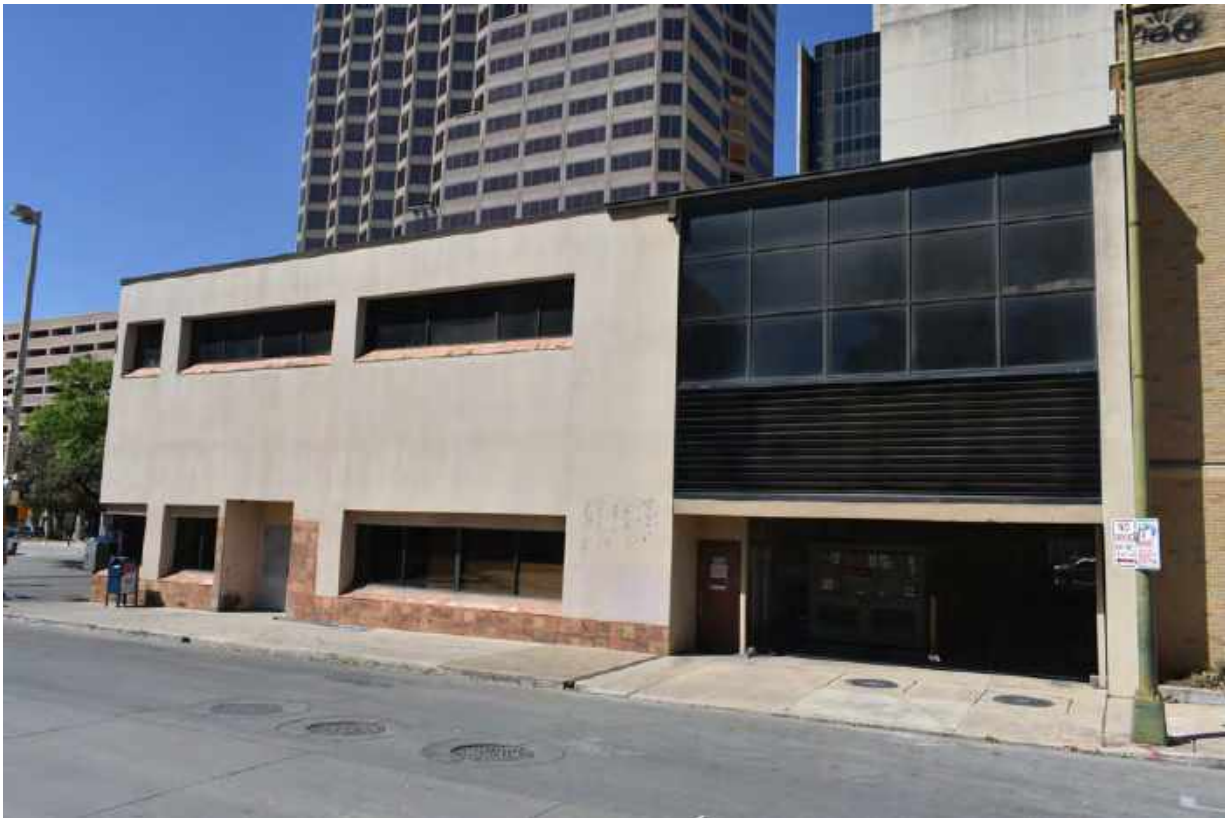
View facing north.

Type: Building	Exterior materials: stucco terra cotta	Primary roof type: flat	Alterations: Doors replaced Signage removed
Style: Commercial			
Form: Rectangular	Porch: stoop integrated

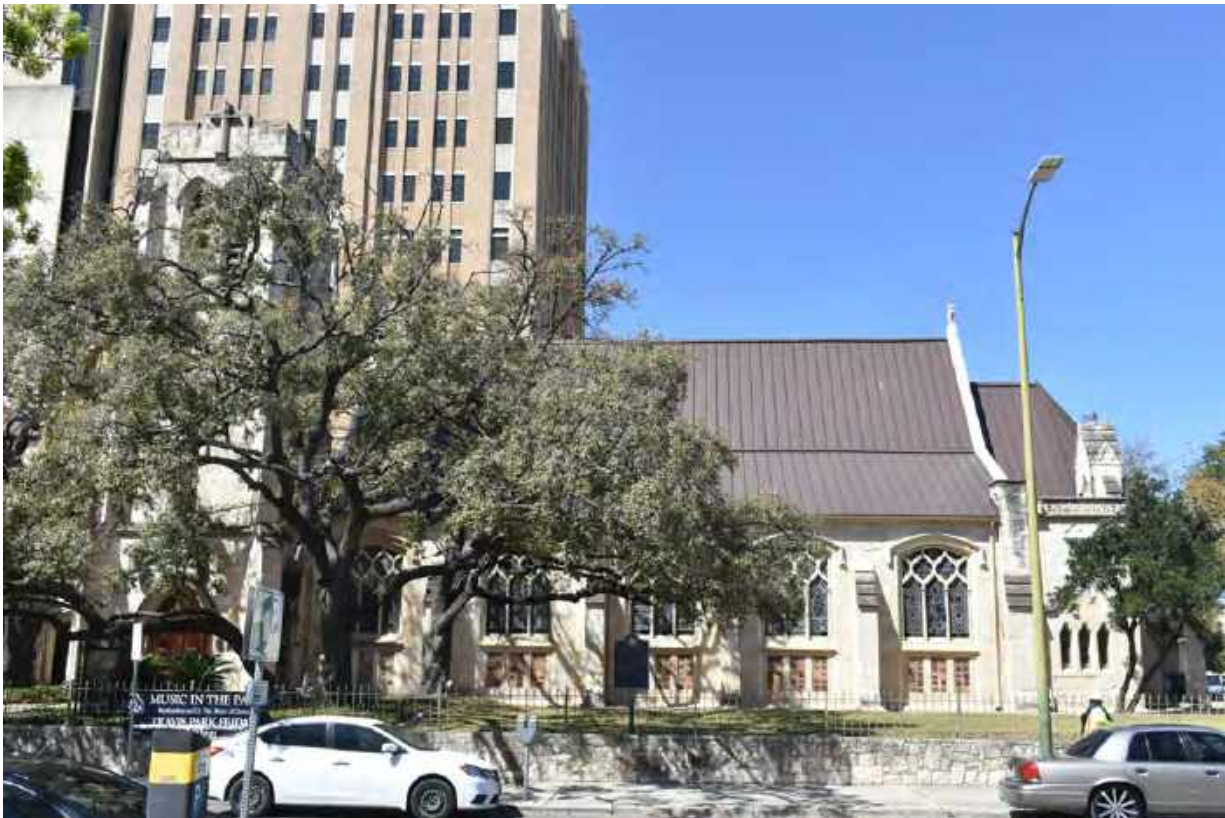
View facing north

Type: Building	Exterior materials: stone brick concrete	Primary roof type: gable, side flat with parapet	Alterations: Addition to primary/side elevation Roof replaced w/ incomp. materials
Style: Gothic Revival			
Form: Irregular	Porch: N/A

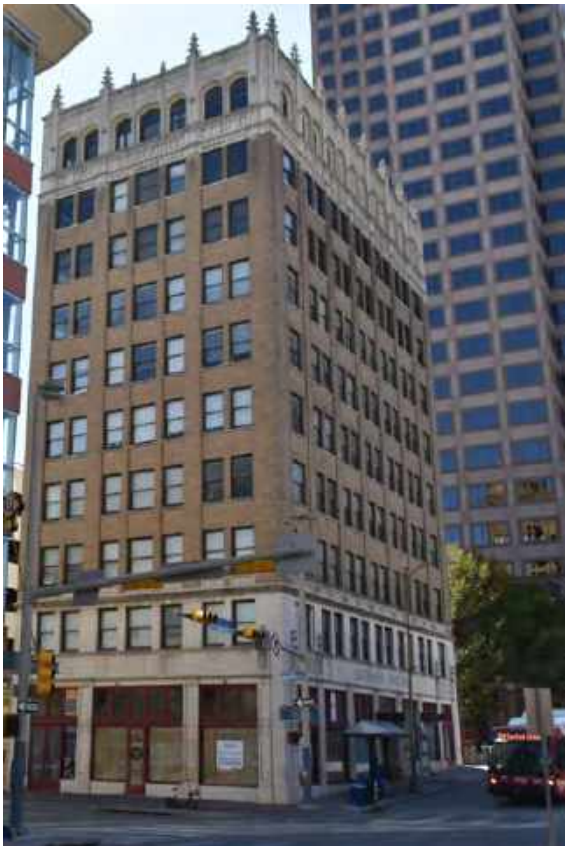
View facing southwest

Type: Building	Exterior materials: stone	Primary roof type: flat	Alterations: Doors replaced
Style: Commercial	brick	with parapet	
Form: Rectangular	Porch: N/A
