APPENDIX C SURVEY FORMS (CONTINUED)

DRAFT
(Information is under FTA review and is subject to change.)

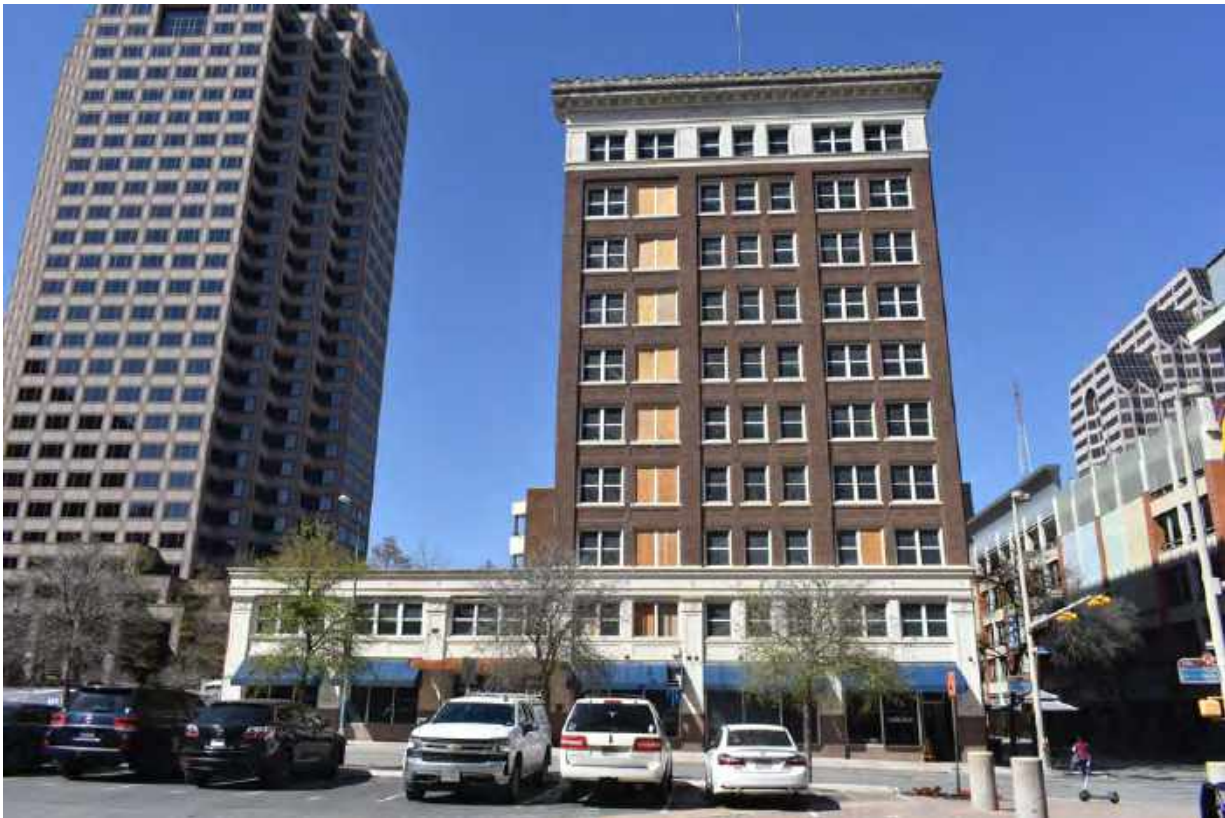
View facing north

Type: Building	Exterior materials: brick stone concrete	Primary roof type: flat with parapet	Alterations: Awning(s) added Doors replaced Window(s) boarded Addition to primary/side elevation
Style: Commercial			
Form: Rectangular	Porch: stoop integrated

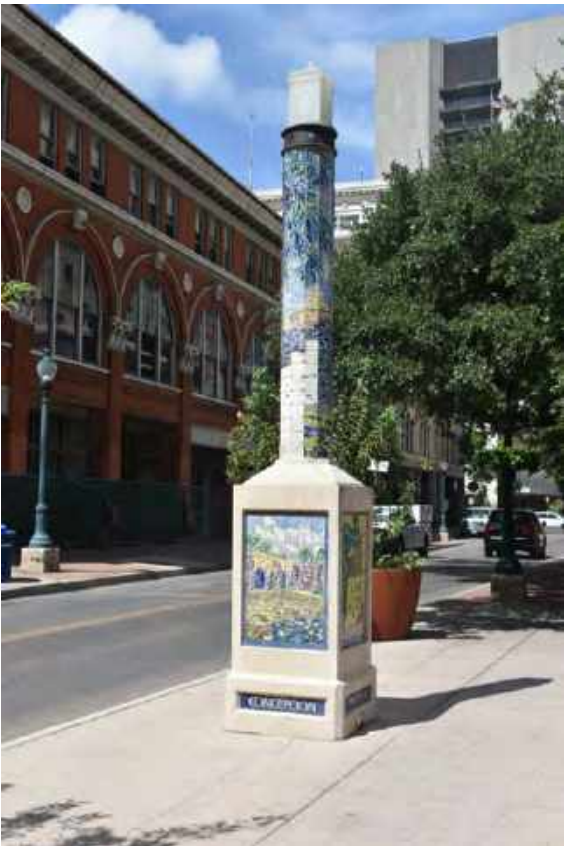
View facing southwest.

Type: Object	Exterior materials: concrete glazed brick/tile/block	Primary roof type: N/A	Alterations: some painted tiles missing
Style: No style			
Form: N/A	Porch: N/A

Although the work possesses high artistic value, it is less than fifty years old. Additionally, no associations were identified linking it to persons or events of historic importance. Furthermore, materials integrity has been diminished due to some missing tiles. Because the building offers neither a local interpretation of a standard design nor an undocumented construction technique, it has limited potential to yield important information. As a result, it is recommended not eligible for the NRHP under Criterion A, B, C, or D.

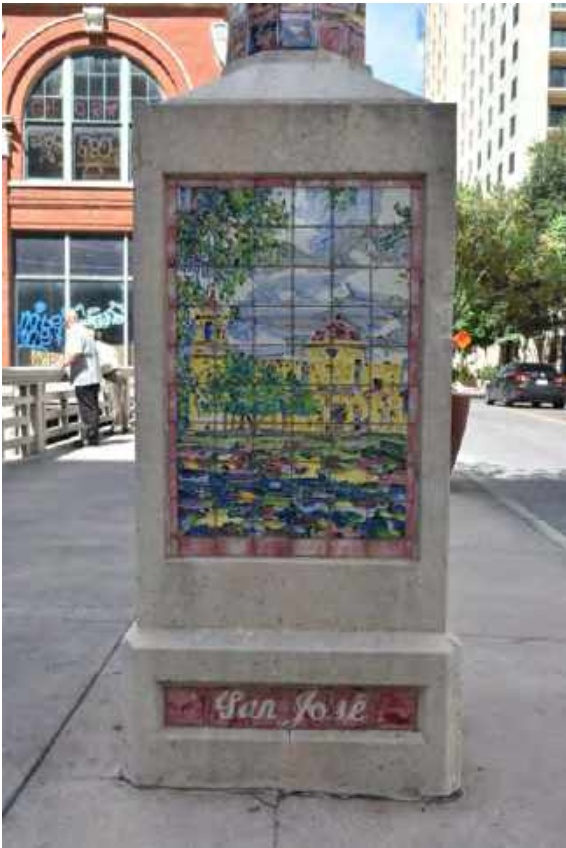
Detail of decorative
application.

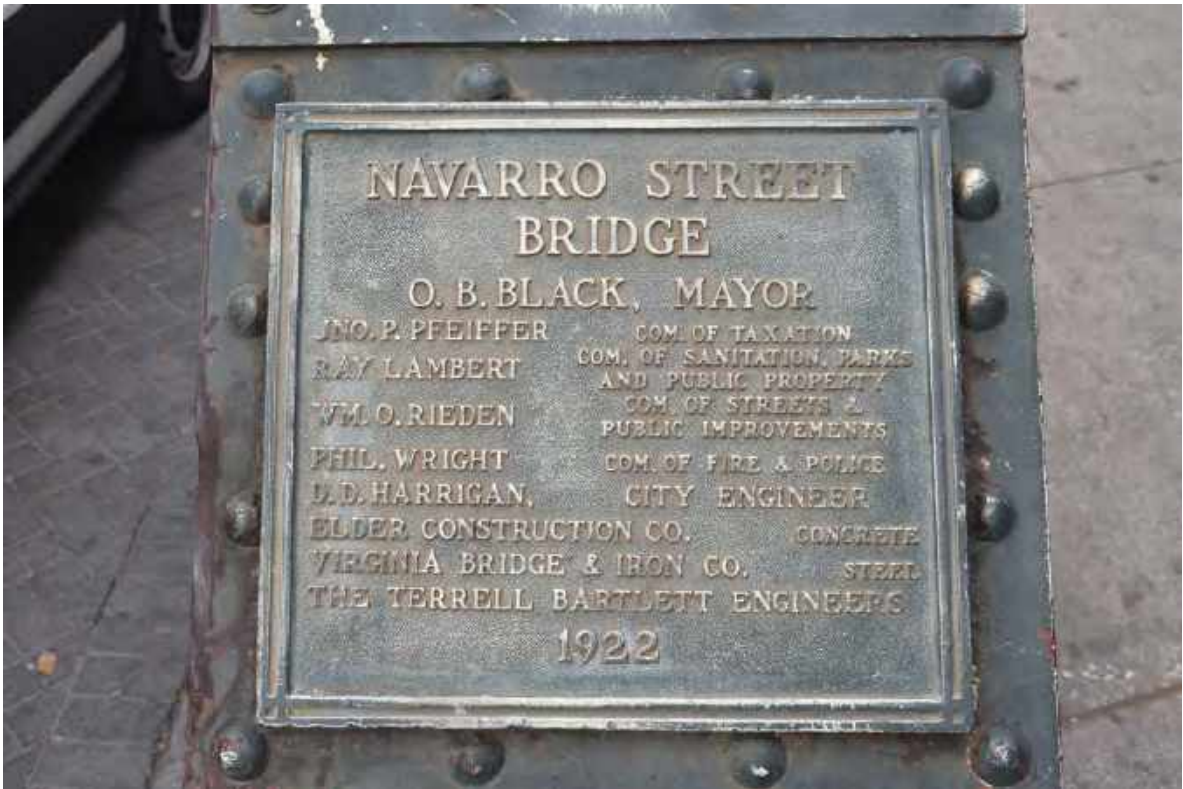
Detail of plaque.

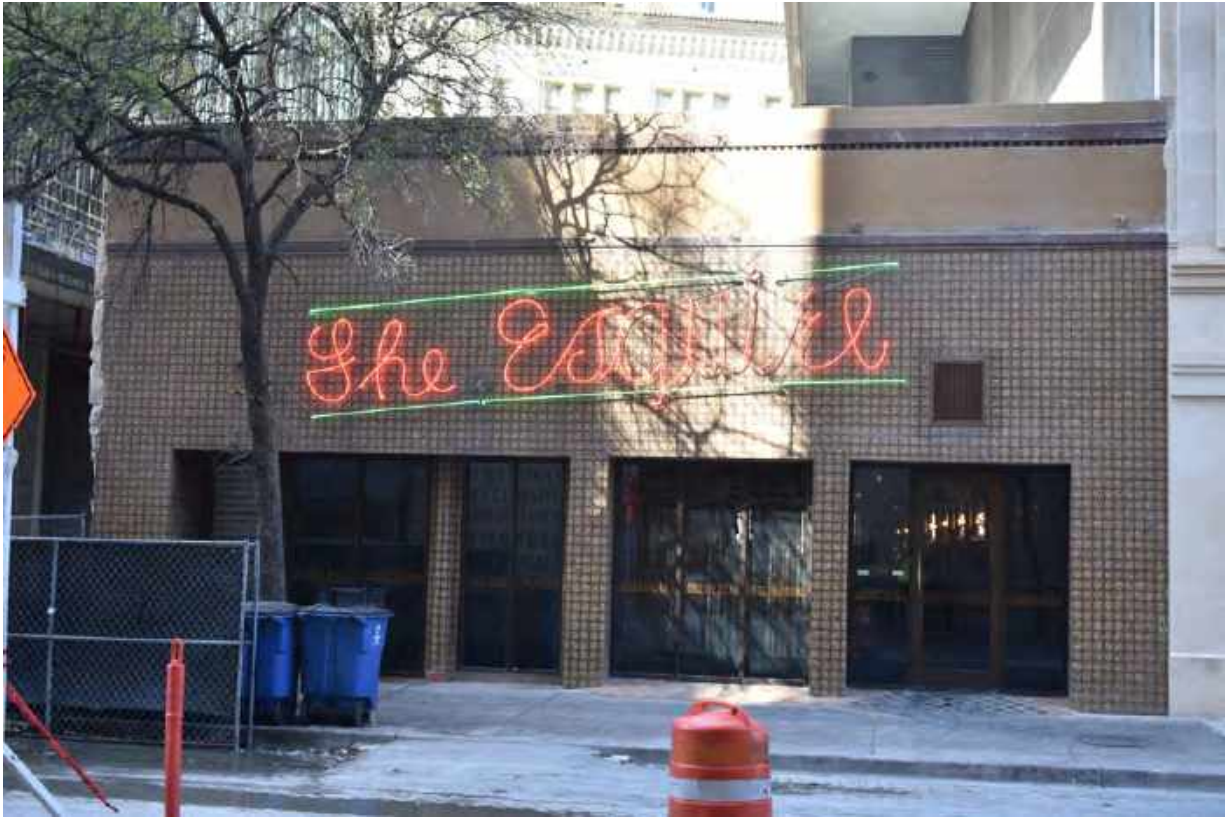
View facing north.

Type: Building	Exterior materials: stucco glazed brick/tile/block brick	Primary roof type: flat	Alterations: Storefront altered/replaced Window opening(s) infilled Exterior staircase added Awning(s) added
Style: Commercial			
Form: Rectangular	Porch: N/A

The resource contributes to the San Antonio Downtown and River Walk NRHP Historic District. While the integrity of materials and workmanship have been diminished by the replacement of the storefront infill, the resource retains the majority of its hysical features dating from its construction and therefore retains integrity overall. Its contributing status to the San Antonio Downtown and River Walk NRHP Historic District is affirmed.

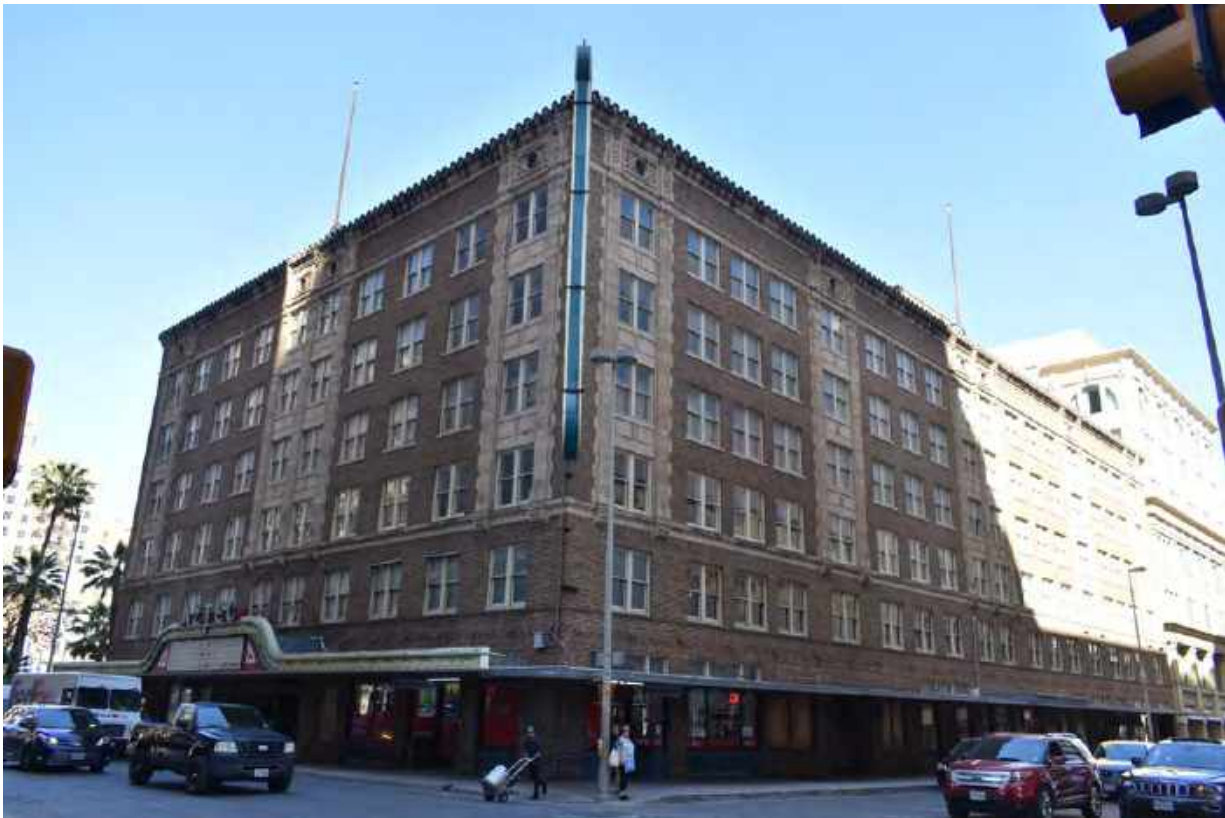
View facing
northeast

Type: Building	Exterior materials: brick concrete	Primary roof type: flat with parapet	Alterations: Storefront altered/replaced
Style: Commercial, Exotic Revival			
Form: Rectangular	Porch: stoop integrated

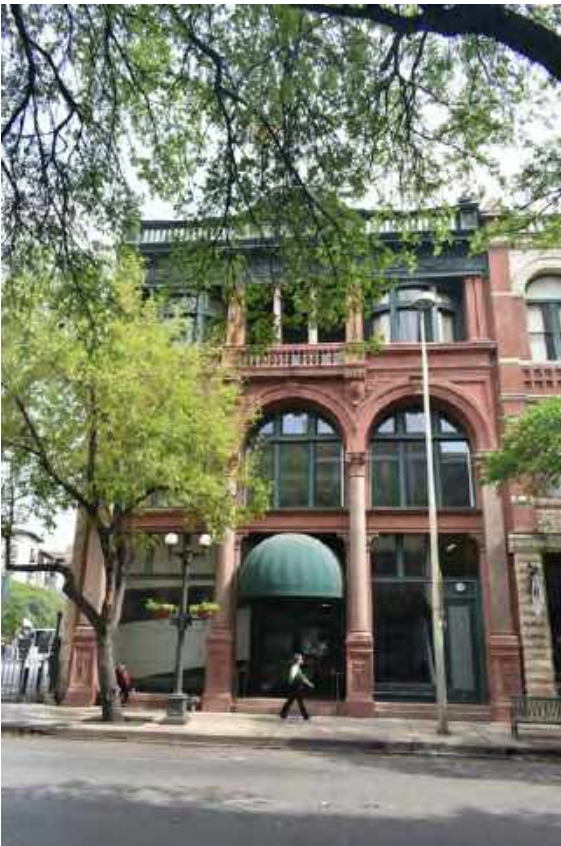
View facing north.

Type: Building	Exterior materials: stone metal brick	Primary roof type: flat with parapet	Alterations: Storefront altered/replaced Awning(s) added
Style: Renaissance Revival			
Form: 2-part commercial block	Porch: stoop integrated

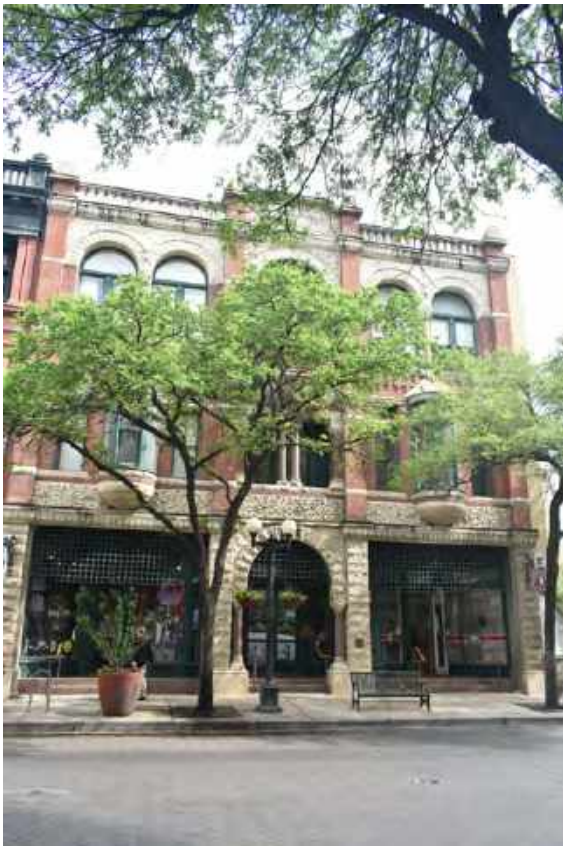
View facing north.

Type: Building	Exterior materials: brick	Primary roof type: flat	Alterations: Window opening(s) infilled (east elevation)
Style: Richardsonian Romanesque	stone	with parapet	Storefront altered/replaced
Form: 2-part commercial block	Porch: stoop integrated		Signage added

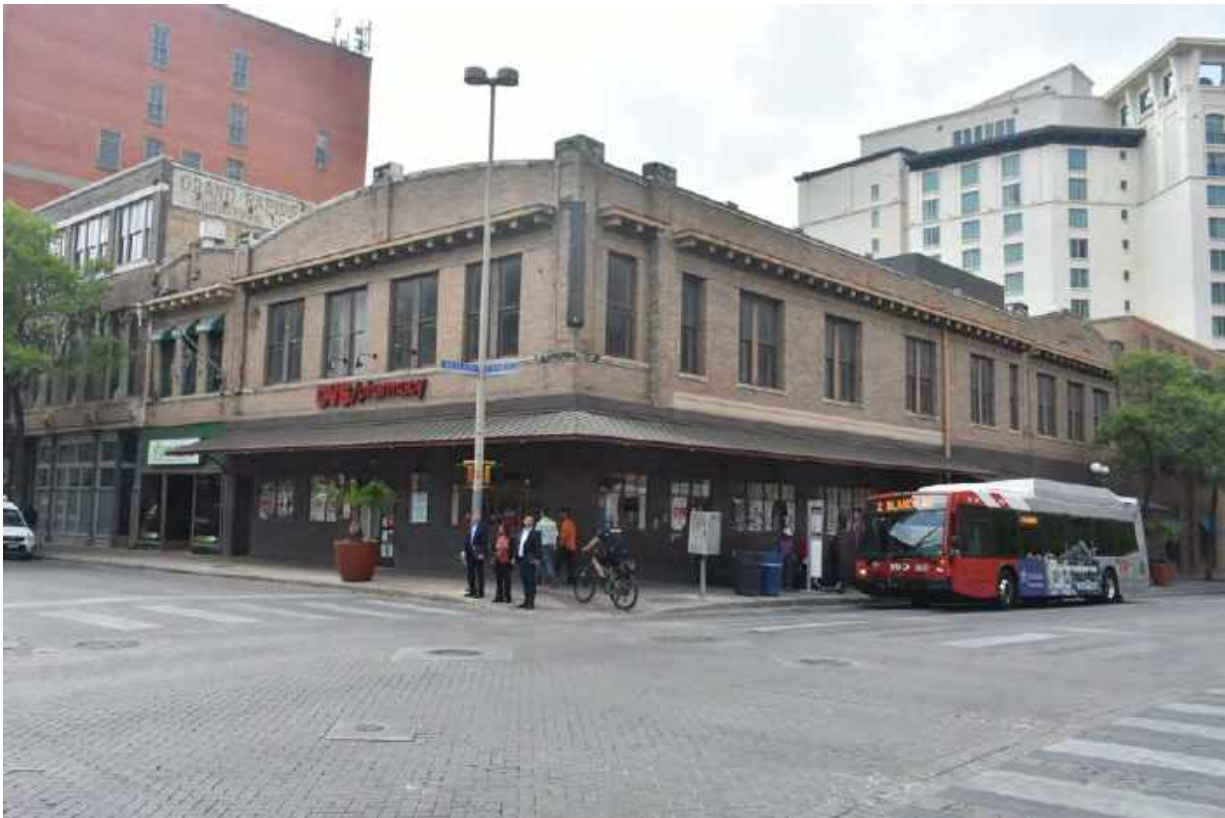
View facing
southeast

Type: Building	Exterior materials: brick	Primary roof type: flat with parapet	Alterations: Awning(s) added Storefront altered/replaced Window opening(s) infilled
Style: Commercial			
Form: 2-part commercial block	Porch: N/A

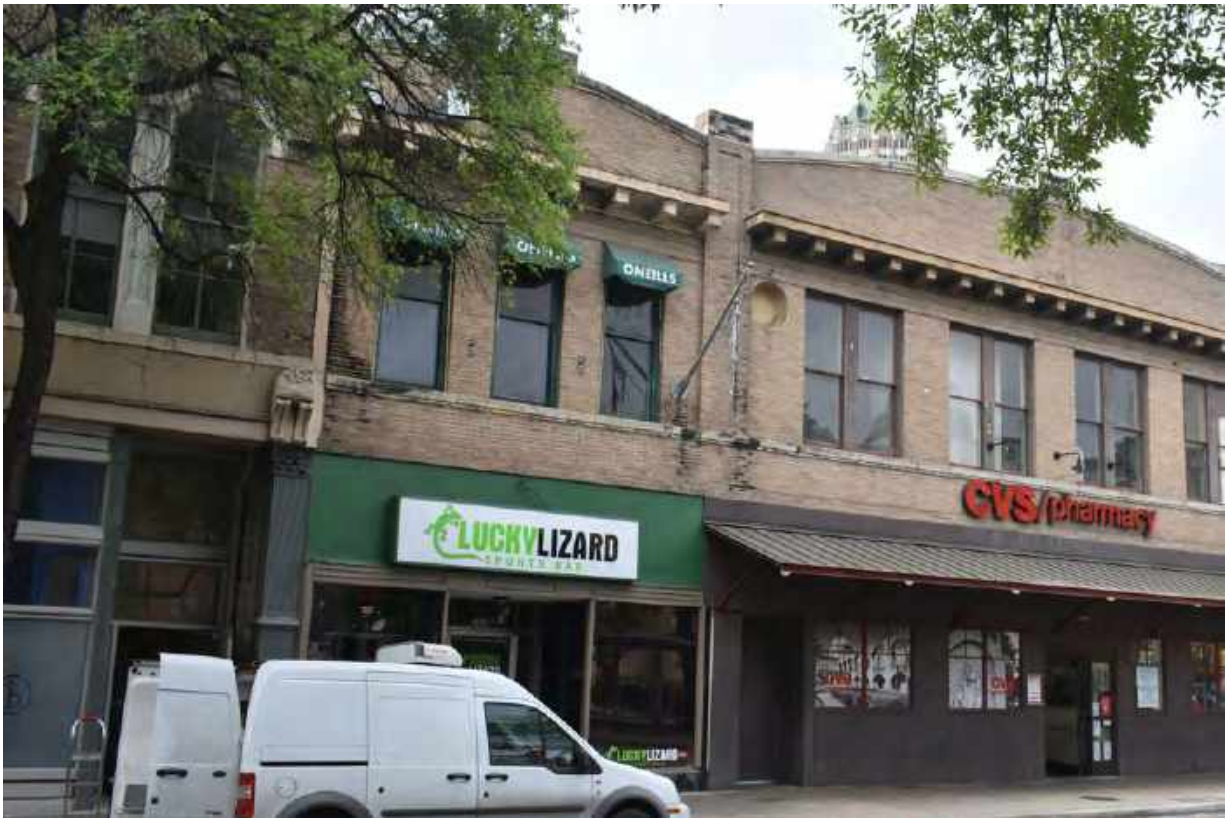
View facing southwest

Type: Building	Exterior materials: brick concrete	Primary roof type: flat with parapet	Alterations: Awning(s) added Signage added Storefront altered/replaced
Style: Commercial			
Form: 2-part commercial block	Porch: stoop integrated

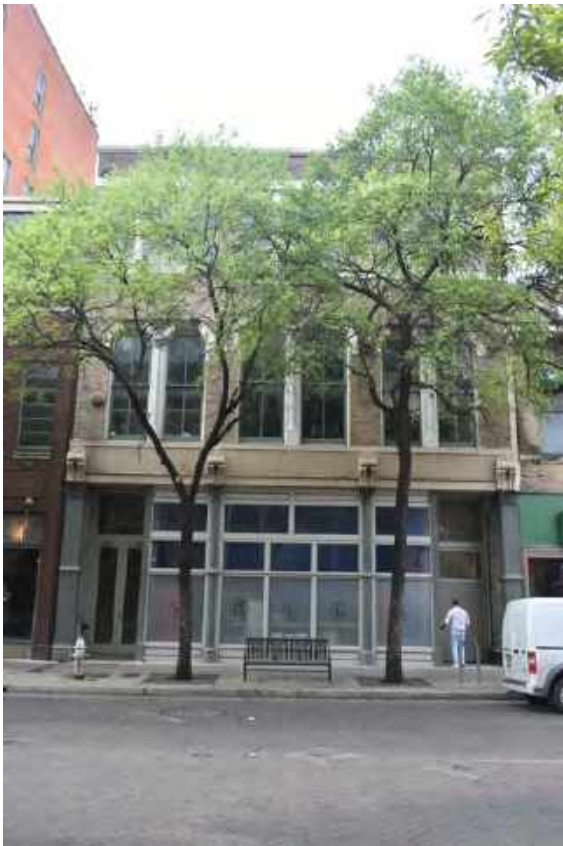
View facing south

Type: Building	Exterior materials: brick concrete metal	Primary roof type: flat with parapet	Alterations: Storefront altered/replaced Addition to upper story
Style: Commercial			
Form: 2-part commercial block	Porch: stoop integrated

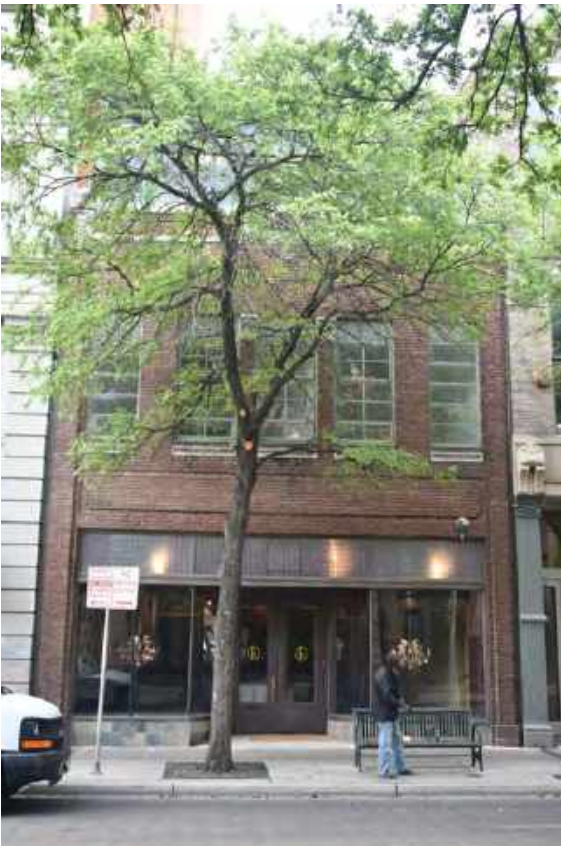
View facing south

Type: Building	Exterior materials: brick	Primary roof type: flat	Alterations: Addition to upper story
Style: Commercial	glazed brick/tile/block	with parapet	Storefront altered/replaced
Form: 2-part commercial block	Porch: stoop integrated

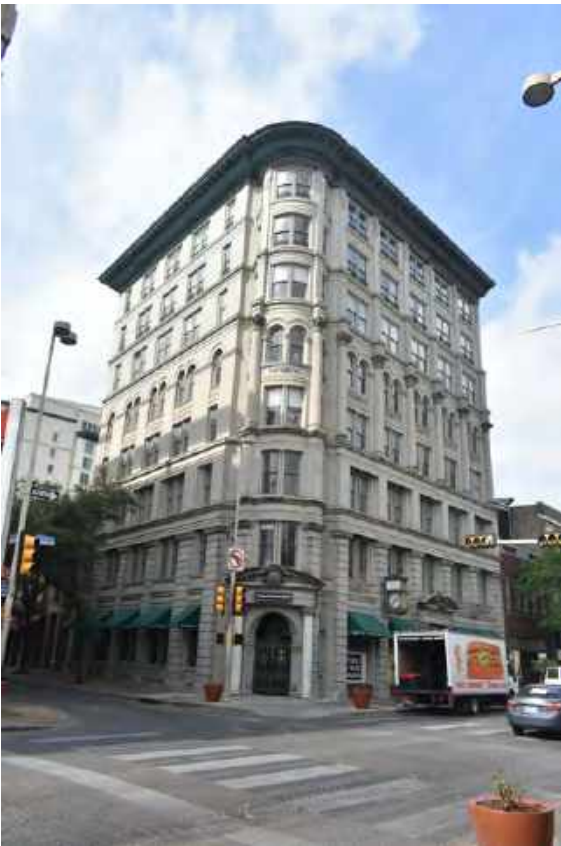
View facing southwest.

Type: Building	Exterior materials: stone concrete/cinder block brick	Primary roof type: flat with parapet	Alterations: Awning(s) added Storefront altered/replaced
Style: Renaissance Revival			
Form: Rectangular	Porch: stoop integrated

The Alamo National Bank Building was built in 1902 by Coughlin & Ayres Architects and James Wahrenberger as contractor. Designed in the Renaissance Revival style, the building features two entrances with broken pediment door surrounds containing dentils, Ionic columns and elaborate cartouches. In 1916, the building was enlarged by three stories. Morris Plan Bank took over the space after Alamo National Bank from 1930-1942. After a period of vacancy during the 1960s, the building was revitalized in 1982. In 1984, the building was nominated to the NRHP under Criterion A for Economics and Criterion C for Architecture and Engineering. The resource, now known as the Commerce Building, currently houses the Texas Selfie Museum on the ground floor and offices above.

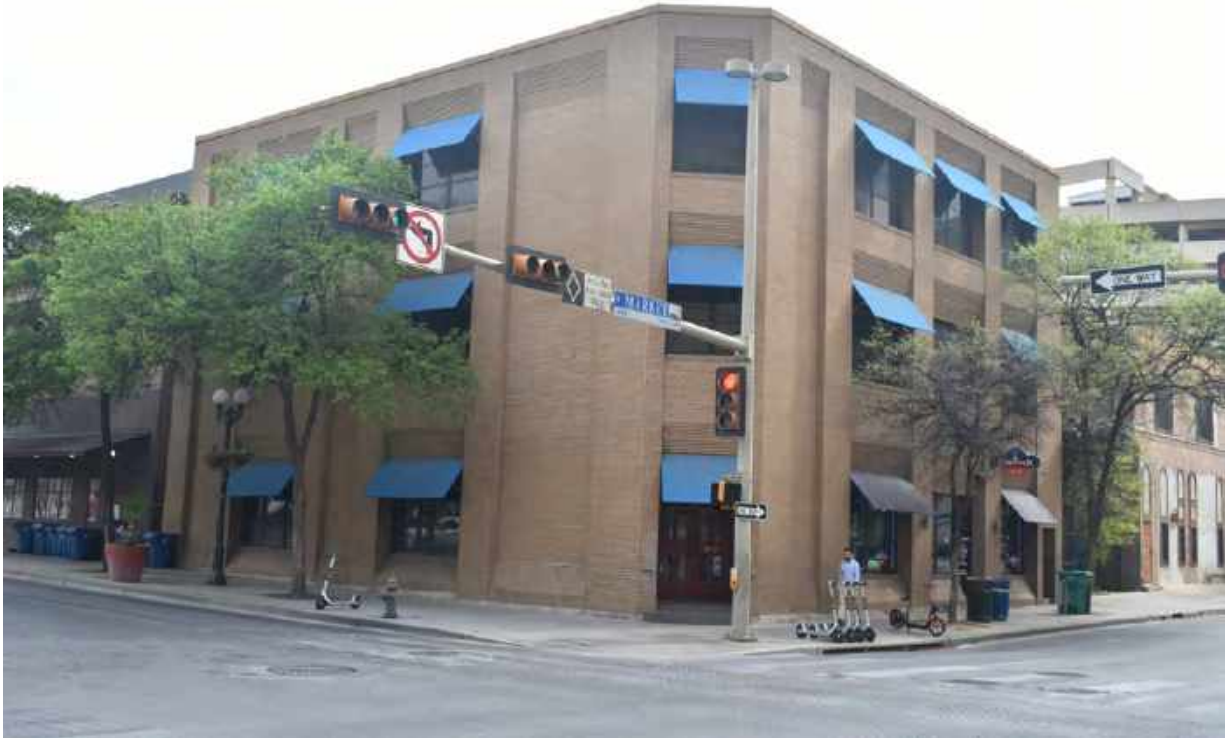
View facing northeast.

Type: Building	Exterior materials: brick	Primary roof type: flat	Alterations: Doors replaced
Style: Commercial			
Form: Rectangular	Porch: N/A

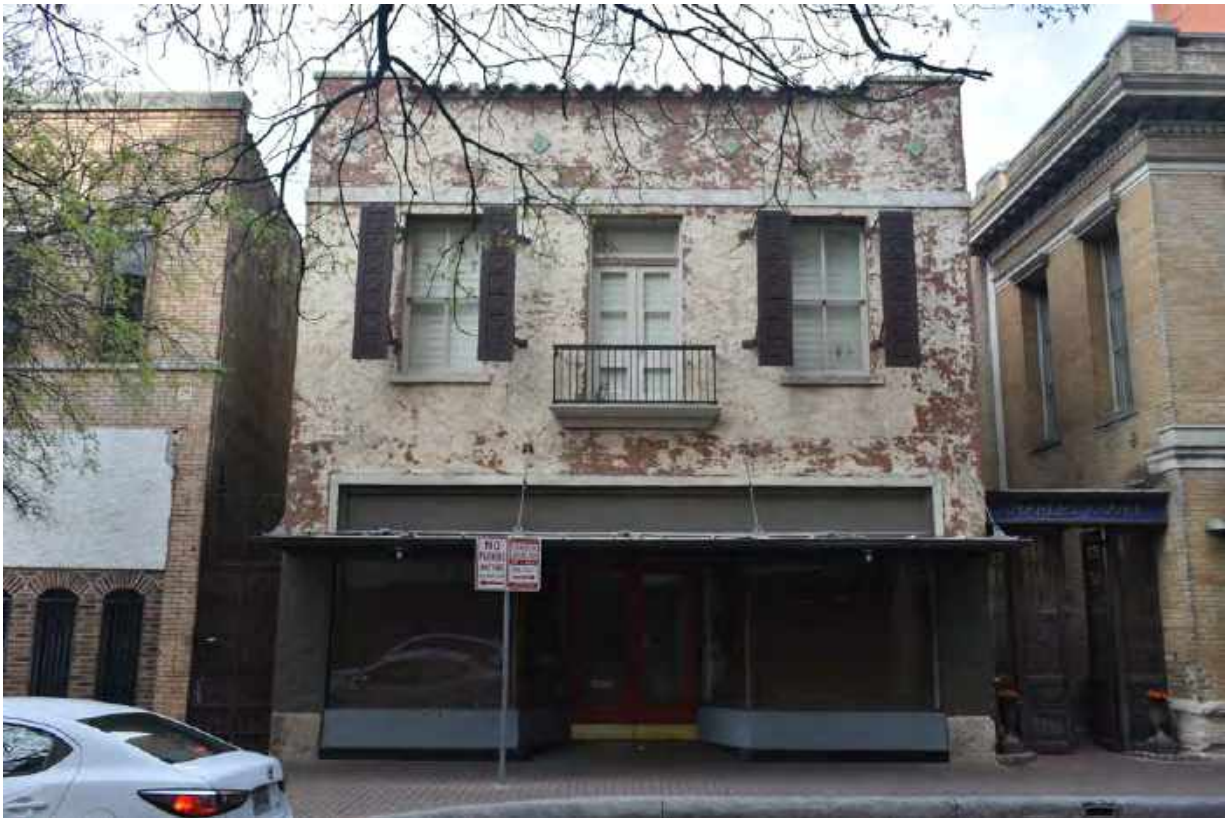
View facing west

Alterations:
Storefront altered/replaced

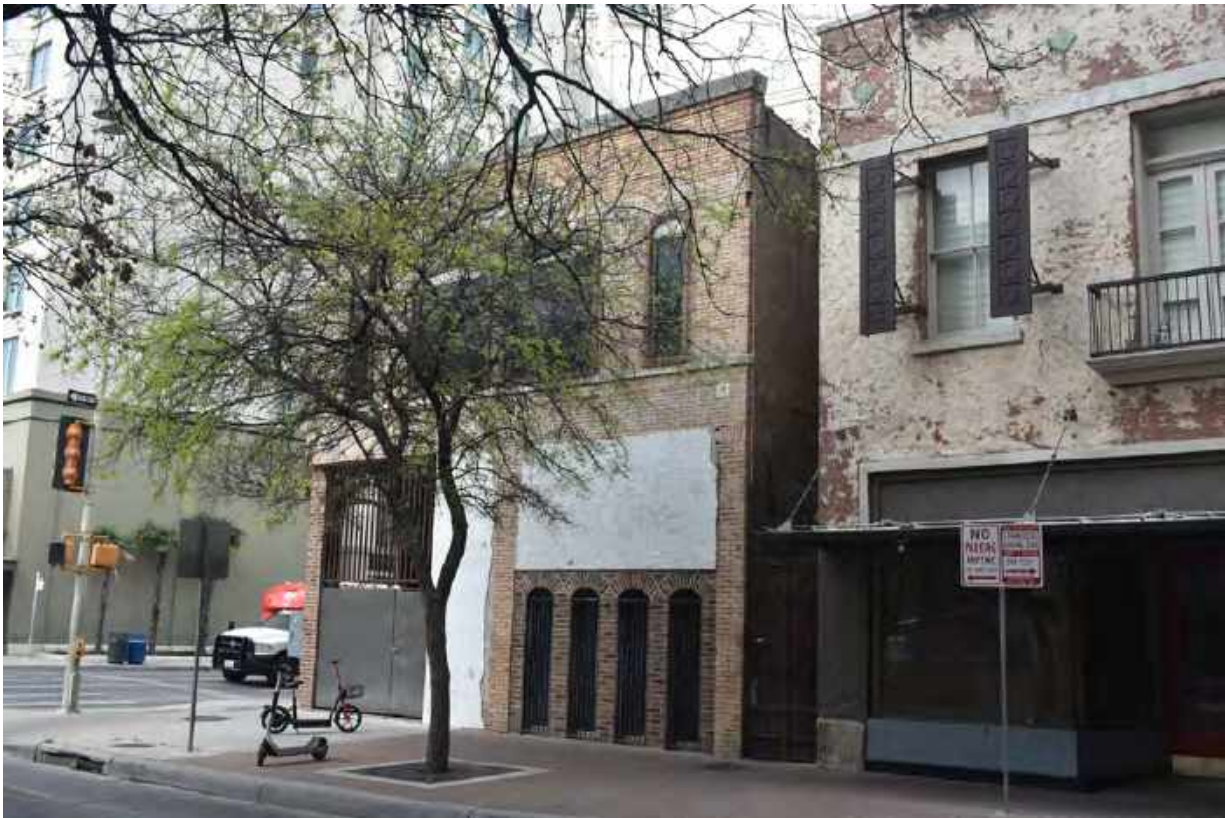
View facing west.

Type: Building	Exterior materials: brick stucco	Primary roof type: flat with parapet	Alterations: Wall cladding replaced - some Window opening(s) altered Window opening(s) infilled Windows replaced – some Storefront altered/replaced Missing windows
Style: Commercial			
Form: Rectangular	Porch: Recessed commerical entry integrated

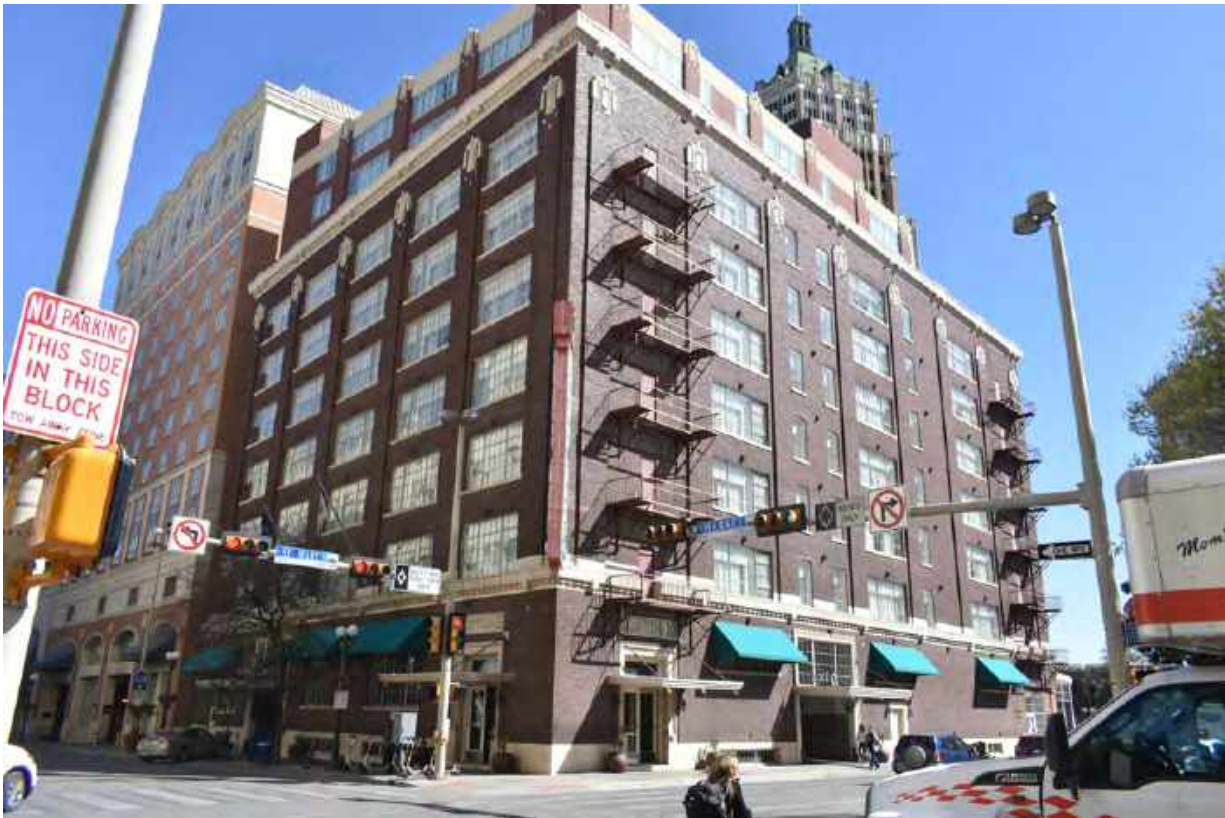
View facing southeast

Type: Building	Exterior materials: brick terra cotta	Primary roof type: flat with parapet	Alterations: Addition to rear/side elevation Addition to upper story Awning(s) added Doors replaced Door (primary) opening altered Signage added
Style: Commercial			
Form: Rectangular	Porch: none

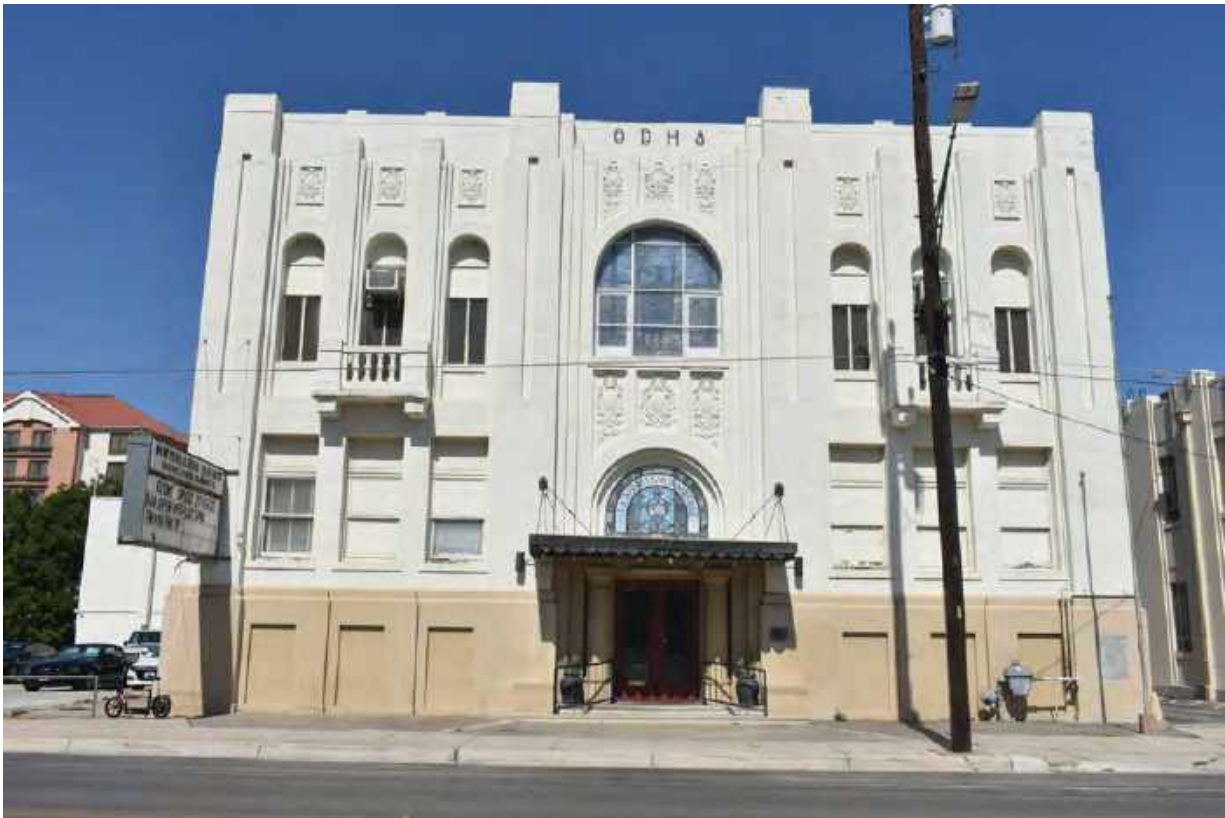
View facing west

Type: Building	Exterior materials: stucco	Primary roof type: flat with parapet	Alterations: Addition to rear/side elevation Windows replaced – some Window opening(s) altered Window opening(s) infilled Signage added
Style: Art Deco			
Form: Irregular	Porch: stoop projecting

This resource is a Contributing Resource to the San Antonio Downtown and River Walk NRHP Historic District and a San Antonio City Landmark. The Hermann Sons building is notable for its local social history as well as its Art Deco design. However, the large addition to the rear has more than doubled the size of the building; detracting from the original design of the meeting hall. Other alterations to the building's fenestration has also diminished integrity of materials. These changes limit the ability of the property from being recommended individually eligible for the NRHP, however its designation as a Contributing Resource to the San Antonio Downtown and River Walk NRHP Historic District is affirmed.

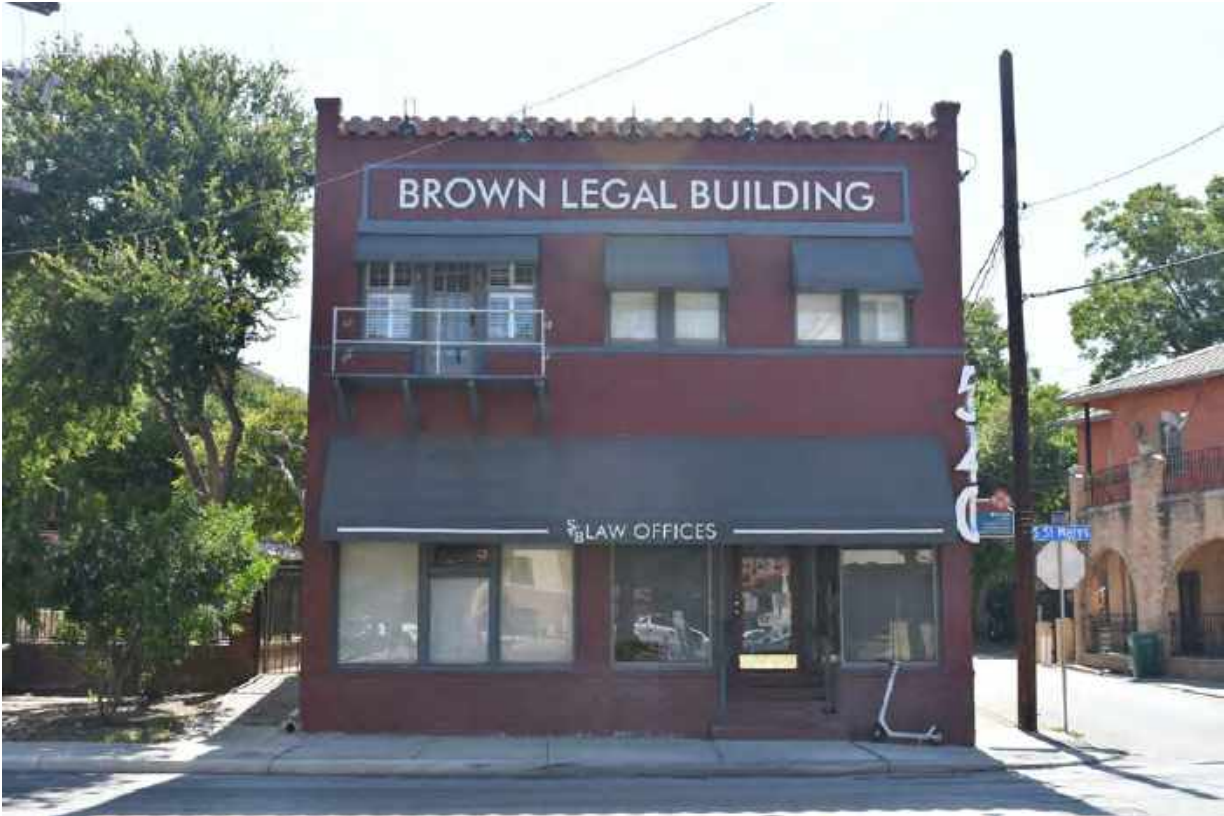
View facing east

Type: Building	Exterior materials: brick	Primary roof type: gable, front	Alterations: Addition to primary/side elevation
Style: Commercial	concrete/cinder block	with parapet	Awning(s) added
Form: Rectangular	Porch: stoop	hipped	Brick/stone painted
	integrated		Storefront altered/replaced
			Window opening(s) infilled
			Doors replaced
			Decorative shutters added
			Signage added

The property is located within the La Villita historic district's NRHP boundary but is inconsistent with the vernacular building types described in the nomination. It is recommended non-contributing to the historic district.

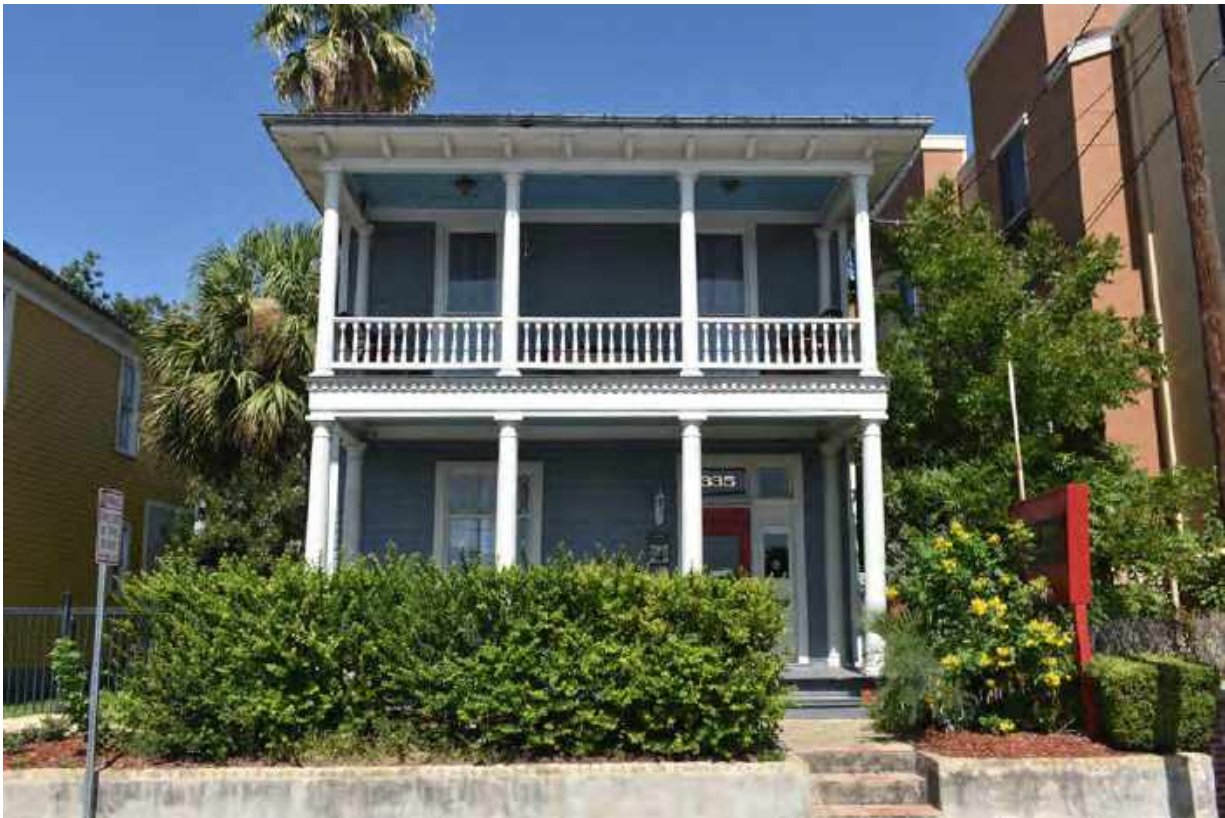
View facing west towards historic-age building (Resource A). Nonhistoric sign (Resource F) on right.

The property at 335 S. Presa St is recommend as individually NRHP eligible. Resources 215A, 215B, 215C, and 215D are recommended contributing to the property. Non historic Resource E is recommended non-contributing to the property. Non historic Resource F, a small object, is included in this record.

Resource 215 is recommended individually eligible for listing in the NRHP under Criterion C at the local level of significance in the area of architecture as the property is a good representative example of their type. The double gallery Colonial Revival houses with Queen Anne features retain their architectural integrity. Even though the former single dwellings are now used as a hotel, their function remains domestic. No associations were identified linking the property to persons or events of historic importance. Because the building offers neither a local interpretation of a standard design nor an undocumented construction technique, it has limited potential to yield important information. As a result, it is recommended not eligible for listing in the NRHP under Criterion A, B, or D.

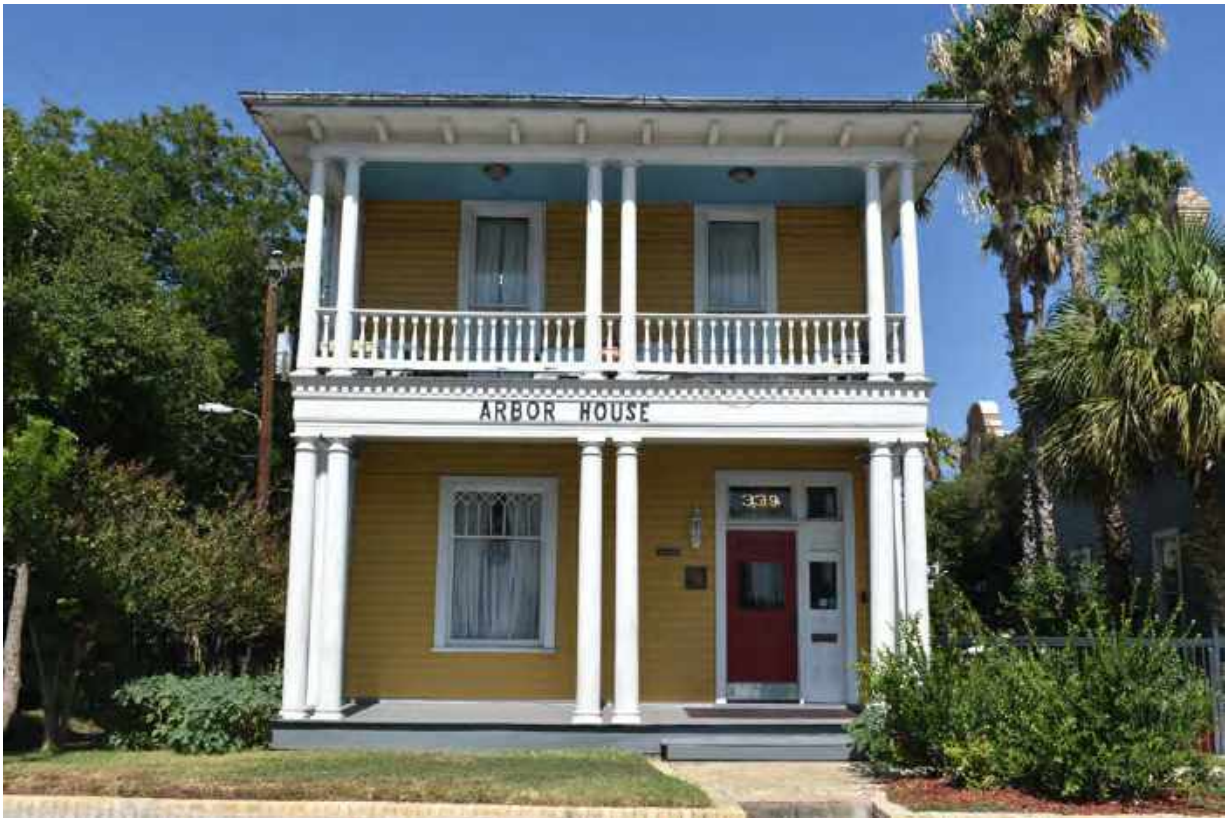
View facing west

The property at 335 S. Presa St is recommend as individually NRHP eligible. Resources 215A, 215B, 215C, and 215D are recommended contributing to the property. Non historic Resource E is recommended non-contributing to the property.

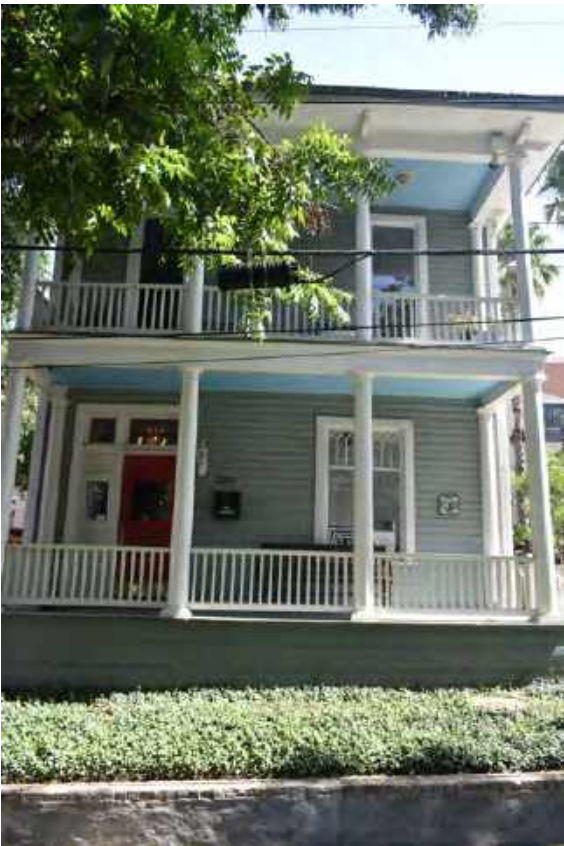
View facing north.

The property at 335 S. Presa St is recommend as individually NRHP eligible. Resources 215A, 215B, 215C, and 215D are recommended contributing to the property. Non historic Resource E is recommended non-contributing to the property.

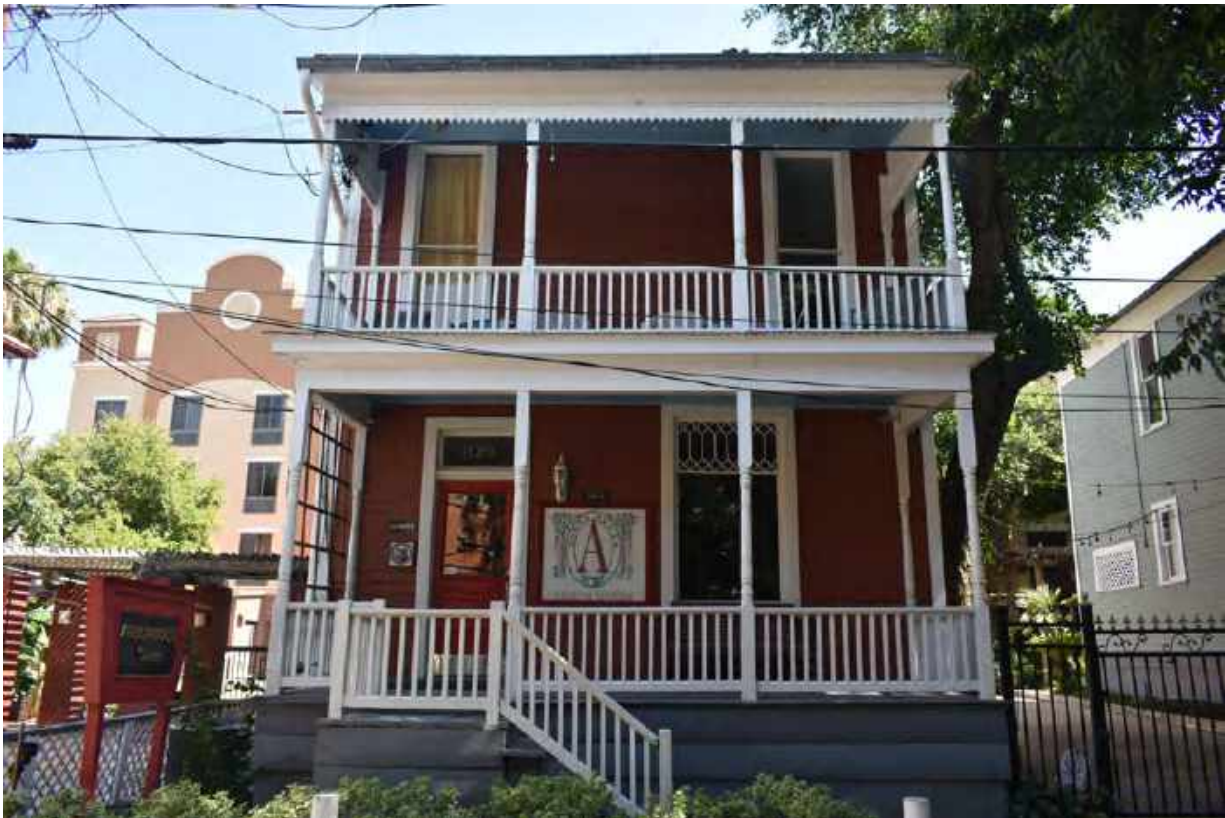
View facing north.

Comments
The property at 335 S. Presa St is recommend as individually NRHP eligible. Resources 215A, 215B, 215C, and 215D are recommended contributing to the property. Non historic Resource E is recommended non-contributing to the property.

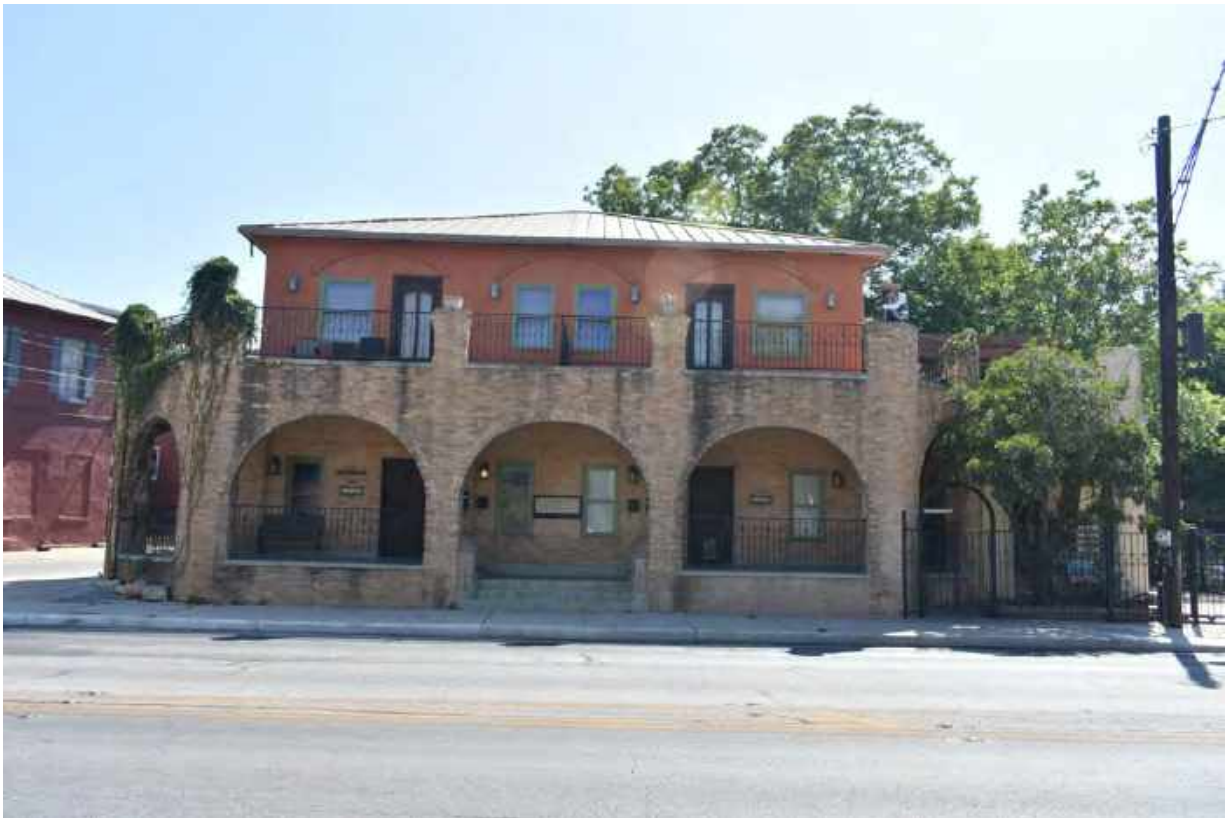
View facing northeast.

Type: Building	Exterior materials: stone brick glass block	Primary roof type: hipped	Alterations: Brick masonry wraparound porch added after 1952 Addition to rear/side elevation Roof replaced w/ incomp. materials Doors replaced (some)
Style: No style			
Form: Rectangular	Porch: wraparound projecting

This building does not embody distinctive characteristics of a type, period, or method of construction and it does not represent the work of a master or possess high artistic value. Additionally, no associations were identified linking it to persons or events of historic importance. Furthermore, design integrity has been diminished due to the addition of a wraparound porch, and materials integrity diminished due to materials not replaced in kind. Because the building offers neither a local interpretation of a standard design nor an undocumented construction technique, it has limited potential to yield important information. As a result, it is recommended not eligible for the NRHP under Criterion A, B, C, or D.
