APPENDIX C SURVEY FORMS (CONTINUED)

DRAFT
(Information is under FTA review and is subject to change.)

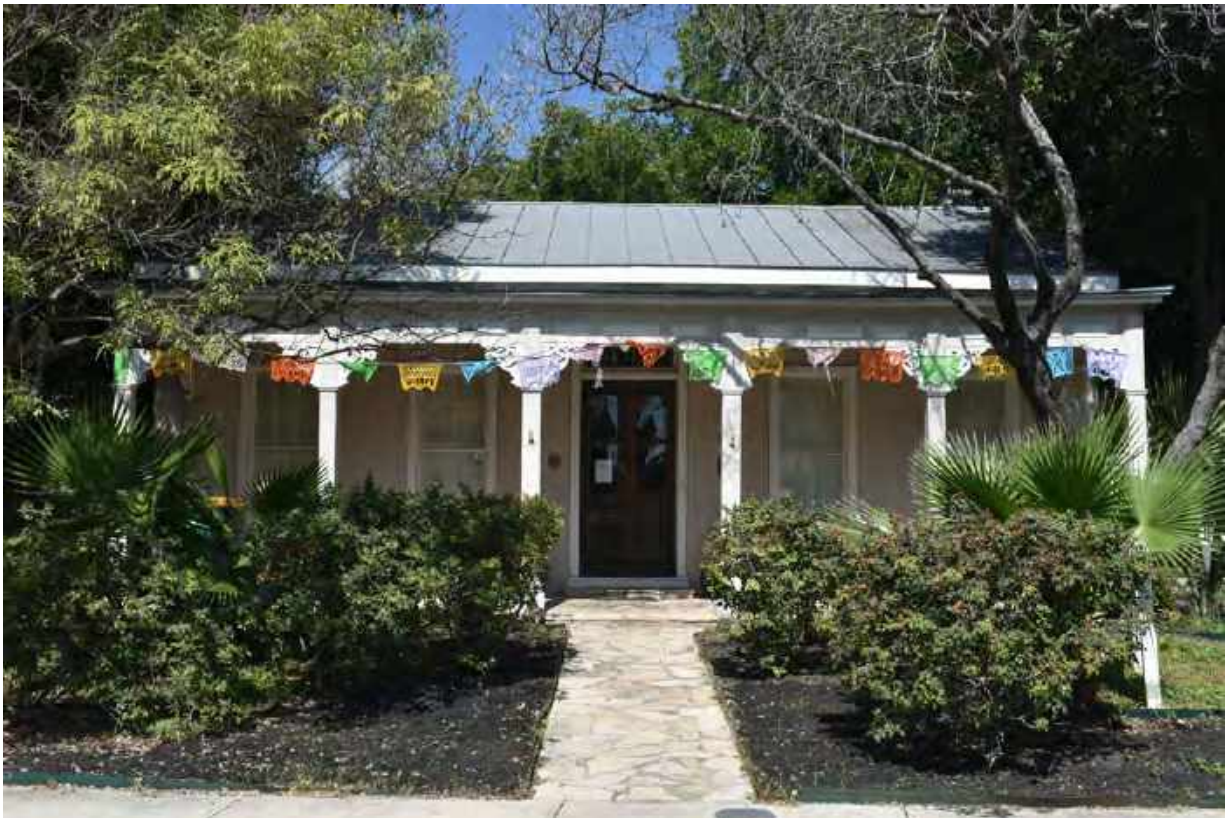
View facing west

Type: Building	Exterior materials: stucco stone	Primary roof type: gable, side	Alterations: Roof replaced w/ incomp. materials
Style: German Vernacular			
Form: Rectangular	Porch: full-width projecting

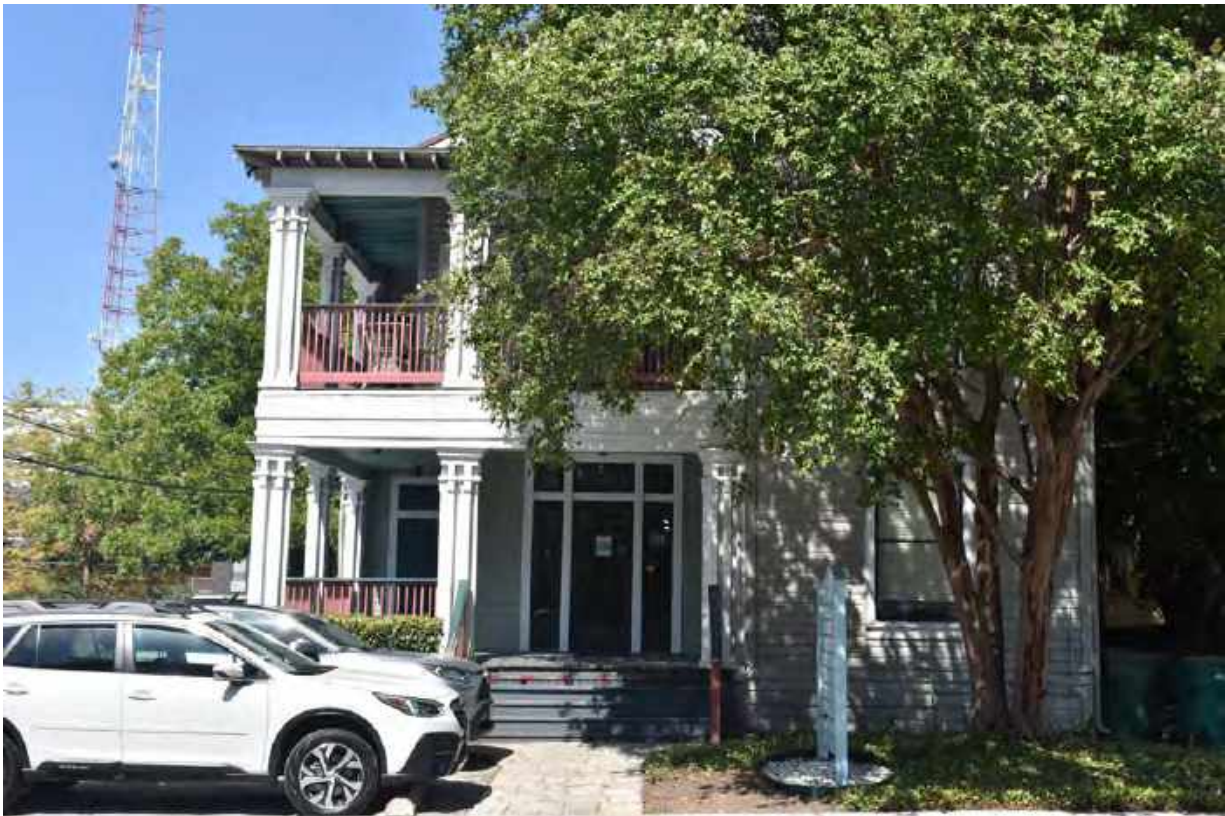
View facing west toward historic-age building (Resource A) with nonhistoric sign on right (Resource B)

Type: Building	Exterior materials: wood siding	Primary roof type: complex gable, crossed	Alterations: Porch rails replaced Landscape/hardscape altered
Style: Queen Anne			
Form: Rectangular	Porch: wraparound integrated

Resource 218A is recommended individually eligible for listing in the NRHP under Criterion C at the local level of significance in the area of architecture as a good representative example of its type. No associations were identified linking the property to persons or events of historic importance. Because the building offers neither a local interpretation of a standard design nor an undocumented construction technique, it has limited potential to yield important information. As a result, it is recommended not eligible for listing in the NRHP under Criterion A, B, or D.

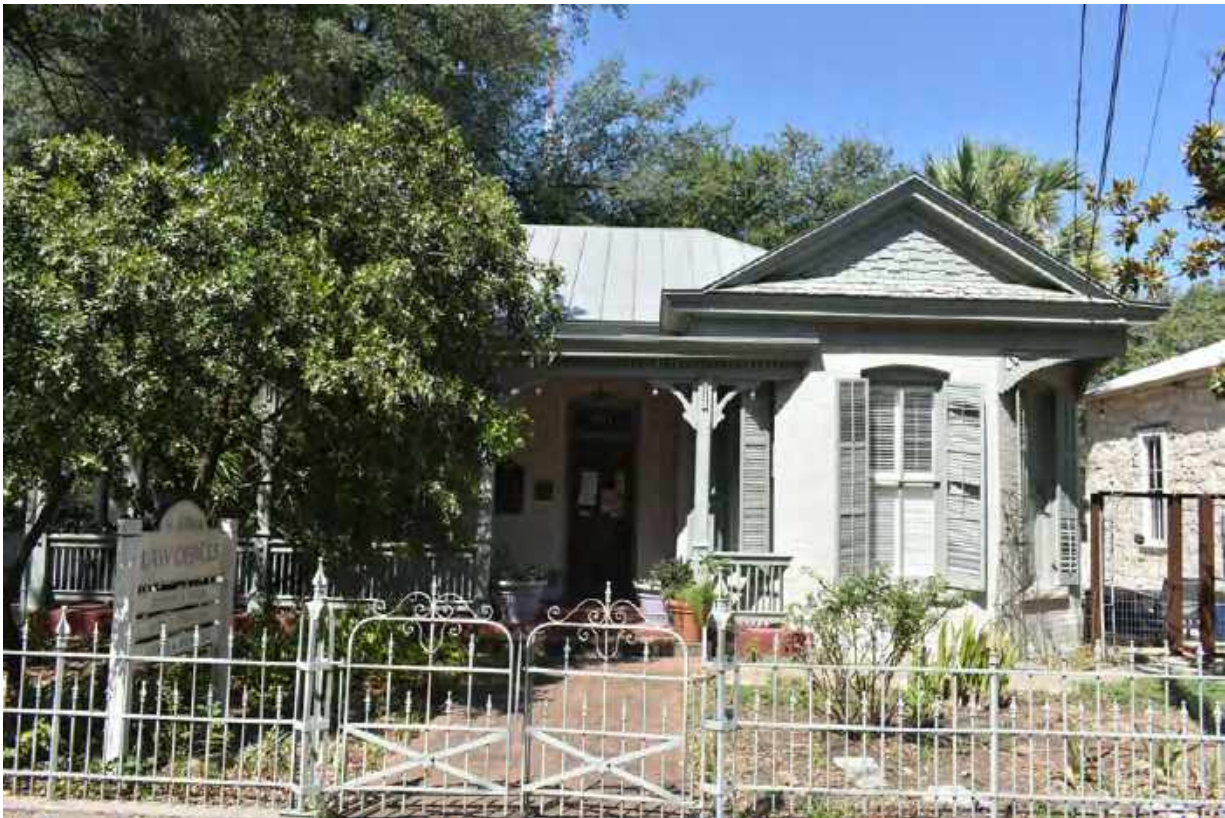
Resource A (rear)
and nonhistoric
Resource B (lower
left); view facing
west

The property is a Recorded Texas Historic Landmark (RTHL) and a City of San Antonio individual historic landmark. Resource 219A is recommended individually eligible for listing in the NRHP under Criterion C at the local level of significance in the area of architecture as a good representative example of its type. No associations were identified linking the property to persons or events of historic importance. Because the building offers neither a local interpretation of a standard design nor an undocumented construction technique, it has limited potential to yield important information. As a result, it is recommended not eligible for listing in the NRHP under Criterion A, B, or D.

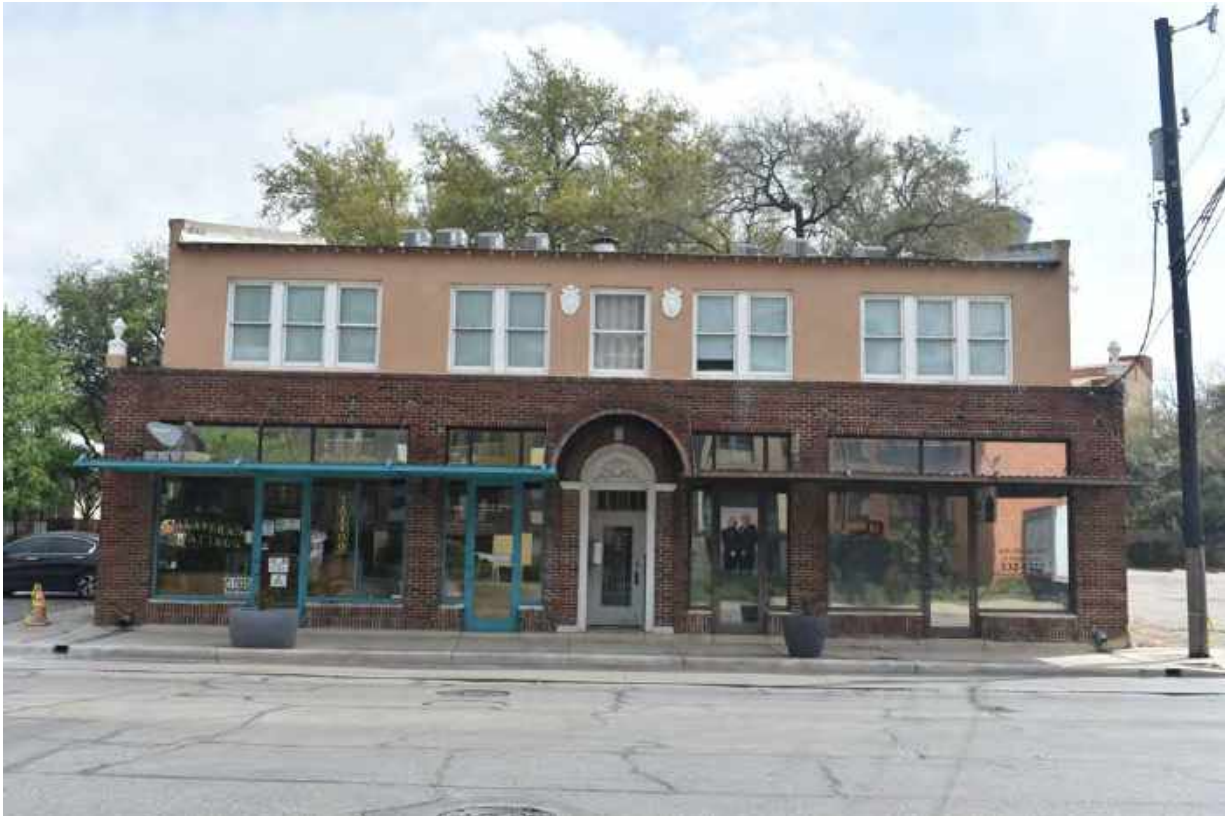
View facing east.

Type: Building	Exterior materials: stucco	Primary roof type: gable, side	Alterations: Windows replaced – all visible Storefront altered/replaced Doors replaced
Style: Commercial	brick		
Form: Rectangular	Porch: N/A

The resource is a two-story commercial buildings that according to Sanborn maps was constructed sometime between 1904 and 1911. The building replaced a one-story adobe dwelling previously located on the site.

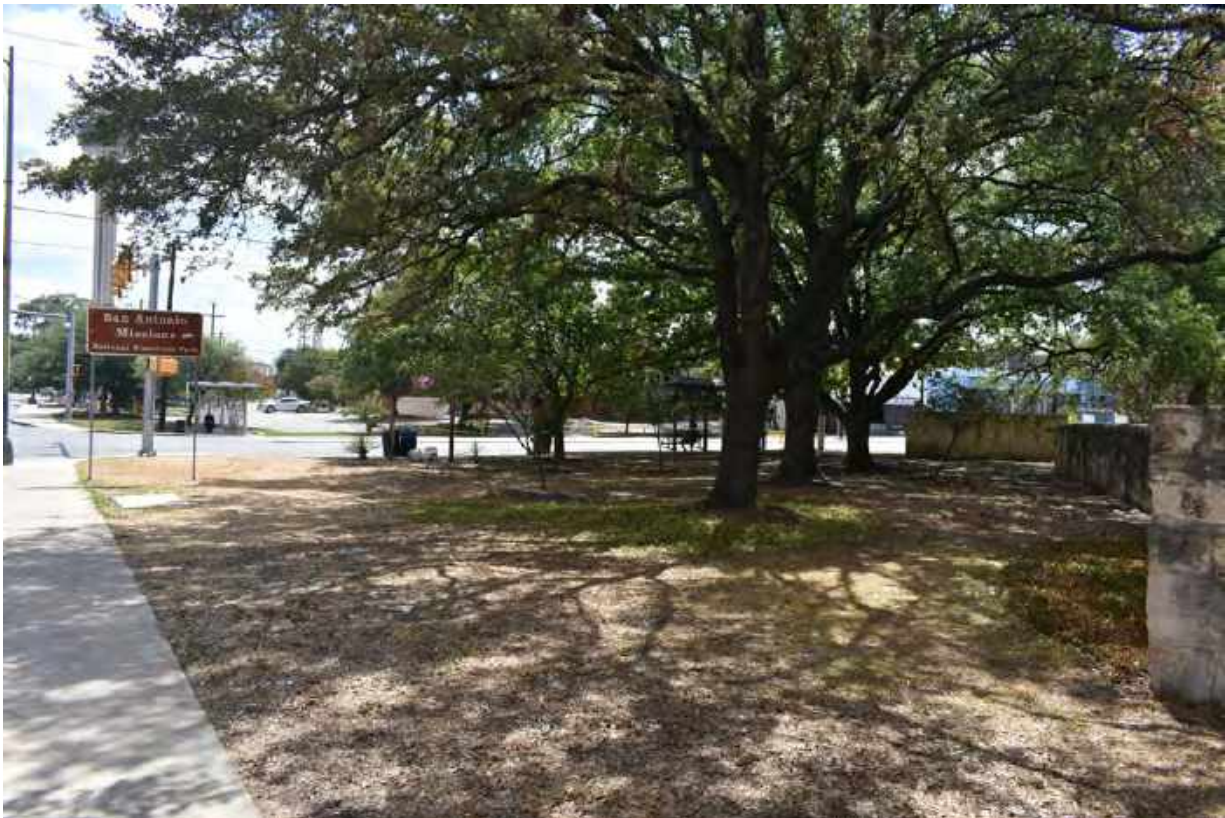
View facing east.

This park does not embody distinctive characteristics of a type, period, or method of construction and it does not represent the work of a master or possess high artistic value. Additionally, no associations were identified linking it to persons or events of historic importance. Because the building offers neither a local interpretation of a standard design nor an undocumented construction technique, it has limited potential to yield important information. As a result, it is recommended not eligible for the NRHP under Criterion A, B, C, or D.

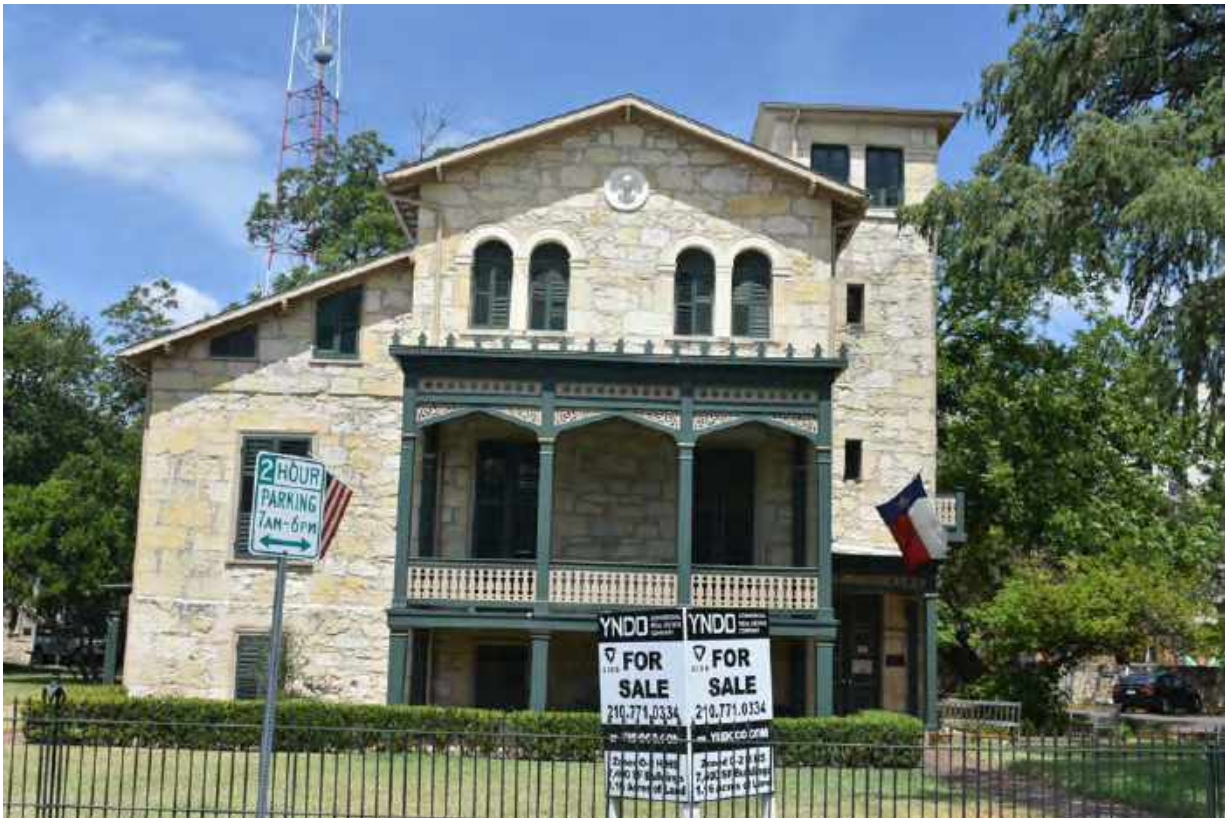
View facing northwest.

German immigrant Anton Frederick Wulff built this house in ca. 1870. Wulff was a successful merchant, alderman, and the City's first parks commissioner (saconservation.org). By 1970, the house had become deteriorated. San Antonio Conservation Society purchased the house in 1974, and restored the building with funds from the Sheerin Foundation (saconservation.org). The metal fence surrounding the property is a 1979 reproduction (saconservation.org). The property is a contributing resource to the King William NRHP Historic District and is a Recorded Texas Historic Landmark.

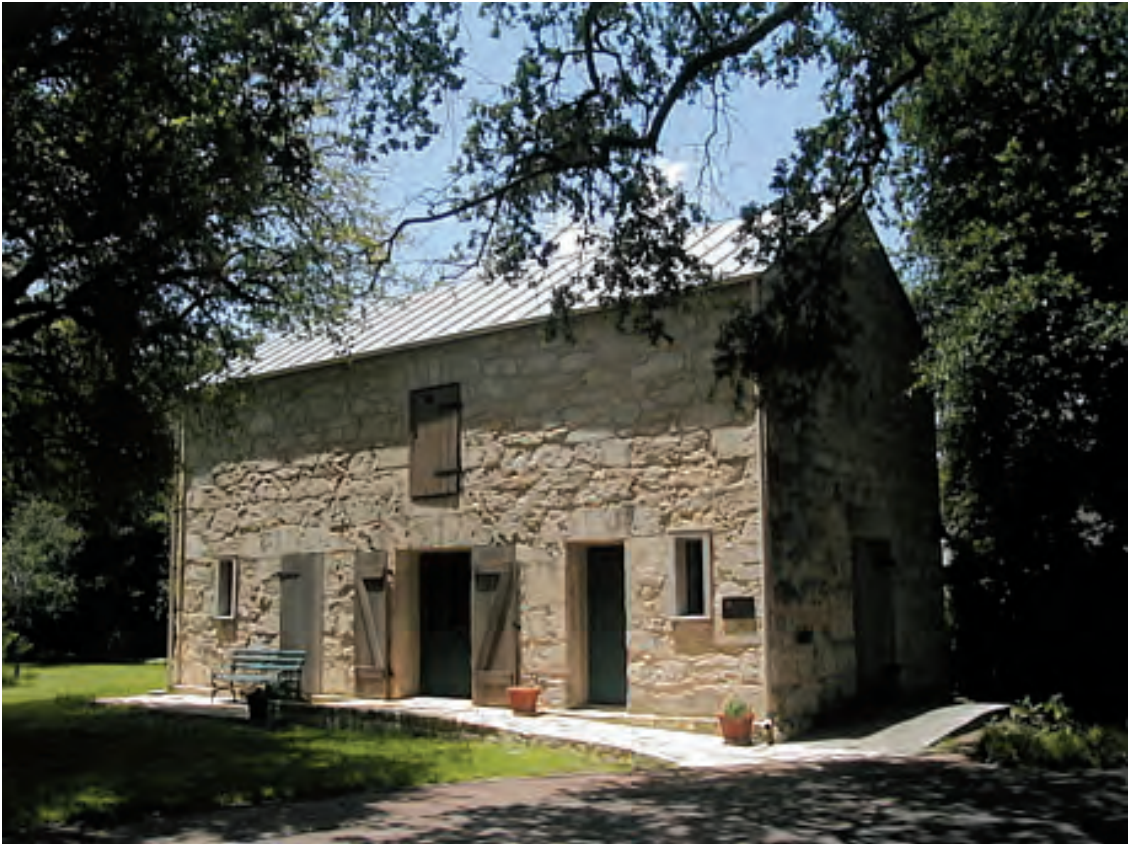
View facing southwest; photograph by Conservation Society of San Antonio.

Comments
The August C. Stuemke Barn was constructed ca. 1867 as part Stuemke's lumberyard at 215 N. Flores Street. The Conservation Society of San Antonio acquired ownership of the building from Frost National Bank and relocated it to 107 King William Street in 1982. The relocation was performed by master mason Curtis Hunt, Jr. who numbered and photographed the building's stones, then dismantled and rebuilt the barn on the King William Street property (Conservation Society of San Antonio 2022).

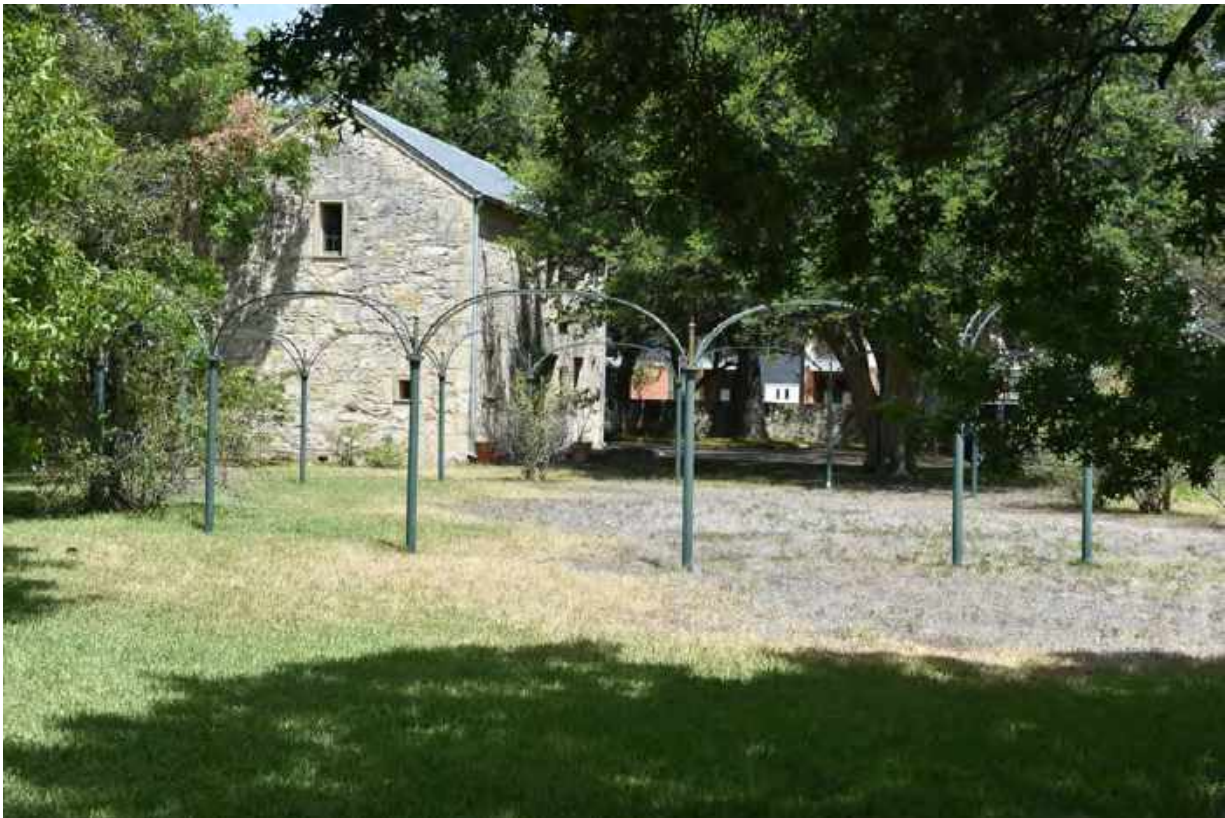
View facing northwest.

The iron rose arbor was originally a domestic landscape resource from the Cable Ranch property in northwest San Antonio. The Conservation Society of San Antonio relocated the arbor in 1980 after receiving it as a gift from the Southwest Research Foundation (Conservation Society of San Antonio 2022) .

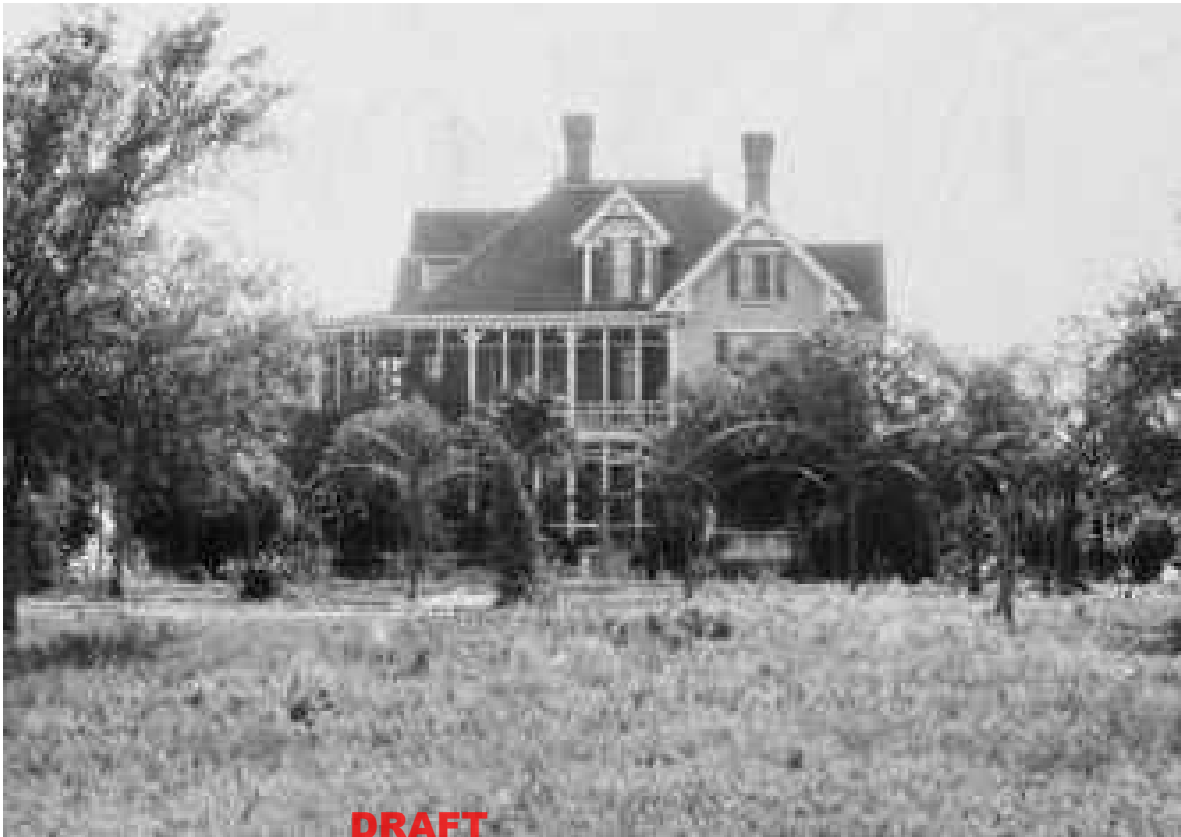
Arbor as originally situated on Cable Ranch property; 1923 photograph (UTSA Library Special Collections).

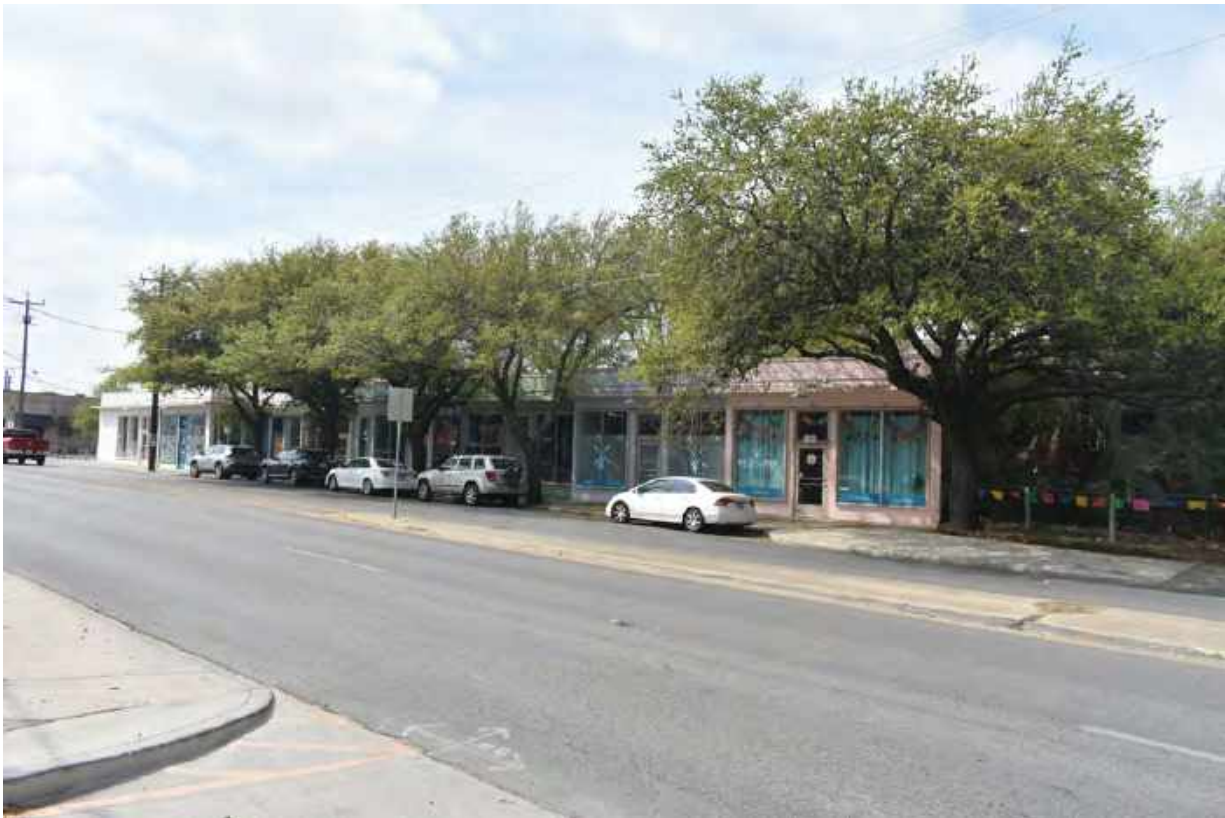
View facing southwest towards Resource B.

This commercial strip center does not embody distinctive characteristics of a type, period, or method of construction and it does not represent the work of a master or possess high artistic value. Additionally, no associations were identified linking it to persons or events of historic importance. Because the building offers neither a local interpretation of a standard design nor an undocumented construction technique, it has limited potential to yield important information. As a result, it is recommended not eligible for the NRHP under Criterion A, B, C, or D.

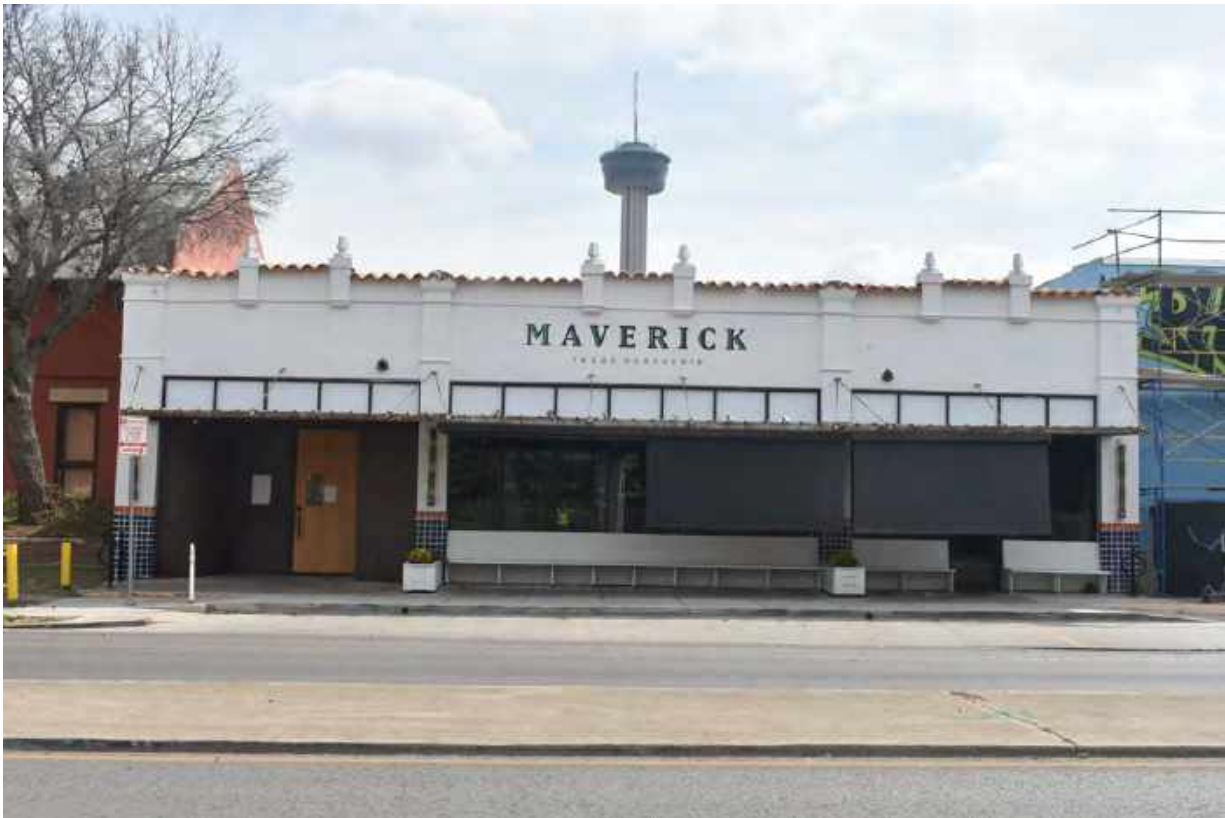
View facing east.

Type: Building	Exterior materials: stucco	Primary roof type: flat with parapet	Alterations: Storefront altered/replaced Doors replaced
Style: Spanish Colonial Revival			
Form: Rectangular	Porch: N/A

This resource does not embody distinctive characteristics of a type, period, or method of construction and it does not represent the work of a master or possess high artistic value. Additionally, no associations were identified linking it to persons or events of historic importance. Because the building offers neither a local interpretation of a standard design nor an undocumented construction technique, it has limited potential to yield important information. As a result, it is recommended not eligible for the NRHP under Criterion A, B, C, or D.

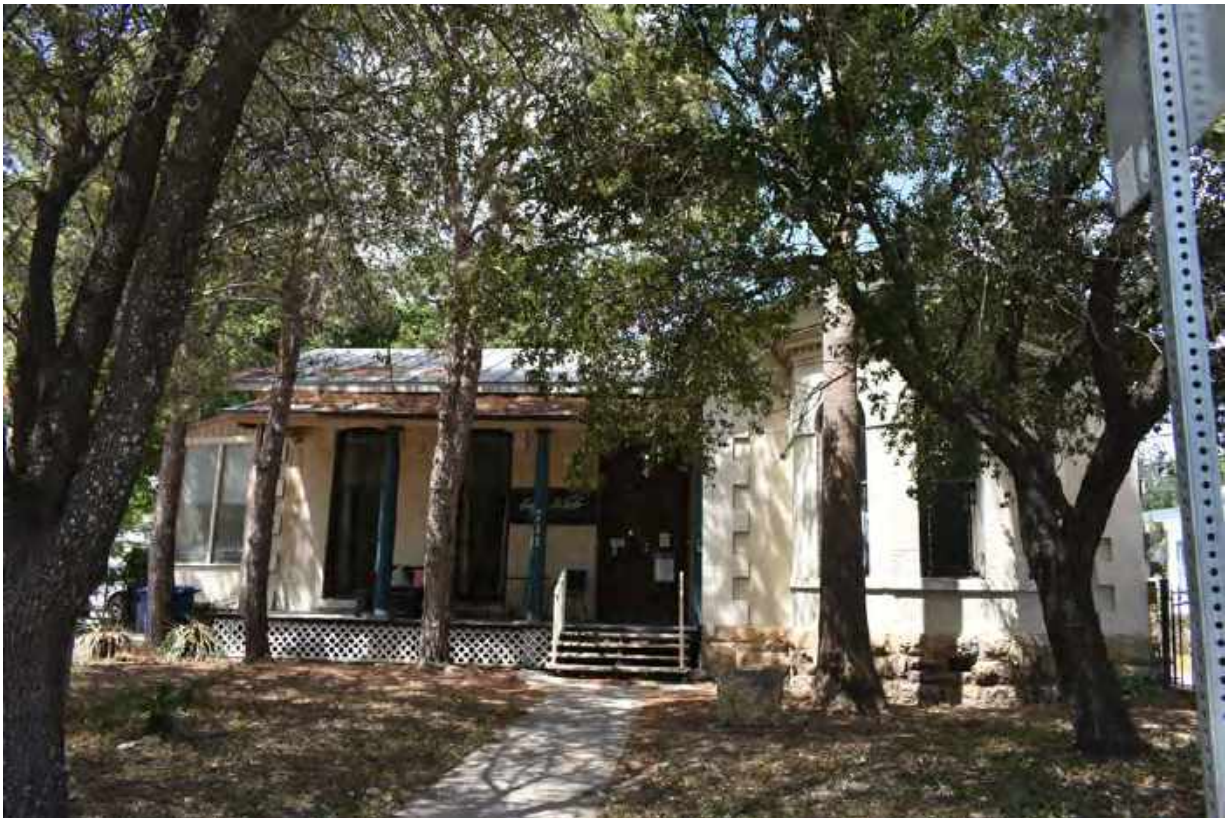
View facing west

Type: Building	Exterior materials: brick	Primary roof type: gable, crossed	Alterations: Addition to rear/side elevation
Style: Italianate	stone	shed	Porch added
Form: Modified L-plan	Porch: partial-width set within ell		Porch altered
			Porch support(s) replaced
			Signage added
			Exterior staircase added

Jeweler Alexander L. Sartor (1855-1915) and his family resided at this ca. 1890 house from 1900 to at least 1910. Sartor previously lived at the Sartor House at 217 King William Street designed by Alfred Giles from 1881 to ca. 1900. Sartor became successful from the family jewelry and watch repair business established by his German-born father also named Alexander in 1845 (Freie Presse Fur Texas 1904). The building changed uses during the 1970s, becoming Howell Hydrocarbons in 1974 (San Antonio Express 1974). Since becoming a commercial space, the building has been used for various salons. The property includes a nonhistoric sign (Resource B) on the front lawn. A photograph of the sign is included in this record.

This resource is located along the commercial corridor along S. St. Mary's Street. Although modified, this resource is notable for its association with Alexander L. Sartor. Therefore, this resource is recommended as a contributing resource within a potentially expanded South Alamo Street-South Saint Mary's Street NRHP Historic District.

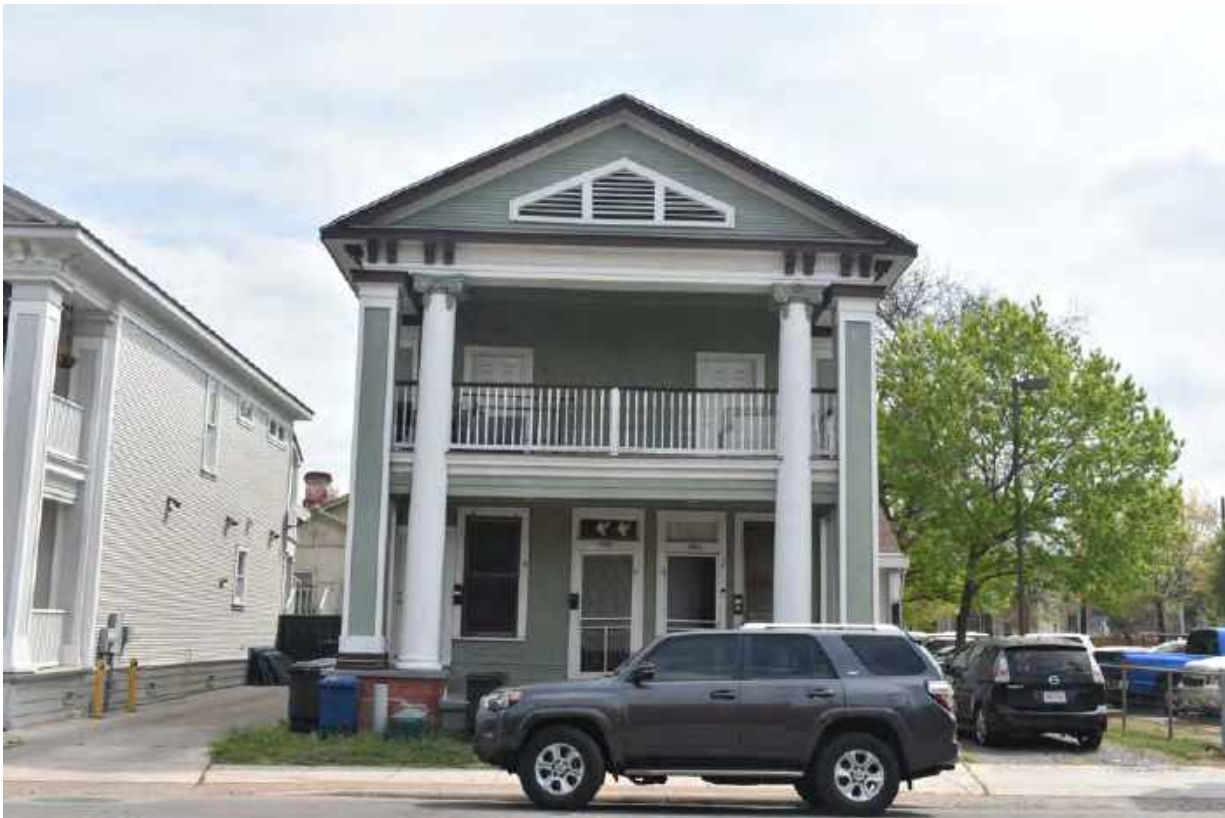
View facing east.

Type: Building	Exterior materials: wood siding	Primary roof type: gable, front	Alterations: Door/entrance added Exterior staircase added Doors replaced Windows replaced – some Addition to primary/side elevation
Style: Neoclassical			
Form: Rectangular	Porch: full-width integrated

This resource is located along the commercial corridor along S. St. Mary's-Presa Streets. This resource is recommended as a contributing resource within a potentially expanded South Alamo Street-South Saint Mary's Street NRHP Historic District.

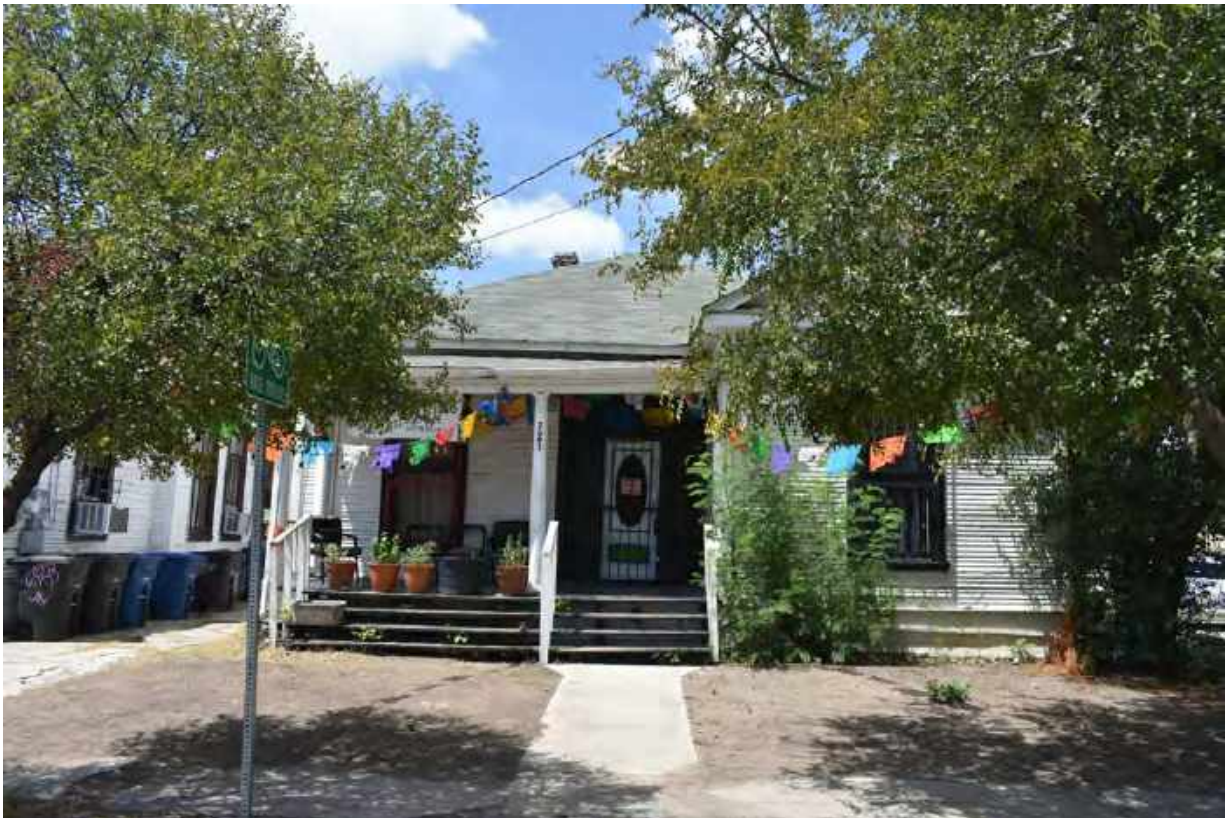
View facing west.

Type: Building	Exterior materials: wood siding	Primary roof type: hipped	Alterations: Door (primary) replaced Stairs replaced Skirting added
Style: Folk Victorian			
Form: Rectangular	Porch: partial-width set within ell

This building does not embody distinctive characteristics of a type, period, or method of construction and it does not represent the work of a master or possess high artistic value. Additionally, no associations were identified linking it to persons or events of historic importance. Furthermore, materials and workmanship integrity have been diminished due to alterations. Because the building offers neither a local interpretation of a standard design nor an undocumented construction technique, it has limited potential to yield important information. As a result, it is recommended not eligible for the NRHP under Criterion A, B, C, or D.

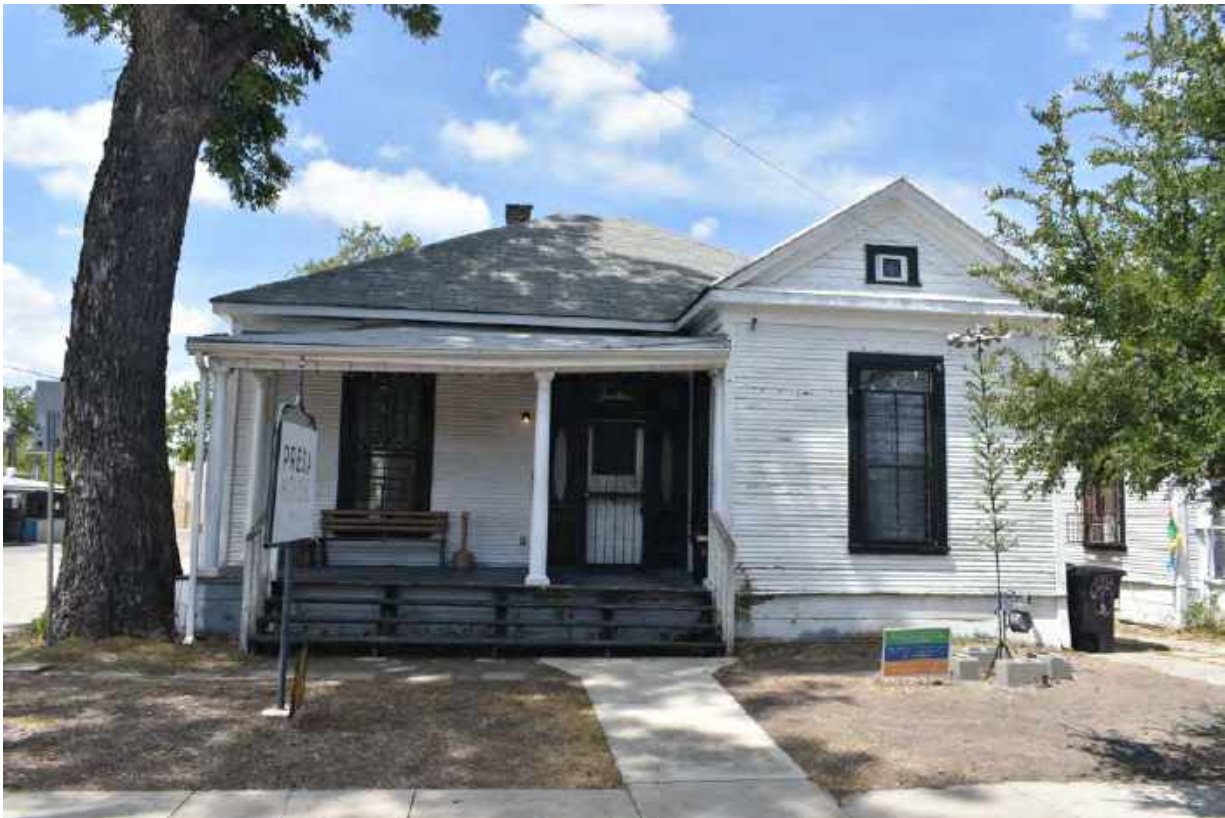
View facing west.

Type: Building	Exterior materials: wood siding	Primary roof type: hipped	Alterations: Addition to rear/side elevation Windows replaced – some Porch stair replaced Skirting added
Style: Folk Victorian			
Form: Rectangular	Porch: partial-width set within ell

This resource does not embody distinctive characteristics of a type, period, or method of construction and it does not represent the work of a master or possess high artistic value. Additionally, no associations were identified linking it to persons or events of historic importance. Furthermore, design, materials, and workmanship integrity have been diminished due to alterations. Because the building offers neither a local interpretation of a standard design nor an undocumented construction technique, it has limited potential to yield important information. As a result, it is recommended not eligible for the NRHP under Criterion A, B, C, or D.

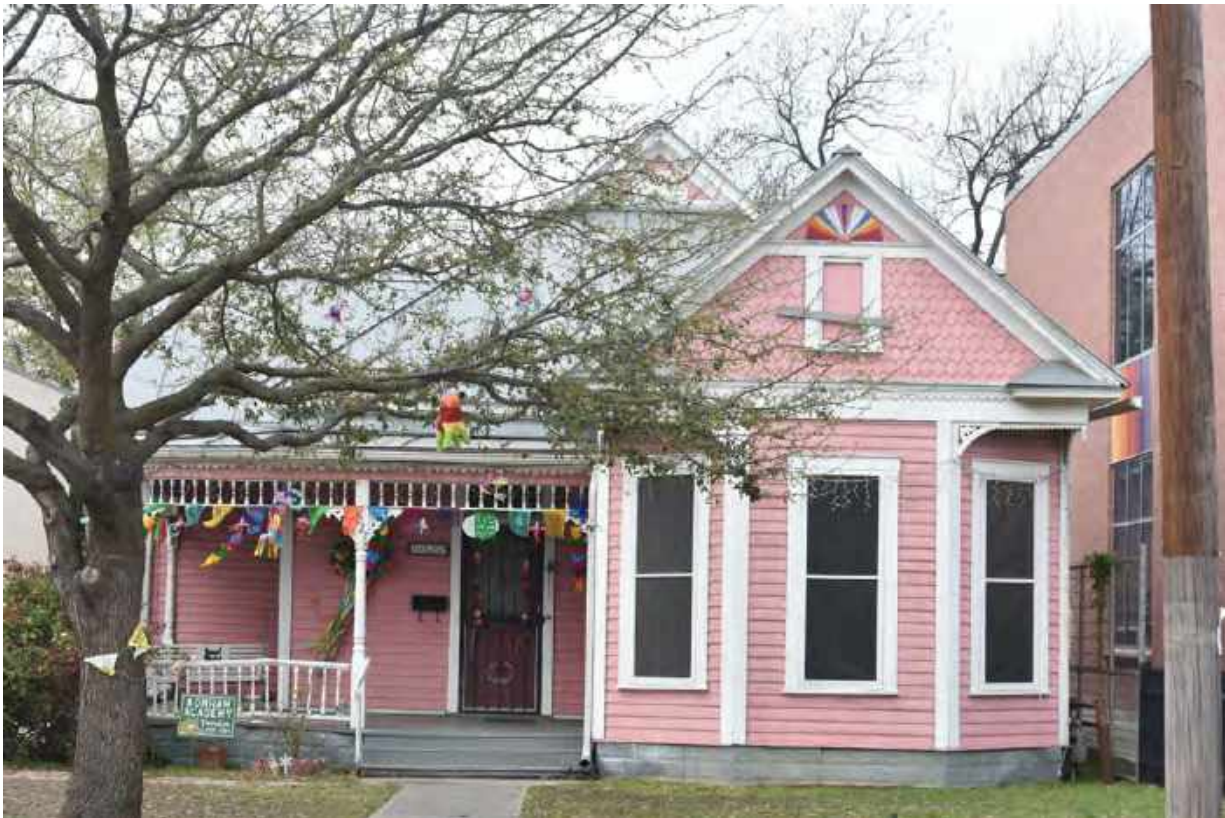
View facing west.

This resource is listed in the National Register of Historic Places as a contributing resource to the South Alamo Street-South Saint Mary's Street NRHP Historic District. Some alterations have occurred including a replaced roof materials, a boarded vent in the gable end, and added decorative elements. These changes diminish the integrity of materials. A large building built north of the residence for Bonham Academy has notably altered the surrounding setting and feeling for the resource. The house retains integrity of location, design, workmanship, and association. Because the building offers neither a local interpretation of a standard design nor an undocumented construction technique, it has limited potential to yield important information. As a result, it is recommended not eligible for the NRHP under Criterion A, B, C, or D.

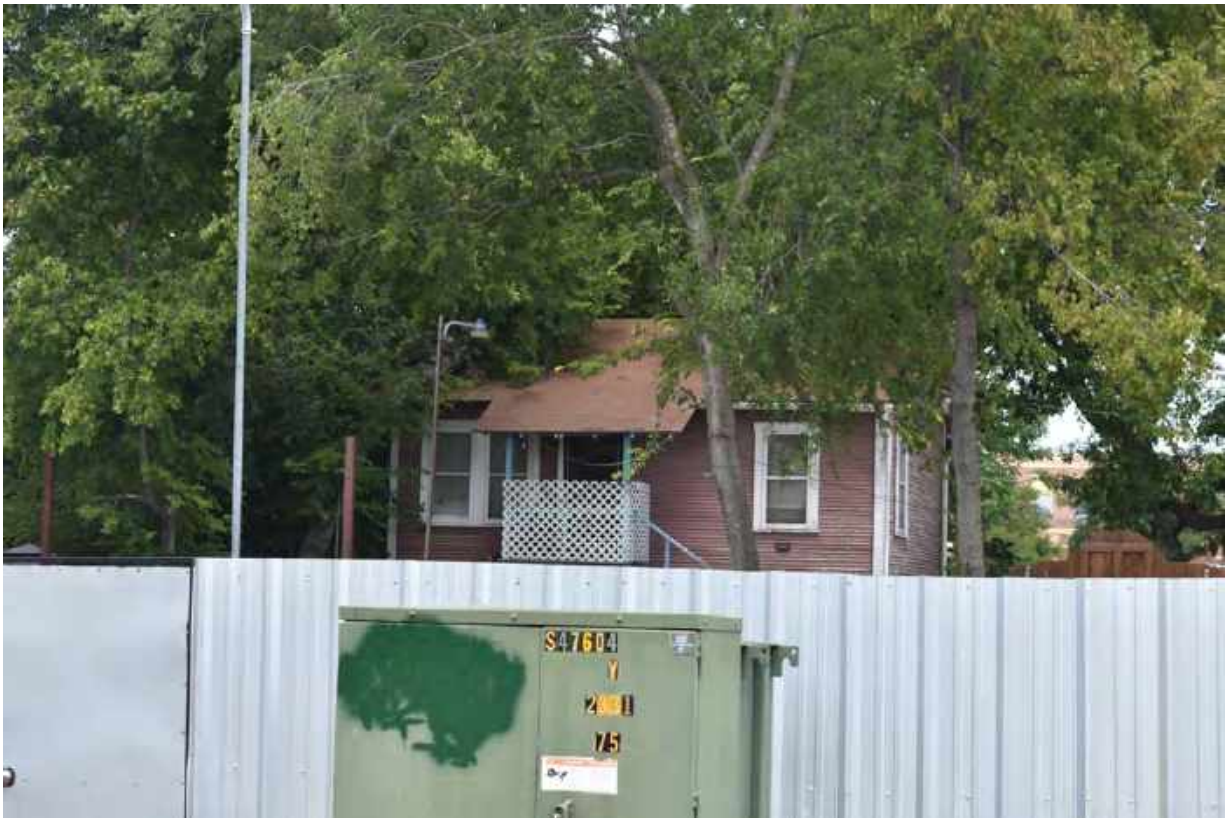
View facing north.

Type: Building	Exterior materials: wood siding	Primary roof type: gable, side	Alterations: Porch enclosed with lattice Porch rails replaced
Style: No style			
Form: Rectangular	Porch: stoop projecting

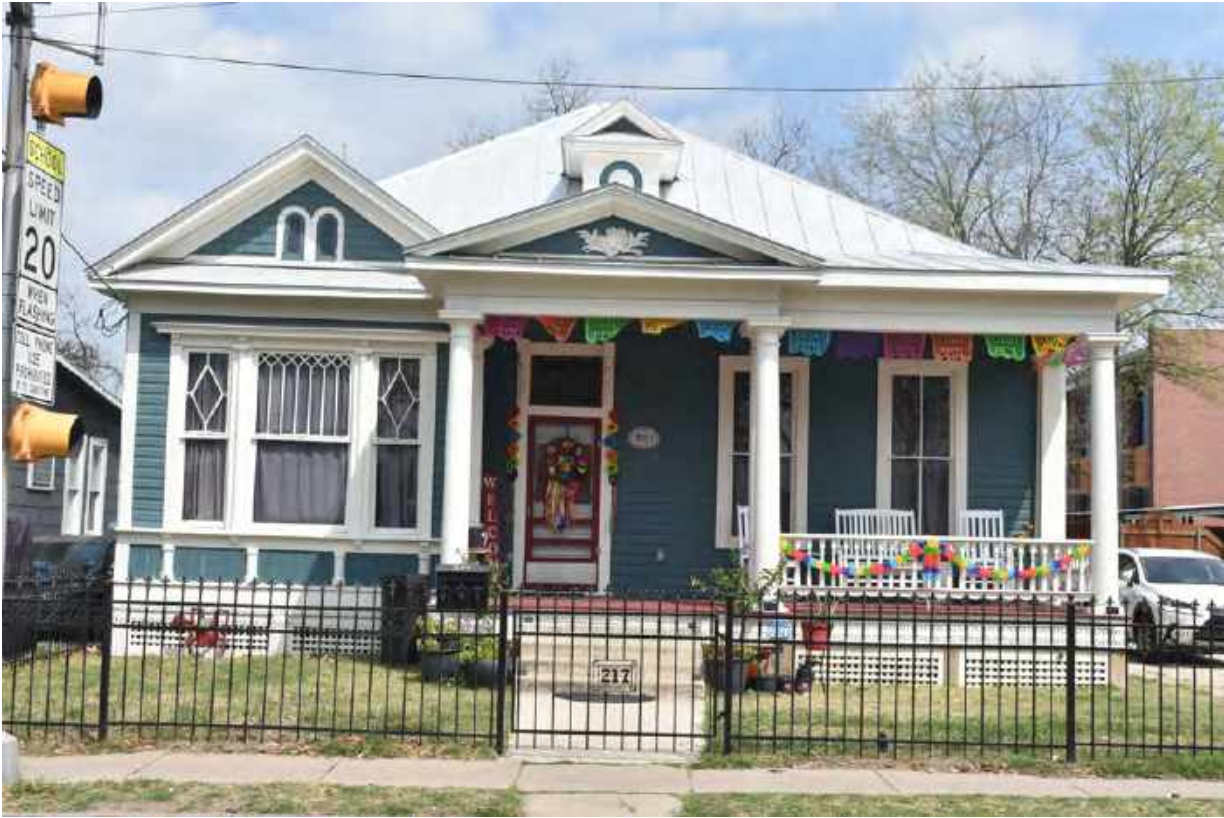
View facing north.

Type: Building	Exterior materials: wood siding wood shingles	Primary roof type: hipped gable, front	Alterations: Roof replaced w/ incomp. materials Vent infilled Decorative elements added
Style: Queen Anne			
Form: Rectangular	Porch: partial-width integrated

This resource is listed in the National Register of Historic Places as a contributing building to the South Alamo Street-South Mary's Street NRHP Historic District and is considered a contributing resource to the City of San Antonio's King William Local Historic District. Although its integrity of materials and workmanship have been diminished by the replacement of the roofing material, the resource retains the majority of the physical features dating from its construction and therefore retains integrity overall. As a result, its contributing status to the South Alamo Street-South Mary's Street NRHP Historic District is affirmed.

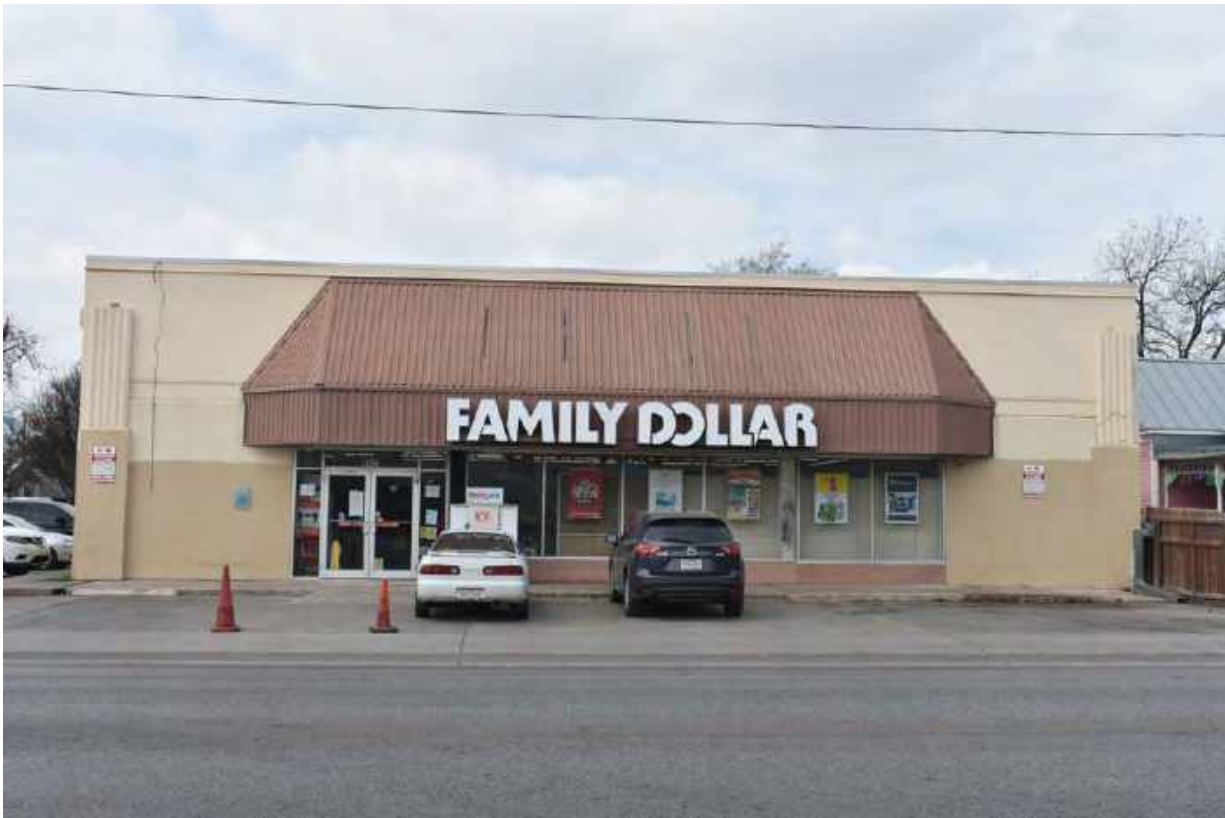
View facing west.

Type: Building	Exterior materials: stucco	Primary roof type: flat	Alterations: Storefront altered/replaced Awning(s) added Door/entrance enclosed
Style: Art Deco			
Form: Rectangular	Porch: partial-width projecting

A newspaper search reveals this building was occupied by a Winn's Variety Store by the mid-1950s. Winn's was founded by Murray Winn in 1927 (San Antonio Express 1971). The first location was reportedly at 913 S. Saint Mary's Street in San Antonio. By the mid-1940s, Winn had expanded his variety store into a chain of 12 locations in San Antonio. In 1947, he sold the chain to Roy and Lynn Spears, who further expanded the chain to 106 stores around Texas by 1971. Based on the estimated date of construction, the resource may have been built as part of the original chain of 12 stores.

This resource was identified as a non-contributing building to the South Alamo Street-South Mary's Street NRHP Historic District. It is also recommended not eligible for individual listing in the NRHP under Criterion A, B, or C. This resource does not embody distinctive characteristics of a type, period, or method of construction and it does not represent the work of a master or possess high artistic value. Additionally, no associations were identified linking it to persons or events of historic importance. While it is associated with Winn's Variety Store, research did not reveal that the resource had any significant associations with the history of the company. Rather, it represents one location in a growing chain that was expanding during the 1930s and 1940s. Alterations to its storefront, awning additions, and enclosed entrance have further diminished integrity of materials, design, and workmanship. As a result, it is recommended not eligible for listing in the NRHP under Criterion A, B, or C. The building's noncontributing status to the King William NRHP Historic District is affirmed.
