APPENDIX C SURVEY FORMS (CONTINUED)

DRAFT
(Information is under FTA review and is subject to change.)

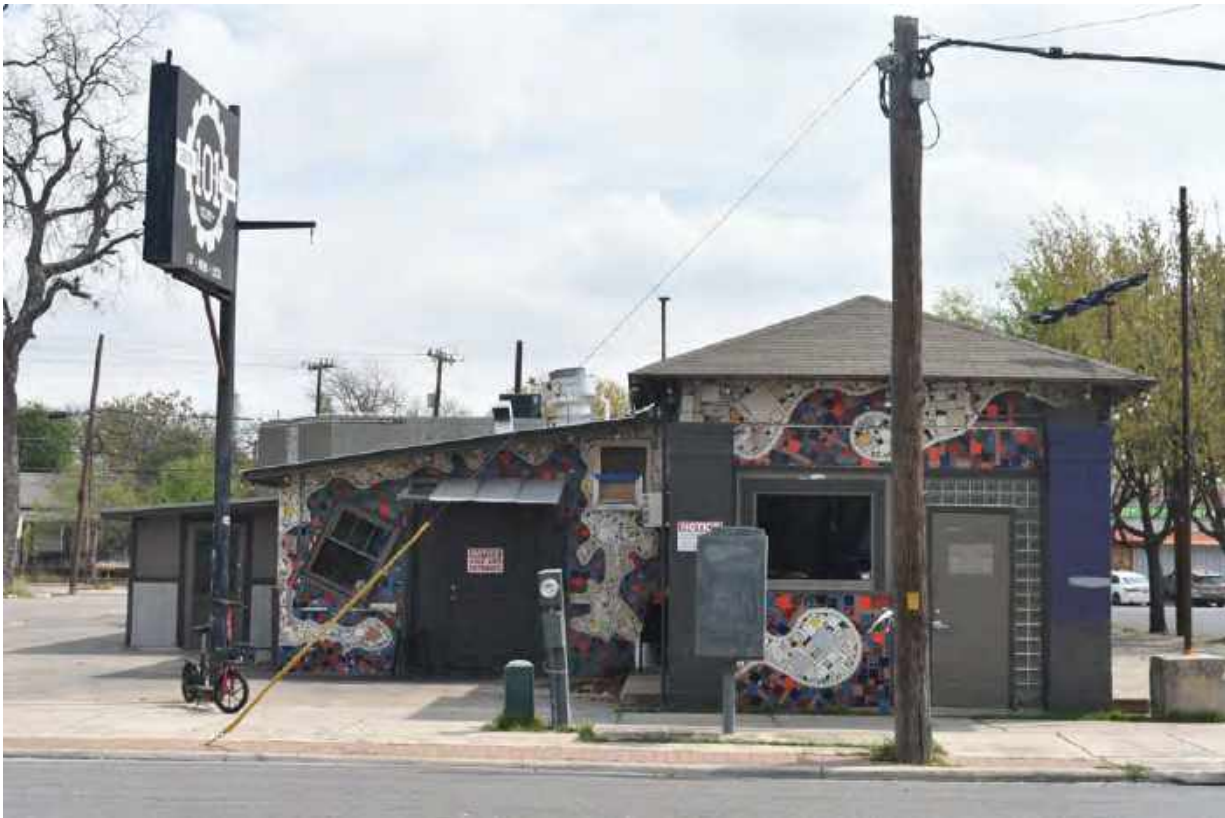
View facing east.

Type:	Building	Exterior materials:	brick	Primary roof type:	flat	Alterations:	Doors replaced
Style:	No style		stucco		hipped		Windows replaced – some
					shed		Addition to primary/side elevation
Form:	Irregular	Porch:	N/A				Brick/stone painted
							Awning(s) added

This resource does not embody distinctive characteristics of a type, period, or method of construction and it does not represent the work of a master or possess high artistic value. Additionally, no associations were identified linking it to persons or events of historic importance. Furthermore, integrity has been diminished as outlined above. Because the building offers neither a local interpretation of a standard design nor an undocumented construction technique, it has limited potential to yield important information. As a result, it is recommended not eligible for the NRHP under Criterion A, B, C, or D.

This resource is located along the commercial corridor along S. St. Mary's Pasa Streets. This resource is recommended as a noncontributing resource within a potentially expanded South Alamo Street-South Saint Mary's Street NRHP Historic District.

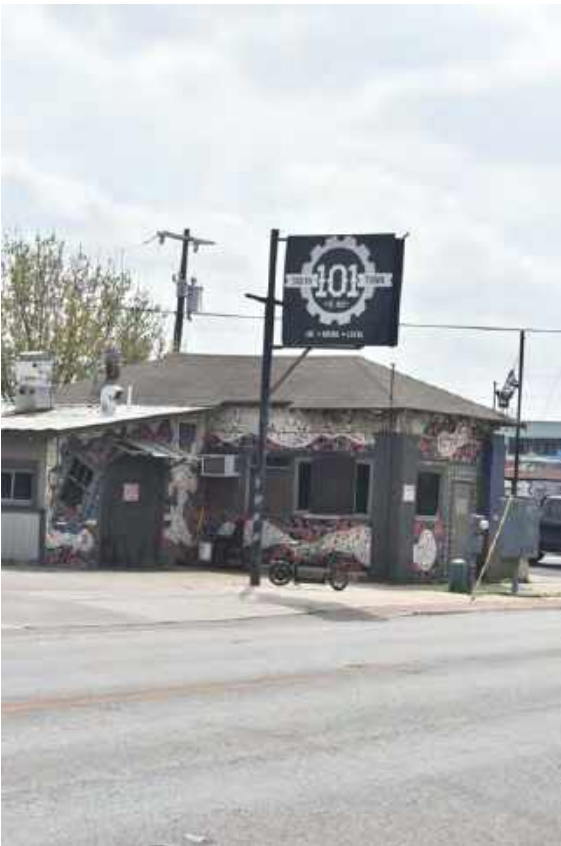
Resource B (sign, foreground) and Resource A (rear); view facing southeast.

Type: Structure	Exterior materials: metal	Primary roof type: N/A	Alterations: Signage replaced
Style: No style			
Form: Sign	Porch: N/A

This resource does not embody distinctive characteristics of a type, period, or method of construction and it does not represent the work of a master or possess high artistic value. Additionally, no associations were identified linking it to persons or events of historic importance. Because the building offers neither a local interpretation of a standard design nor an undocumented construction technique, it has limited potential to yield important information. As a result, it is recommended not eligible for the NRHP under Criterion A, B, C, or D.

This resource is located along the commercial corridor along S. St. Mary's-Presa Streets. This resource is recommended as a noncontributing resource within a potentially expanded South Alamo Street-South Saint Mary's Street NRHP Historic District.

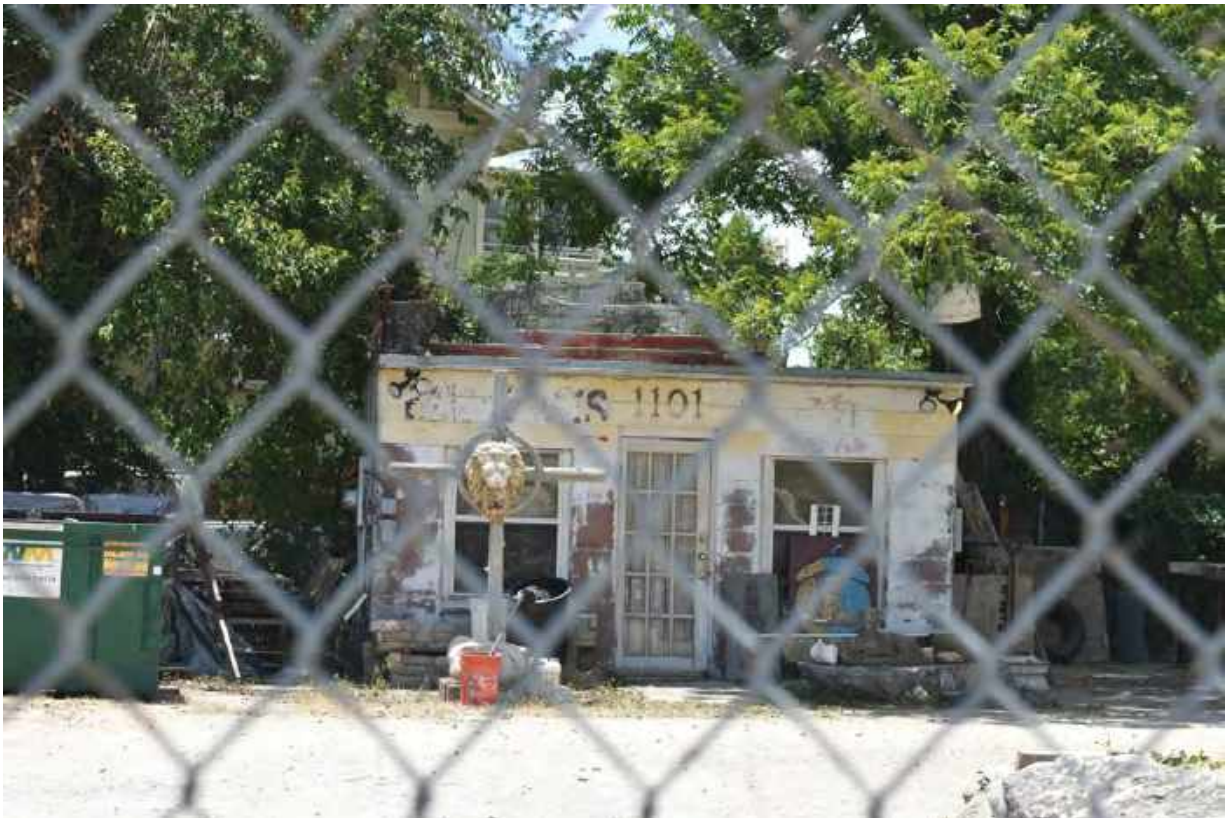
Resource A
(Historic-age);
view facing south

Type: Building	Exterior materials: wood siding	Primary roof type: flat	Alterations: Doors replaced Windows replaced – all visible
Style: No style			
Form: Rectangular	Porch: none

Resources A and B are part of the studio complex operated by Carlos Cortes, a local artist specializing in faux bois and trabaja rustico. Resource A is a historic-age office and Resource B is a nonhistoric metal shed. A photograph of Resource B is included in this record. Since 1924, the Cortes family has created faux bois work with much of their sculptures present throughout San Antonio. Public projects include recent installations along the River Walk, bus stops, and park shelters. The property was formerly a used car dealership in the 1950s. Mueller Motors operated at the site, specializing in Chrysler-Plymouth automobiles (San Antonio Light 1954). Autrey Datsun Sales, a specialist of Japanese vehicles, took over the property during the early 1960s. By 1967, T&L Auto Sales operated at this location (Express and News 1967).

Although the legacy of the Cortes family is interesting and important to the faux bois tradition of San Antonio, the artist has only operated at this property less than fifty years. This resource does not embody distinctive characteristics of a type, period, or method of construction and it does not represent the work of a master or possess high artistic value. Additionally, no associations were identified linking it to persons or events of historic importance. Material integrity of the office building has diminished from the replacement of doors and windows. Because the building offers neither a local interpretation of a standard design nor an undocumented construction technique, it has limited potential to yield important information. As a result, it is recommended not eligible for the NRHP under Criterion A, B, C, or D. The building is a noncontributing resource to the South Alamo Street-South Saint Mary's Street NRHP Historic District but is considered a contributing resource to the City of San Antonio's King William Local Historic District. The building does not retain sufficient historic and physical integrity and its noncontributing status to the South Alamo Street-South Saint Mary's Street NRHP Historic District is affirmed.

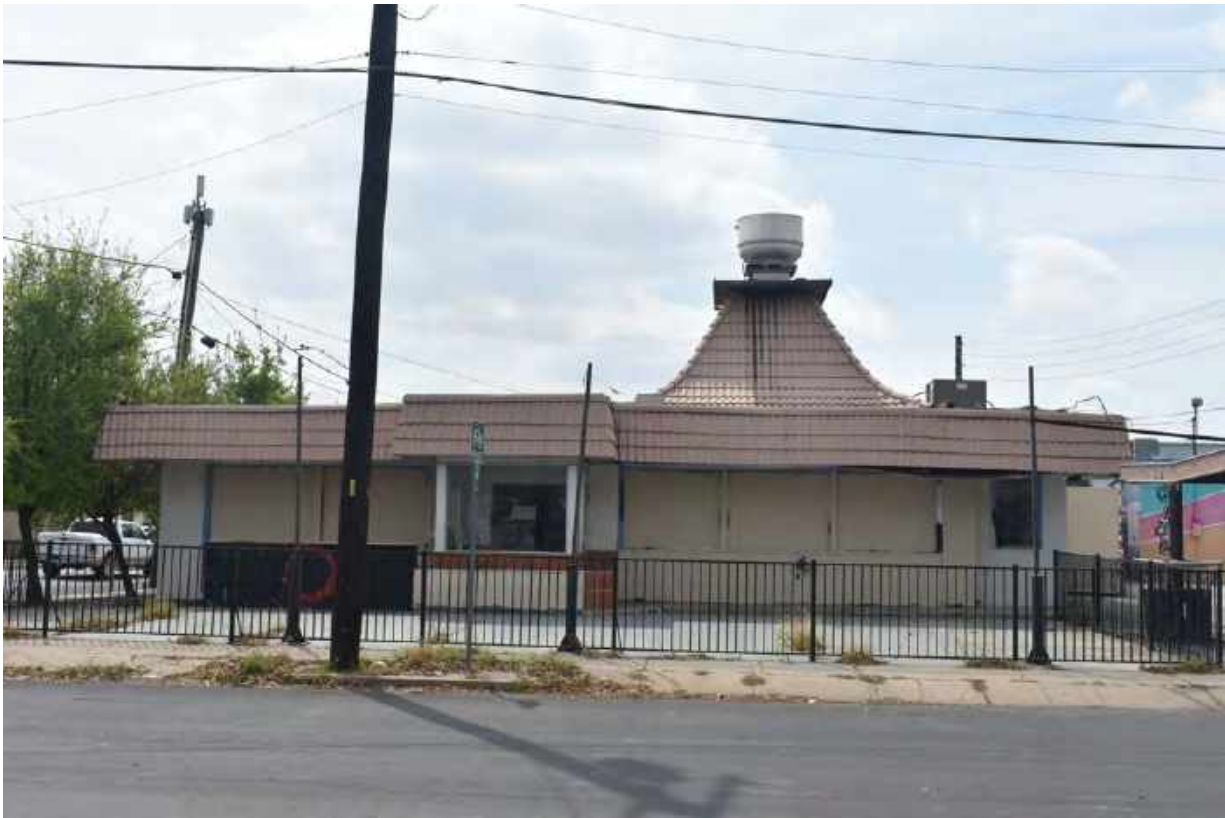
View facing south.

Type:	Exterior materials:	Primary roof type:	Alterations:
Building	stucco	flat	Addition to primary/side elevation
Style:	concrete/cinder block	fang zan-jiang-inspired	Door/entrance added
Exotic Revival, Mid-Cent. Modern		mansard	Doors replaced
Form:	Porch:		Signage removed
Irregular	none		Carport removed
			Window opening(s) infilled
			Roofline altered/exhaust vent added

This resource is located along the commercial corridor along S. St. Mary's-Presa Streets. This resource is recommended as a noncontributing resource within a potentially expanded South Alamo Street-South Saint Mary's Street NRHP Historic District.

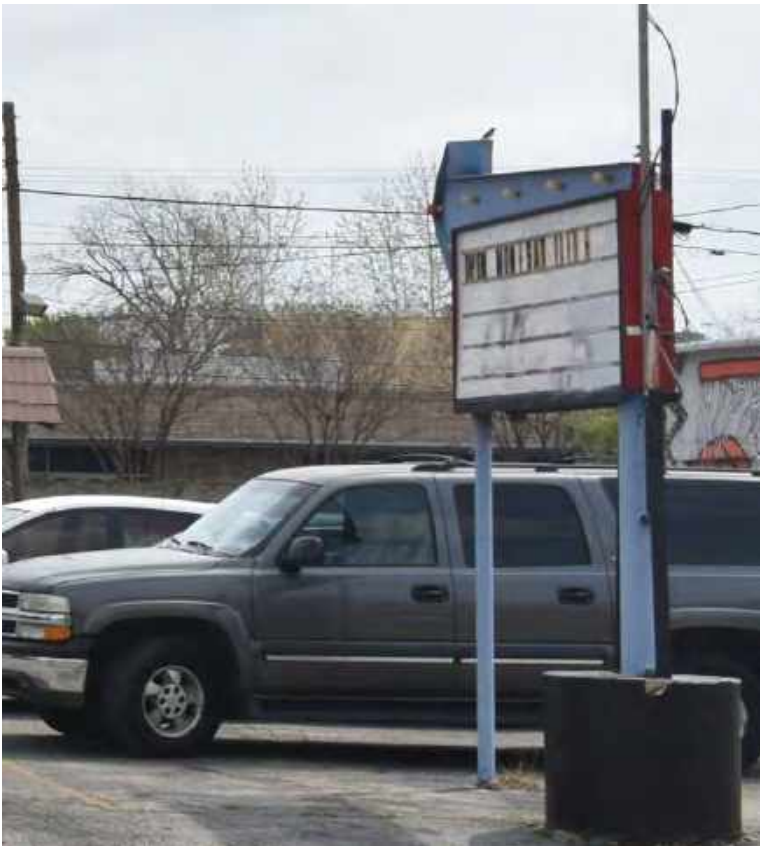
View facing southeast.

Though it possesses integrity, this resource is a common sign that was mass produced throughout the twentieth century. The resource was not found to embody distinctive characteristics of a type, period, or method of construction, represent the work of a master, or possess high artistic value. Additionally, no associations were identified linking it to events or persons of historic importance. Because the building offers neither a local interpretation of a standard design nor an undocumented construction technique, it has limited potential to yield important information. As a result, it is recommended not eligible for the NRHP under Criterion A, B, C, or D.

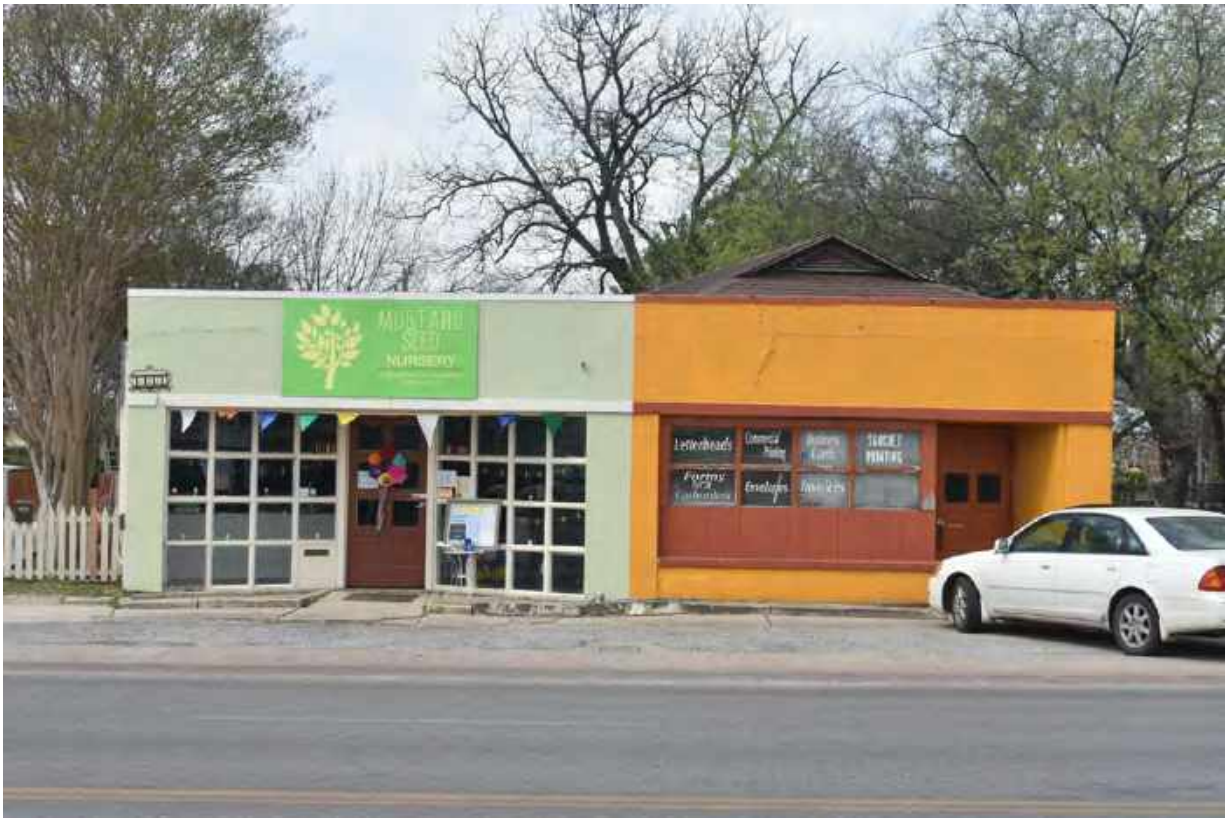
View facing southwest

Type: Building	Exterior materials: stucco processed wood board wood siding brick	Primary roof type: gable-on-hip flat with parapet	Alterations: Completely modified from its original appearance Storefront altered/replaced Signage added
Style: Commercial			
Form: 1-part commercial block	Porch: stoop integrated

This building does not embody distinctive characteristics of a type, period, or method of construction and it does not represent the work of a master or possess high artistic value. Additionally, no associations were identified linking it to persons or events of historic importance. Furthermore, integrity has been irreparably diminished due to extensive modification. Because the building offers neither a local interpretation of a standard design nor an undocumented construction technique, it has limited potential to yield important information. As a result, it is recommended not eligible for the NRHP under Criterion A, B, C, or D.

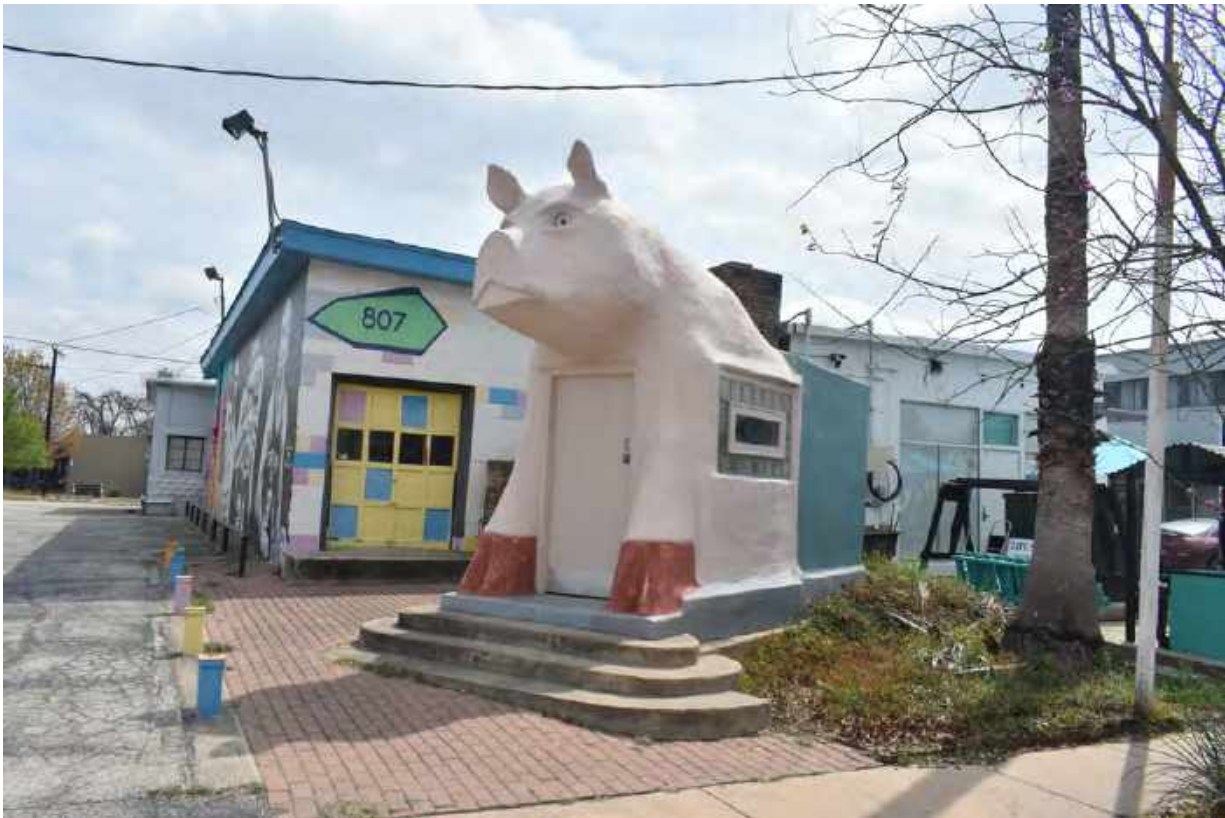
View facing east.

Type: Building	Exterior materials: stucco	Primary roof type: flat	Alterations: Windows replaced – all visible Window opening(s) infilled New foundation constructed
Style: Programmatic/Mimetic	Style: glass block		
Form: Rectangular	Porch: N/A

The Big Pig is recommended individually eligible for listing in the NRHP under Criterion C at the local level of significance in the area of architecture as an exceedingly rare example of programmatic architecture. Regarding Criterion Consideration B, which addresses moved properties, such properties can be historically significant if they still have an orientation, setting, and general environment that are comparable to those of the historic location and that are compatible with the property’s significance (Andrus 1995). As the Big Pig is adjacent to the location of Pig Stand #24, it satisfies the Criterion Consideration. No associations were identified linking the property to persons or events of historic importance. Because the building offers neither a local interpretation of a standard design nor an undocumented construction technique, it has limited potential to yield important information. As a result, it is recommended not eligible for listing in the NRHP under Criterion A, B, or D.

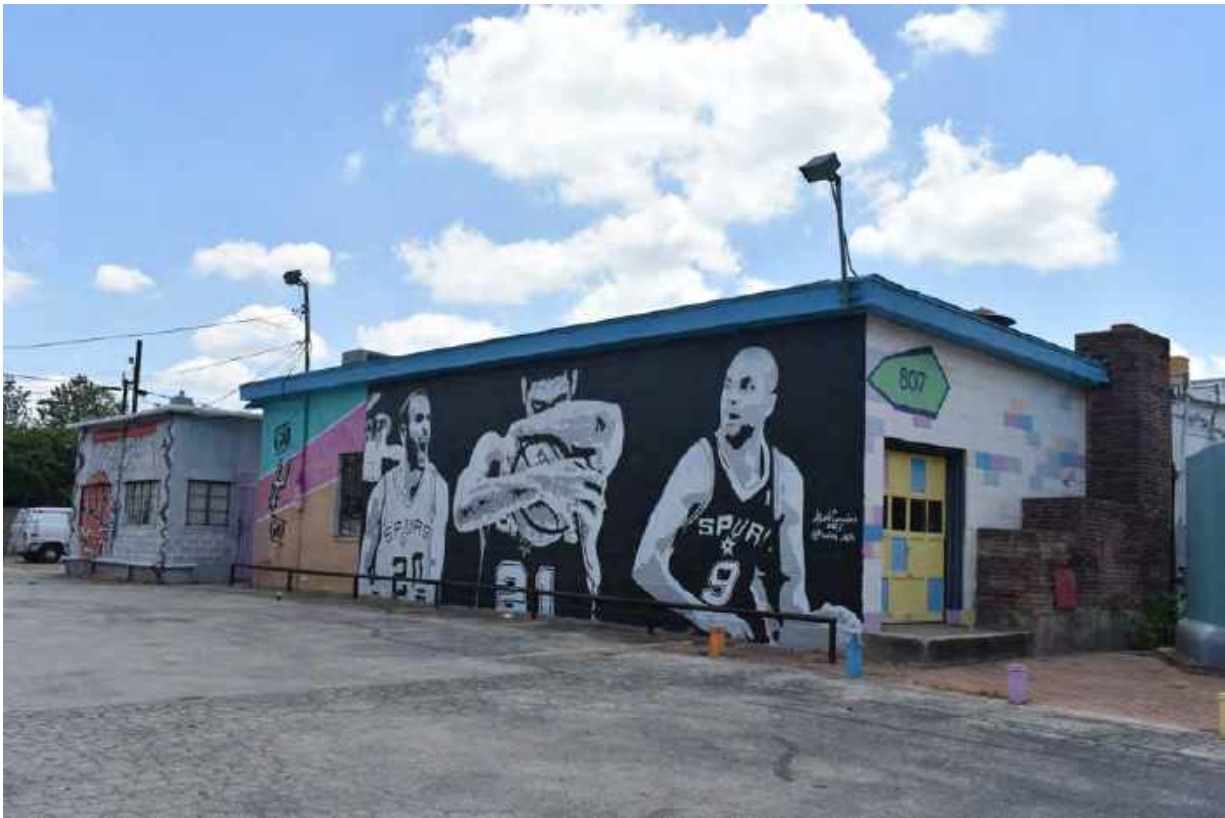
View facing southeast.

Type: Building	Exterior materials: brick stucco	Primary roof type: flat	Alterations: Window opening(s) infilled Doors replaced Brick/stone painted
Style: No style			
Form: Rectangular	Porch: N/A

The resource is not recommended individually eligible for listing in the NRHP under Criterion A, B, C, or D. While it is associated with the Pig Stand restaurant, research did not reveal that they have any significant historic associations with its history. The resources do not embody distinctive characteristics of a type, period, or method of construction and do not represent the work of a master or possess high artistic value. Additionally, no associations were identified linking them to persons of historic importance. Because the building offers neither a local interpretation of a standard design nor an undocumented construction technique, it has limited potential to yield important information.

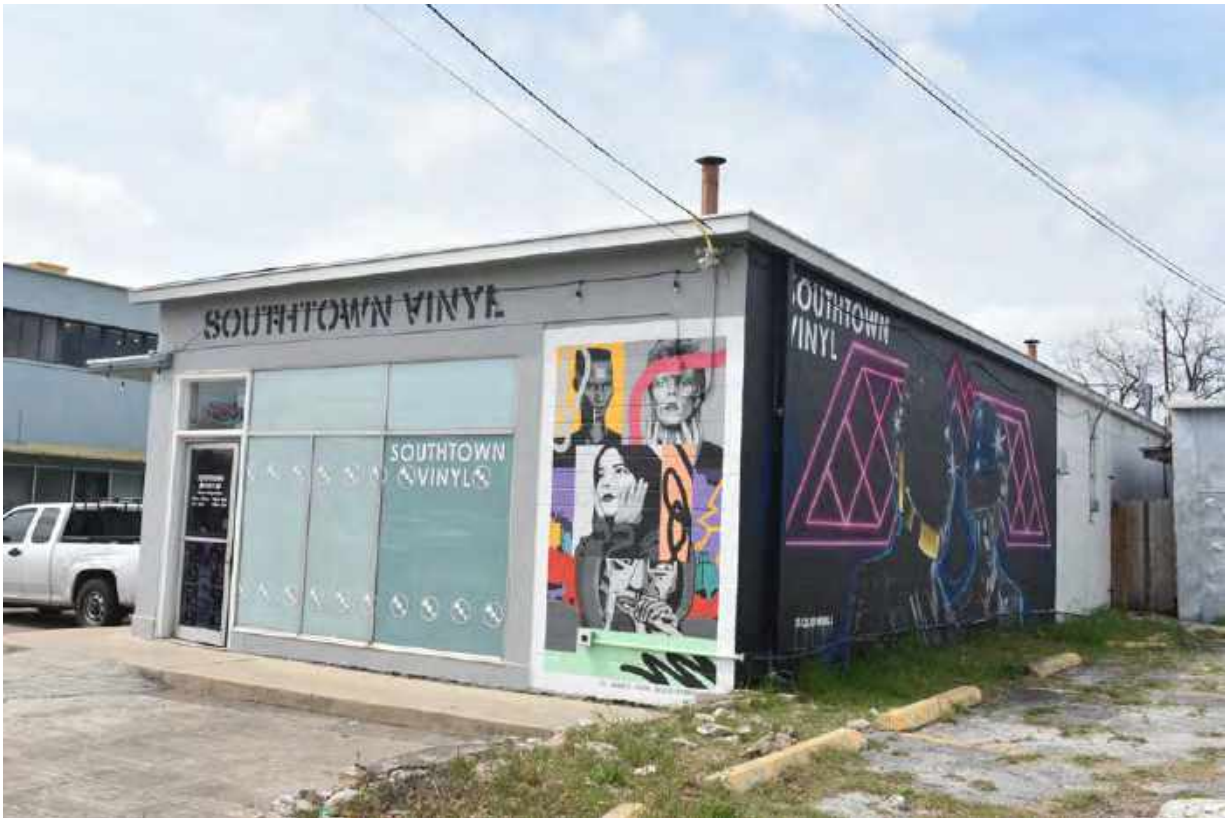
View facing west.

Type: Building	Exterior materials: stucco concrete/cinder block	Primary roof type: flat	Alterations: Storefront altered/replaced Doors replaced
Style: No style			
Form: Rectangular	Porch: full-width projecting

This building was formerly occupied by a new and used car dealer in the mid-1950s (San Antonio Light 1954) and later an auto repair shop in the 1960s (San Antonio Express 1964). In 1965, the building became a location of Mary Carter Paint Store (Express and News 1965).

This resource was not found to embody distinctive characteristics of a type, period, or method of construction, represent the work of a master, or possess high artistic value. Additionally, no associations were identified linking it to events or persons of historic importance. Furthermore, integrity has been diminished as outlined above. Because the building offers neither a local interpretation of a standard design nor an undocumented construction technique, it has limited potential to yield important information. As a result, it is recommended not eligible for the NRHP under Criterion A, B, C, or D.

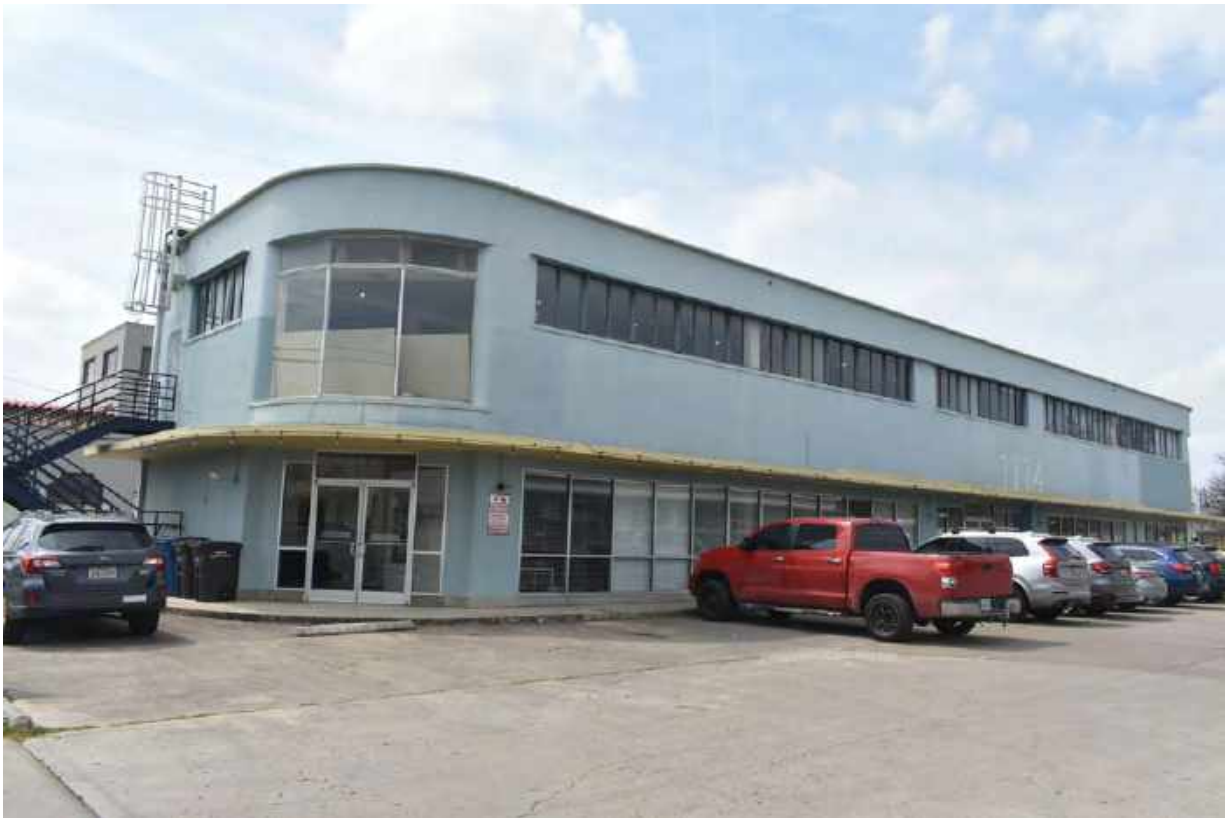
View facing southwest.

Type: Building	Exterior materials: stucco	Primary roof type: flat	Alterations: Storefront altered/replaced Doors replaced
Style: Streamline Moderne			
Form: Rectangular	Porch: wraparound projecting

According to the 1951 Sanborn, this resource was built ca. 1946 and used as a furniture store. A newspaper search reveals that this building was occupied by an appliance and television store, Joske's Outlet store, from at least 1953 to 1958 (Express and News 1953; San Antonio Light 1958). By 1958, it was occupied by the Southside Boat Center (Express and News 1958). By the early 1970s, the resource was occupied by the Parish-Draughon's Technical Institute, which taught refrigeration and air conditioning repair (San Antonio Express 1970).

This resource does not embody distinctive characteristics of a type, period, or method of construction and it does not represent the work of a master or possess high artistic value. Additionally, no associations were identified linking it to persons or events of historic importance. Because the building offers neither a local interpretation of a standard design nor an undocumented construction technique, it has limited potential to yield important information. As a result, it is recommended not eligible for the NRHP under Criterion A, B, C, or D.

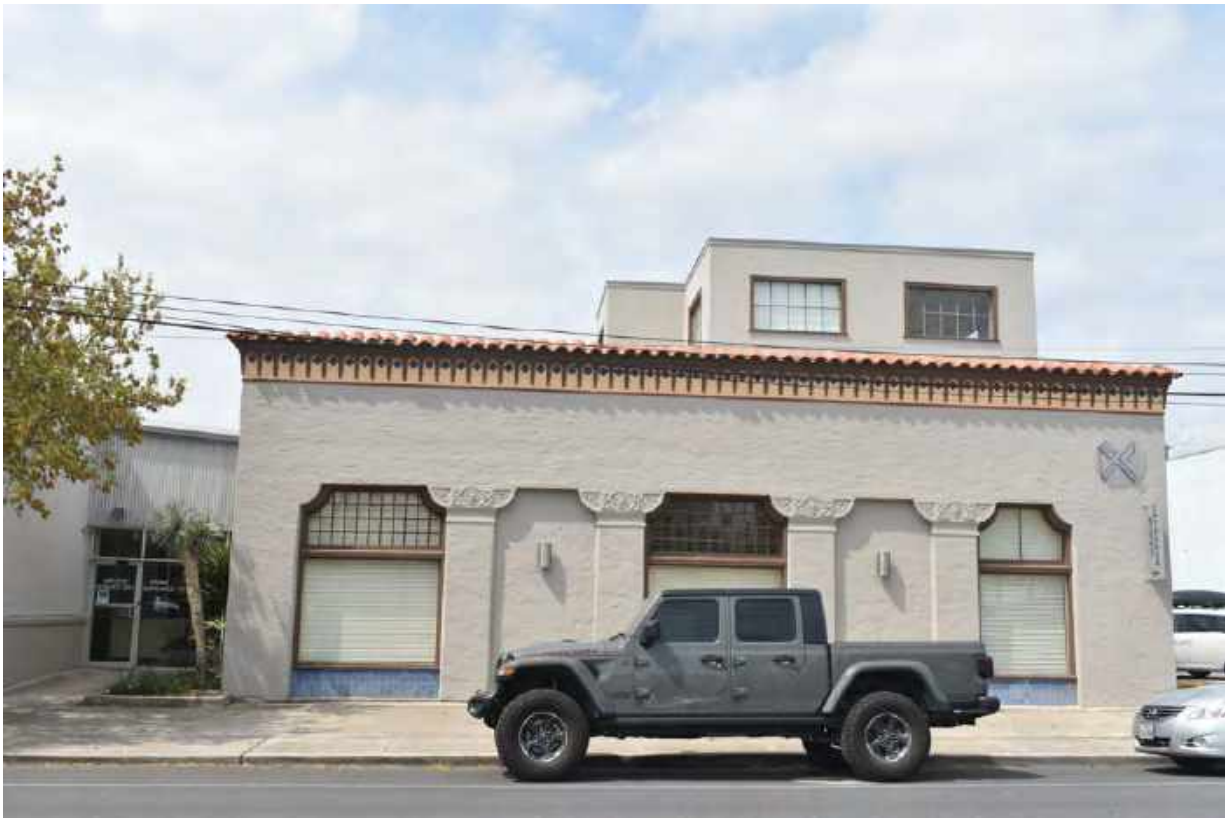
View facing west.

Type: Building	Exterior materials: stucco metal	Primary roof type: flat with parapet	Alterations: Addition to primary/side elevation Windows replaced – some Storefront altered/replaced Door/entrance enclosed Doors replaced Window opening(s) infilled
Style: Spanish Colonial Revival			
Form: Irregular	Porch: partial-width projecting

According to city directories, this resource was constructed as an ice factory and office for the Lone Star Ice, Co. around 1929. The Lone Star Ice, Co. appears to have originally been a subsidiary of the Lone Star Cotton Mill. The Lone Star Cotton Mill was founded in 1921 by Adolphus Busch III following the closure of the Lone Star Brewing Company during Prohibition. The company began manufacturing ice around 1922. By the time the resource was constructed in 1929, the Lone Star Ice, Co. owned and operated 9 factories and 22 retail stores in San Antonio. Their headquarters were located at the former Lone Star Brewing Company factory building at 200 West Jones Avenue. The Lone Star Ice, Co. appears to have later changed its name to the Lone Star Ice and Food and began operating a chain of convenience stores after World War II.

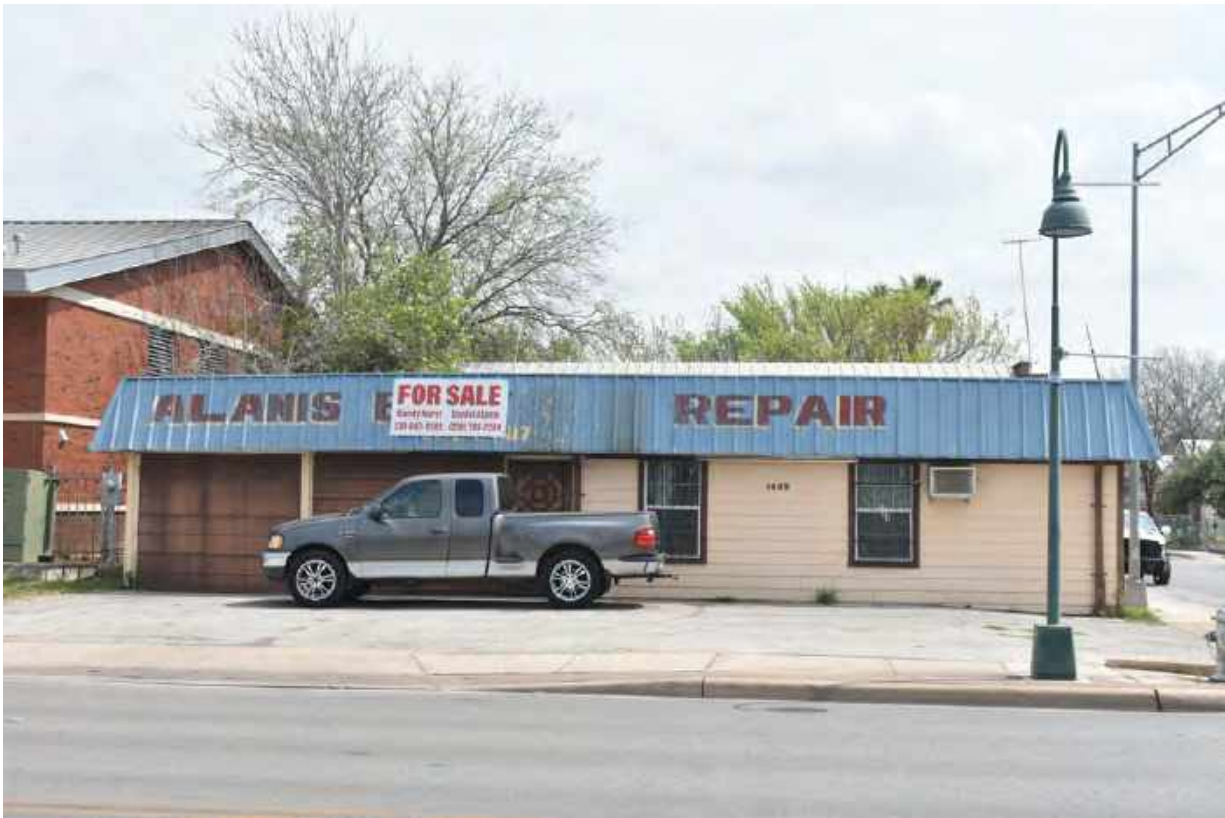
View facing east.

Type: Building	Exterior materials: vinyl siding	Primary roof type: mansard	Alterations: Addition to primary/side elevation
Style: No style	brick	flat	Window opening(s) infilled
Form: Rectangular	aluminum siding	with parapet	Carport removed
	Porch: none		Gas pumps removed
			Signage removed
			Wall cladding replaced
			Garage door(s) replaced

The existing resource is present on the 1951 Sanborn, and is noted as being Minton's Gulf Service gas station (San Antonio Express 1958). It consisted of the brick portion of the building that is located to the east on Florida Street, and originally featured a large canopy that extended west towards S. Saint Mary's Street. A review of historic aerials reveals that the canopy was removed by 1973 and the additions to the east and west of the original portion of the building constructed by 1983. The form of the resource does not match any of those presented in *A Field Guide to Gas Stations in Texas*. Some features are characteristic of Magnolia stations dating from the 1920s and 1930s, such as the brick exterior and stepped parapet, but overall the resource does not appear to align with the design of Gulf gas stations as described in the guide. Visible alterations include the removal of the gas pumps and canopy, construction of two additions to the east and west, removal of original signage, and infilling of window openings.

Based on research conducted at the reconnaissance level, the resource is recommended not eligible under Criterion A. It does not appear to be an early location of a gas station in the area or otherwise significantly associated with overall neighborhood development. No associations with persons significant in our past were identified; therefore, the resource is not recommended eligible under Criterion B. The resource possesses some features that are characteristic of Magnolia gas stations dating from the 1920s and 1930s; however, even if the property's origins as a Magnolia station could be confirmed, the building is not a recognizable example of Magnolia's architectural program. Additionally,, the resource does not represent exemplary engineering techniques, nor was it designed by a noted architect or as a prototype for an oil company or brand. Furthermore, integrity has been diminished as outlined above. For these reasons, the resource is recommended as not individually eligible under Criterion C. Because the building offers neither a local interpretation of a standard design nor an undocumented construction technique, it has limited potential to yield important information. As a result, it is recommended not eligible for

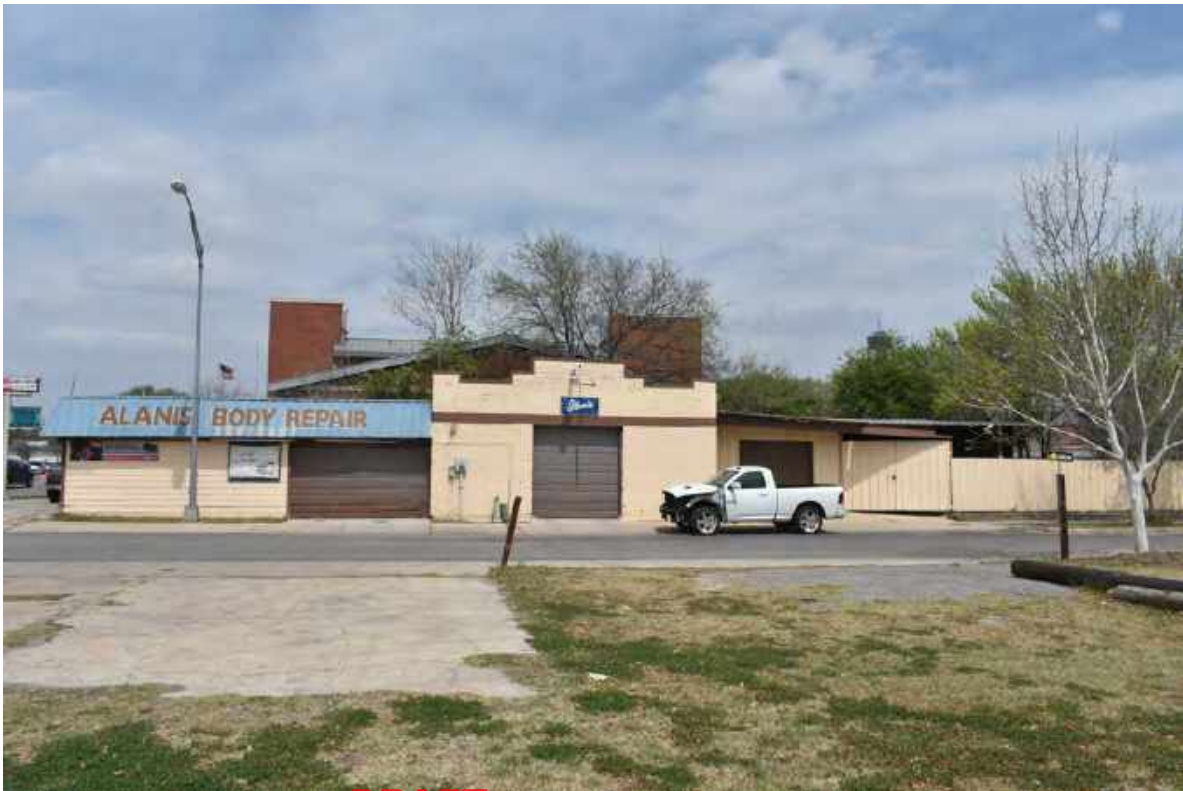
View facing north (original
portion of gas station located
at center).

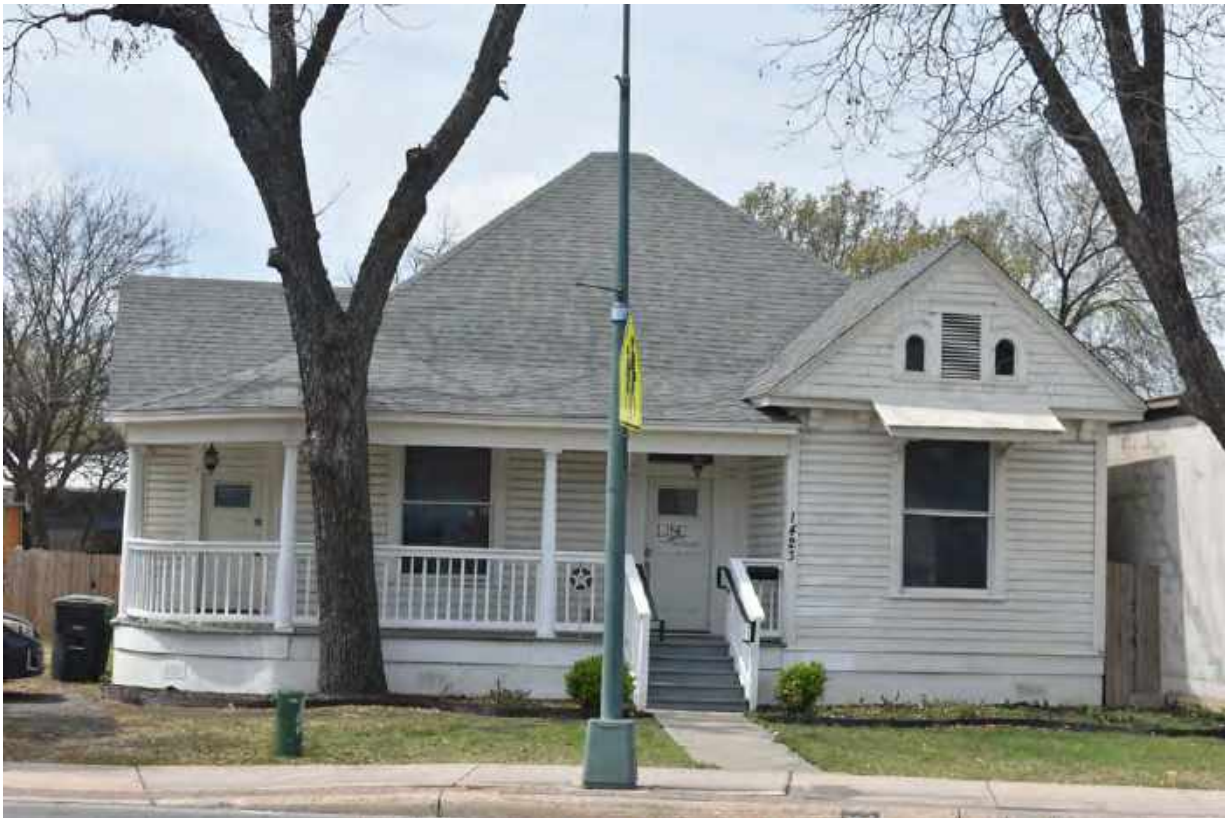
View facing west.

Type: Building	Exterior materials: wood siding	Primary roof type: hipped gable, front	Alterations: Doors replaced Windows replaced – some Sidelights removed Porch altered Porch rails replaced Addition to rear/side elevation
Style: Queen Anne			
Form: L-plan	Porch: wraparound projecting

This resource is a contributing resource to the South Alamo Street-South Mary's Street NRHP Historic District and is considered a contributing resource to the City of San Antonio's King William Local Historic District. Although the resource's integrity of materials and workmanship have been diminished by the replacement of the original entry doors and window sashes, the resource retains the majority of physical features dating from its construction and therefore retains integrity overall. As a result, its contributing status to the South Alamo Street-South Mary's Street NRHP Historic District is affirmed.

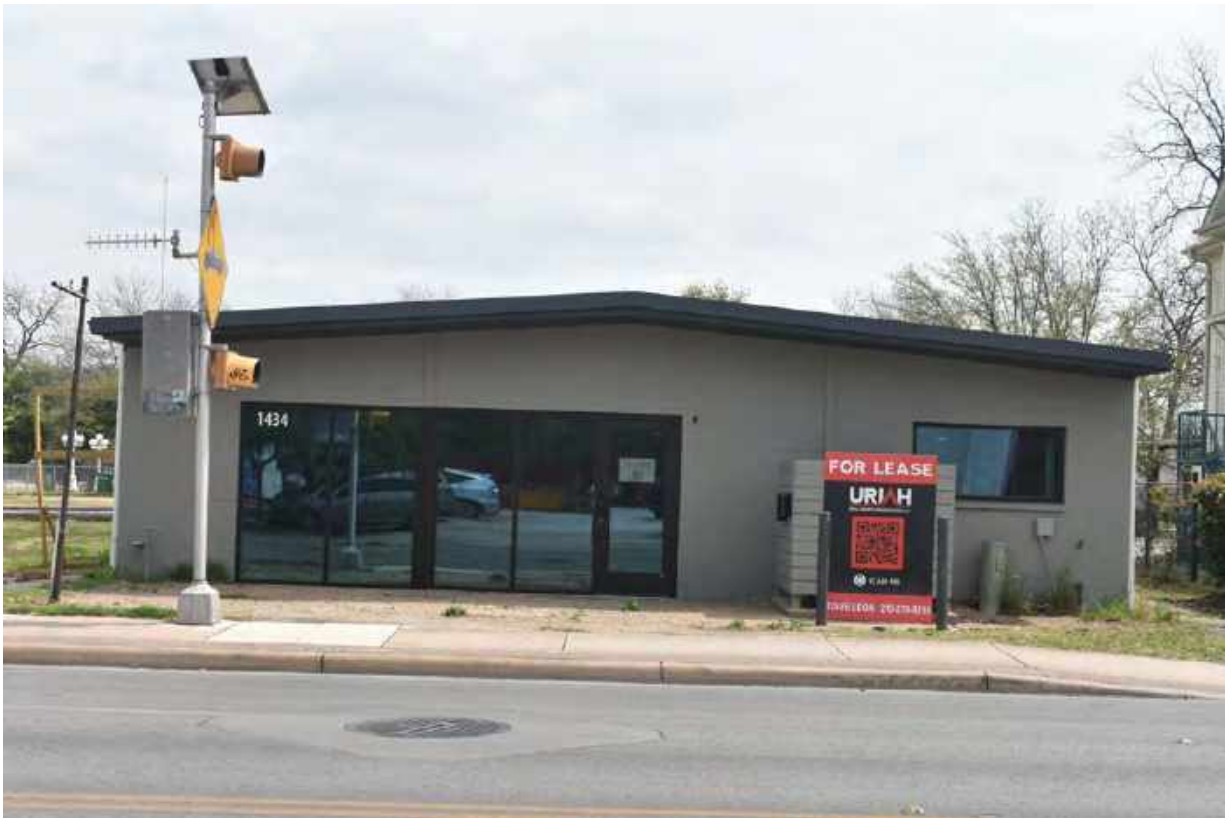
View facing east.

Type: Building	Exterior materials: concrete/cinder block	Primary roof type: gable, front	Alterations: Storefront altered/replaced Windows replaced – all visible
Style: No style			
Form: Rectangular	Porch: N/A

This resource is utilitarian in nature. It was not found to embody distinctive characteristics of a type, period, or method of construction, represent the work of a master, or possess high artistic value. Additionally, no associations were identified linking it to events or persons of historic importance. Material and workmanship integrity aspects have been diminished due to the altered storefront and replaced windows. Moreover, the vacant lot to the north of the resource detracts from the setting and feeling integrity aspects. Because the building offers neither a local interpretation of a standard design nor an undocumented construction technique, it has limited potential to yield important information. As a result, it is recommended not eligible for the NRHP under Criterion A, B, C, or D.

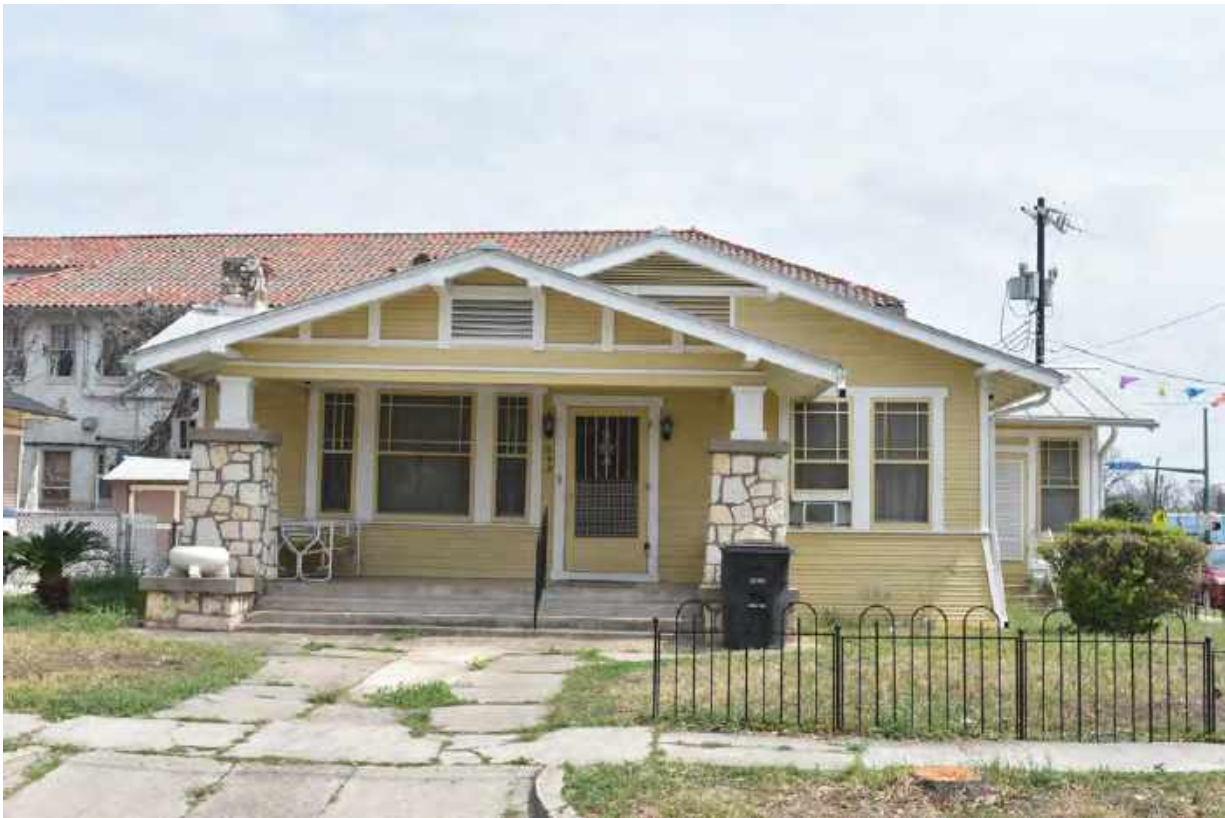
View facing east.

Type: Building	Exterior materials: wood siding	Primary roof type: gable, crossed	Alterations: Roof replaced w/ incomp. materials Addition to rear/side elevation
Style: Craftsman			
Form: L-plan	Porch: partial-width projecting

This resource is a contributing resource to the South Alamo Street-South Mary's Street NRHP Historic District and is considered a contributing resource to the City of San Antonio King William Local Historic District. Although its integrity of materials and workmanship have been diminished by the construction of a rear addition and replacement of roofing materials, it retains the majority of its physical features dating from its construction and therefore it retains integrity overall. As a result, its contributing status to the South Alamo Street-South Mary's Street NRHP Historic District is affirmed.

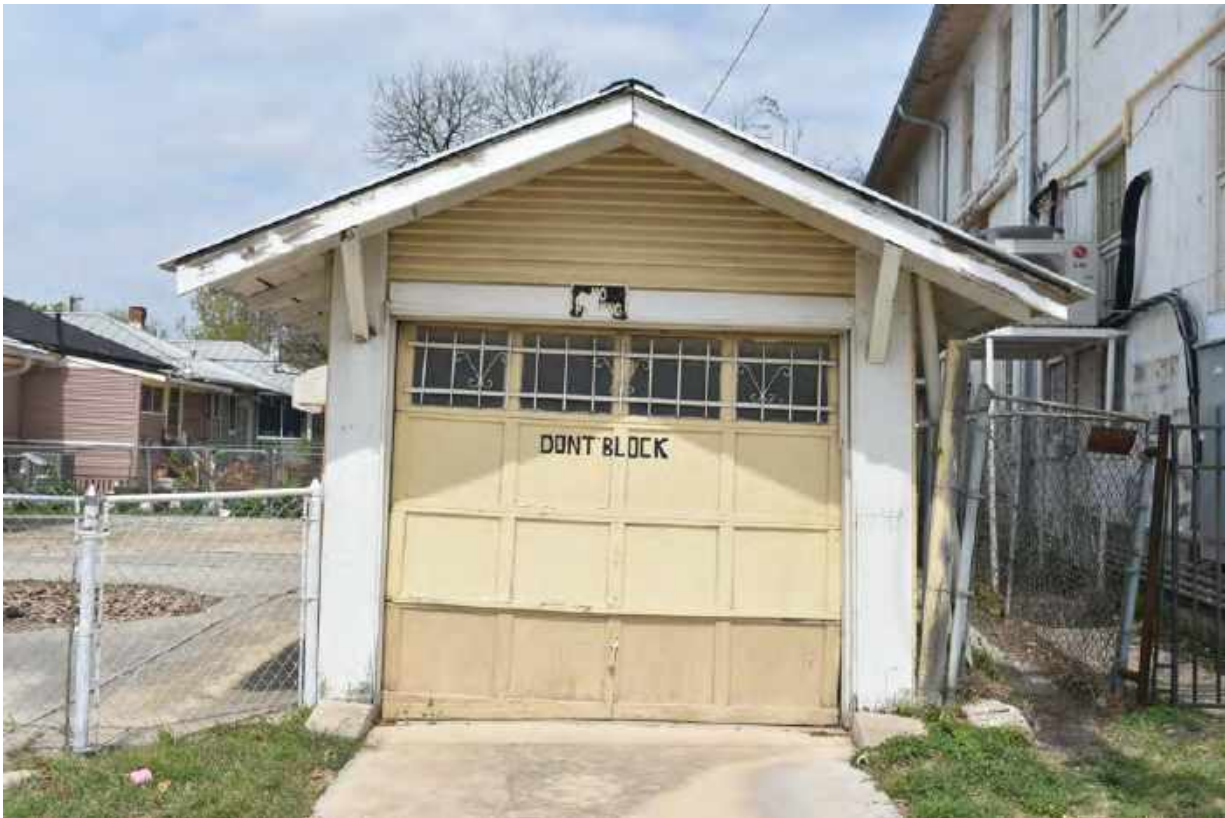
View facing north.

Type: Building	Exterior materials: wood siding	Primary roof type: gable, front	Alterations: Garage door(s) replaced Roof replaced w/ incomp. materials Addition to rear/side elevation
Style: No style			
Form: Rectangular	Porch: N/A

This resource is listed in the National Register of Historic Places as a contributing building to the South Alamo Street-South Mary's Street Historic District. Although its integrity of materials and workmanship have been diminished by the replacement of the roofing materials and garage door as well as the construction of a rear addition, it retains the majority of its physical features dating from its construction and therefore retains integrity overall. As a result, its contributing status to the South Alamo Street-South Mary's Street Historic District is affirmed.
