APPENDIX C SURVEY FORMS (CONTINUED)

DRAFT
(Information is under FTA review and is subject to change.)

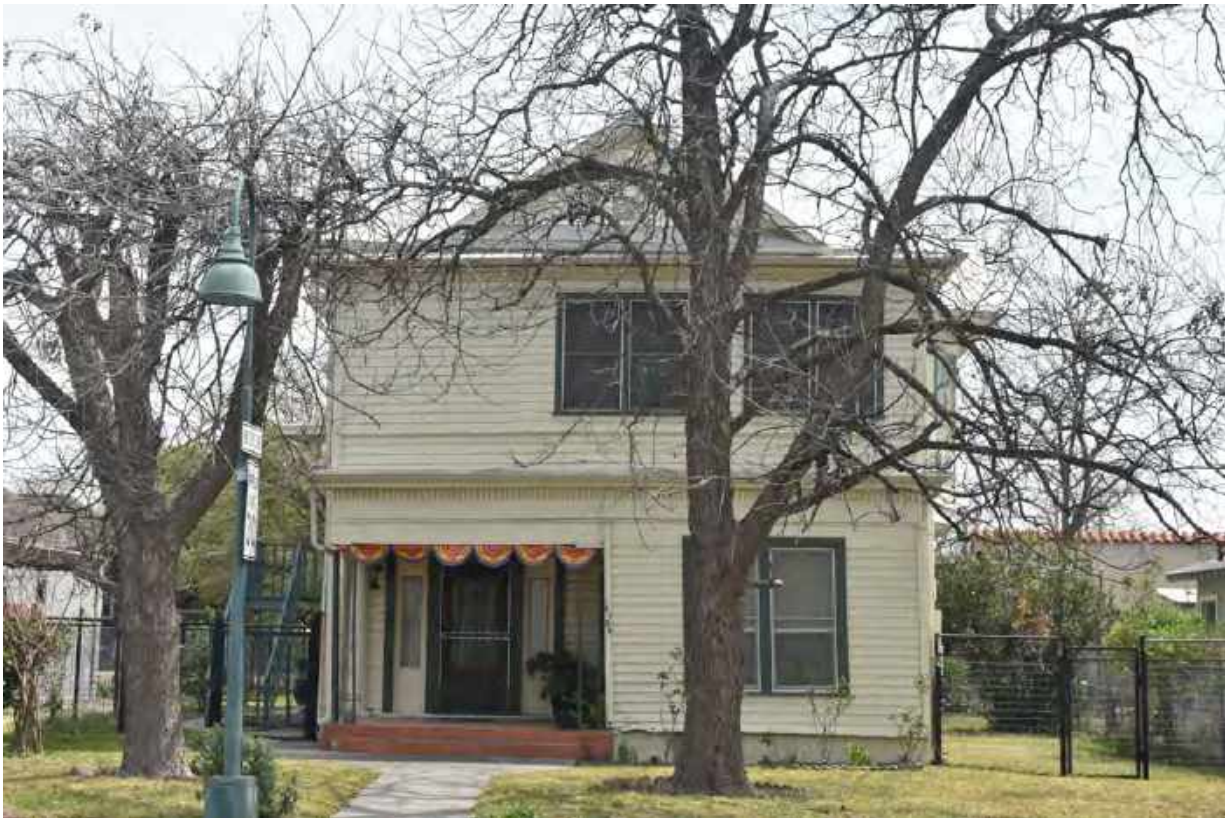
View facing east.

Type: Building	Exterior materials: wood siding	Primary roof type: gable-on-hip gable, front	Alterations: Porch enclosed Porch support(s) and rails replaced Window opening(s) infilled Door/entrance added Exterior staircase added Roof replaced w/ incomp. materials Windows replaced – some
Style: Queen Anne			
Form: Rectangular	Porch: partial-width integrated

This resource was constructed sometime between 1904 and 1912 and does not represent a very early period of residential development in this area of San Antonio. Properties associated with early residential development were generally constructed between the 1870s and 1890s. Examples of such properties can be found in the neighboring King William National Register Historic District and South Alamo Street-South Saint Mary's Street National Register Historic District. The resource is instead associated with the ongoing trend in residential development in this neighborhood and has no significant associations linking it to events or trends of historic importance. The resource is also a highly altered example of a Folk Victorian residential building. Because the property's integrity has been impacted by alterations undertaken after its construction, it no longer embodies the distinctive characteristics that would make it significant as an example of the style and does not demonstrate any innovative, important, or outstanding design features. Additionally, no associations were identified linking it to persons of historic importance. Because the building offers neither a local interpretation of a standard design nor an undocumented construction technique, it has limited potential to yield important information. As a result, it is recommended not eligible for the NRHP under Criterion A, B, or C.

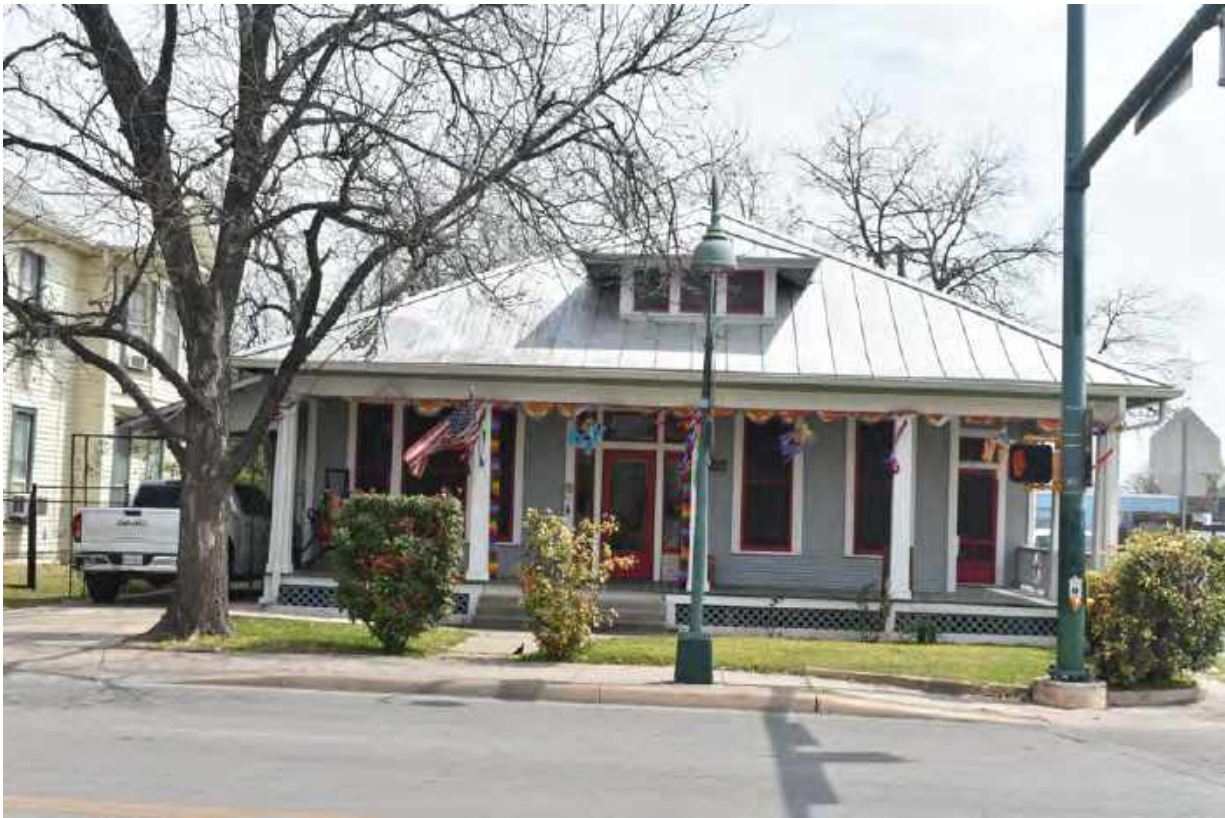
View facing east

Type: Building	Exterior materials: wood siding	Primary roof type: hipped	Alterations: Roof replaced w/ incomp. materials Porch rails removed Carport added Porch added (east elevation)
Style: Folk Victorian			
Form: Rectangular	Porch: wraparound integrated

This resource does not embody distinctive characteristics of a type, period, or method of construction and it does not represent the work of a master or possess high artistic value. Additionally, no associations were identified linking it to persons or events of historic importance. Material integrity has been diminished because of the carport and porch additions, removal of porch rails, and metal roof replacement. Because the building offers neither a local interpretation of a standard design nor an undocumented construction technique, it has limited potential to yield important information. As a result, it is recommended not eligible for the NRHP under Criterion A, B, C, or D.

This resource is located along the commercial corridor along S. Saint Marys Presa Streets. Despite some material alterations, the house retains the majority of its integrity and overall design. Therefore, this resource is recommended as a contributing resource within a potentially expanded South Alamo Street-South Saint Mary's Street NRHP Historic District.

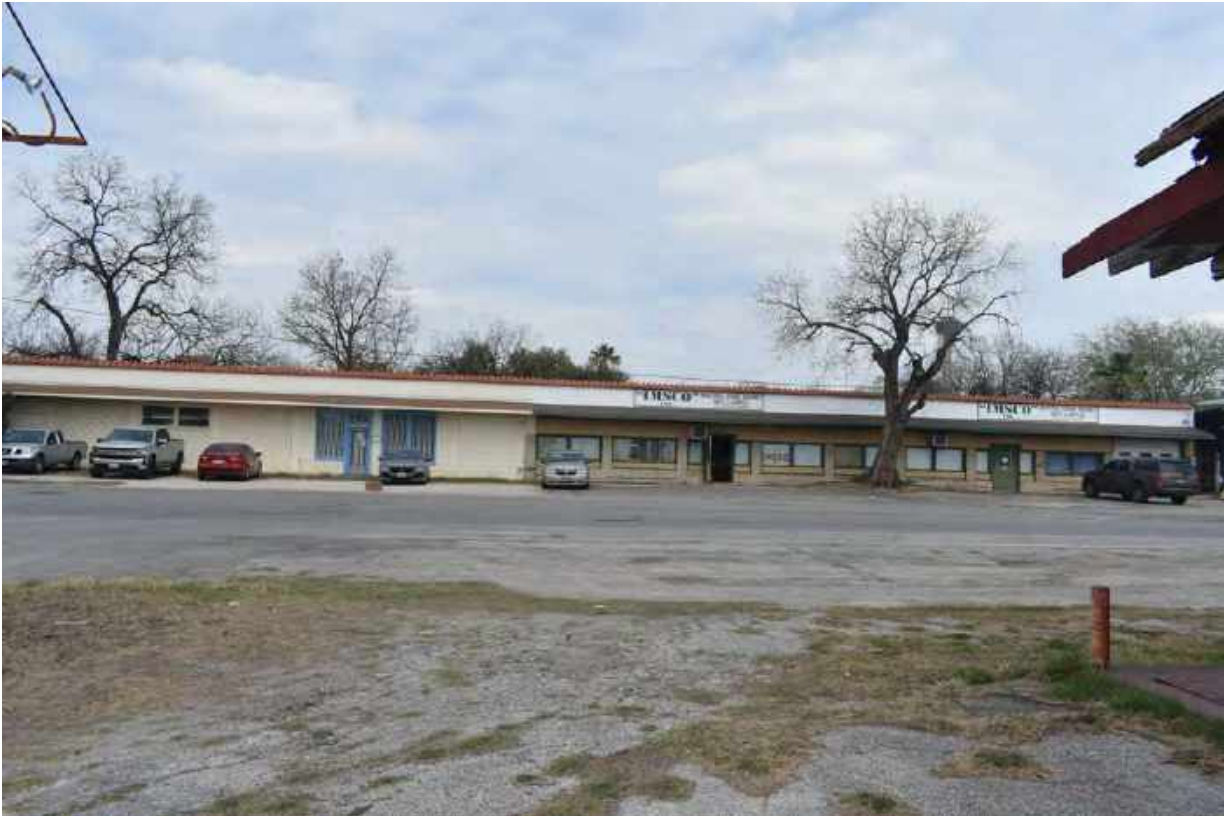
View facing north.

Type: Building	Exterior materials: concrete/cinder block	Primary roof type: flat	Alterations: Completely modified from its original appearance
Style: No style	brick	with parapet	Garage enclosed
Form: Rectangular	wood horizontal board		Garage door(s) replaced
	Porch: full-width projecting		Windows replaced – all visible
			Storefront altered/replaced

This resource is pictured as two separate buildings on the 1951 Sanborn, an auto repair shop to the west and lumber shed to the east. The two buildings were likely joined at an unknown date. A newspaper search revealed that the east portion of the building was occupied by Martin Business Machines throughout the 1960s (Express and News 1963).

This resource was not found to embody distinctive characteristics of a type, period, or method of construction, represent the work of a master, or possess high artistic value. Additionally, no associations were identified linking it to events or persons of historic importance. Furthermore, integrity has been diminished as outlined above. These alterations lessen the integrity of design, materials, and workmanship. Because the building offers neither a local interpretation of a standard design nor an undocumented construction technique, it has limited potential to yield important information. As a result, it is recommended not eligible for the NRHP under Criterion A, B, C, or D.

This resource is located along the commercial corridor along S. St. Mary's Presa Streets. This resource is recommended as a noncontributing resource within a potentially expanded South Alamo Street-South Saint Mary's Street NRHP Historic District.

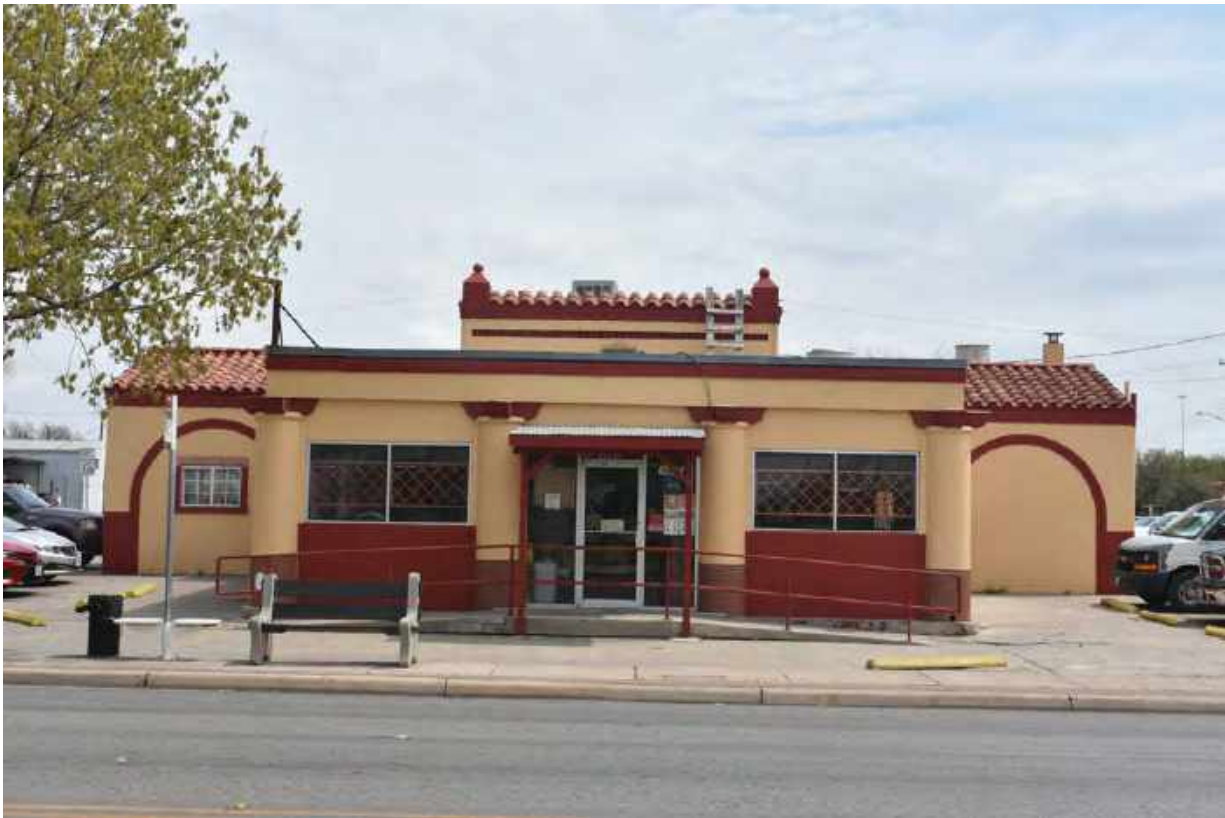
View facing east.

This resource is recommended not eligible under Criterion A. It does not appear to be an early location of a gas station in the area or otherwise significantly associated with overall neighborhood development. No associations with persons significant in our past were identified; therefore, the property is not recommended eligible under Criterion B. While the property is a representative example of the Magnolia company's Spanish Eclectic 1930s gas station, its integrity has been diminished by alterations to original features and finishes over time. Most notably, the property has undergone alterations listed in *A Field Guide to Gas Stations in Texas* as Tier 3 alterations. Integrity guidelines outlined in the guide note that Tier 3 gas stations generally have alterations that change the building's form and overall historic character to such an extent that it no longer has the ability to convey significance as a gas station. Given the cumulative impact of alterations to this resource, it is not recommended as eligible under this aspect of Criterion C. Furthermore, the property does not represent exemplary engineering techniques, nor was it designed by a noted architect or as a prototype for an oil company or brand. For these reasons, the property is recommended as not individually eligible under Criterion C. Because the building offers neither a local interpretation of a standard design nor an undocumented construction technique, it has insufficient to yield important information as a result, it is recommended not eligible for the NRHP under Criterion A, B, C, or D.

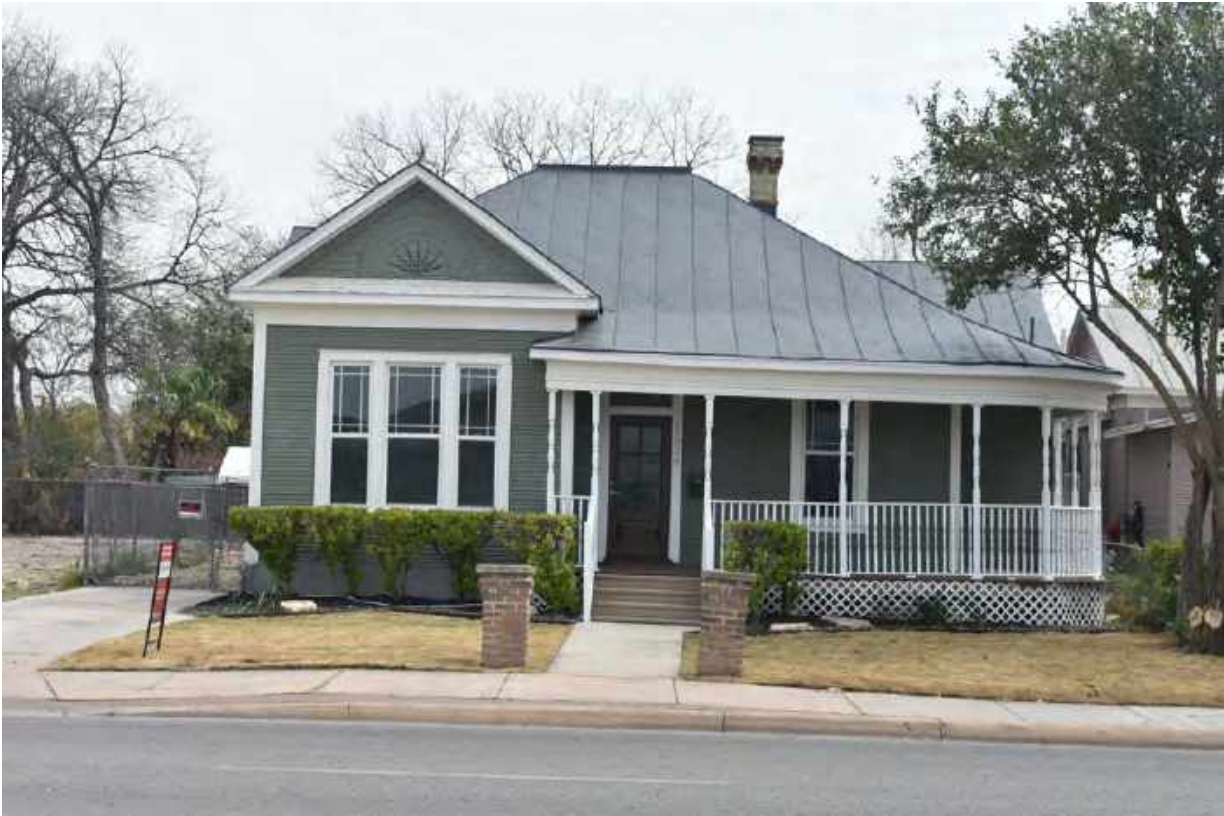
View facing east.

Type: Building	Exterior materials: wood siding	Primary roof type: gable-on-hip	Alterations: Roof replaced w/ incomp. materials Addition to rear/side elevation Doors replaced
Style: Folk Victorian			
Form: Rectangular	Porch: wraparound projecting

This dwelling does not embody distinctive characteristics of a type, period, or method of construction and it does not represent the work of a master or possess high artistic value. Additionally, no associations were identified linking it to persons or events of historic importance. Furthermore, design integrity has been diminished due to an addition, and materials and workmanship integrity diminished due to altered and replaced materials. Because the building offers neither a local interpretation of a standard design nor an undocumented construction technique, it has limited potential to yield important information. As a result, it is recommended not eligible for the NRHP under Criterion A, B, C, or D.

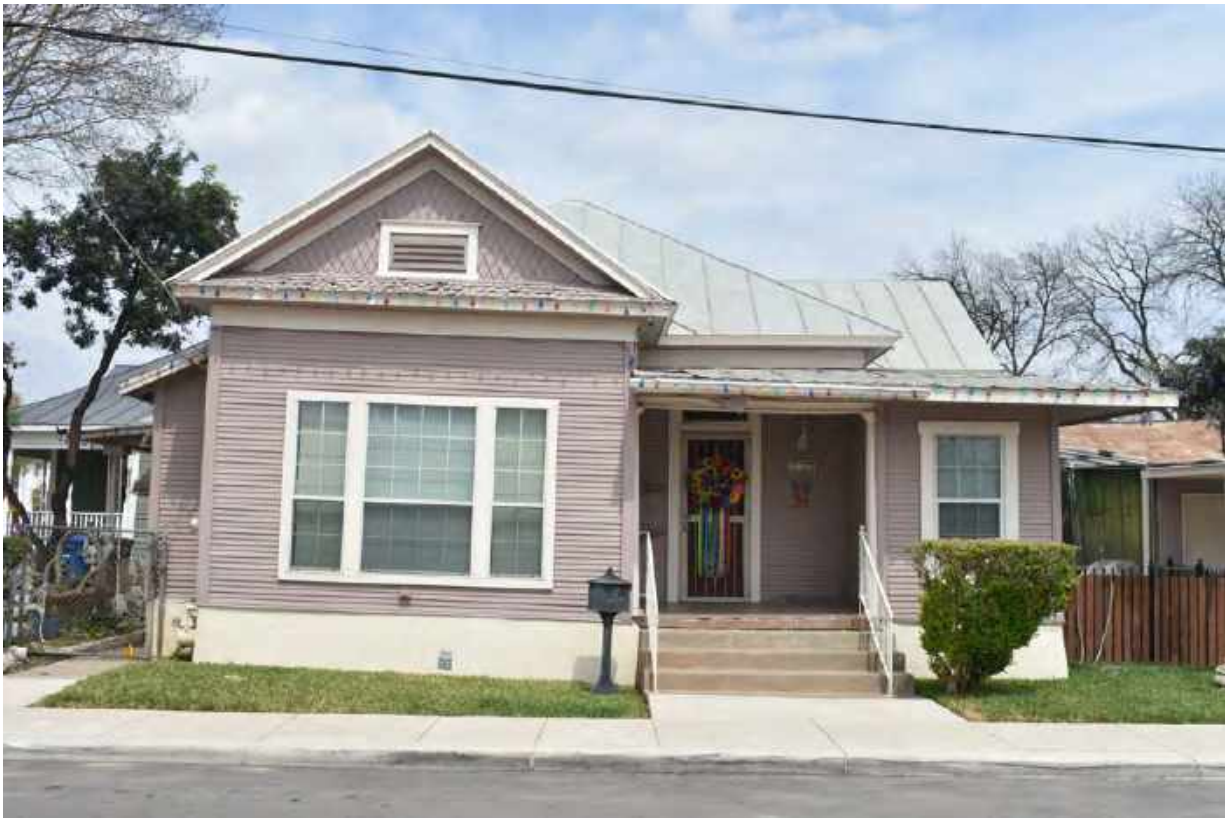
Resource A
(Historic-age);
view facing north.

Type: Building	Exterior materials: wood siding	Primary roof type: gable-on-hip	Alterations: Roof replaced w/ incomp. materials Windows replaced – all visible Entry stairs and railing replaced Door/entrance added Addition to rear/side elevation Awning(s) added
Style: Folk Victorian			
Form: Rectangular	Porch: partial-width integrated

This resource was constructed sometime between 1904 and 1912 and does not represent a very early period of residential development in this area of San Antonio. Properties associated with early residential development were generally constructed between the 1870s and 1890s. Examples of such properties can be found in the neighboring King William National Register Historic District and South Alamo Street-South Saint Mary's Street National Register Historic District. The resource is instead associated with the ongoing trend in residential development in this neighborhood and has no significant associations linking it to events or trends of historic importance. The resource is also a highly altered example of a Folk Victorian residential building. Because the property's integrity has been impacted by alterations undertaken after its construction, it no longer embodies the distinctive characteristics that would make it significant as an example of the style and does not demonstrate any innovative, important, or outstanding design features. Additionally, no associations were identified linking it to persons of historic importance. As a result, it is recommended not individually eligible for the NRHP under Criterion A, B, or C. This resource is located along the commercial corridor along S. St. Mary's-Presa Streets. This resource is recommended as a noncontributing resource within a potentially expanded South Alamo Street-South Saint Mary's Street NRHP Historic District.

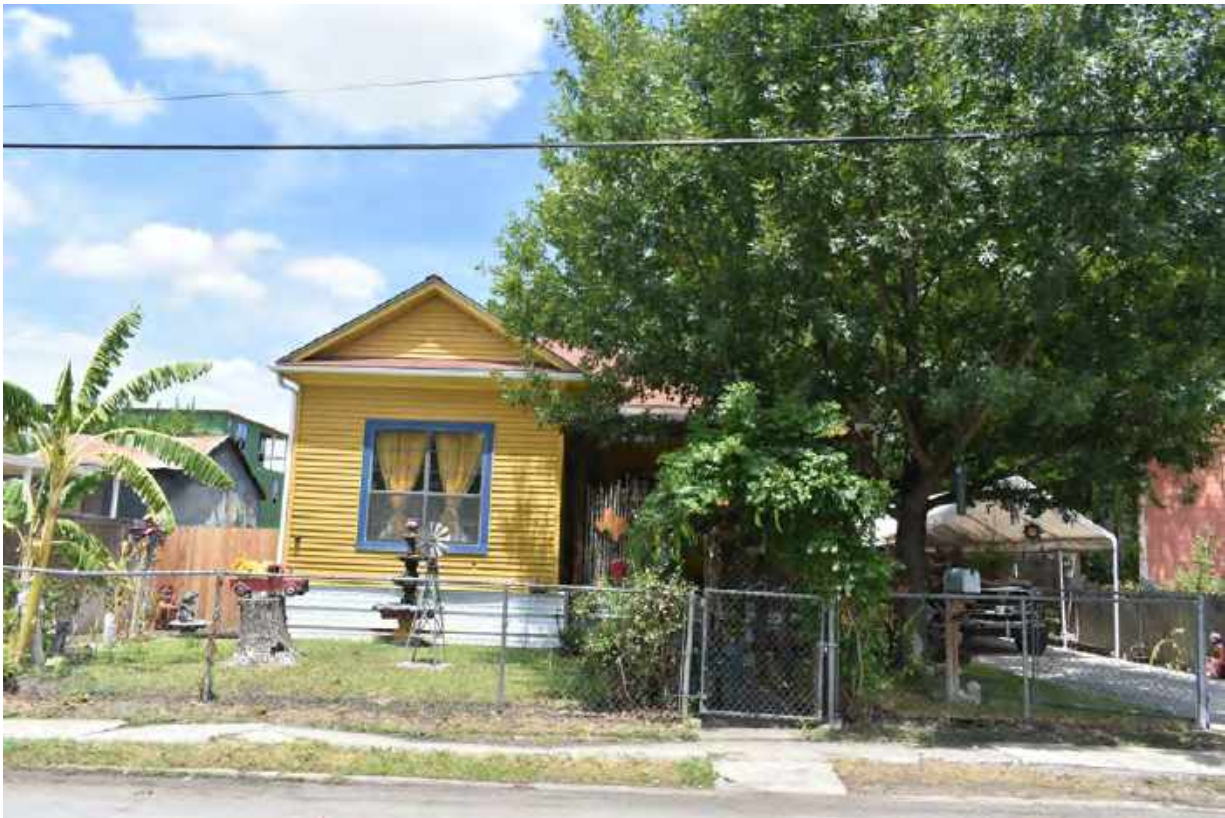
View facing northwest.

Type: Building	Exterior materials: vinyl siding	Primary roof type: hipped	Alterations: Windows replaced – all visible Porch rails replaced Metal skirting added Addition to rear/side elevation
Style: Folk Victorian			
Form: Rectangular	Porch: partial-width set within ell

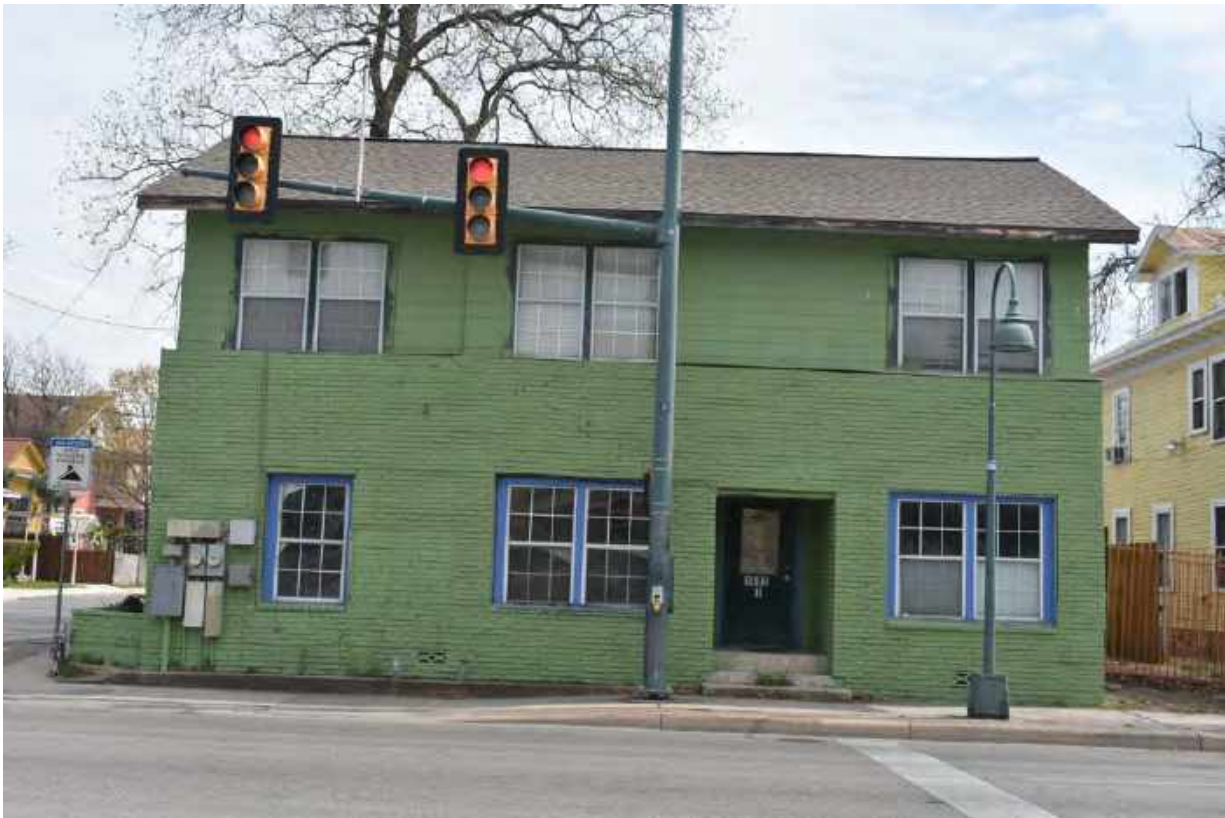
View Resource A
facing east.

Type: Building	Exterior materials: vinyl siding brick	Primary roof type: gable, side	Alterations: Windows replaced – all visible Window opening(s) infilled Doors replaced Addition to upper story
Style: No style			
Form: Rectangular	Porch: stoop integrated

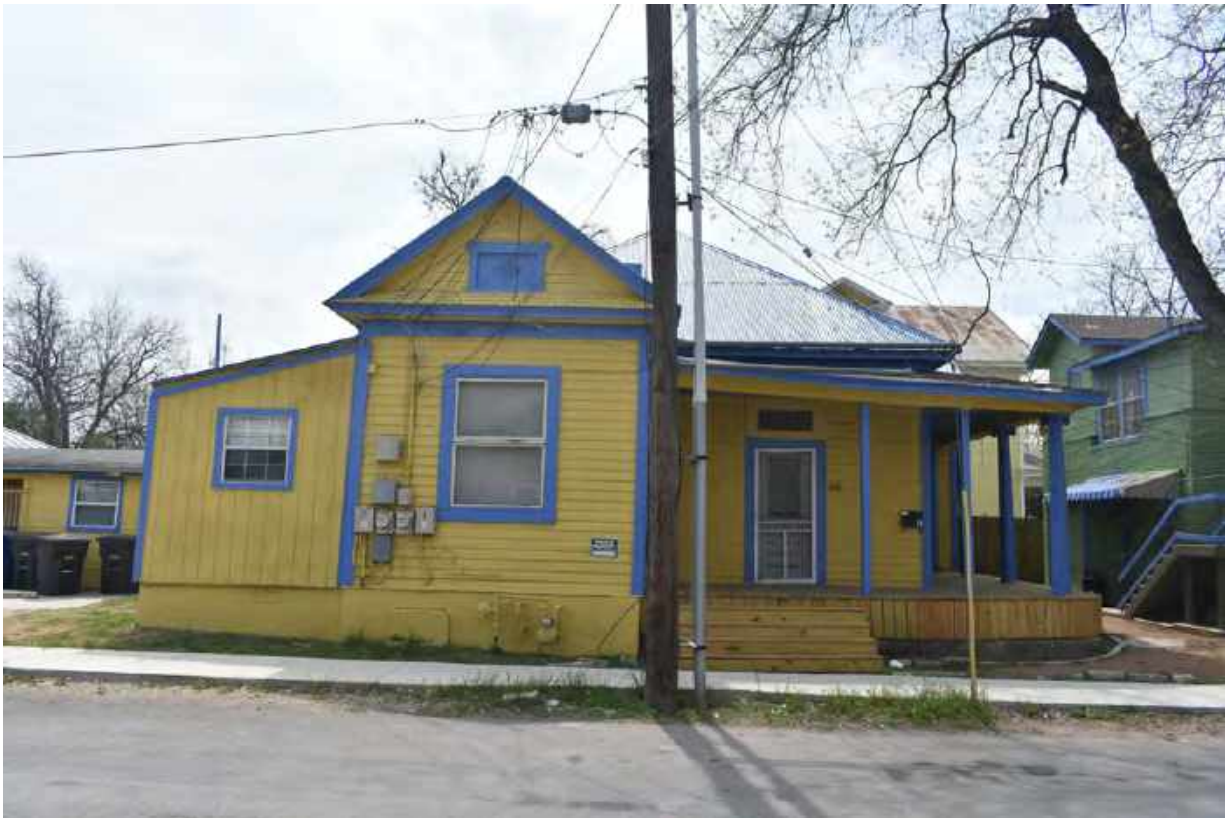
View facing south.

Type: Building	Exterior materials: vinyl siding brick	Primary roof type: gable-on-hip	Alterations: Wall cladding replaced Roof replaced w/ incomp. materials Window opening(s) infilled Door/entrance added Porch rails replaced Porch support(s) replaced Windows replaced – all visible Relocated
Style: Folk Victorian			
Form: Rectangular	Porch: N/A

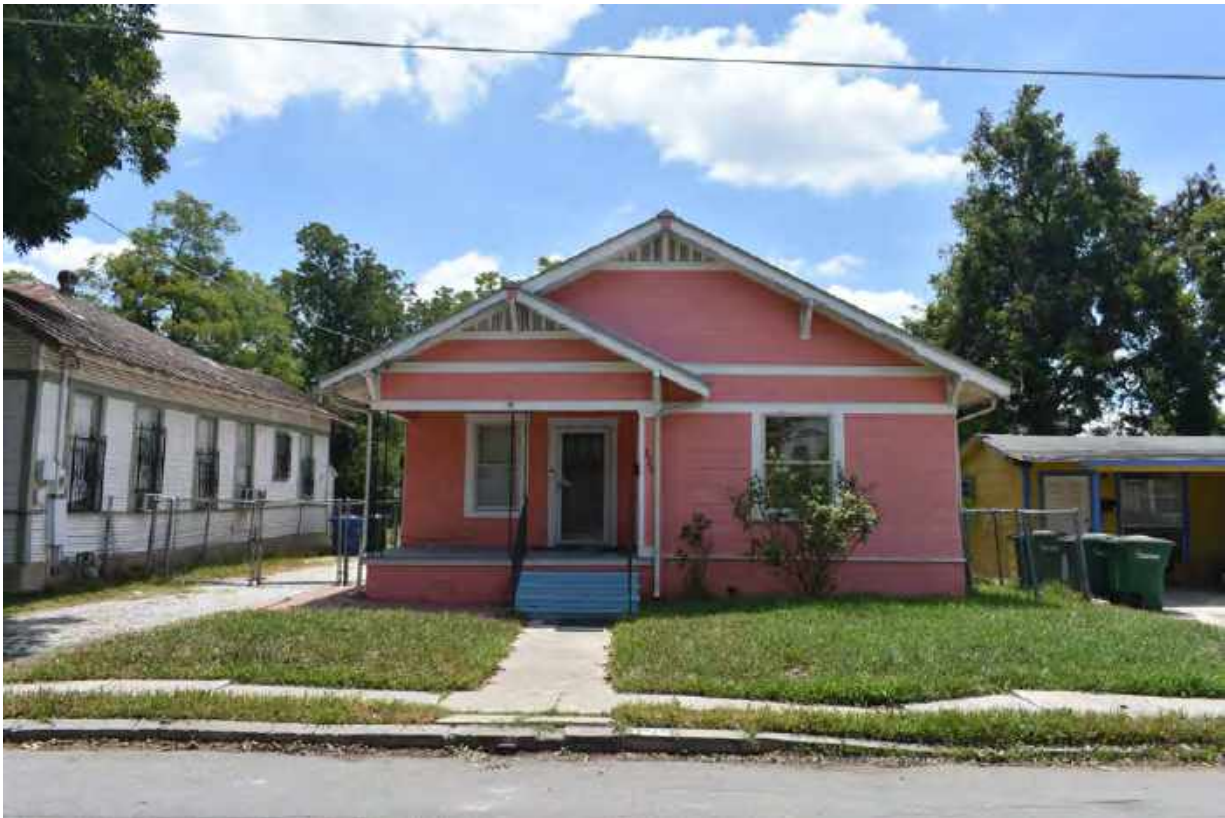
View facing southeast.

Type: Building	Exterior materials: asbestos	Primary roof type: gable, front	Alterations: Windows replaced – all visible Porch support(s) replaced Door (primary) replaced
Style: Craftsman			
Form: Bungalow	Porch: partial-width projecting

This dwelling does not embody distinctive characteristics of a type, period, or method of construction and it does not represent the work of a master or possess high artistic value. Additionally, no associations were identified linking it to persons or events of historic importance. Furthermore, materials and workmanship integrity has been diminished due to materials not replaced in kind. Because the building offers neither a local interpretation of a standard design nor an undocumented construction technique, it has limited potential to yield important information. As a result, it is recommended not eligible for the NRHP under Criterion A, B, C, or D.

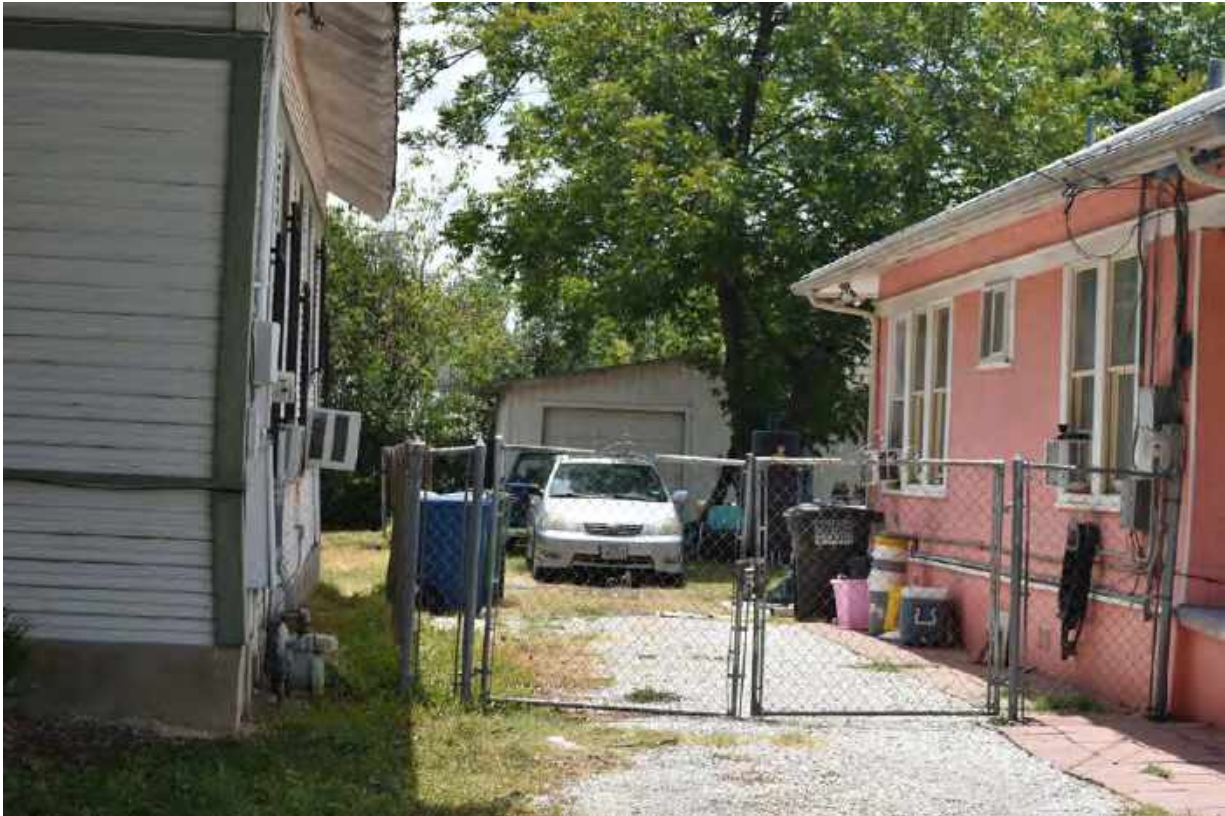
View facing south.

Type: Building	Exterior materials: wood siding panels	Primary roof type: gable, front	Alterations: Garage door(s) replaced
Style: No style			
Form: Rectangular	Porch: N/A

This garage does not embody distinctive characteristics of a type, period, or method of construction and it does not represent the work of a master or possess high artistic value. Additionally, no associations were identified linking it to persons or events of historic importance. Furthermore, materials integrity has been diminished due to a garage door not replaced in kind. Because the building offers neither a local interpretation of a standard design nor an undocumented construction technique, it has limited potential to yield important information. As a result, it is recommended not eligible for the NRHP under Criterion A, B, C, or D.

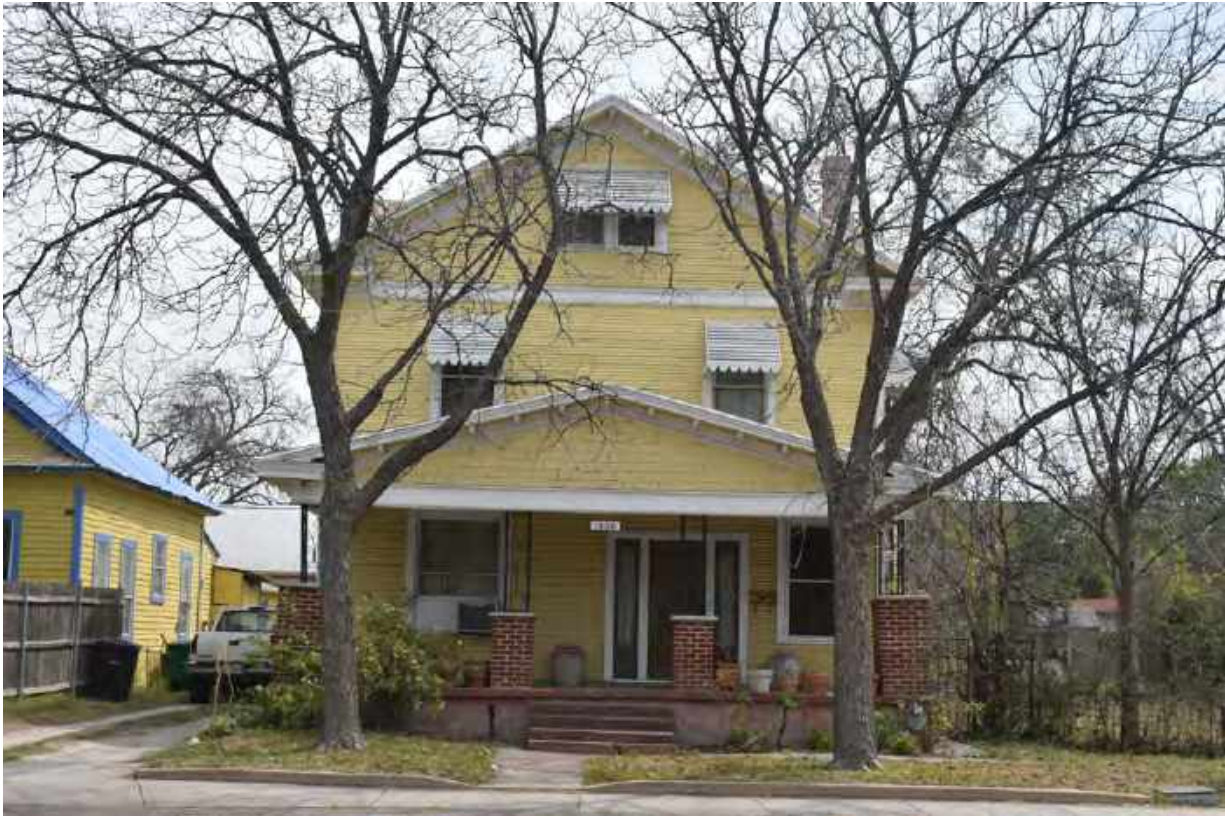
View facing east.

Type: Building	Exterior materials: wood siding wood shingles	Primary roof type: gable, front	Alterations: Awning(s) added Porch support(s) and rails replaced Window opening(s) infilled Glazing replaced at door (primary)
Style: Colonial Revival			
Form: Rectangular	Porch: full-width projecting

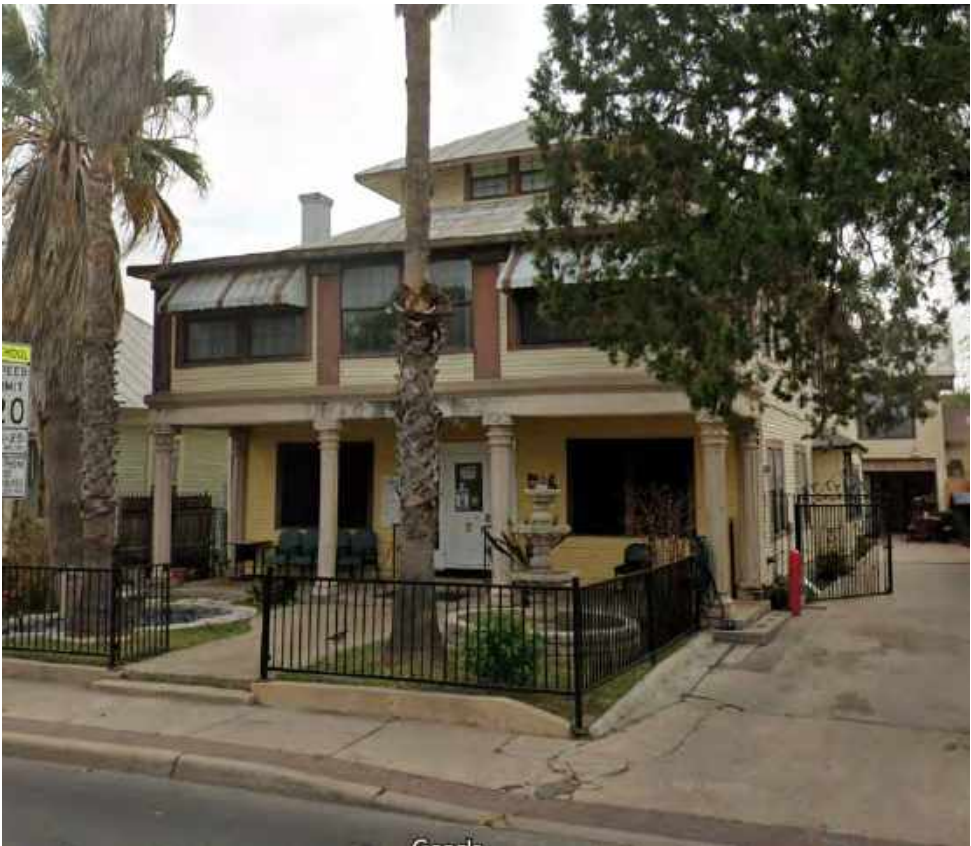
View facing east.

Type: Building	Exterior materials: wood siding vinyl siding	Primary roof type: hipped	Alterations: Additions have doubled the building's size Windows replaced – all visible Roof replaced w/ incomp. materials Door (primary) replaced Wall cladding replaced - some Porch enclosed
Style: No style			
Form: Irregular	Porch: full-width integrated

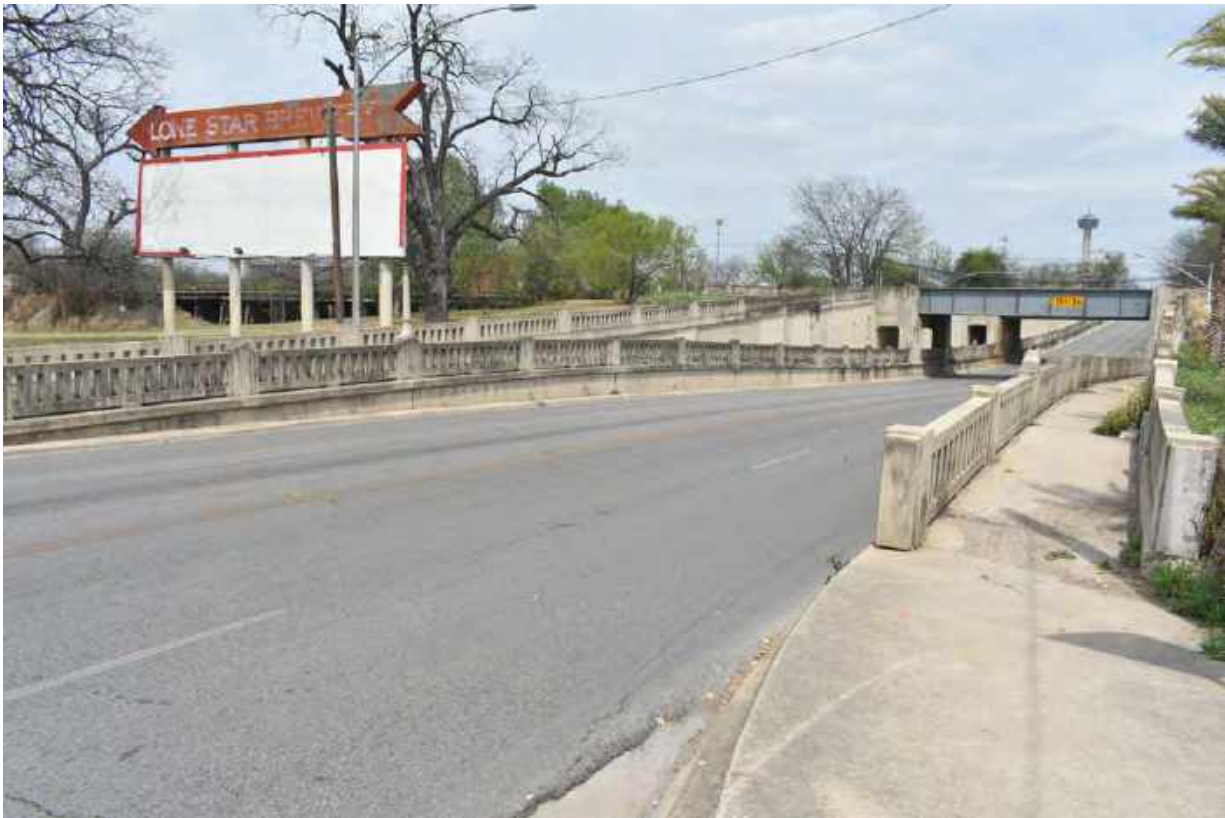
View facing north;
note the south
overpass (inactive)
on right.

Type: Structure	Exterior materials: concrete	Primary roof type: N/A	Alterations: Missing lamps/lamp posts Damage to balustrade
Style: Art Deco	Style: metal		
Form: Bridge	Porch: N/A

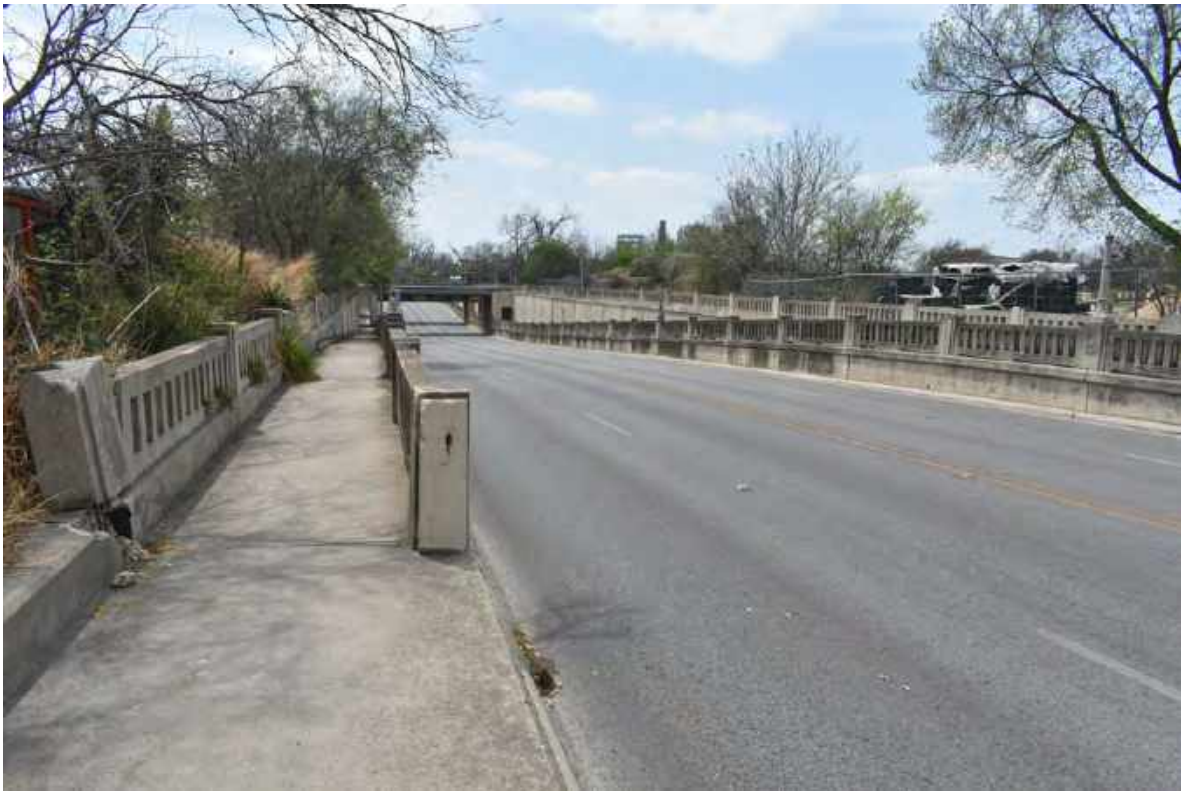
View facing southwest; note the north (active) overpass on left.

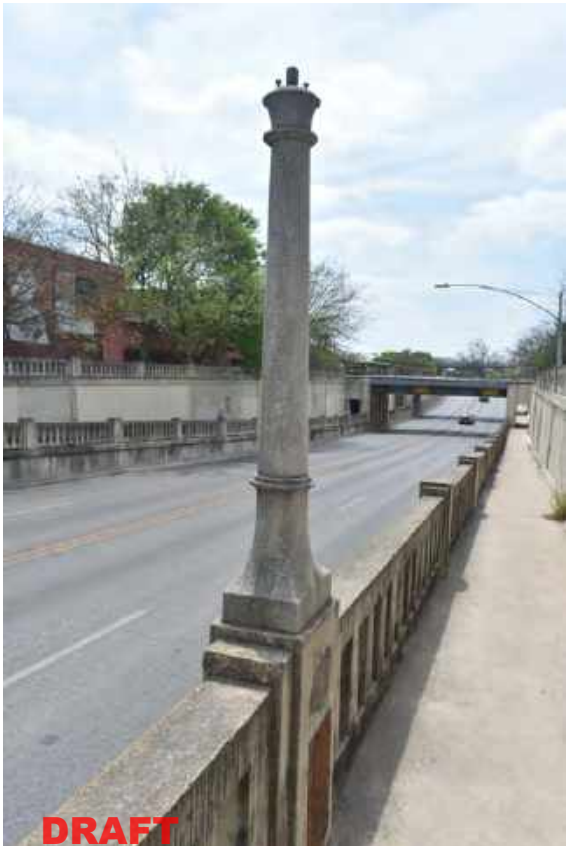
Lamp detail; view facing south.

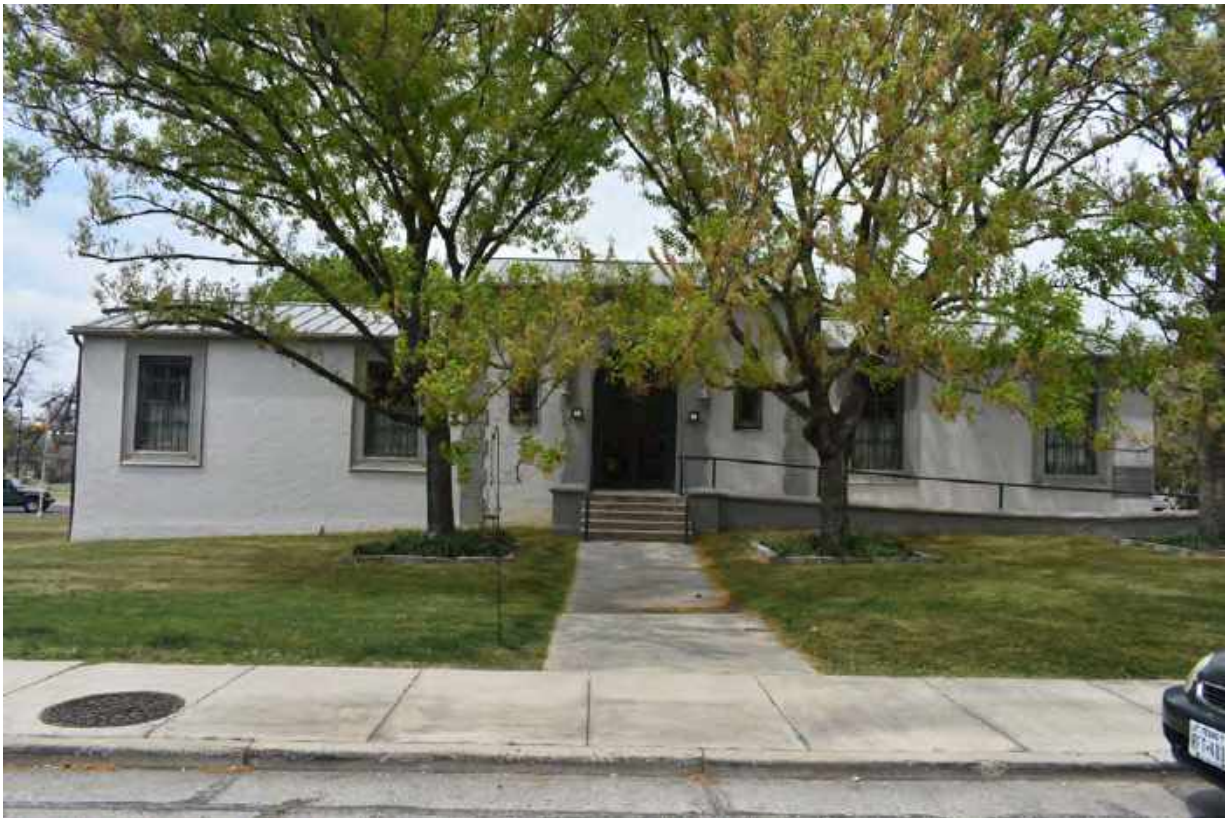
View facing west.

Type: Building	Exterior materials: stucco	Primary roof type: gable, crossed	Alterations: Roof replaced w/ incomp. materials Doors replaced Addition to rear/side elevation
Style: Neoclassical			
Form: T-plan	Porch: stoop projecting

The resource was originally constructed in 1929 as the Roosevelt Park Public Library, the first branch library in the San Antonio Public Library system. John M. Marriott is noted as the architect and W. H. Wolter is noted as the contractor. The building served as a branch of the city library until its closure in 1968 after which it served as offices for the Police and Fire Pension fund (SA2020 2018). The resource was converted to commercial/retail in 2014. In addition to this historic-age building (Resource A), this parcel also has a historic-age sign (Resource B) and a historic-age masonry wall (Resource C).

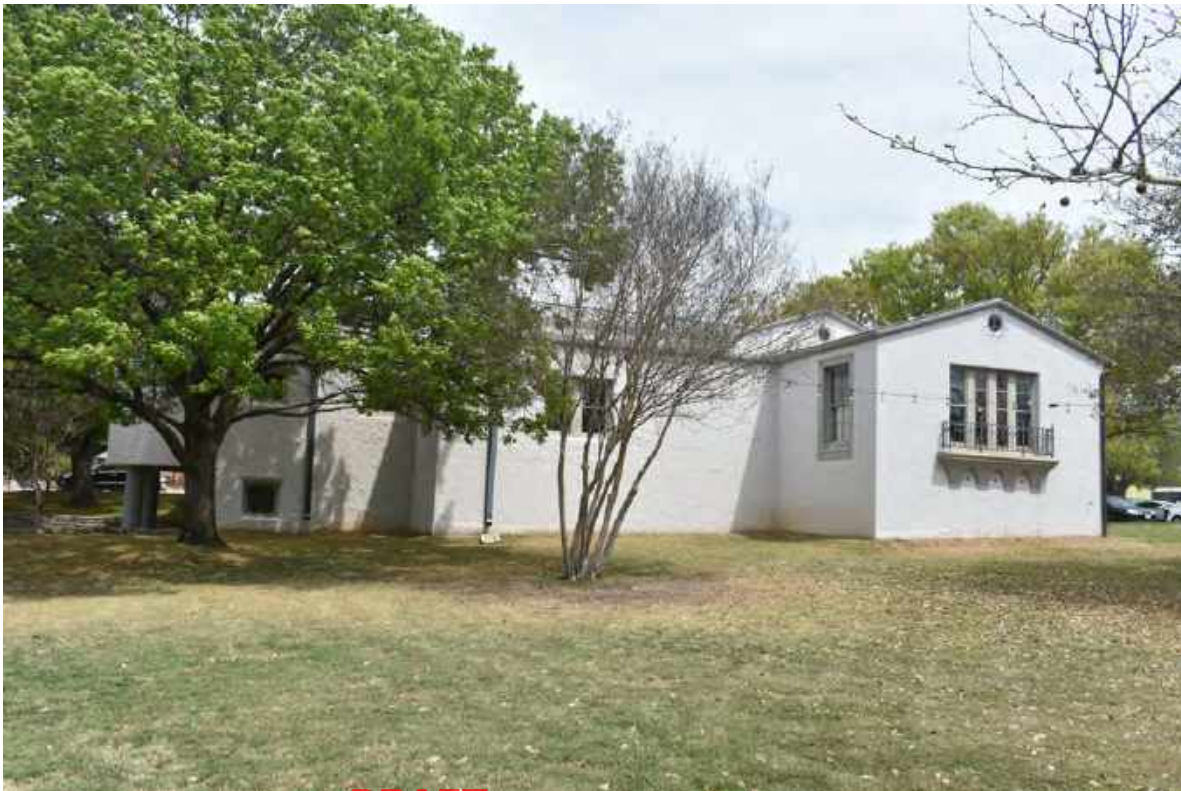
View facing north towards addition at the rear.

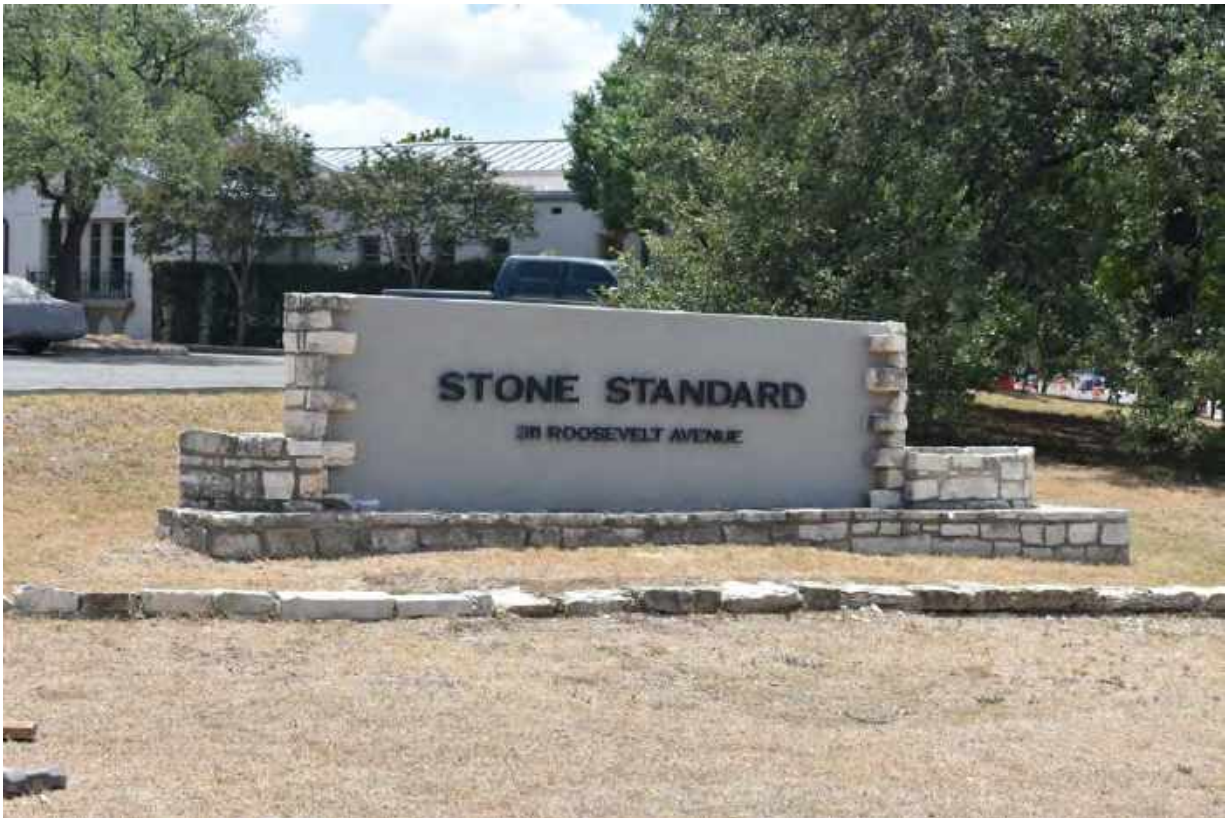
View facing southeast.

Type: Structure	Exterior materials: stone stucco	Primary roof type: N/A	Alterations: Signage changed
Style: Rustic			
Form: Rectangular	Porch: N/A

This sign does not embody distinctive characteristics of a type, period, or method of construction and it does not represent the work of a master or possess high artistic value. Additionally, no associations were identified linking it to persons or events of historic importance. Because the building offers neither a local interpretation of a standard design nor an undocumented construction technique, it has limited potential to yield important information. As a result, it is recommended not eligible for the NRHP under Criterion A, B, C, or D.
