APPENDIX C SURVEY FORMS (CONTINUED)

DRAFT
(Information is under FTA review and is subject to change.)

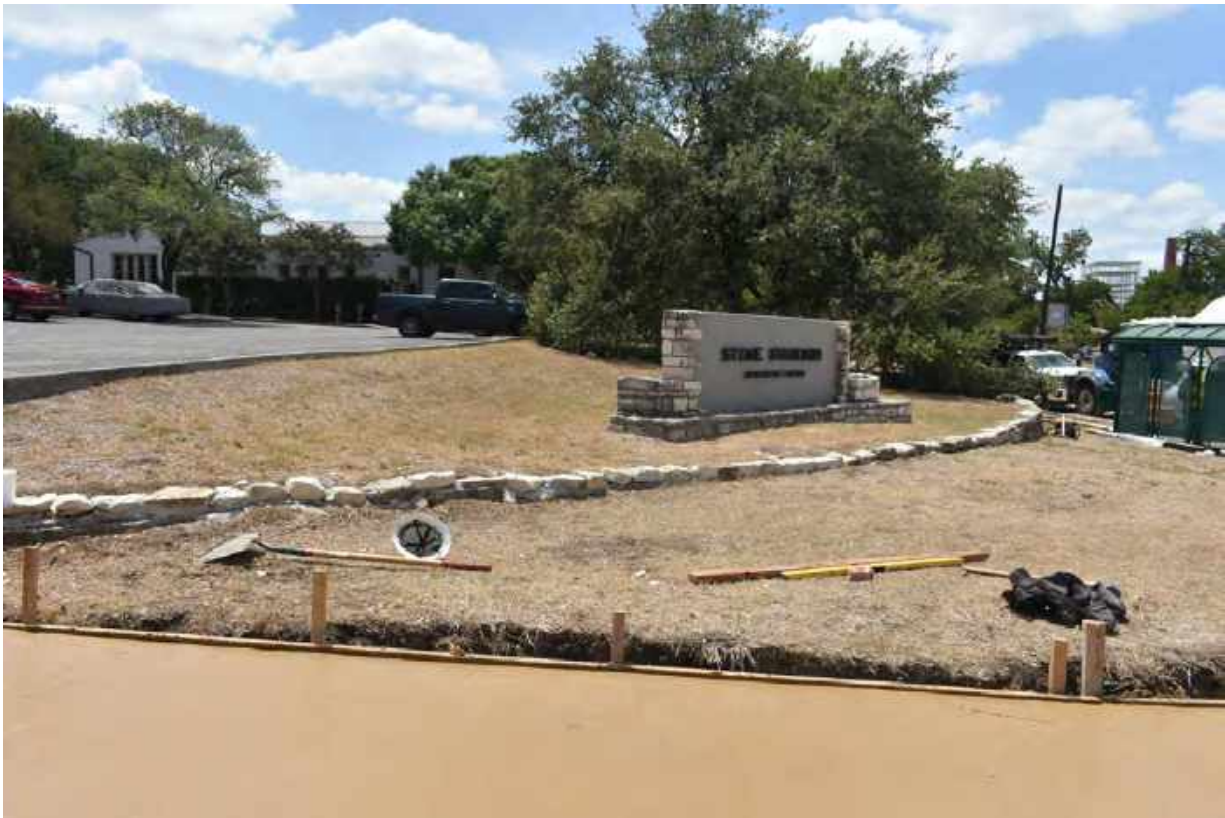
View facing south.

Type: Structure	Exterior materials: stone	Primary roof type: N/A	Alterations: Appears unaltered
Style: Rustic			
Form: Linear	Porch: N/A

This wall does not embody distinctive characteristics of a type, period, or method of construction and it does not represent the work of a master or possess high artistic value. Additionally, no associations were identified linking it to persons or events of historic importance. Because the building offers neither a local interpretation of a standard design nor an undocumented construction technique, it has limited potential to yield important information. As a result, it is recommended not eligible for the NRHP under Criterion A, B, C, or D.

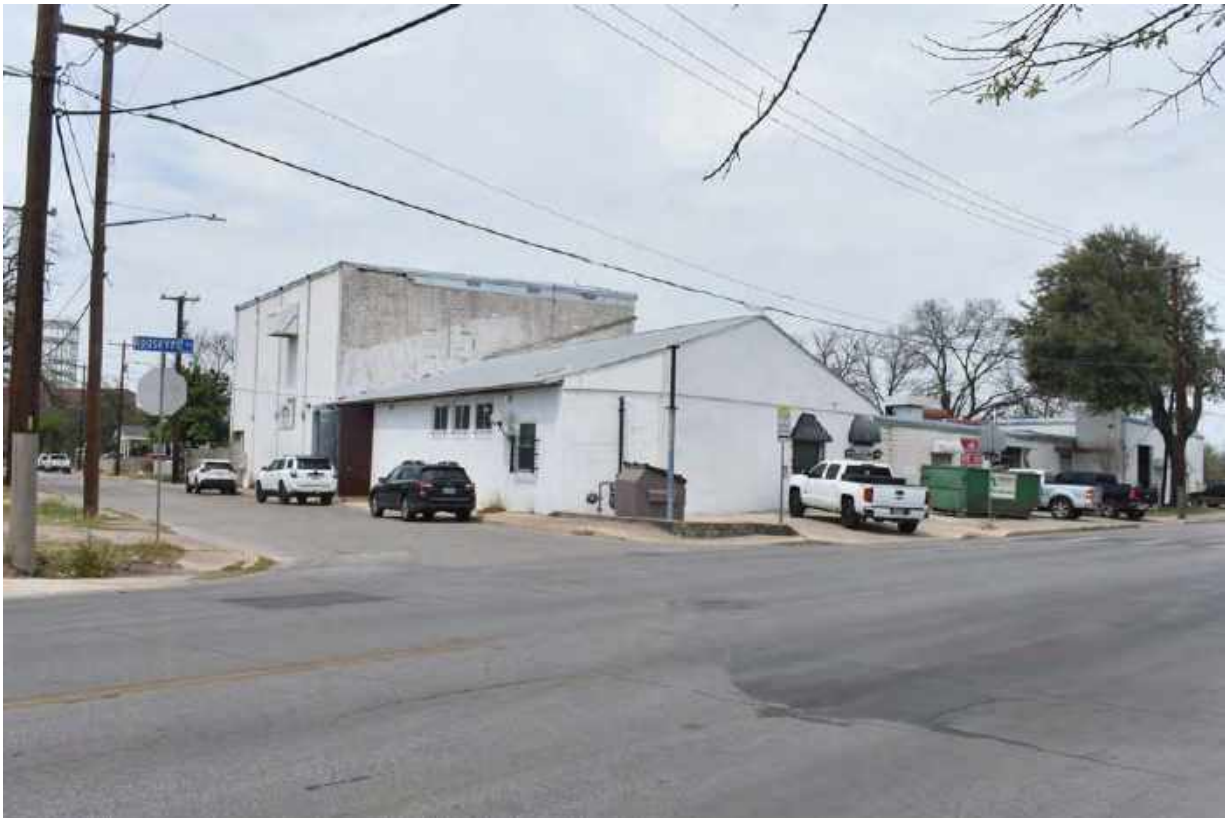
View facing northwest.

Type: Building	Exterior materials: concrete/cinder block stucco	Primary roof type: gable, front flat	Alterations: Door (primary) replaced Windows replaced – some Addition to rear/side elevation Roofline altered Window opening(s) infilled/added Garage enclosed Awning(s) added
Style: No style			
Form: Irregular	Porch: stoop projecting

This resource does not embody distinctive characteristics of a type, period, or method of construction and it does not represent the work of a master or possess high artistic value. Additionally, no associations were identified linking it to persons or events of historic importance. Furthermore, integrity has been diminished as outlined above. Because the building offers neither a local interpretation of a standard design nor an undocumented construction technique, it has limited potential to yield important information. As a result, it is recommended not eligible for the NRHP under Criterion A, B, C, or D.

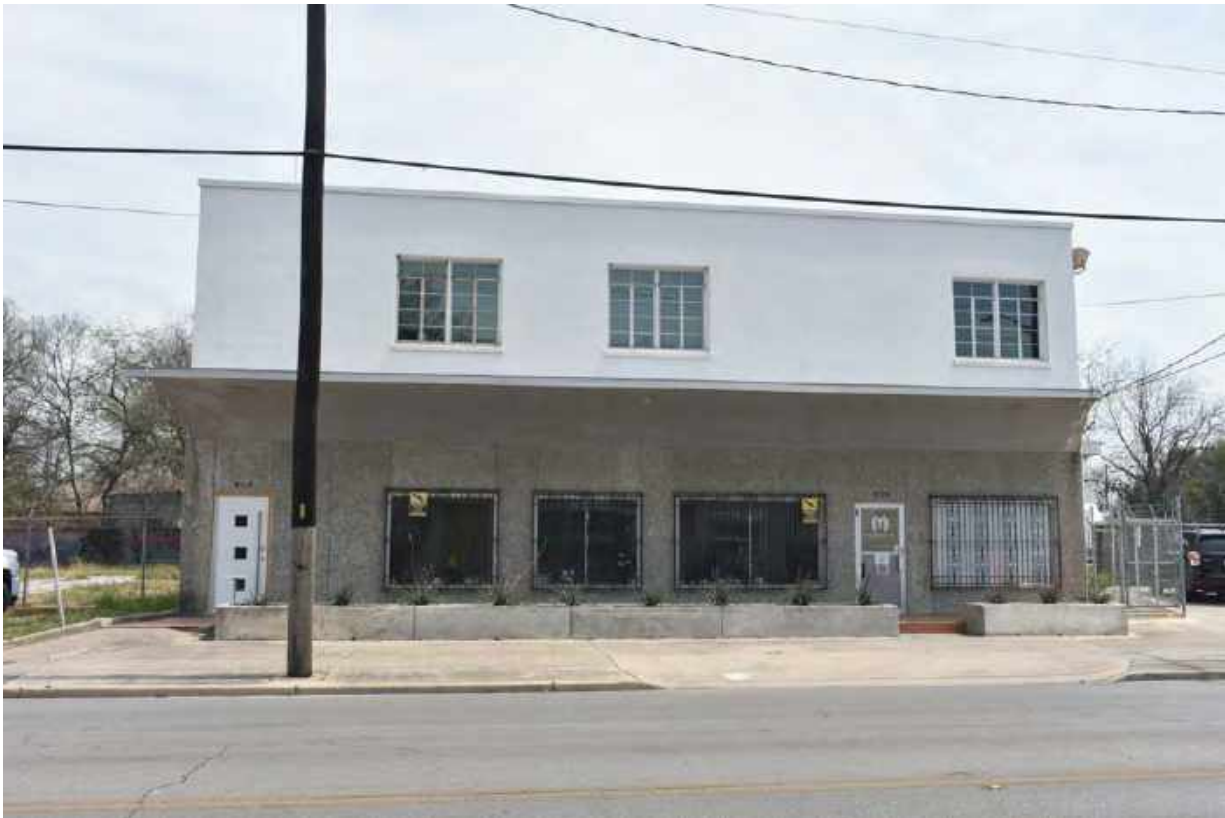
View facing east.

Type: Building	Exterior materials: stucco	Primary roof type: flat	Alterations: Doors replaced
Style: International	aggregate concrete panels	with parapet	Windows added (south elevation)
Form: Rectangular	Porch: full-width projecting

This resource does not embody distinctive characteristics of a type, period, or method of construction and it does not represent the work of a master or possess high artistic value. Additionally, no associations were identified linking it to persons or events of historic importance. As a result, it is recommended not individually eligible for listing in the NRHP under Criterion A, B, or C.

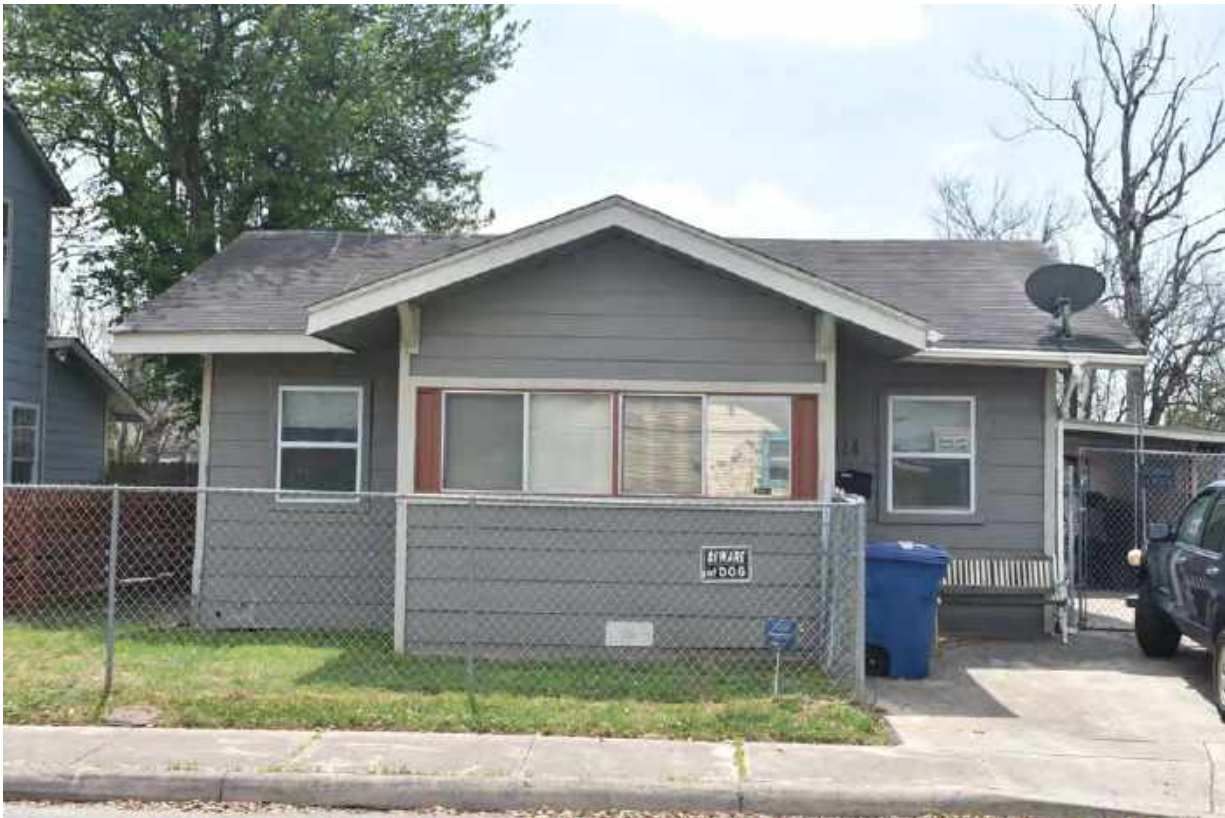
View facing south.

Type: Building	Exterior materials: wood siding	Primary roof type: gable, crossed	Alterations: Completely modified from its original appearance Wall cladding replaced Windows replaced – all visible Parapet altered or removed Doors replaced Porch enclosed
Style: Craftsman			
Form: Bungalow	Porch: N/A

This resource was constructed sometime between 1904 and 1912 and does not represent a very early period of residential development in this area of San Antonio. Properties associated with early residential development were generally constructed between the 1870s and 1890s. Examples of such properties can be found in the neighboring King William National Register Historic District and South Alamo Street-South Saint Mary's Street National Register Historic District. The resource is instead associated with the ongoing trend in residential development in this neighborhood and has no significant associations linking it to events or trends of historic importance. The resource is also a highly altered example of a Craftsman-style residential building. Because the property's integrity has been impacted by alterations undertaken after its construction, it no longer embodies the distinctive characteristics that would make it significant as an example of the style and does not demonstrate any innovative, important, or outstanding design features. Additionally, no associations were identified linking it to persons of historic importance. Because the building offers neither a local interpretation of a standard design nor an undocumented construction technique, it has limited potential to yield important information. As a result, it is recommended not eligible for the NRHP under Criterion A, B, or C.

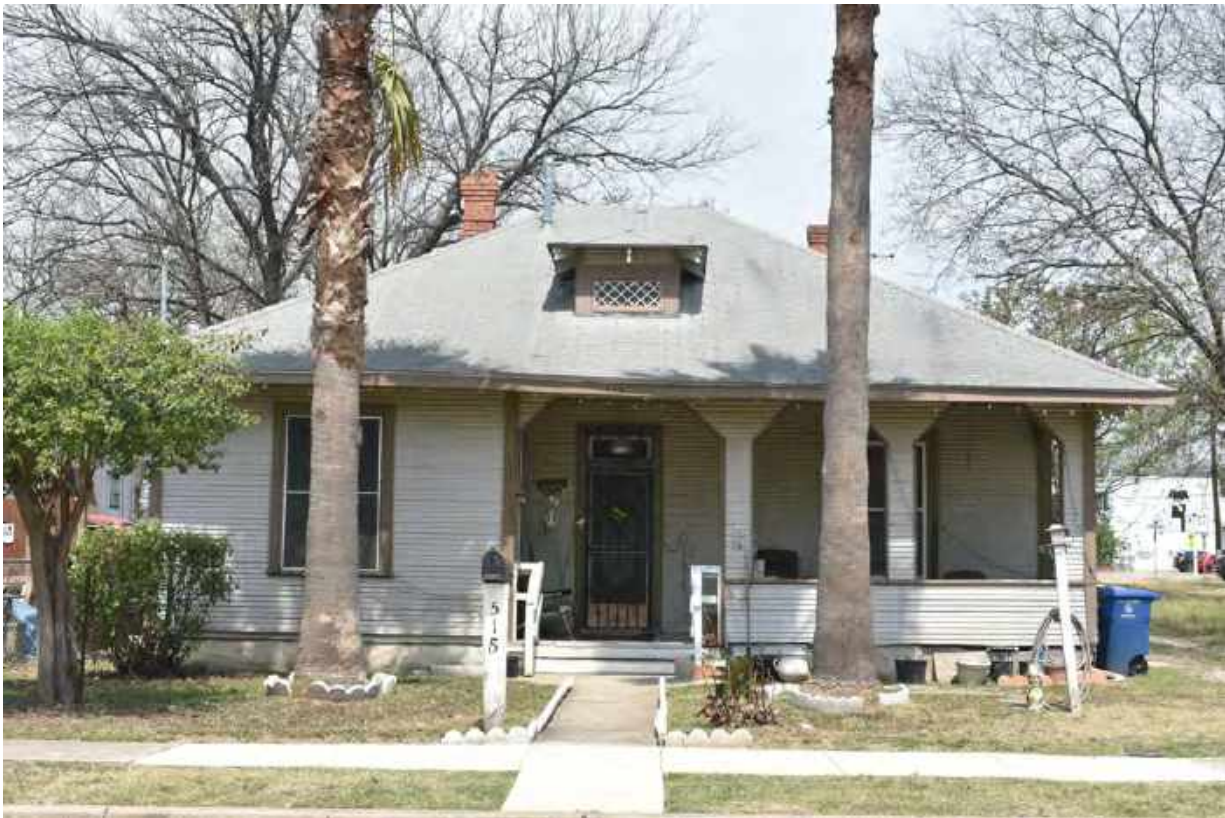
View facing north.

Type: Building	Exterior materials: wood siding	Primary roof type: hipped	Alterations: Wall cladding replaced Awning(s) added at rear Porch support(s) and rails replaced Chimney removed
Style: Craftsman			
Form: Bungalow	Porch: partial-width integrated

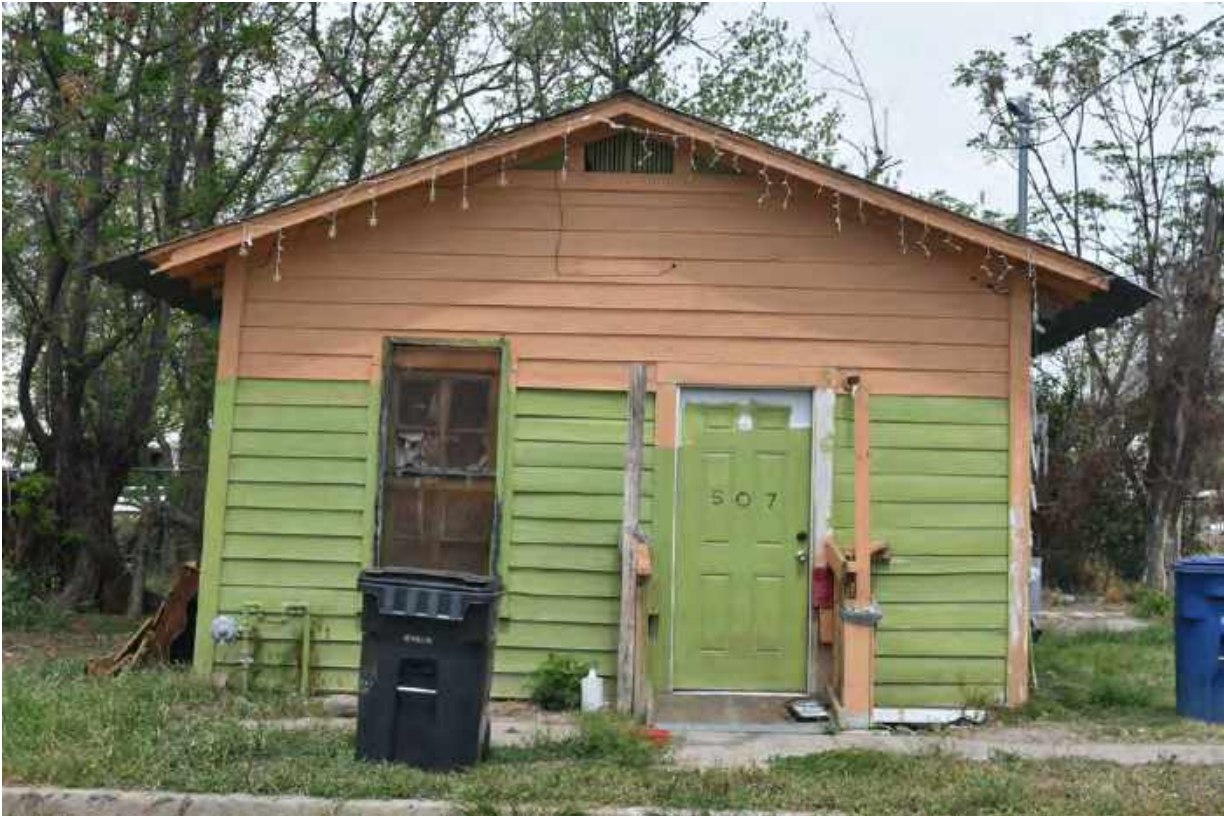
View facing north.

Type: Building	Exterior materials: wood siding	Primary roof type: gable, front	Alterations: Door (primary) replaced Awning on primary elevation removed Window(s) boarded Porch enclosed/rear addition
Style: No style			
Form: Rectangular	Porch: none

This resource does not embody distinctive characteristics of a type, period, or method of construction and it does not represent the work of a master or possess high artistic value. Additionally, no associations were identified linking it to persons or events of historic importance. Furthermore, integrity has been diminished as outlined above. Because the building offers neither a local interpretation of a standard design nor an undocumented construction technique, it has limited potential to yield important information. As a result, it is recommended not eligible for the NRHP under Criterion A, B, C, or D.

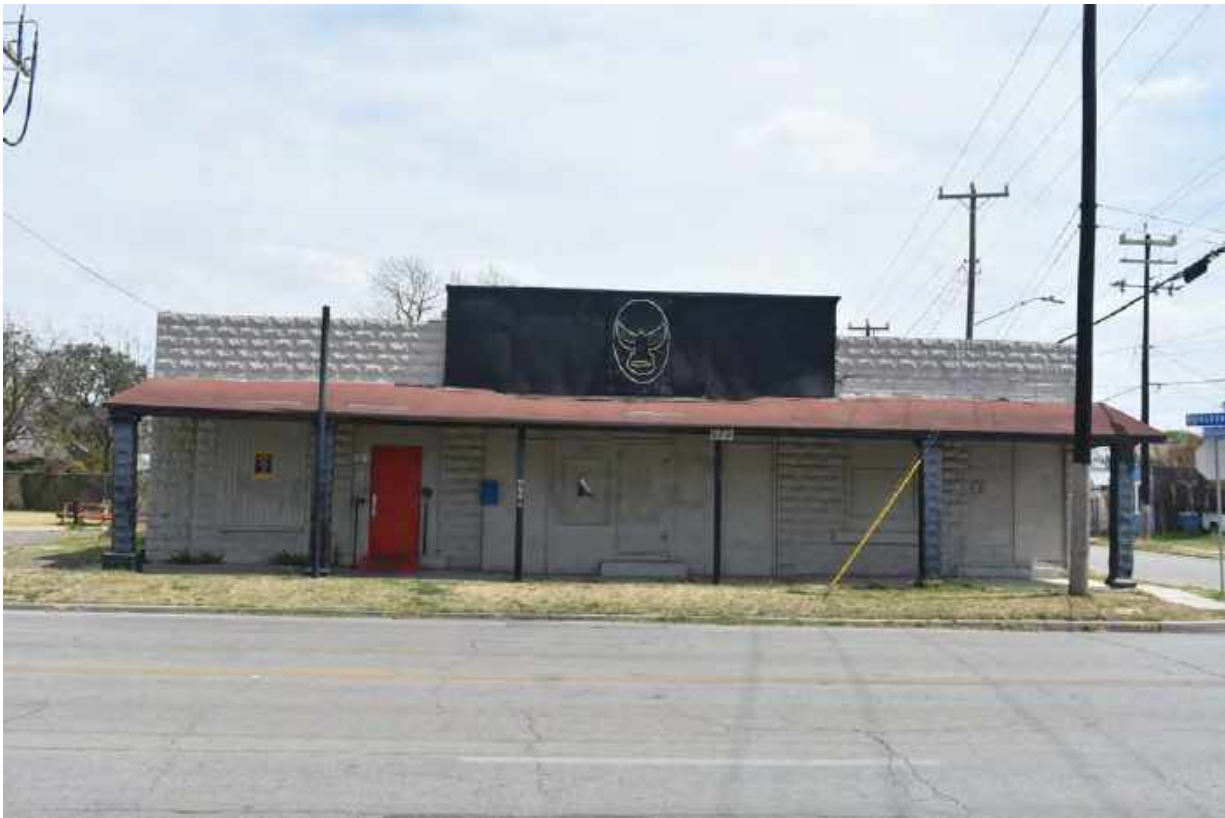
View facing east.

Type: Building	Exterior materials: brick	Primary roof type: gable, front flat	Alterations: Completely modified from its original appearance Storefront altered/replaced Wall cladding replaced - some Windows replaced – all visible Doors replaced
Style: No style			
Form: Rectangular	Porch: N/A

This resource is utilitarian in nature. It was not found to embody distinctive characteristics of a type, period, or method of construction, represent the work of a master, or possess high artistic value. Additionally, no associations were identified linking it to events or persons of historic importance. Furthermore, integrity has been diminished as outlined above. Because the building offers neither a local interpretation of a standard design nor an undocumented construction technique, it has limited potential to yield important information. As a result, it is recommended not eligible for the NRHP under Criterion A, B, C, or D.

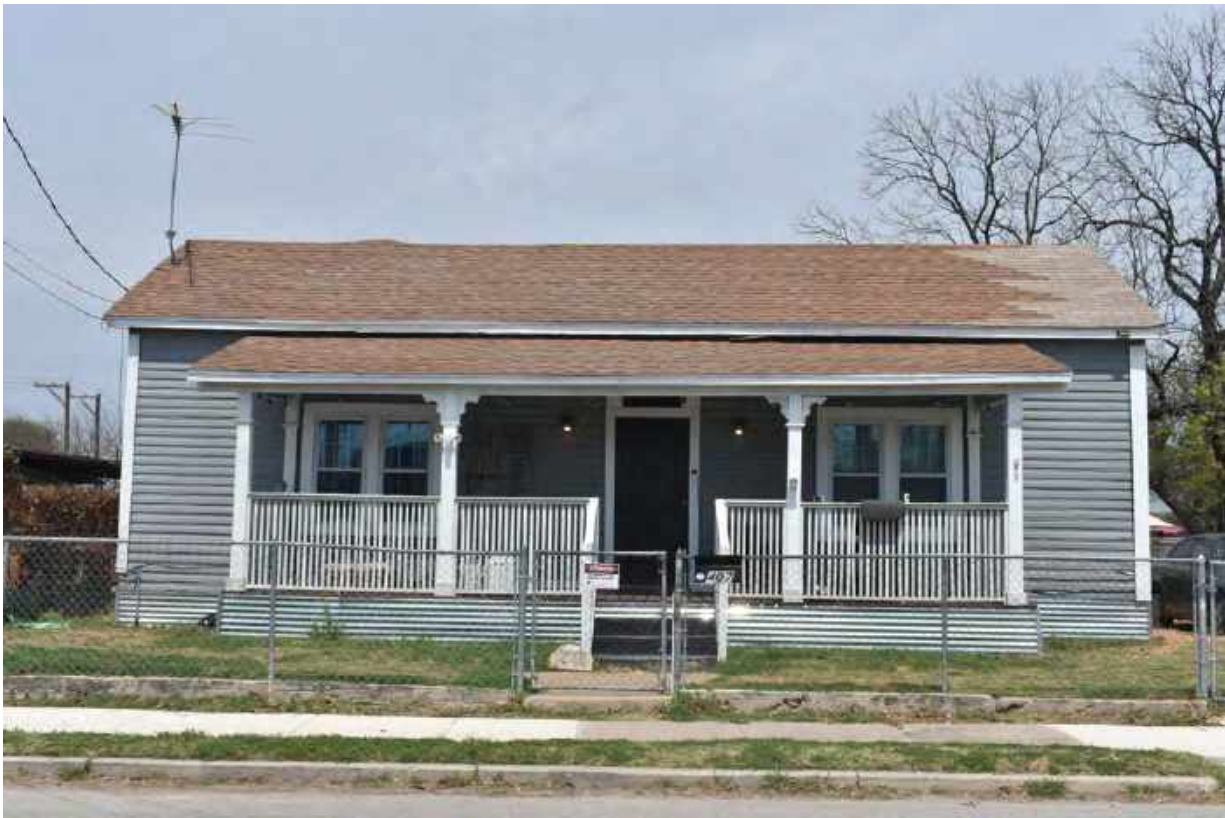
View facing north.

Type: Building	Exterior materials: wood siding	Primary roof type: gable, crossed	Alterations: Windows replaced – all visible Porch rails replaced Doors replaced Addition to rear/side elevation
Style: Folk Victorian			
Form: L-plan	Porch: partial-width projecting

This resource was constructed sometime between 1904 and 1912 and does not represent a very early period of residential development in this area of San Antonio. Properties associated with early residential development were generally constructed between the 1870s and 1890s. Examples of such properties can be found in the neighboring King William National Register Historic District and South Alamo Street-South Saint Mary's Street National Register Historic District. The resource is instead associated with the ongoing trend in residential development in this neighborhood and has no significant associations linking it to events or trends of historic importance. The resource is also a highly altered example of a Folk Victorian residential building. Because the property's integrity has been impacted by alterations undertaken after its construction, it no longer embodies the distinctive characteristics that would make it significant as an example of the style and does not demonstrate any innovative, important, or outstanding design features. Additionally, no associations were identified linking it to persons of historic importance. Because the building offers neither a local interpretation of a standard design nor an undocumented construction technique, it has limited potential to yield important information. As a result, it is recommended not eligible for the NRHP under Criterion A, B, or C.

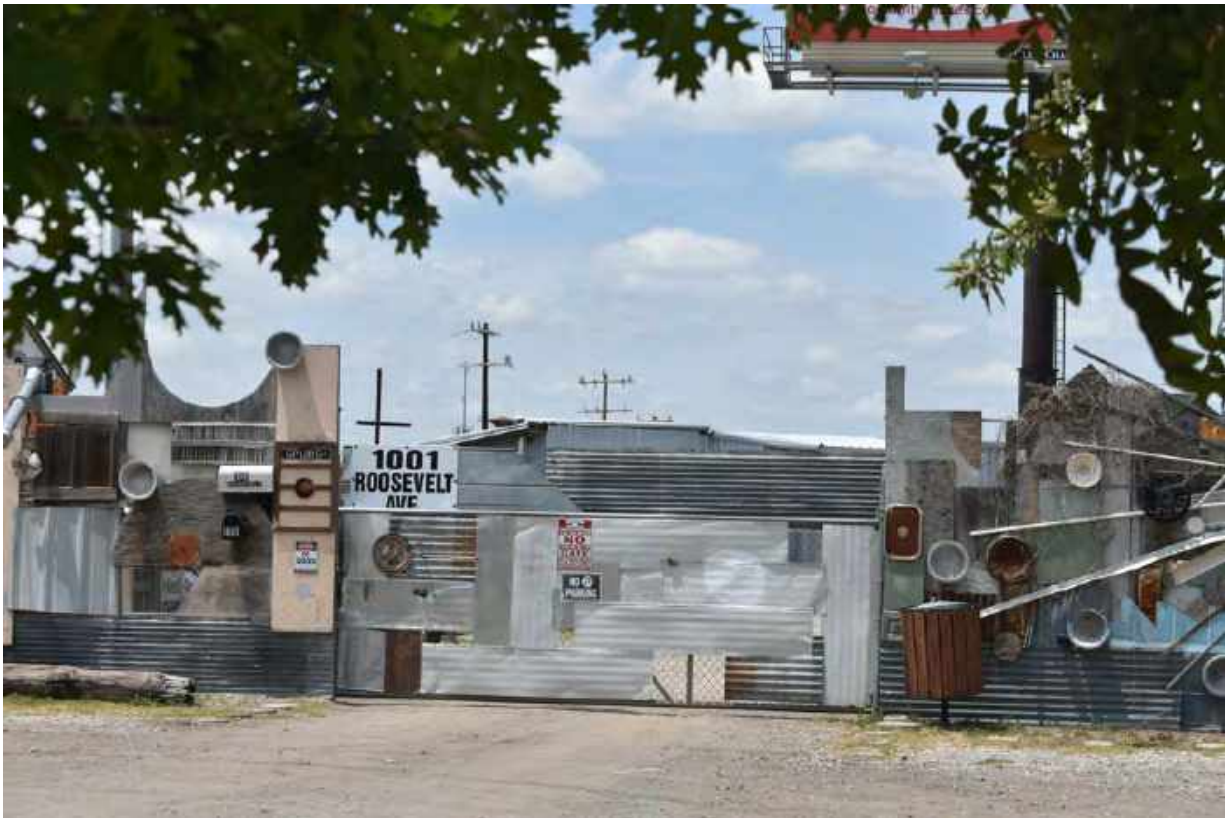
Resource A roof visible above fence (nonhistoric Resource G); view facing west.

Type: Building	Exterior materials: metal	Primary roof type: shed	Alterations: Garage door(s) replaced Wall cladding replaced Windows added
Style: No style			
Form: Rectangular	Porch: partial-width projecting

This resource does not embody distinctive characteristics of a type, period, or method of construction and it does not represent the work of a master or possess high artistic value. Additionally, no associations were identified linking it to persons or events of historic importance. Furthermore, integrity has been diminished based on material alterations of added windows, replaced wall cladding, and replaced garage doors. Because the building offers neither a local interpretation of a standard design nor an undocumented construction technique, it has limited potential to yield important information. As a result, it is recommended not eligible for the NRHP under Criterion A, B, C, or D.

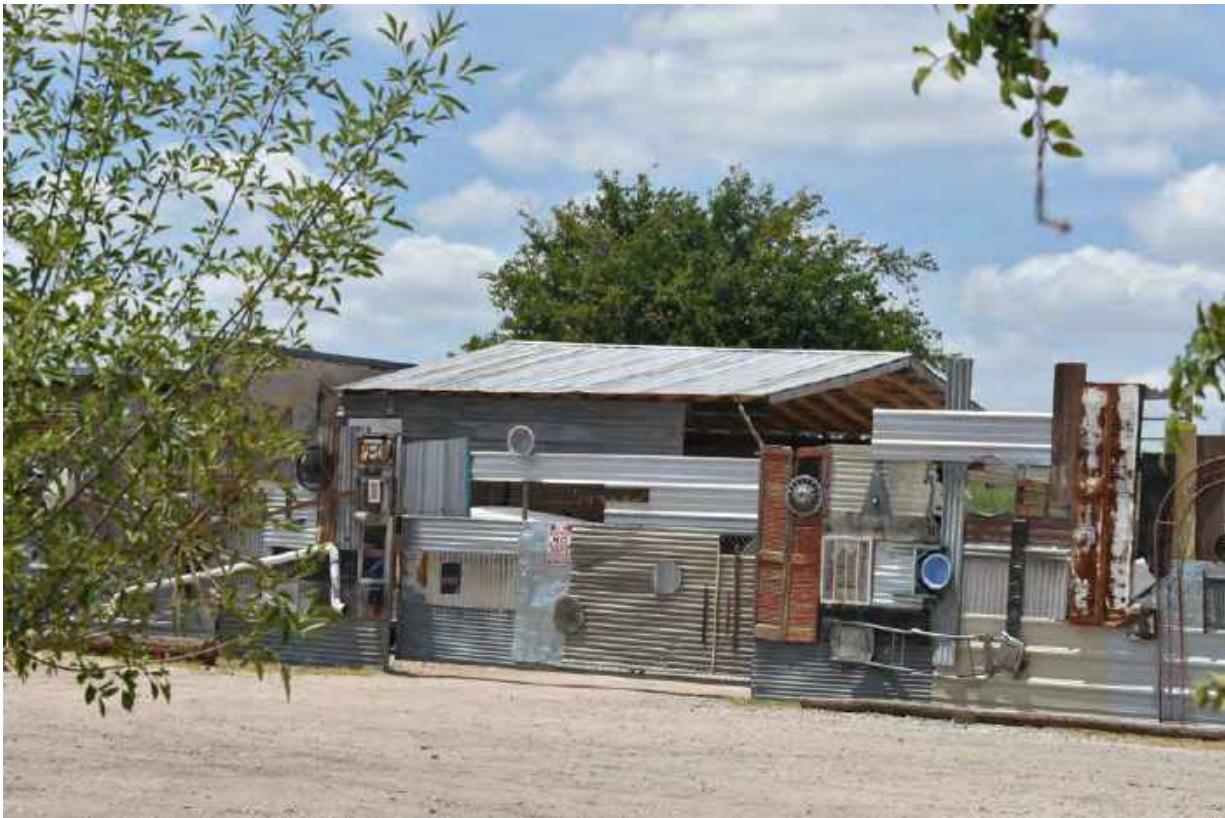
Resource B roof visible above fence (nonhistoric Resource G); view facing southwest.

Though it possesses integrity, this resource was not found to embody distinctive characteristics of a type, period, or method of construction, represent the work of a master, or possess high artistic value. Additionally, no associations were identified linking it to events or persons of historic importance. Because the building offers neither a local interpretation of a standard design nor an undocumented construction technique, it has limited potential to yield important information. As a result, it is recommended not eligible for the NRHP under Criterion A, B, C, or D.

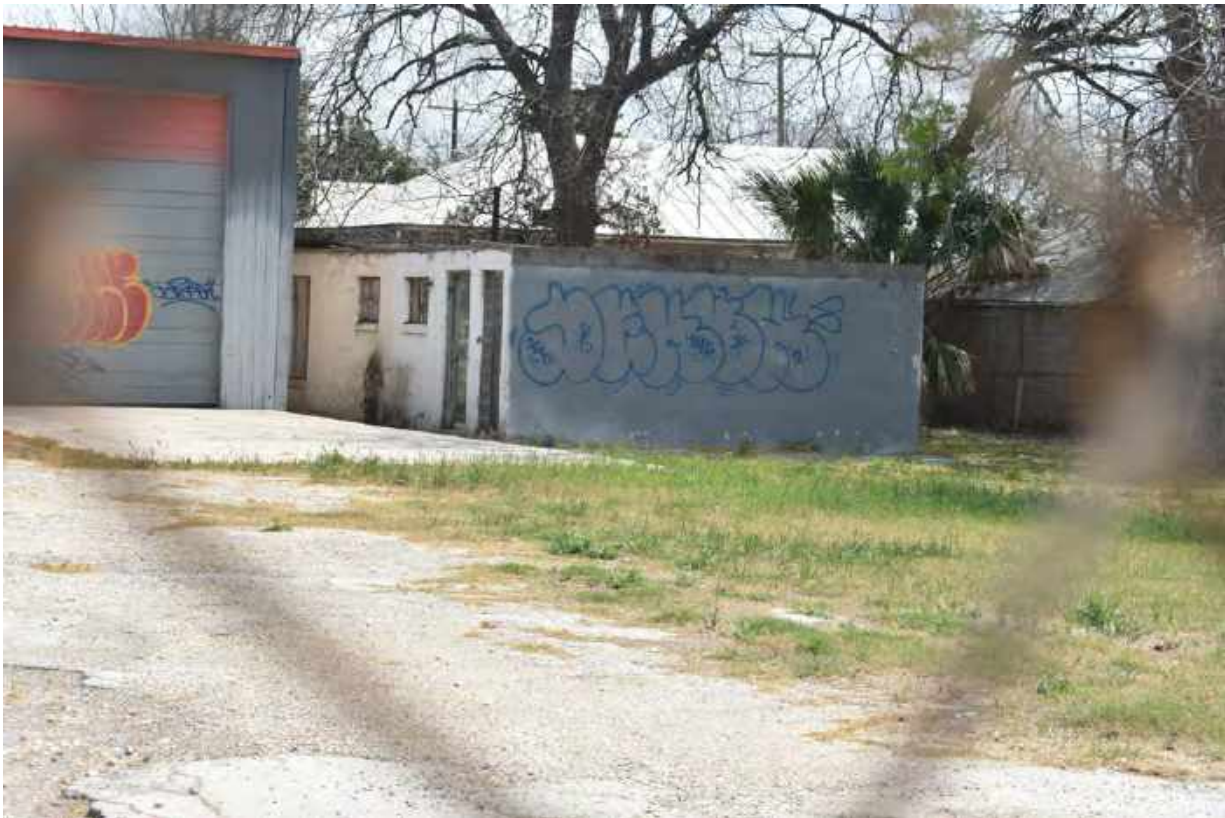
View facing east

Type: Building	Exterior materials: concrete/cinder block stucco	Primary roof type: flat (roof missing)	Alterations: Missing elements Graffiti Window(s) boarded
Style: No style			
Form: Rectangular	Porch: N/A

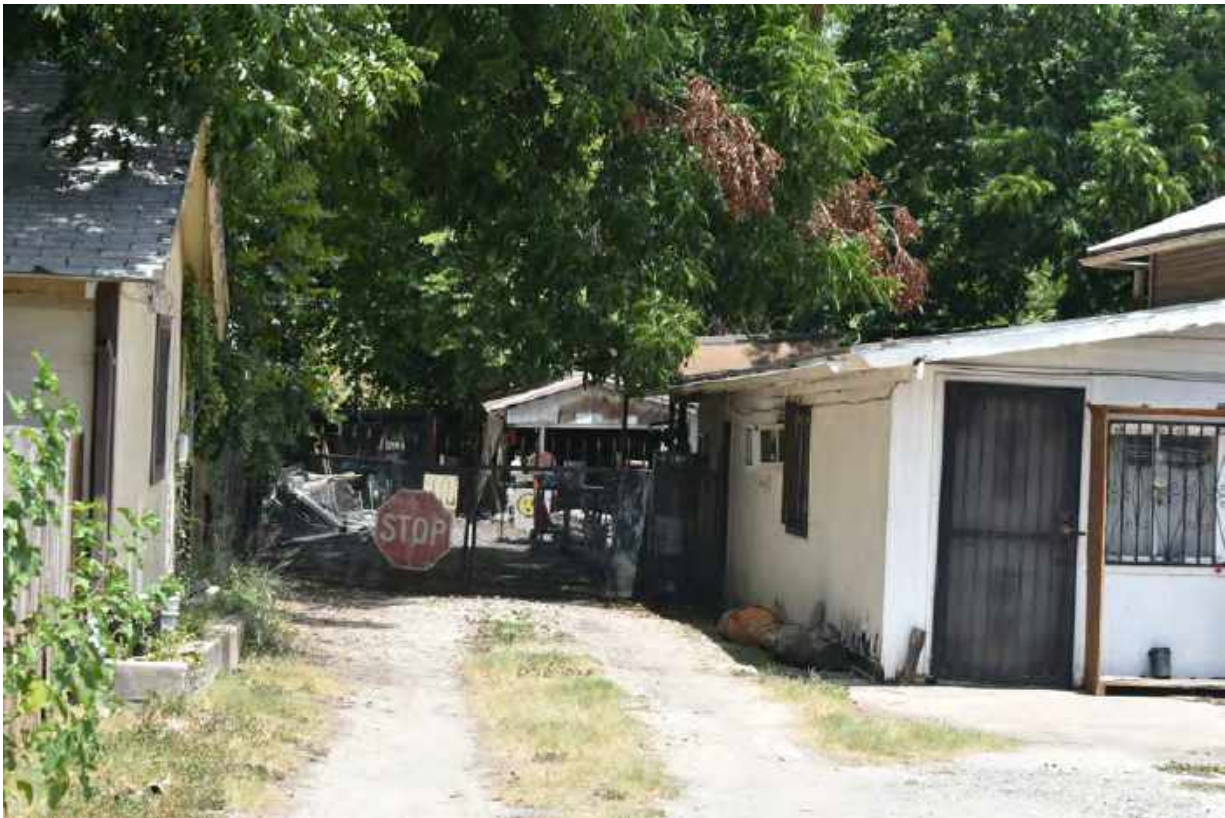
View facing north.

Type: Building	Exterior materials: metal	Primary roof type: gable, front	Alterations: Roof replaced w/ incomp. materials Wall cladding replaced Addition to primary/side elevation
Style: No style			
Form: Rectangular	Porch: N/A

This garage does not embody distinctive characteristics of a type, period, or method of construction and it does not represent the work of a master or possess high artistic value. Additionally, no associations were identified linking it to persons or events of historic importance. Furthermore, design, materials, and workmanship integrity has been diminished due to additions and replaced building materials. Because the building offers neither a local interpretation of a standard design nor an undocumented construction technique, it has limited potential to yield important information. As a result, it is recommended not eligible for the NRHP under Criterion A, B, C, or D.

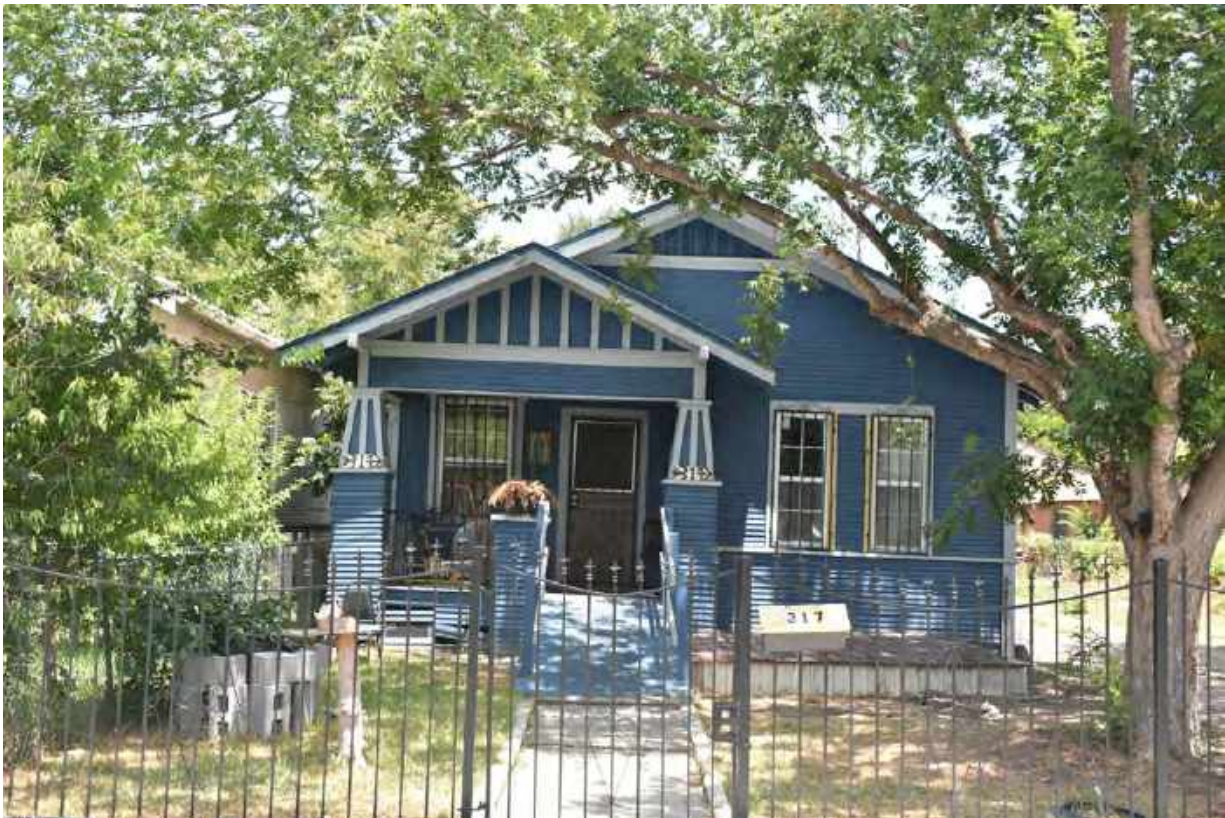
View facing north

Type: Building	Exterior materials: wood siding brick	Primary roof type: gable, front	Alterations: Brick/stone painted Deck added Porch rails replaced Window opening(s) altered Windows replaced – all visible Wheelchair ramp added
Style: Craftsman			
Form: Bungalow	Porch: partial-width integrated

This resource does not embody distinctive characteristics of a type, period, or method of construction and it does not represent the work of a master or possess high artistic value. Additionally, no associations were identified linking it to persons or events of historic importance. Furthermore, integrity has been diminished as outlined above. Because the building offers neither a local interpretation of a standard design nor an undocumented construction technique, it has limited potential to yield important information. As a result, it is recommended not eligible for the NRHP under Criterion A, B, C, or D.

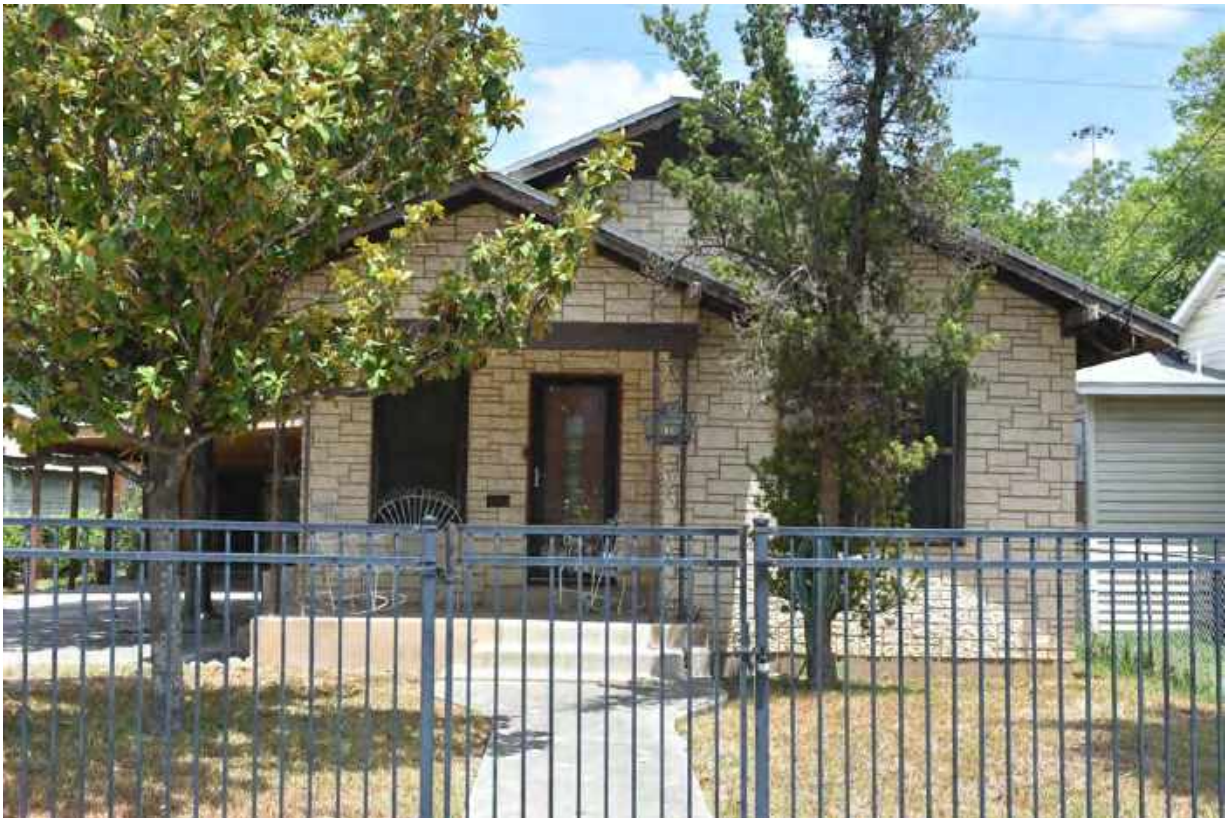
View facing north

Type: Building	Exterior materials: asphalt	Primary roof type: gable, front	Alterations: Addition to rear/side elevation Carport added Porch support(s) replaced Roof replaced w/ incomp. materials Wall cladding replaced Windows replaced – some
Style: Craftsman			
Form: Bungalow	Porch: partial-width integrated

This resource does not embody distinctive characteristics of a type, period, or method of construction and it does not represent the work of a master or possess high artistic value. Additionally, no associations were identified linking it to persons or events of historic importance. The design has been altered by a large rear addition and added carport. Other alterations including replaced porch supports, roof materials, wall cladding, and some windows further diminish integrity of materials. Because the building offers neither a local interpretation of a standard design nor an undocumented construction technique, it has limited potential to yield important information. As a result, it is recommended not eligible for the NRHP under Criterion A, B, C, or D.

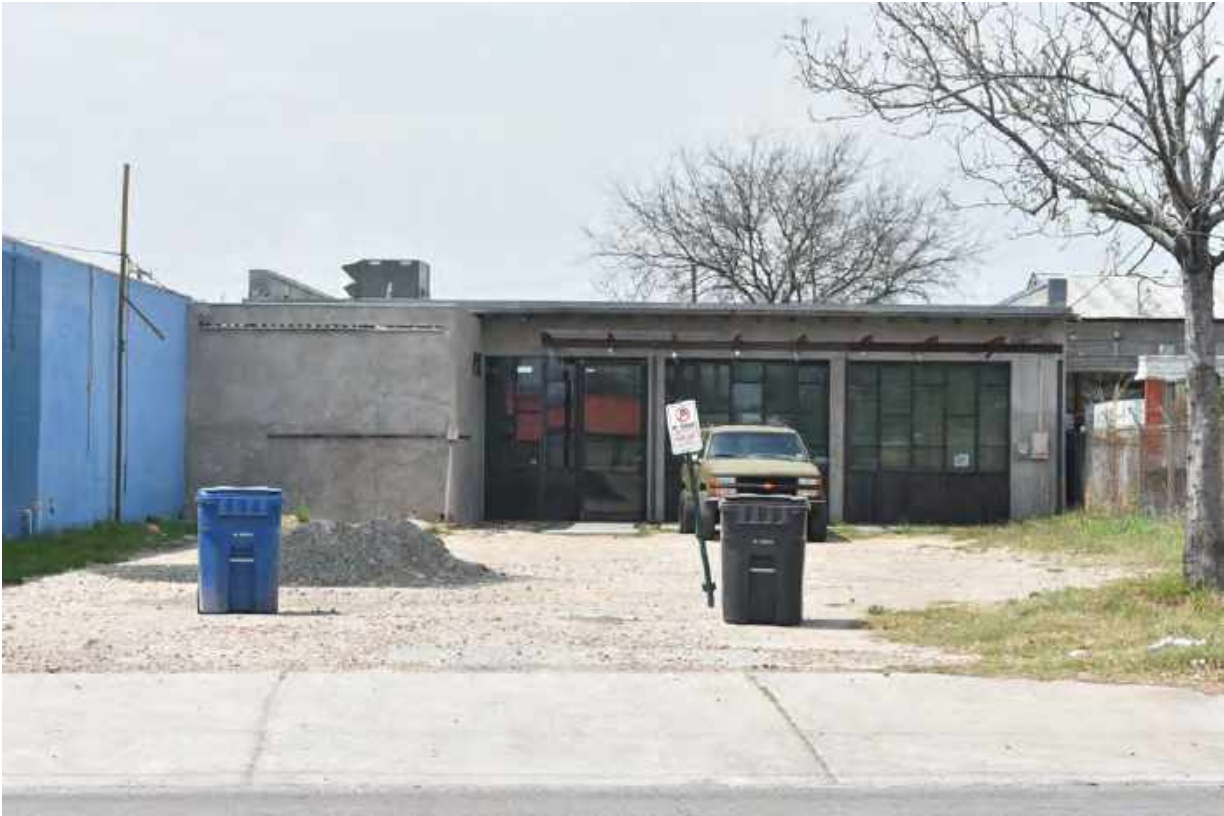
View facing west.

Type: Building	Exterior materials: concrete	Primary roof type: flat with parapet	Alterations: Addition to primary elevation Door (primary) opening altered Door (primary) replaced Wall cladding replaced Garage enclosed
Style: No style			
Form: Rectangular	Porch: N/A

Adams Truck Company occupied this building in the early 1960s and was later occupied by Perez Automotive Repair in the 2010s.

This resource was not found to embody distinctive characteristics of a type, period, or method of construction, represent the work of a master, or possess high artistic value. Additionally, no associations were identified linking it to events or persons of historic importance. Furthermore, integrity has been diminished as outlined above. Because the building offers neither a local interpretation of a standard design nor an undocumented construction technique, it has limited potential to yield important information. As a result, it is recommended not eligible for the NRHP under Criterion A, B, C, or D.

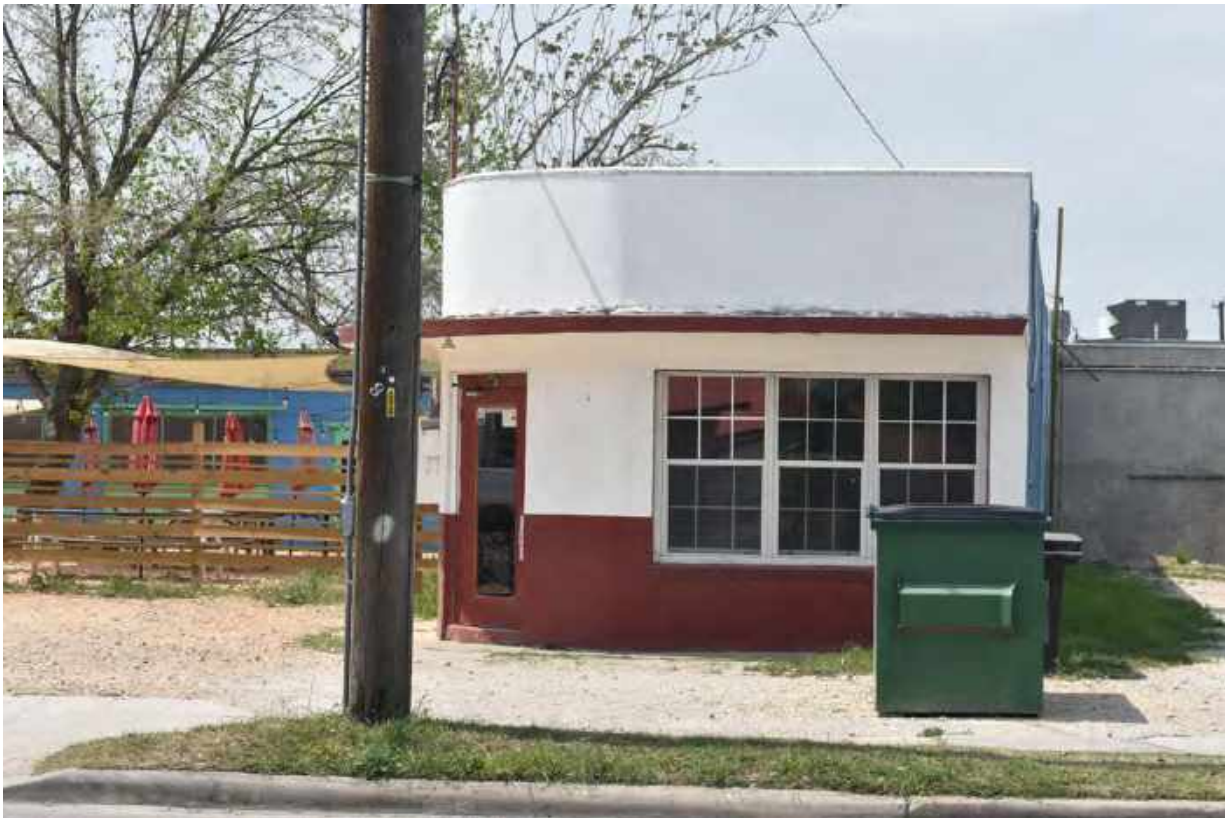
View facing west

Type: Building	Exterior materials: stucco	Primary roof type: flat with parapet	Alterations: Windows replaced – all visible Doors replaced
Style: Streamline Moderne			
Form: Irregular	Porch: stoop projecting

This resource does not embody distinctive characteristics of a type, period, or method of construction and it does not represent the work of a master or possess high artistic value. Additionally, no associations were identified linking it to persons or events of historic importance. Material and workmanship has been diminished from window and door replacements, which removed distinctive glass block on the front facade picture window. Because the building offers neither a local interpretation of a standard design nor an undocumented construction technique, it has limited potential to yield important information. As a result, it is recommended not eligible for the NRHP under Criterion A, B, C, or D.

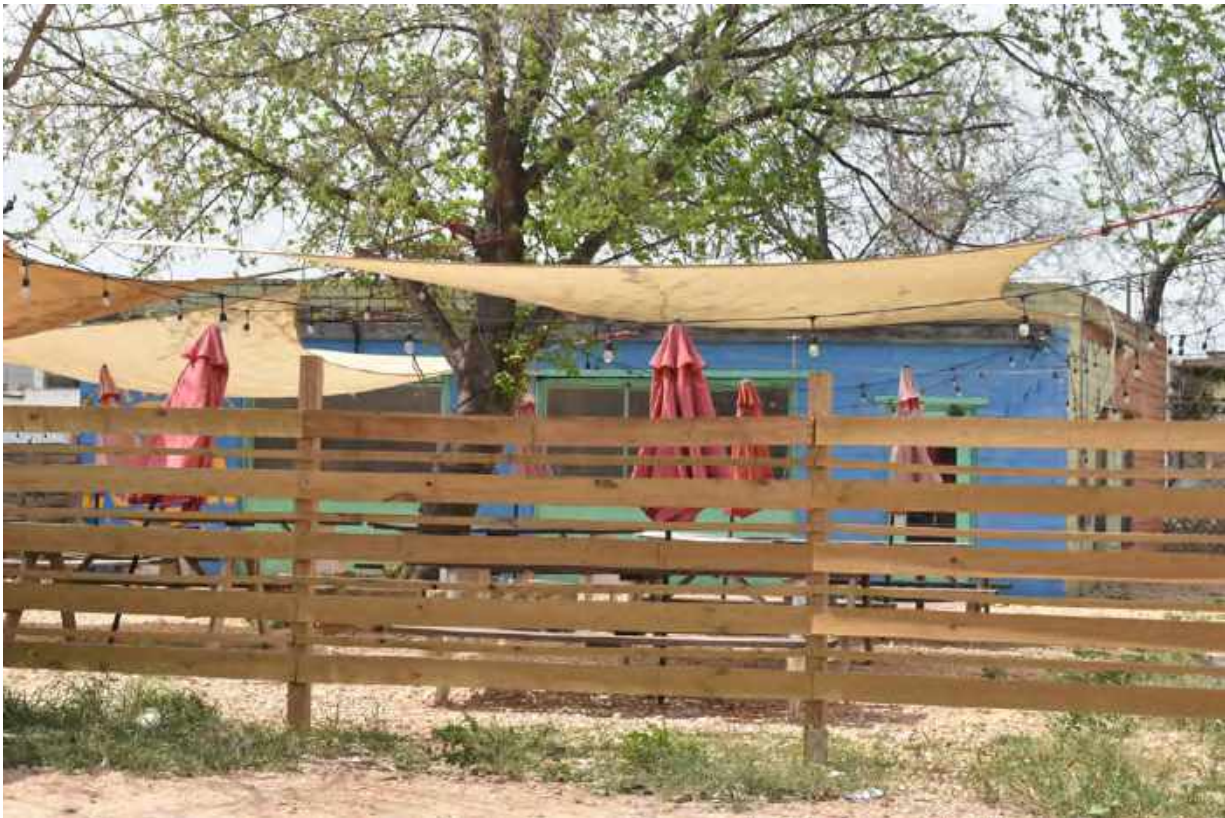
View facing southwest.

Type: Building	Exterior materials: concrete/cinder block	Primary roof type: flat	Alterations: Doors replaced Garage enclosed
Style: No style			
Form: Irregular	Porch: N/A

This resource does not embody distinctive characteristics of a type, period, or method of construction and it does not represent the work of a master or possess high artistic value. Additionally, no associations were identified linking it to persons or events of historic importance. The former warehouse garage has been enclosed and converted into additional restaurant space, hindering integrity of design and association. Material integrity has also been diminished from replacement doors. Because the building offers neither a local interpretation of a standard design nor an undocumented construction technique, it has limited potential to yield important information. As a result, it is recommended not eligible for the NRHP under Criterion A, B, C, or D.

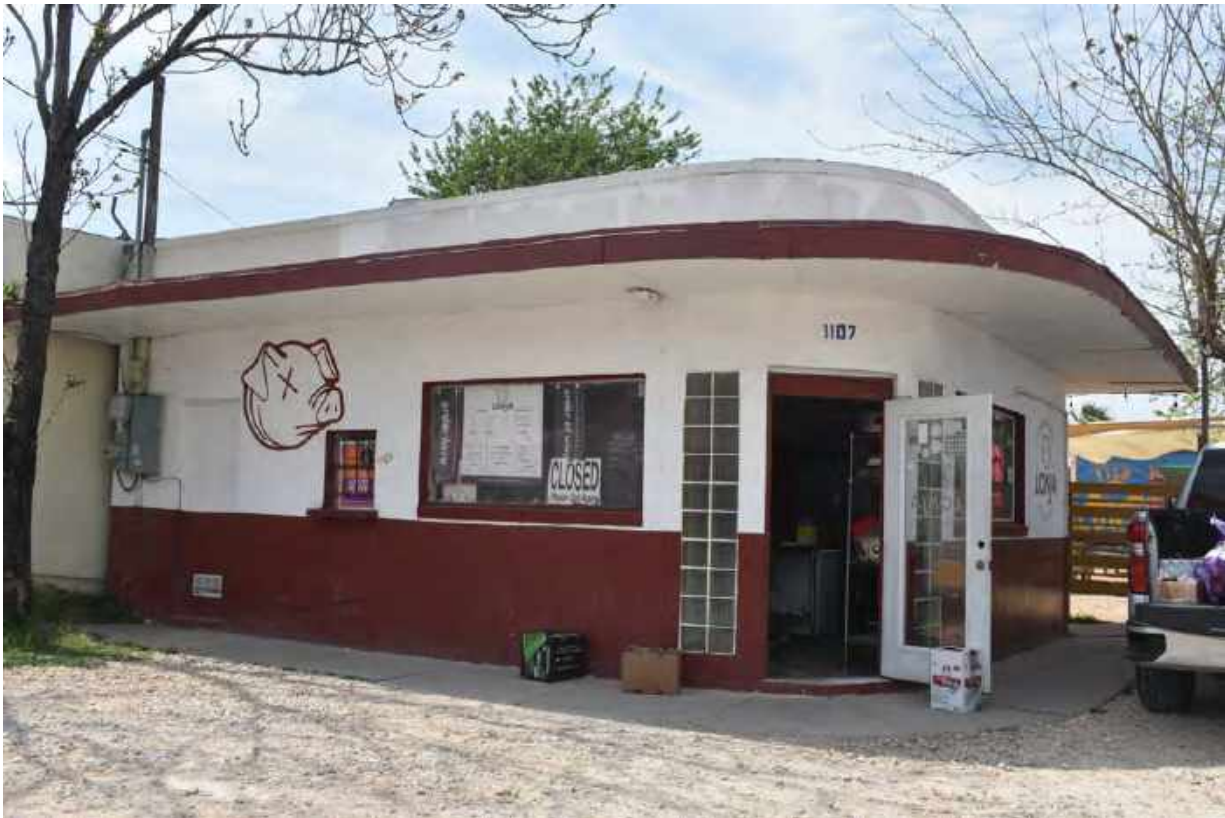
View facing southwest.

Type: Building	Exterior materials: stucco glass block	Primary roof type: flat with parapet	Alterations: Door/entrance enclosed Door (primary) replaced Windows replaced – some
Style: Streamline Moderne			
Form: Irregular	Porch: stoop projecting

This resource does not embody distinctive characteristics of a type, period, or method of construction and it does not represent the work of a master or possess high artistic value. Additionally, no associations were identified linking it to persons or events of historic importance. Alterations to its fenestration have impaired material integrity. Because the building offers neither a local interpretation of a standard design nor an undocumented construction technique, it has limited potential to yield important information. As a result, it is recommended not eligible for the NRHP under Criterion A, B, C, or D.
