APPENDIX C SURVEY FORMS (CONTINUED)

DRAFT
(Information is under FTA review and is subject to change.)

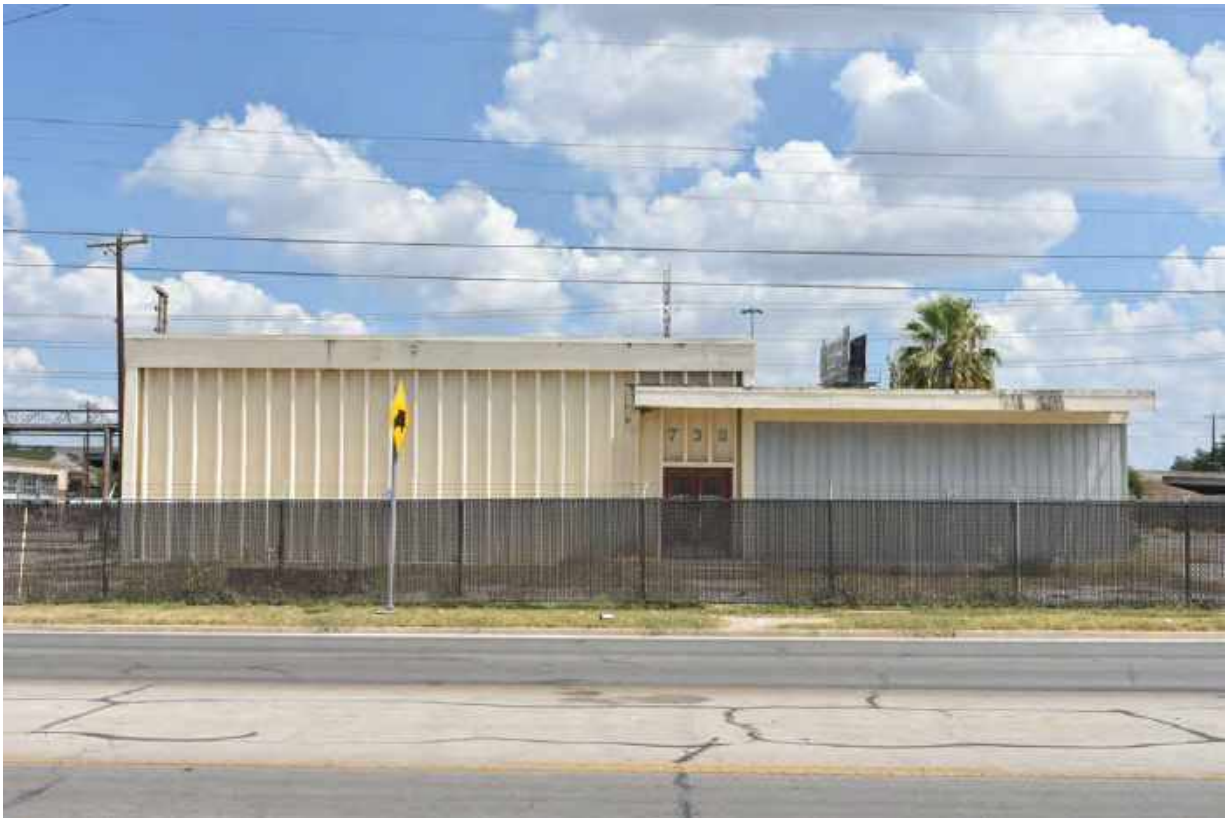
View facing north

Type: Building	Exterior materials: stucco metal	Primary roof type: flat	Alterations: Door (primary) replaced Portion demolished Window opening(s) infilled Wall cladding replaced - some
Style: Mid-Century Modern			
Form: Irregular	Porch: partial-width projecting

The Torgenson Company, an agricultural equipment business, is the earliest identified occupant of this building during the 1960s. This building includes a former office on its front facade, a warehouse in the central section, and a loading dock/garage bay area towards the rear. A long wing previously extended southeasterly; where the current gray metal cladding is present. Between 1986 and 2000, this section was removed and replaced with the current wall cladding.

This resource does not embody distinctive characteristics of a type, period, or method of construction and it does not represent the work of a master or possess high artistic value. Additionally, no associations were identified linking it to persons or events of historic importance. The design was fundamentally altered with the large demolition of the southeast wing in the late twentieth century. Moreover, the replacement doors and infilled windows further detract from the integrity of materials. Because the building offers neither a local interpretation of a standard design nor an undocumented construction technique, it has limited potential to yield important information. As a result, it is recommended not eligible for the NRHP under Criterion A, B, C, or D.

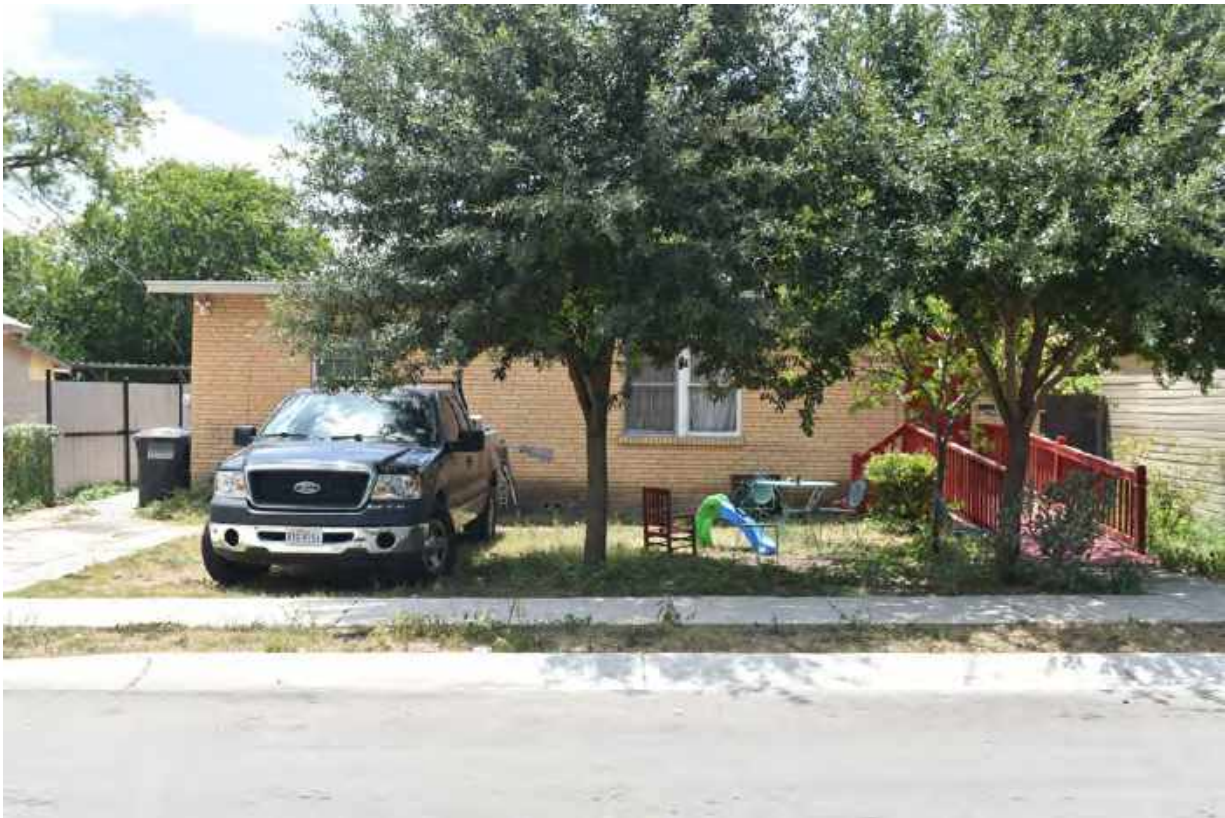
View facing south

Type: Building	Exterior materials: brick vinyl siding	Primary roof type: gable, side	Alterations: Addition to rear/side elevation Windows replaced – all visible Wheelchair ramp added Exterior staircase added
Style: Ranch			
Form: Rectangular	Porch: none

This resource does not embody distinctive characteristics of a type, period, or method of construction and it does not represent the work of a master or possess high artistic value. Additionally, no associations were identified linking it to persons or events of historic importance. Furthermore, integrity has been diminished as outlined above. Because the building offers neither a local interpretation of a standard design nor an undocumented construction technique, it has limited potential to yield important information. As a result, it is recommended not eligible for the NRHP under Criterion A, B, C, or D.

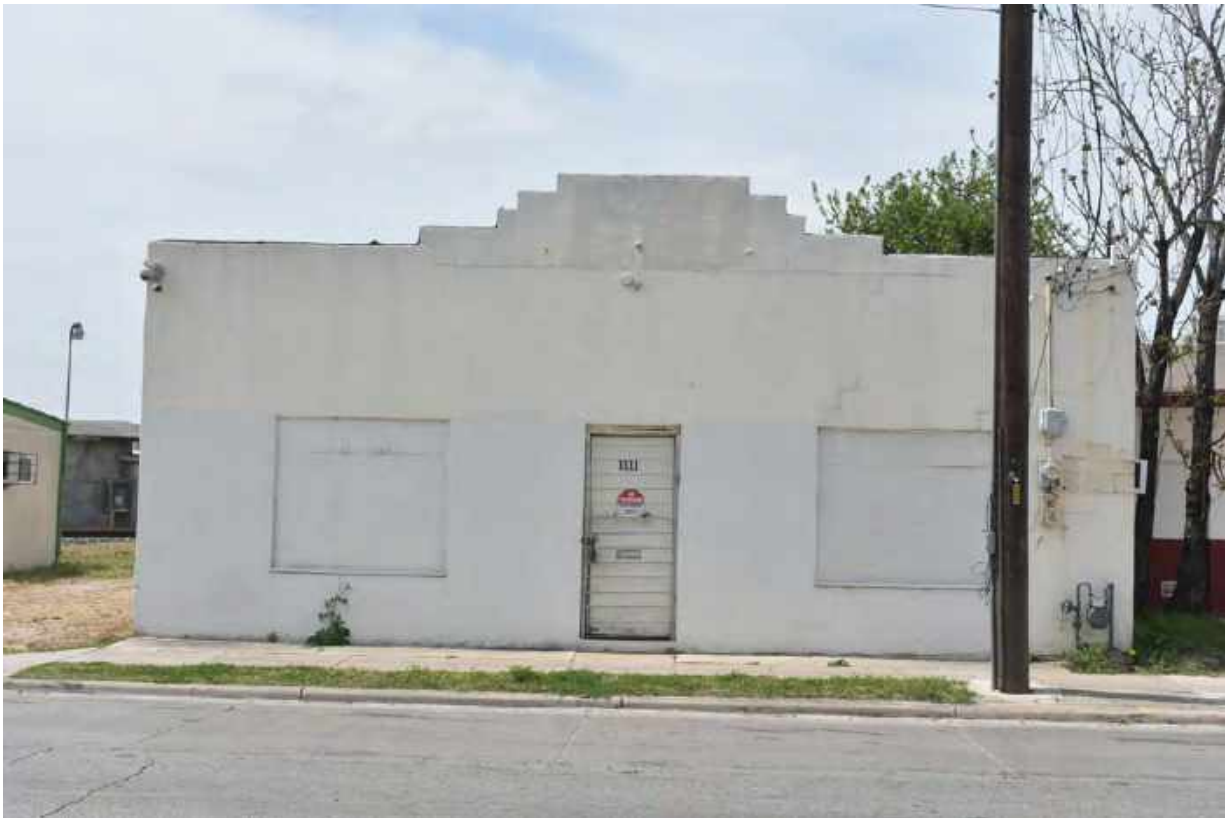
View facing west

Type: Building	Exterior materials: stucco	Primary roof type: flat with parapet	Alterations: Door/entrance enclosed Doors replaced Window opening(s) infilled Window(s) boarded
Style: No style			
Form: Rectangular	Porch: N/A

This resource does not embody distinctive characteristics of a type, period, or method of construction and it does not represent the work of a master or possess high artistic value. Additionally, no associations were identified linking it to persons or events of historic importance. Furthermore, integrity has been diminished as outlined above. Because the building offers neither a local interpretation of a standard design nor an undocumented construction technique, it has limited potential to yield important information. As a result, it is recommended not eligible for the NRHP under Criterion A, B, C, or D.

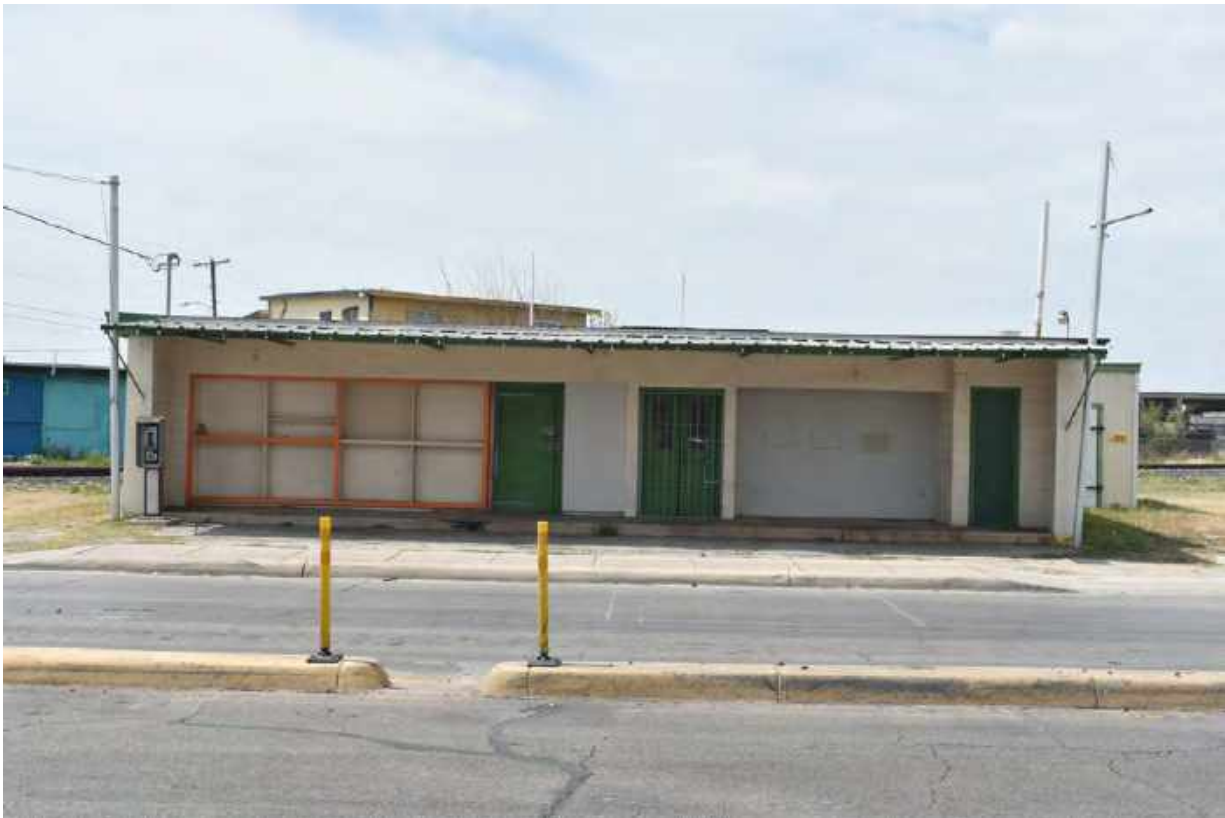
View facing west.

Type: Building	Exterior materials: stucco concrete/cinder block processed wood board	Primary roof type: flat with parapet	Alterations: Addition to primary/side elevation Signage removed Storefront altered/replaced
Style: No style			
Form: Rectangular	Porch: full-width integrated

This resource does not embody distinctive characteristics of a type, period, or method of construction and it does not represent the work of a master or possess high artistic value. Additionally, no associations were identified linking it to persons or events of historic importance. Furthermore, integrity has been diminished as outlined above. Because the building offers neither a local interpretation of a standard design nor an undocumented construction technique, it has limited potential to yield important information. As a result, it is recommended not eligible for the NRHP under Criterion A, B, C, or D.

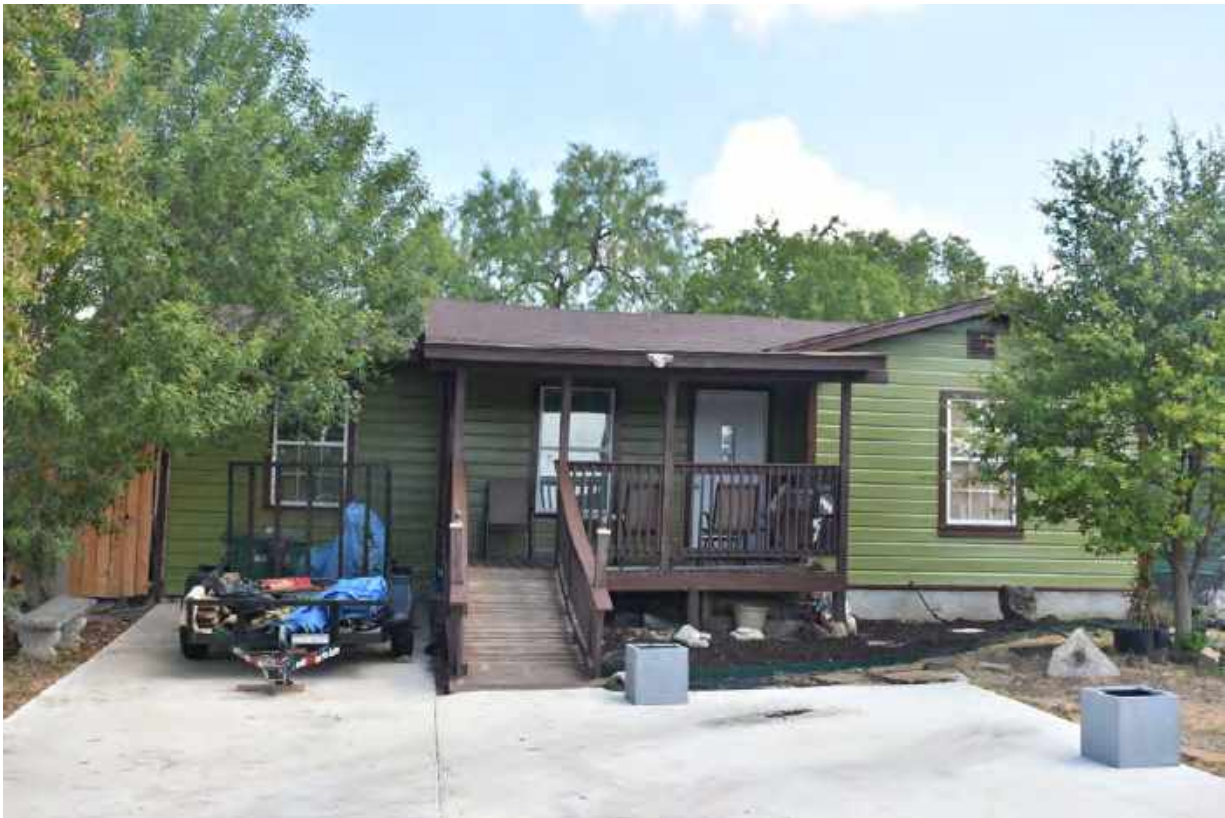
View facing north.

Type: Building	Exterior materials: wood siding	Primary roof type: gable, side	Alterations: Porch rails replaced Porch support(s) replaced Windows replaced – all visible Door (primary) replaced Addition to rear/side elevation Garage enclosed
Style: Minimal Traditional			
Form: Rectangular	Porch: partial-width projecting

This dwelling does not embody distinctive characteristics of a type, period, or method of construction and it does not represent the work of a master or possess high artistic value. Additionally, no associations were identified linking it to persons or events of historic importance. Furthermore, design integrity has been diminished due to a rear addition and materials integrity has been diminished due to materials not replaced in kind. Because the building offers neither a local interpretation of a standard design nor an undocumented construction technique, it has limited potential to yield important information. As a result, it is recommended not eligible for the NRHP under Criterion A, B, C, or D.

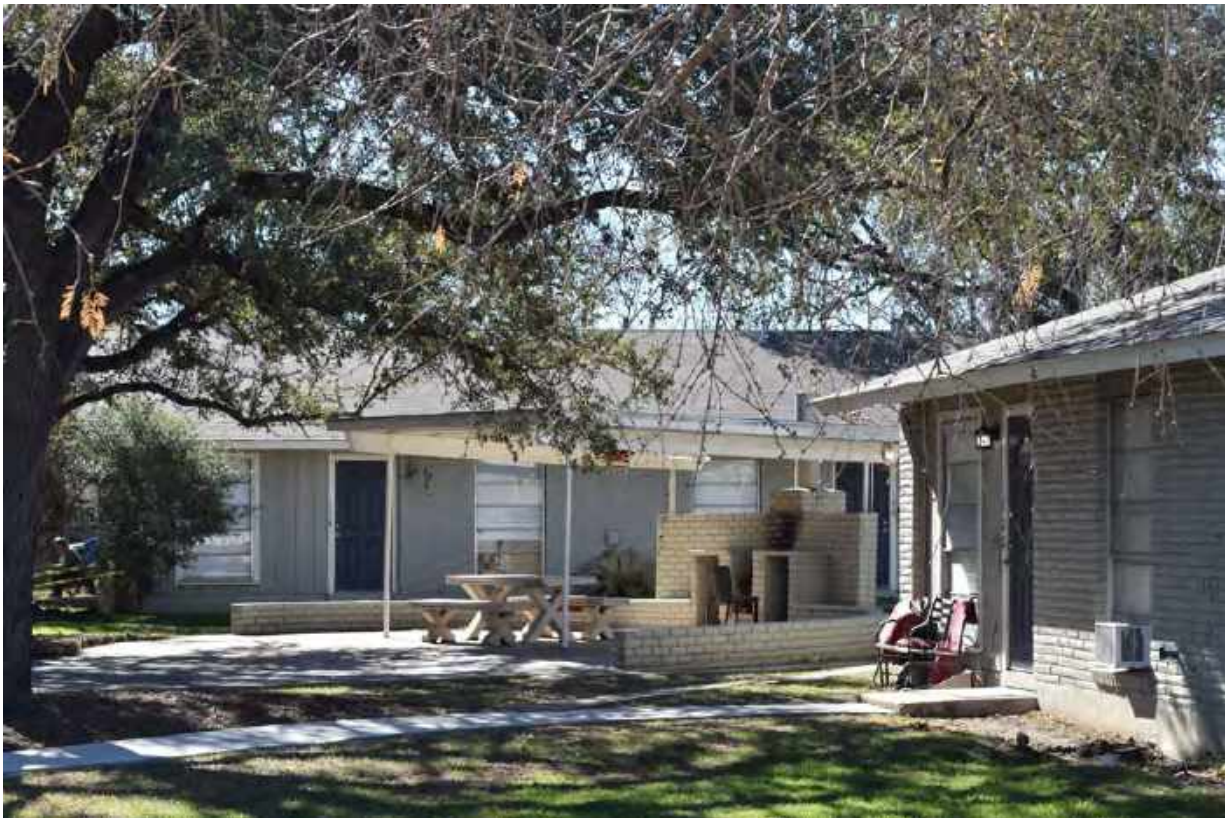
View facing south
(background)

Type: Building	Exterior materials: brick wood siding panels	Primary roof type: gable, side	Alterations: Doors replaced Brick/stone painted
Style: Ranch			
Form: Rectangular	Porch: none

This resource does not embody distinctive characteristics of a type, period, or method of construction and it does not represent the work of a master or possess high artistic value. Additionally, no associations were identified linking it to persons or events of historic importance. Furthermore, integrity has been diminished from material replacements and alterations. As a result, it is recommended not eligible for listing in the NRHP under Criterion A, B, or C.

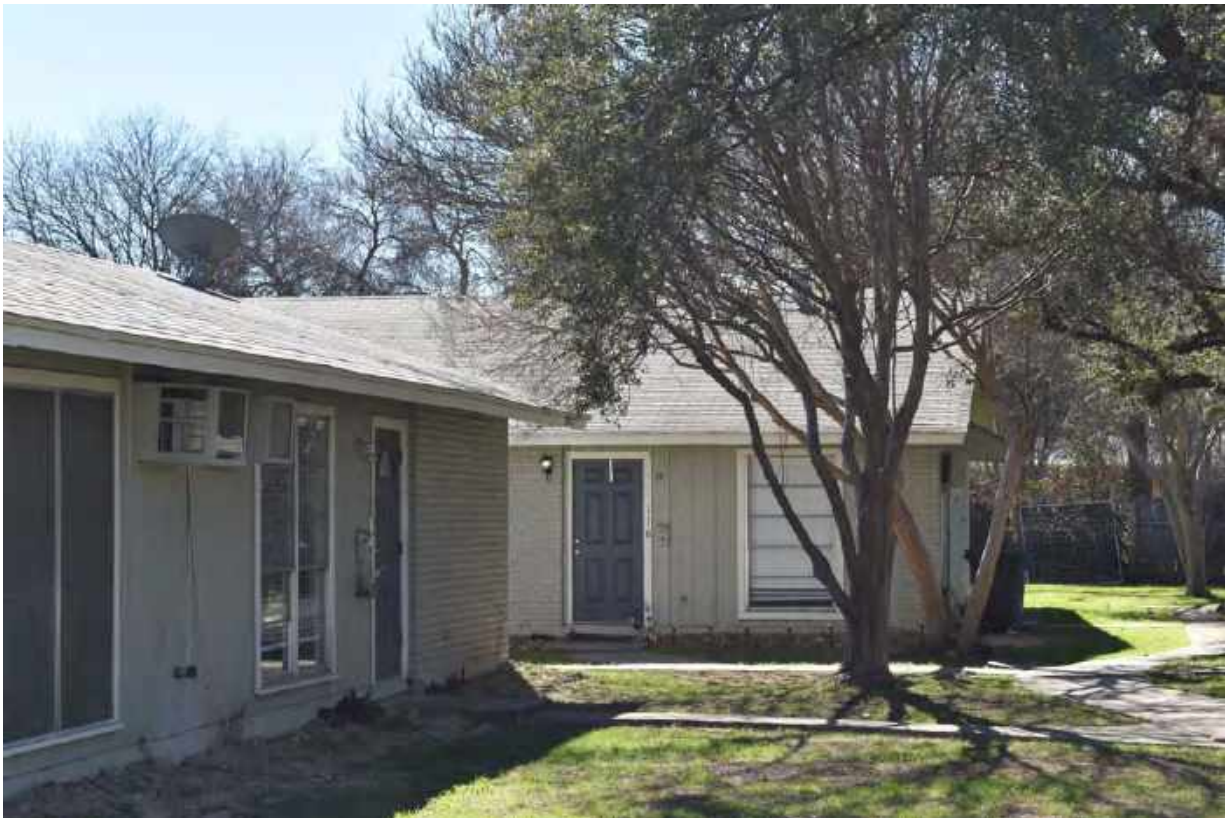
Resource ID: 287C **Parcel ID:** 389795 **Year Built:** 1960 **Year Source:** CAD

View facing south

Type: Building	Exterior materials: brick wood siding panels	Primary roof type: gable, side	Alterations: Doors replaced Brick/stone painted
Style: Ranch			
Form: Rectangular	Porch: none

This resource does not embody distinctive characteristics of a type, period, or method of construction and it does not represent the work of a master or possess high artistic value. Additionally, no associations were identified linking it to persons or events of historic importance. Furthermore, integrity has been diminished from material replacements and alterations. As a result, it is recommended not eligible for listing in the NRHP under Criterion A, B, or C.

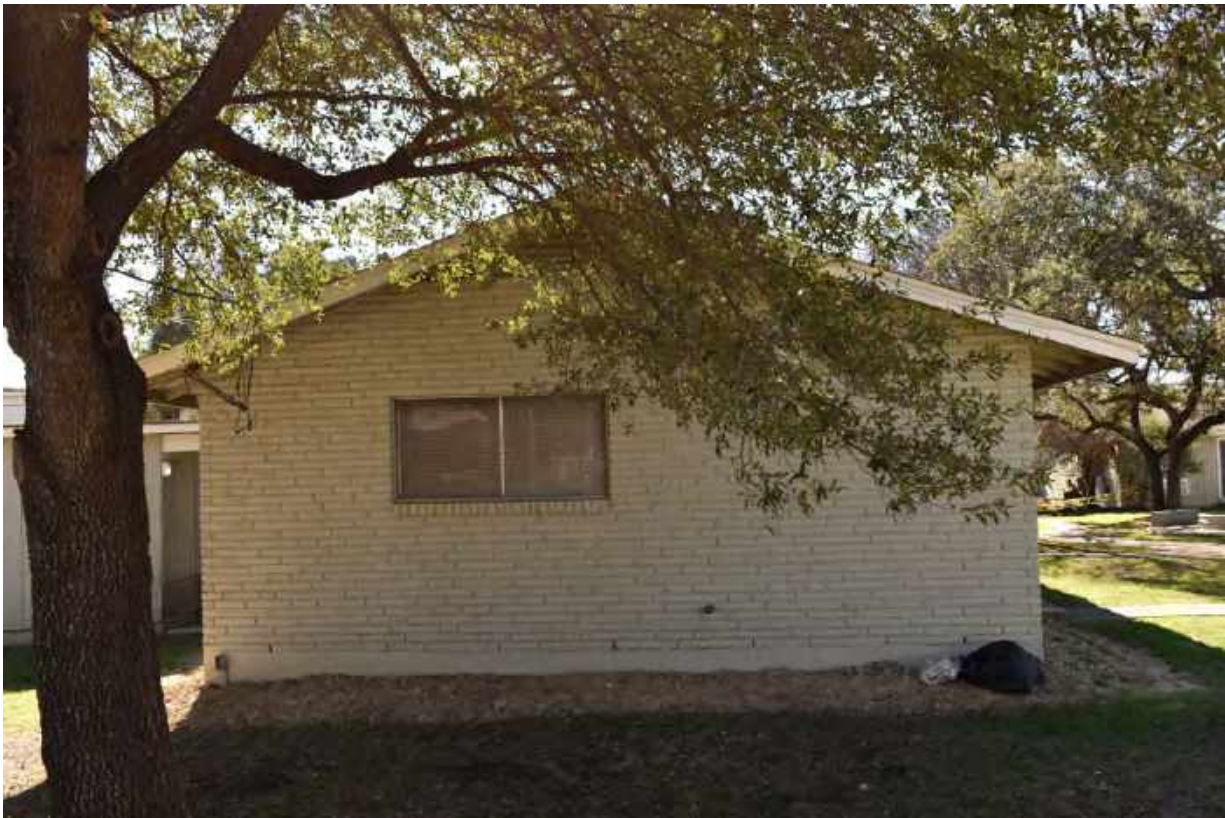
Resource ID: 287D **Parcel ID:** 389795 **Year Built:** 1960 **Year Source:** CAD

View facing south

Type: Building	Exterior materials: brick wood siding panels	Primary roof type: gable, side	Alterations: Doors replaced Brick/stone painted
Style: Ranch			
Form: Rectangular	Porch: none

This resource does not embody distinctive characteristics of a type, period, or method of construction and it does not represent the work of a master or possess high artistic value. Additionally, no associations were identified linking it to persons or events of historic importance. Furthermore, integrity has been diminished from material replacements and alterations. As a result, it is recommended not eligible for listing in the NRHP under Criterion A, B, or C.

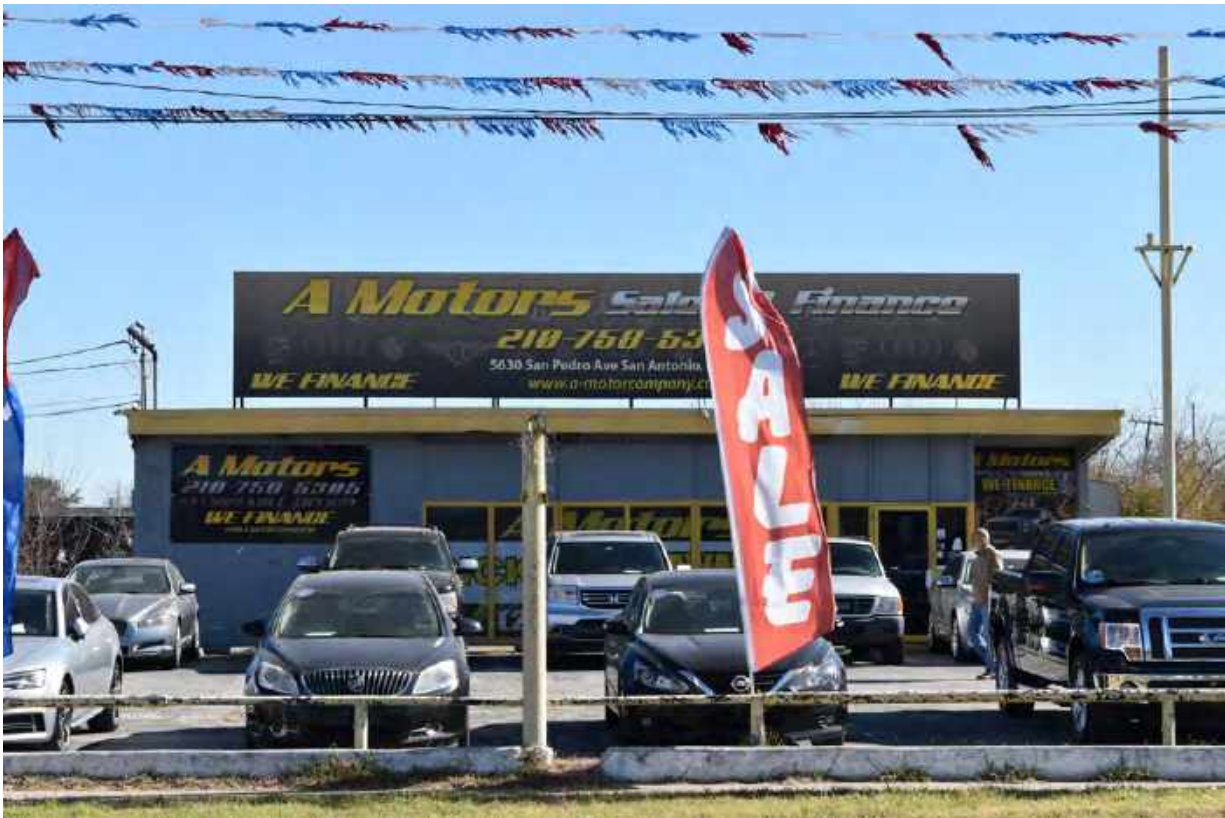
View facing east

Type: Building	Exterior materials: brick	Primary roof type: shed	Alterations: Addition to primary/side elevation
Style: No style	concrete/cinder block	flat	Brick/stone painted
Form: Irregular	stucco		Signage added
	Porch: stoop		Window opening(s) infilled
	integrated		Windows replaced – some

This resource does not embody distinctive characteristics of a type, period, or method of construction and it does not represent the work of a master or possess high artistic value. Additionally, no associations were identified linking it to persons or events of historic importance. Furthermore, integrity has been diminished as outlined above. As a result, it is recommended not eligible for listing in the NRHP under Criterion A, B, or C.

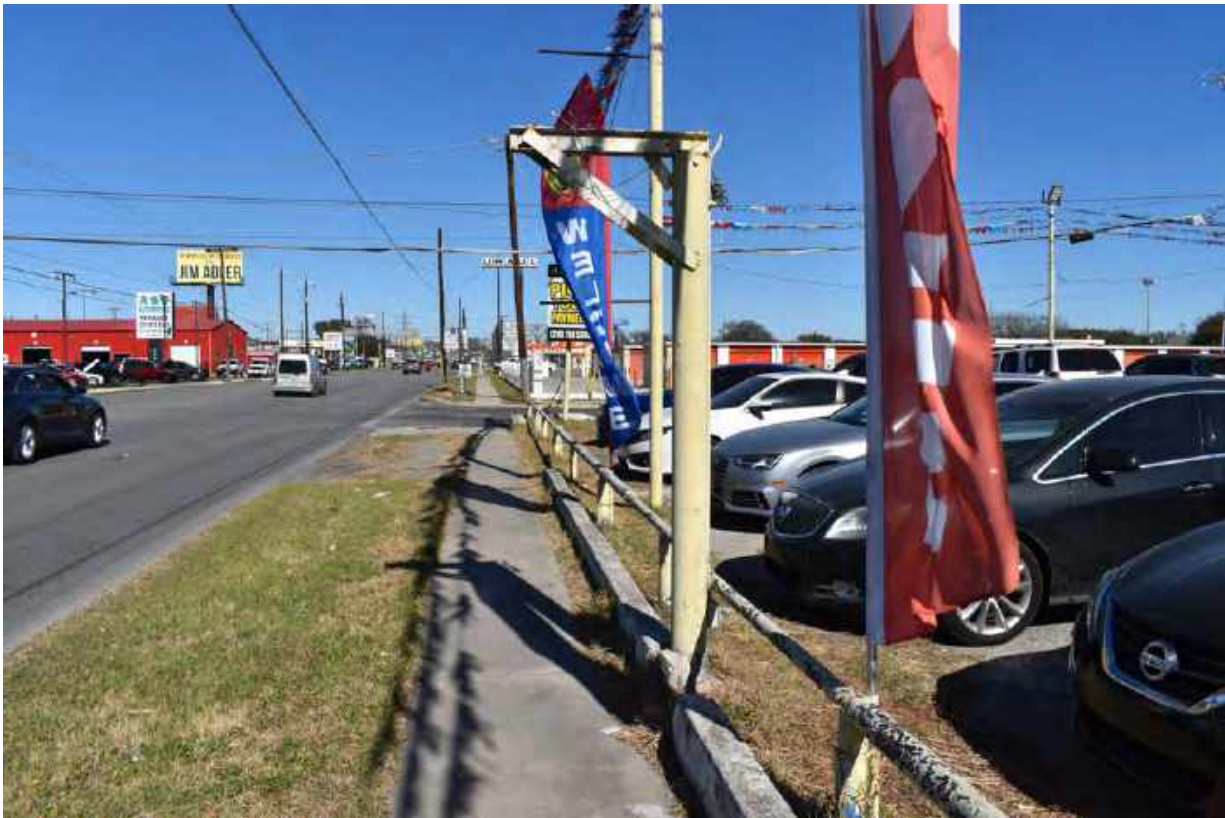
Resource ID: 288B **Parcel ID:** 430915 **Year Built:** ca. 1963 **Year Source:** Historic aerials

View facing north

Type: Object	Exterior materials: metal	Primary roof type: N/A	Alterations: Missing elements
Style: No style			
Form: Sign	Porch: N/A

This resource is utilitarian in nature. It was not found to embody distinctive characteristics of a type, period, or method of construction, represent the work of a master, or possess high artistic value. Additionally, no associations were identified linking it to events or persons of historic importance. Furthermore, integrity has been diminished as outlined above. As a result, it is recommended not eligible for listing in the NRHP under Criterion A, B, or C.

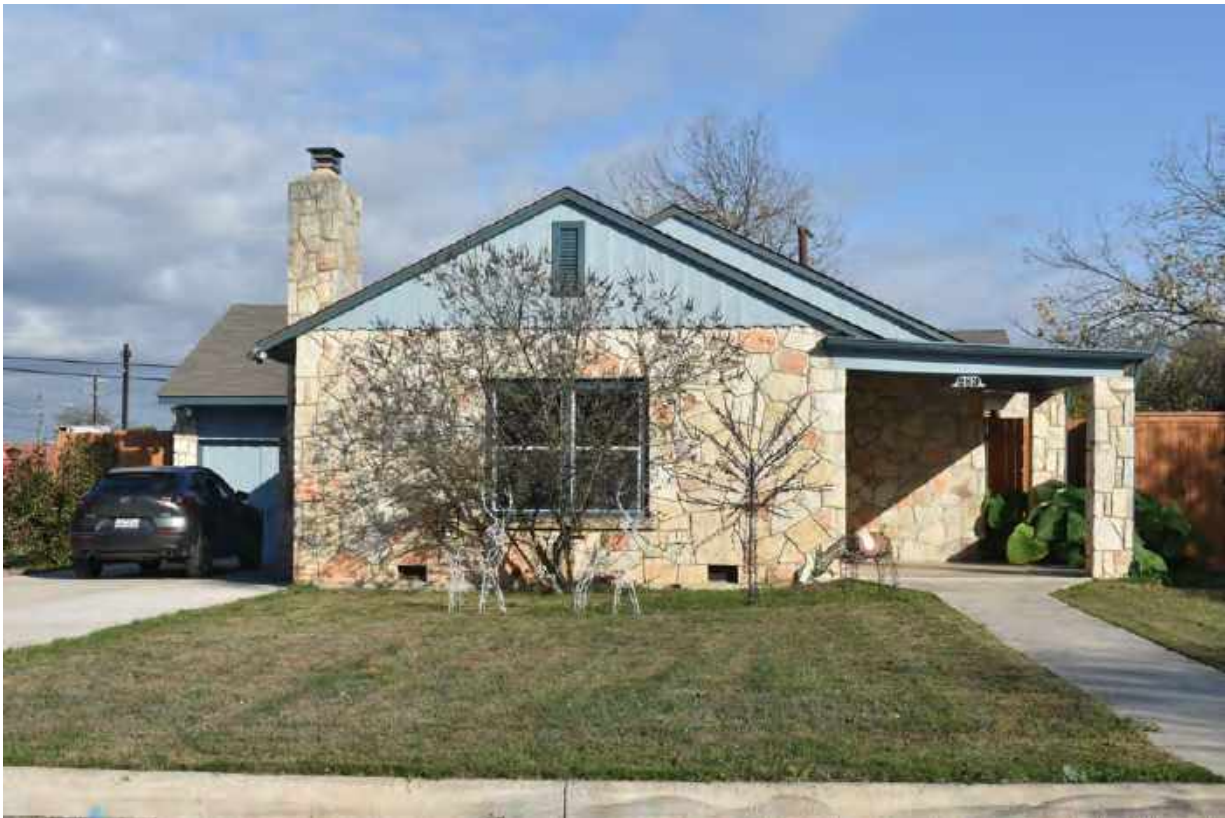
Resource ID: 289A **Parcel ID:** 4312942

Resource A
(Historic-age);
view facing north

Type: Building	Exterior materials: stone wood siding panels	Primary roof type: gable, front	Alterations: Door/entrance enclosed Garage door(s) replaced Rafters covered Window opening(s) infilled Windows replaced – all visible
Style: Minimal Traditional			
Form: Irregular	Porch: partial-width projecting

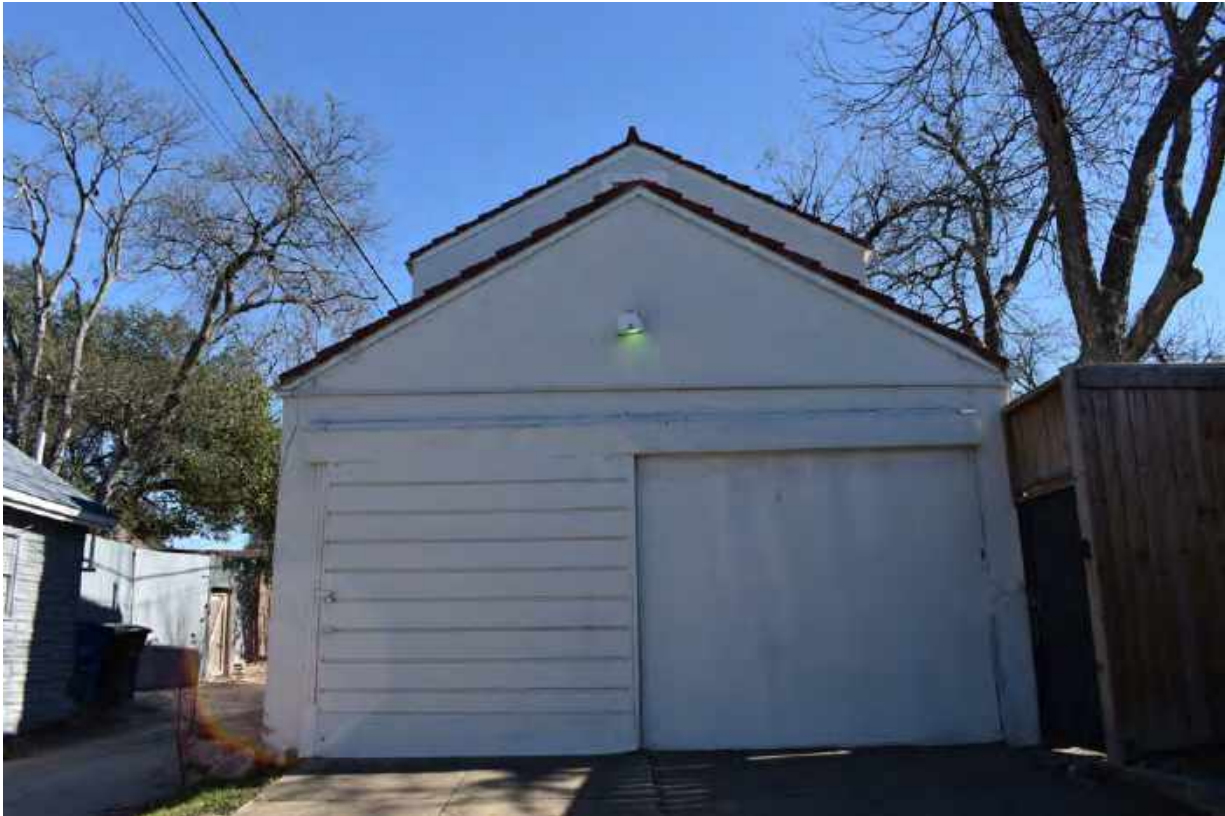
Resource ID: 290B **Parcel ID:** 377521 **Year Built:** 1924 **Year Source:** CAD

View facing east

Alterations:
Garage door(s) replaced
Door (secondary) replaced
Windows replaced – all visible

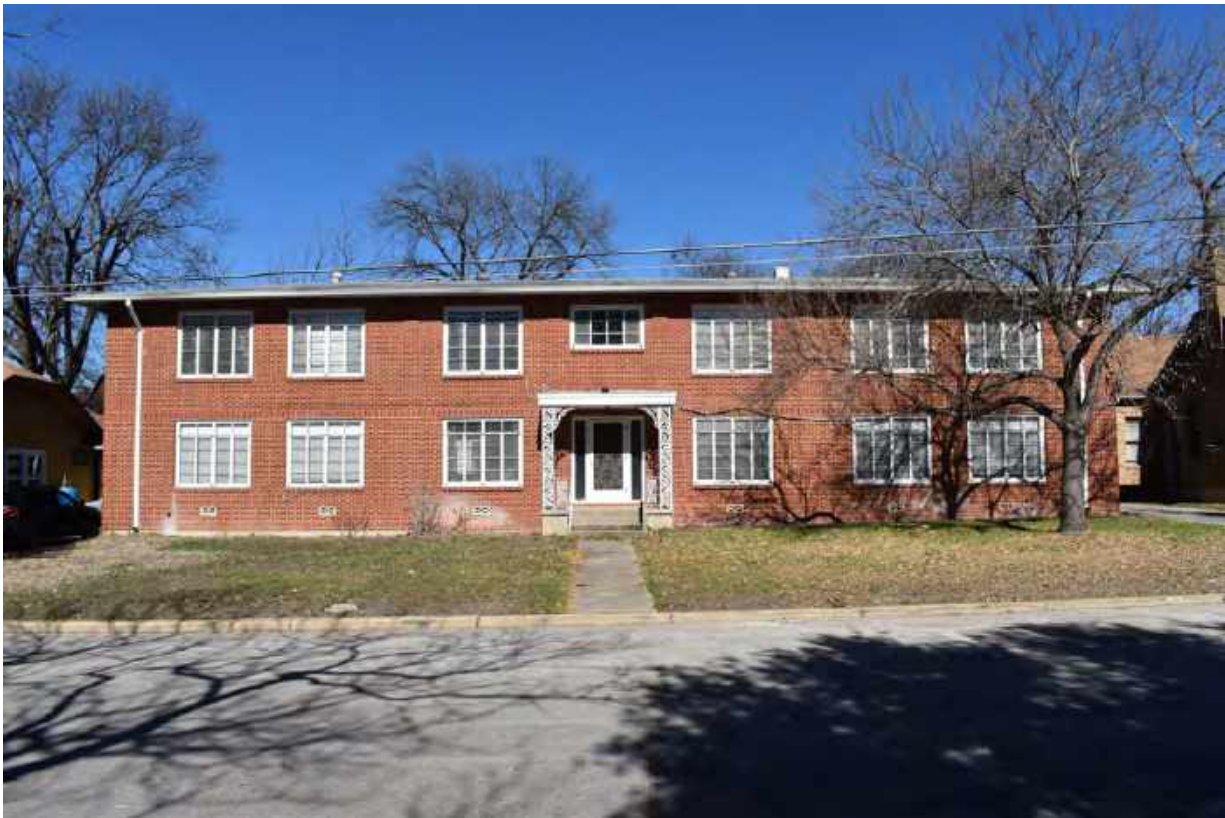
Resource ID: 291A **Parcel ID:** 376889 **Year Built:** 1950 **Year Source:** CAD

View facing north

Alterations:
Windows replaced – some (rear)

This resource does not embody distinctive characteristics of a type, period, or method of construction and it does not represent the work of a master or possess high artistic value. Additionally, no associations were identified linking it to persons or events of historic importance. The replacement of some windows on the north elevation have hindered the integrity of materials. As a result, it is recommended not eligible for listing in the NRHP under Criterion A, B, or C. However, it is a recommended a contributing resource to the recommended eligible Alta Vista Historic District, as it is representative of a multi-family residence from within the period of significance and retains sufficient integrity.

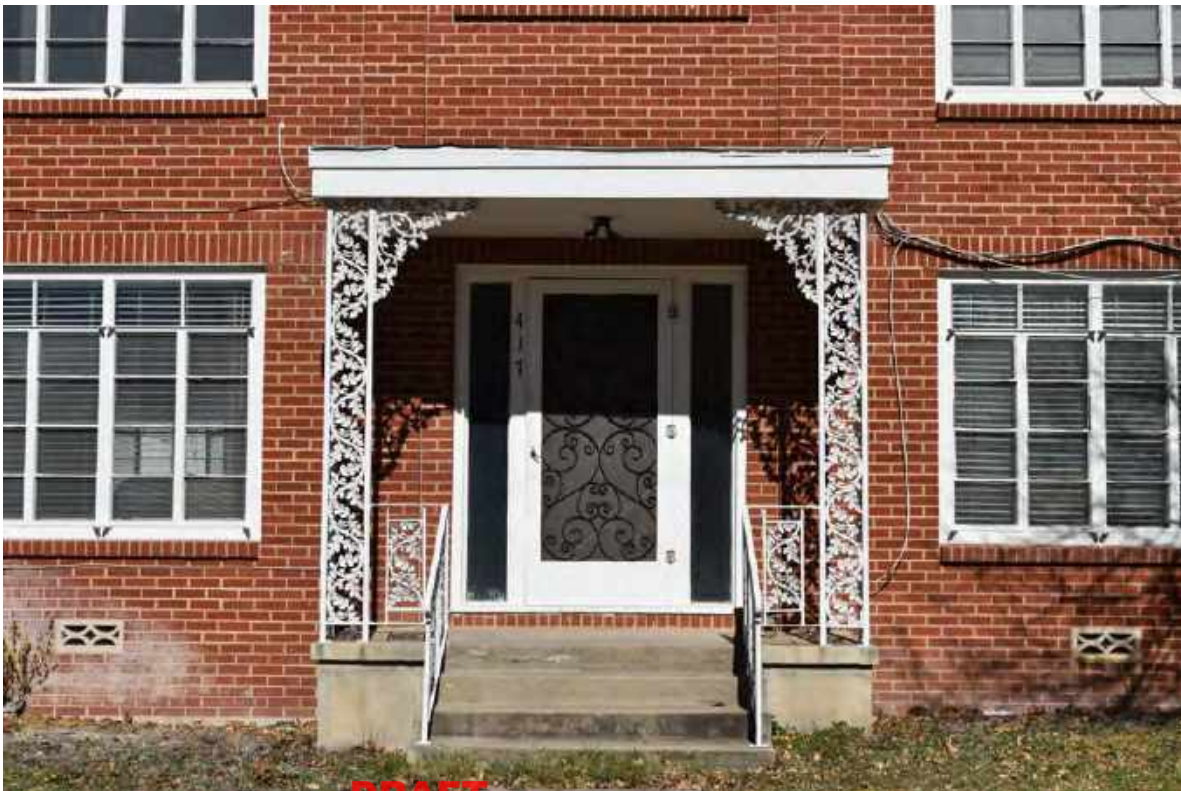
Entrance detail; view facing north

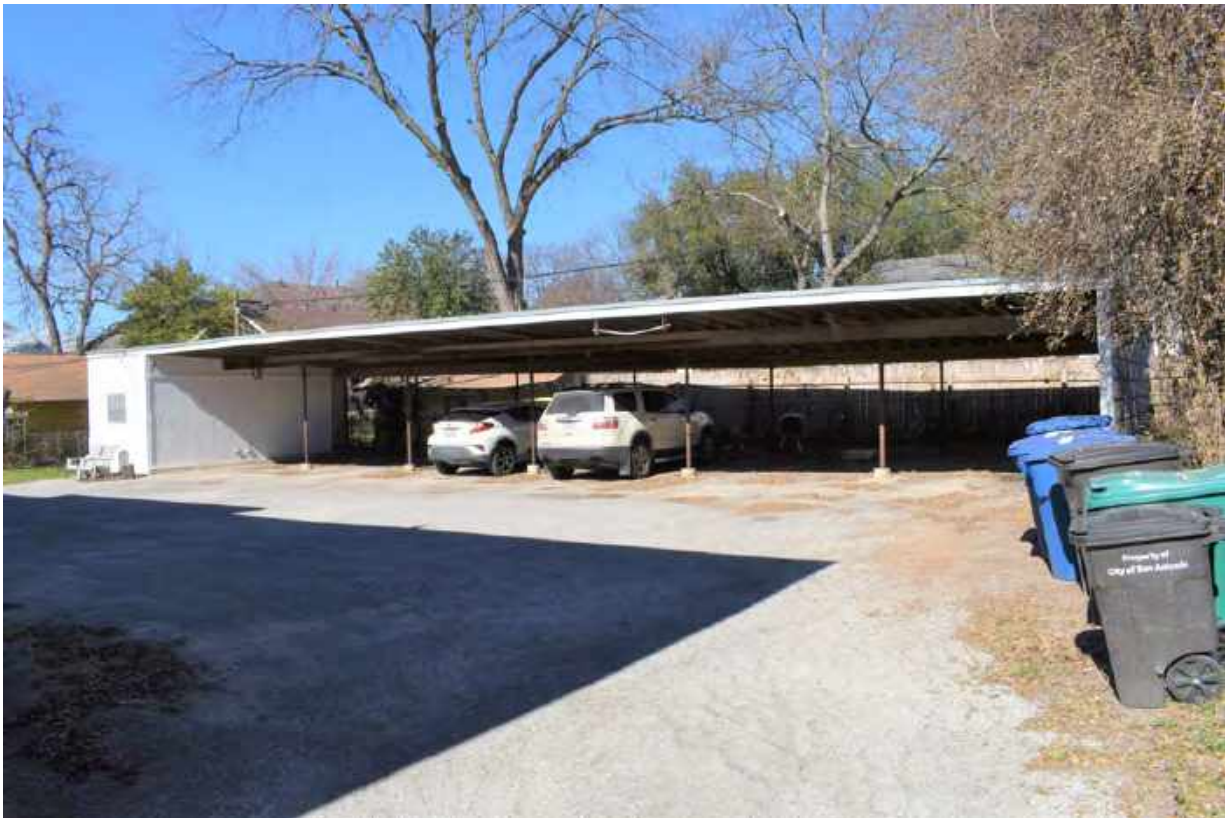
View facing northwest

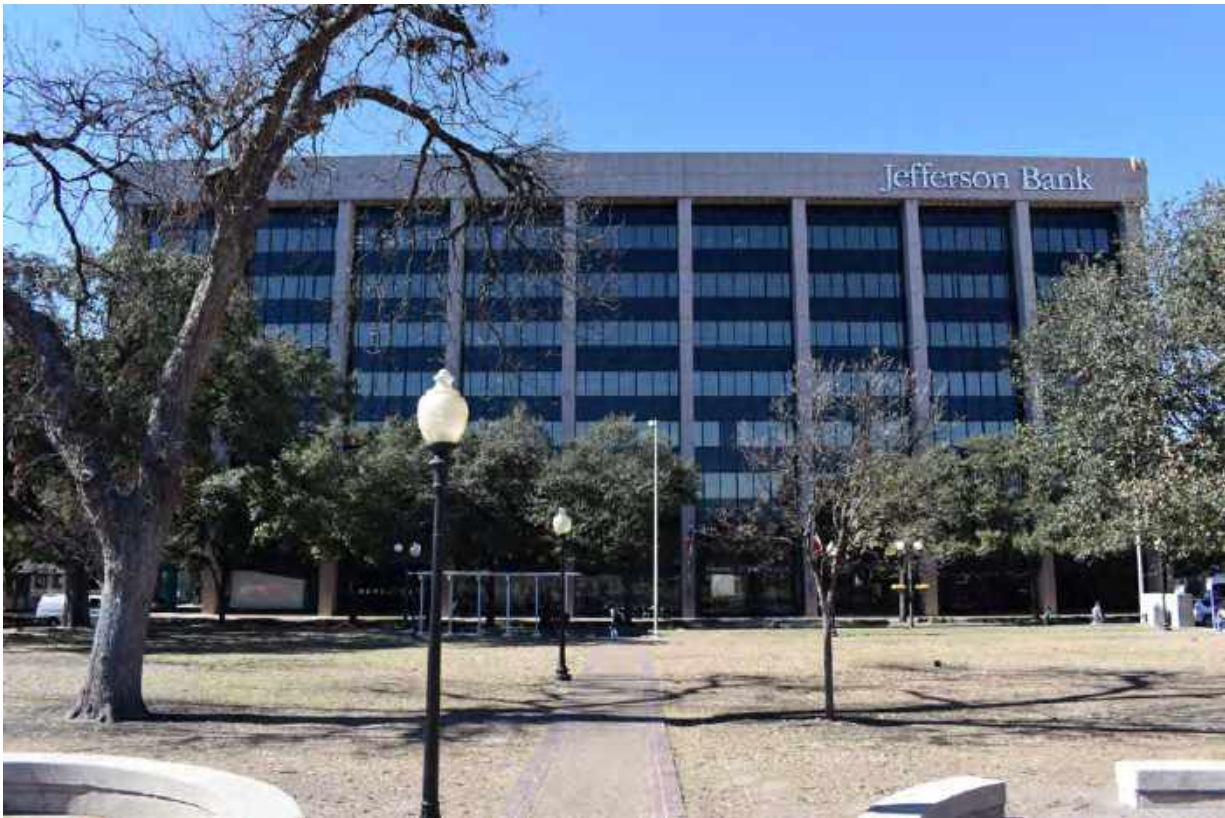
Resource A
(Historic-age);
view facing west

Travis Park Plaza is a seven story building home to Jefferson Bank, Hopscotch Gallery, and a number of other businesses. Built in 1970 as Travis Park West, the New Formalist building was designed by architect Harwood K. Smith (1913-2002) (San Antonio Express 1970; The Dallas Morning News 2002). The design incorporates pink granite mined from Burnet County and bronze cermaic glass, and includes an underground passageway to the attached parking garage to the west (San Antonio Express 1970). The building's original tenants included First National Bank and San Antonio Loan & Trust Company. Jefferson Bank currently occupies the majority of the building, and manages a drive-through on its west elevation. The complex includes the historic-age building and attached parking garage, joined by a banking drive-through (Resource A), a nonhistoric standalone sign for Jefferson Bank (Resource B), and two nonhistoric granite benches on the west

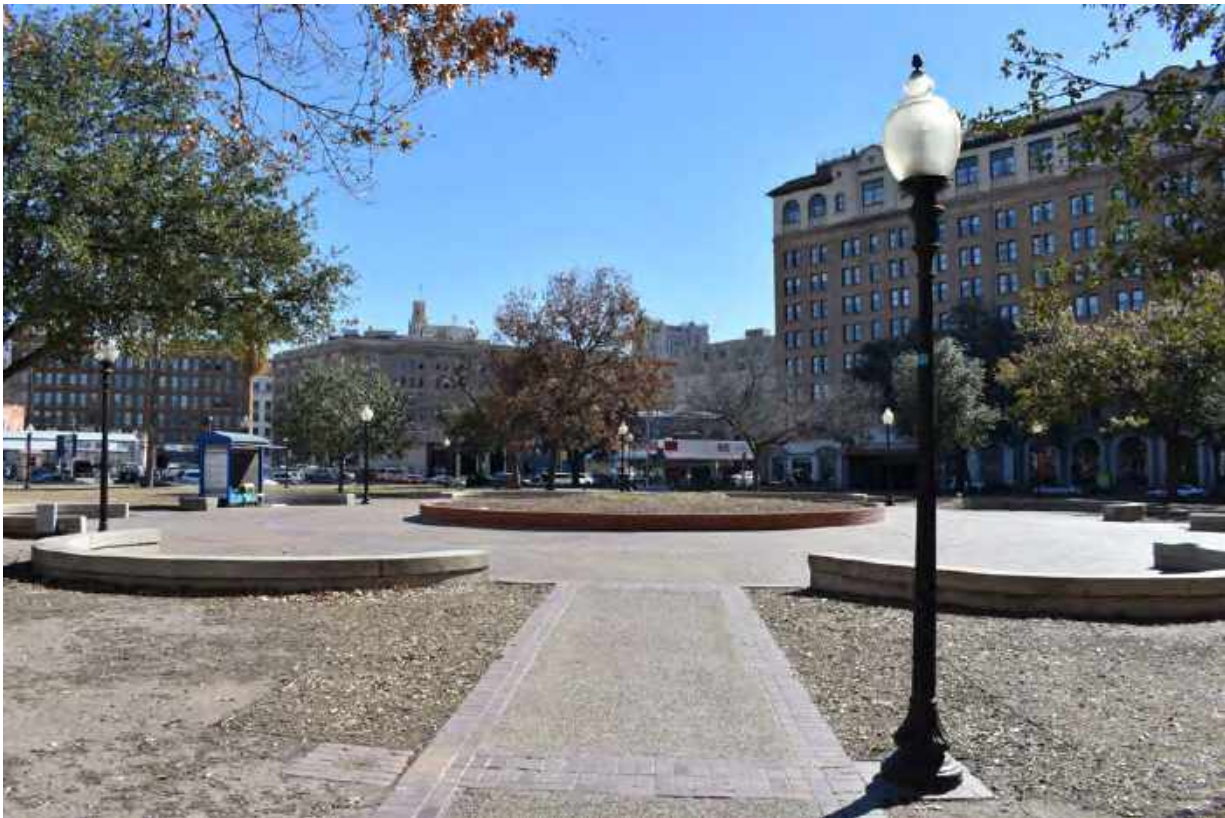
Resource A
(Historic-age);
view facing
southeast

The park has experienced design changes with its restoration in 1993 and Confederate monument removal in 2017. These changes inhibit the park from being recommended individually eligible for the NRHP. Despite its alterations, the park remains significant for its association with the development of San Antonio. The park is a contributing resource to the San Antonio Downtown and River Walk NRHP Historic District. The property retains sufficient historic and physical integrity and its contributing status is affirmed.

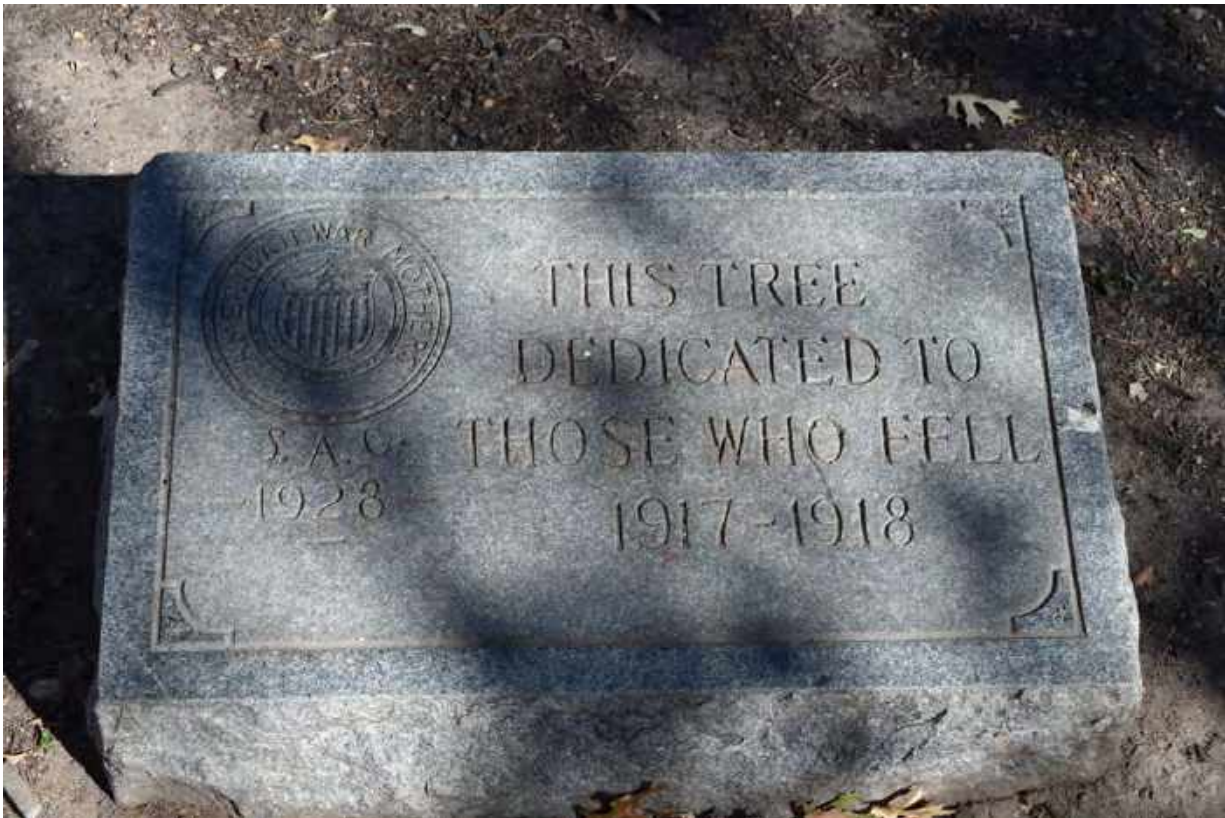
View facing northeast

This resource does not embody distinctive characteristics of a type, period, or method of construction and it does not represent the work of a master or possess high artistic value. Additionally, no associations were identified linking it to persons or events of historic importance. As a result, it is recommended not eligible for listing in the NRHP under Criterion A, B, or C. Although not individually eligible, the monument is affirmed as a contributing resource to the Travis Park property, which is a contributing resource to the San Antonio Downtown and River Walk NRHP Historic District.

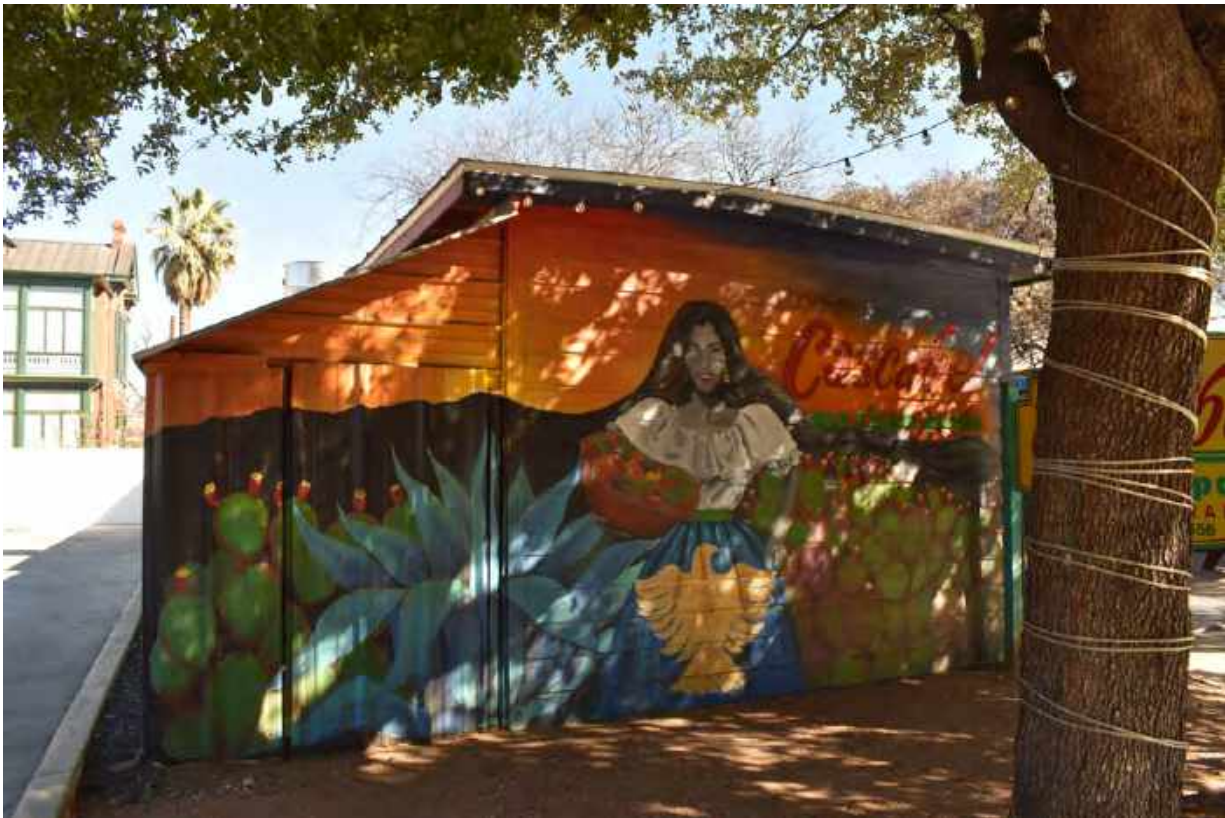
Resource A
(Historic-age);
view facing east

Type: Building	Exterior materials: wood siding panels metal	Primary roof type: shed	Alterations: Addition to primary/side elevation Wall cladding replaced - some
Style: No style			
Form: Irregular	Porch: partial-width integrated

This resource does not embody distinctive characteristics of a type, period, or method of construction and it does not represent the work of a master or possess high artistic value. Additionally, no associations were identified linking it to persons or events of historic importance. Design integrity has been compromised by a primary addition and wall cladding has been replaced in some areas. As a result, it is recommended not eligible for listing in the NRHP under Criterion A, B, or C. This resource is located along the commercial corridor along S. St. Mary's-Presa Streets. This resource is recommended as a noncontributing resource within a potentially expanded South Alamo Street-South Saint Mary's Street NRHP Historic District.
