APPENDIX C SURVEY FORMS (CONTINUED)

DRAFT
(Information is under FTA review and is subject to change.)

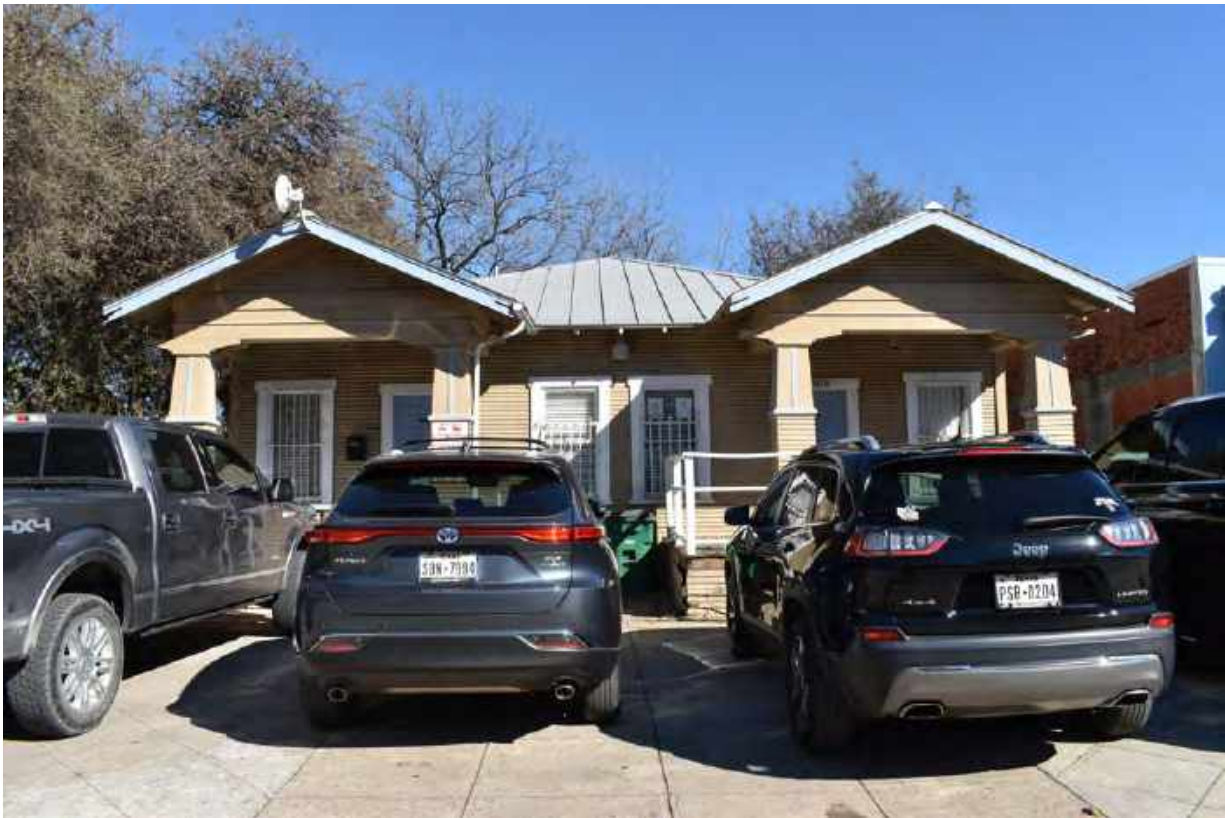
Resource A
(Historic-age);
view facing
northeast

Type: Building	Exterior materials: wood siding	Primary roof type: hipped	Alterations: Doors replaced Ramp added
Style: Craftsman			
Form: Bungalow	Porch: partial-width projecting

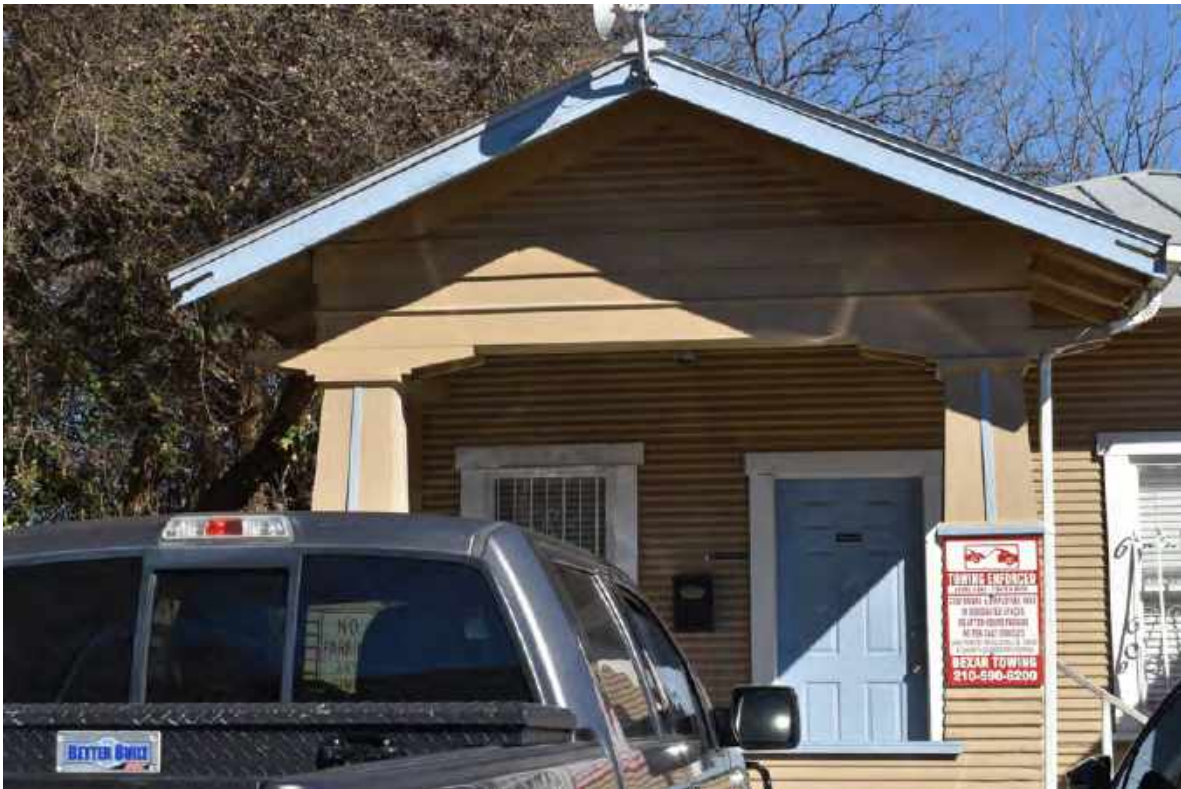
Resource A (Historic-age)
entrance detail; view facing
northeast

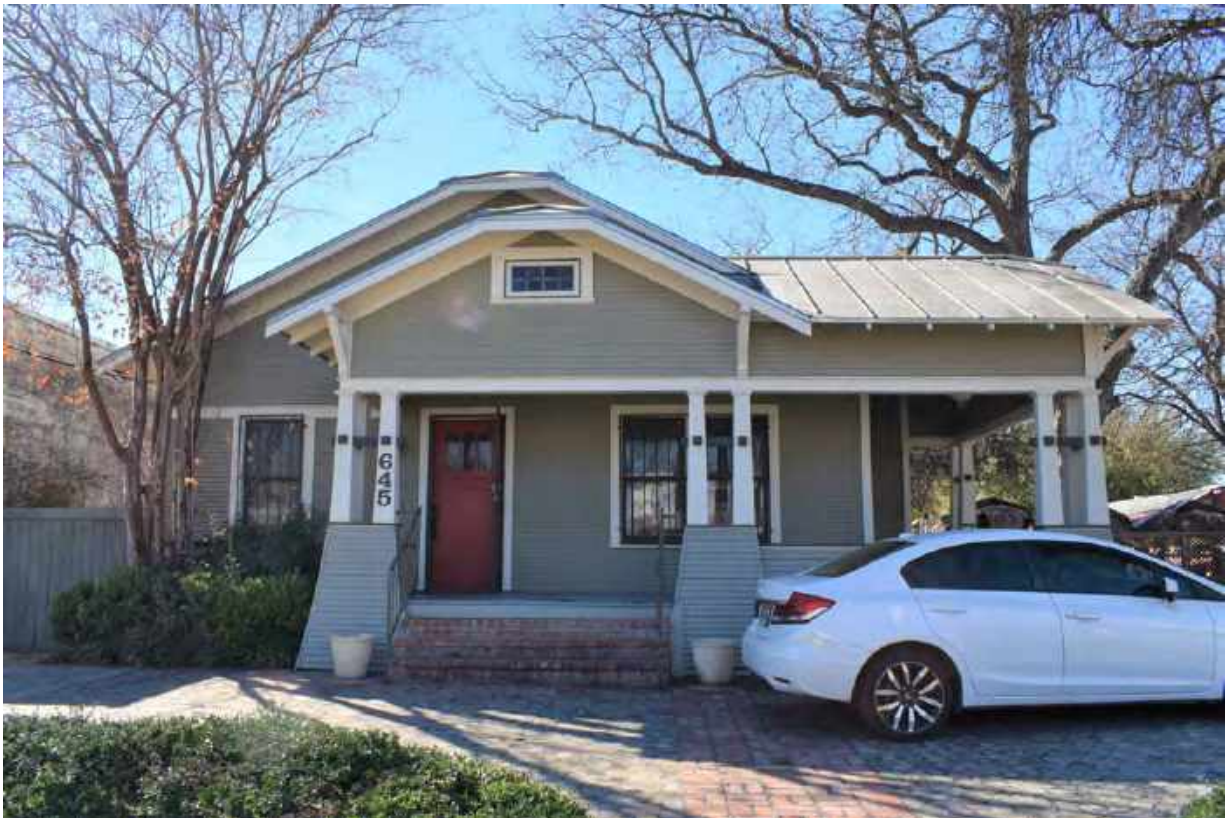
Resource A
(Historic-age);
view facing
southwest

This resource does not embody distinctive characteristics of a type, period, or method of construction and it does not represent the work of a master or possess high artistic value. Additionally, no associations were identified linking it to persons or events of historic importance. Furthermore, integrity has been diminished due to added security bars and surrounding parking lot. As a result, it is recommended not eligible for listing in the NRHP under Criterion A, B, or C. This resource is located along the commercial corridor along S. St. Mary's-Presa Streets. This resource retains enough integrity to be recommended as a contributing resource within a potentially expanded South Alamo Street-South Saint Mary's Street NRHP Historic District.

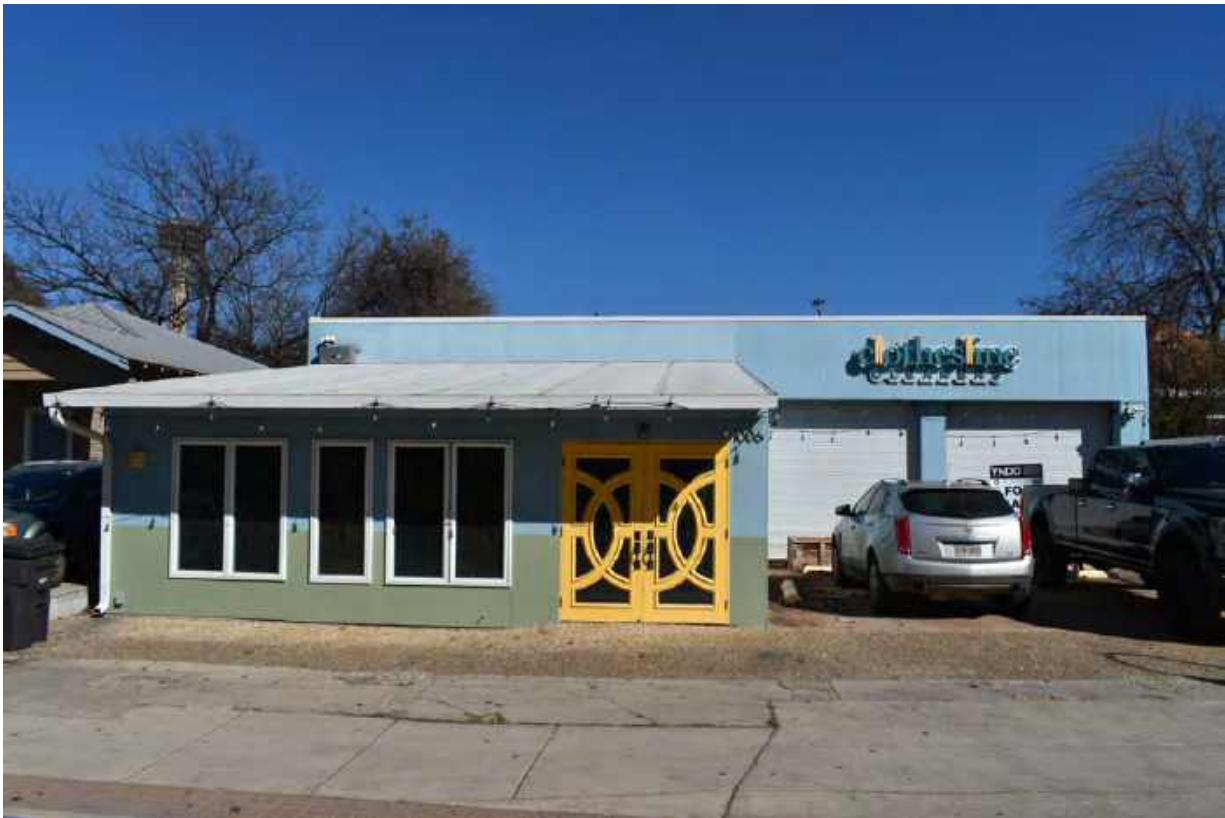
View facing
northeast

Type: Building	Exterior materials: stucco	Primary roof type: flat shed	Alterations: Addition to primary elevation Garage door(s) replaced Porch added (rear) Signage added
Style: No style			
Form: Irregular	Porch: none

This resource does not embody distinctive characteristics of a type, period, or method of construction and it does not represent the work of a master or possess high artistic value. Additionally, no associations were identified linking it to persons or events of historic importance. Furthermore, integrity has been diminished as outlined above. As a result, it is recommended not eligible for listing in the NRHP under Criterion A, B, or C. This resource is located along the commercial corridor along S. St. Mary's-Presa Streets. This resource is recommended as a noncontributing resource within a potentially expanded South Alamo Street-South Saint Mary's Street NRHP Historic District.

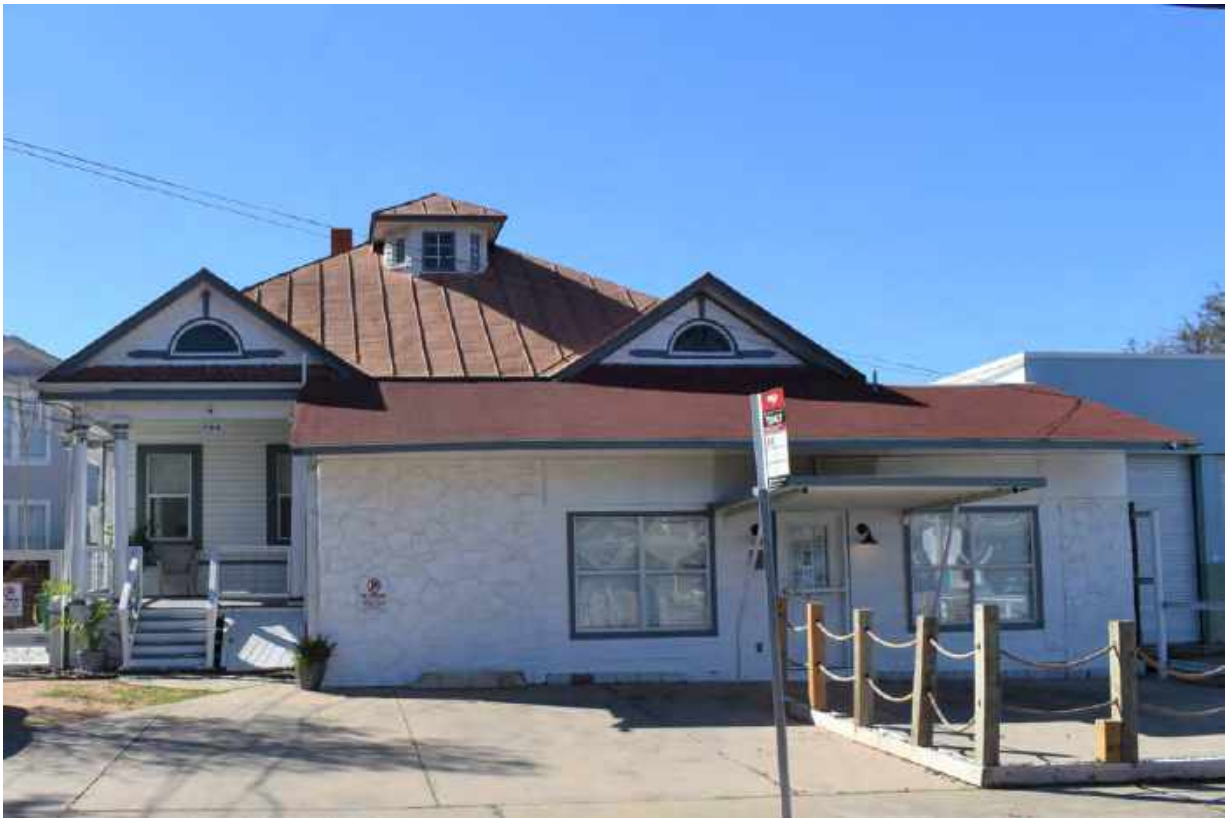
View facing southwest

Type: Building	Exterior materials: wood siding stone	Primary roof type: hipped	Alterations: Addition to primary elevation Addition to rear/side elevation Doors replaced Porch altered Porch enclosed Wall cladding replaced - some Windows replaced – all visible
Style: Queen Anne			
Form: Irregular	Porch: partial-width projecting

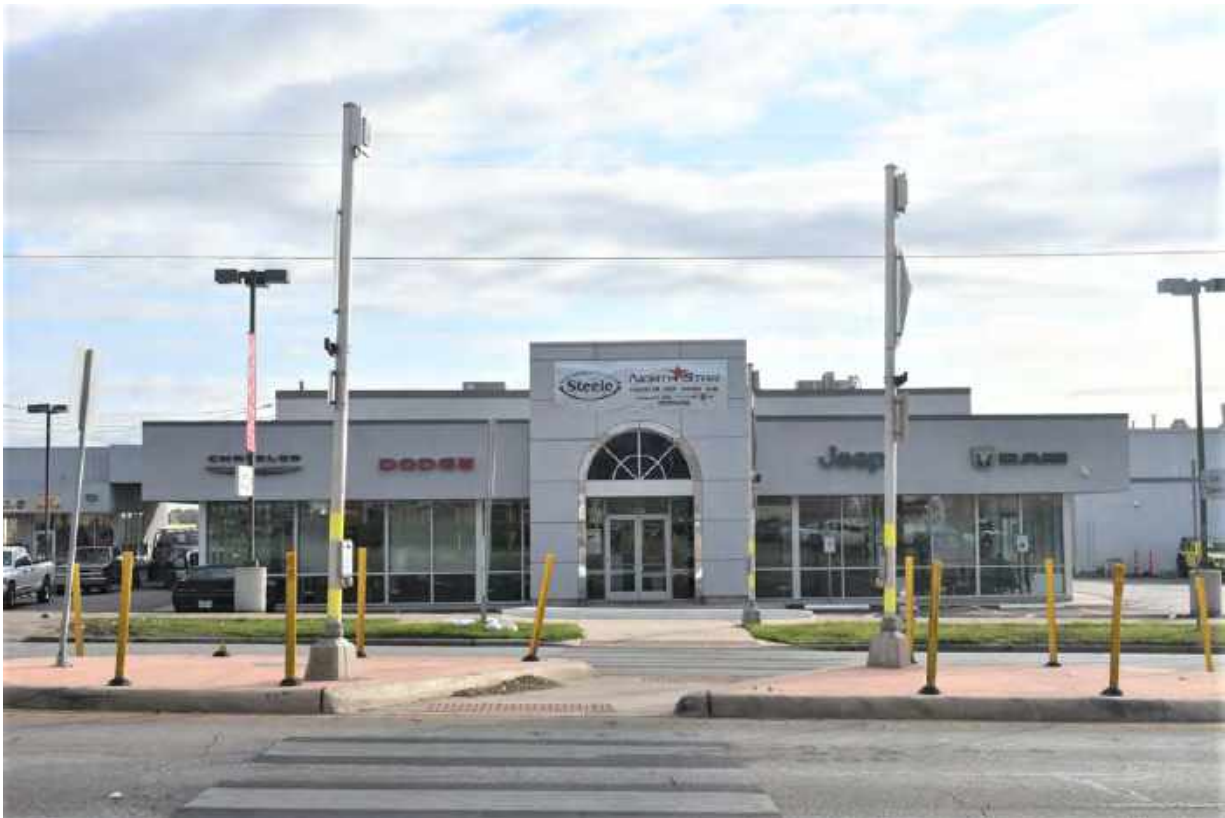
Resource A
(Historic-age);
view facing east

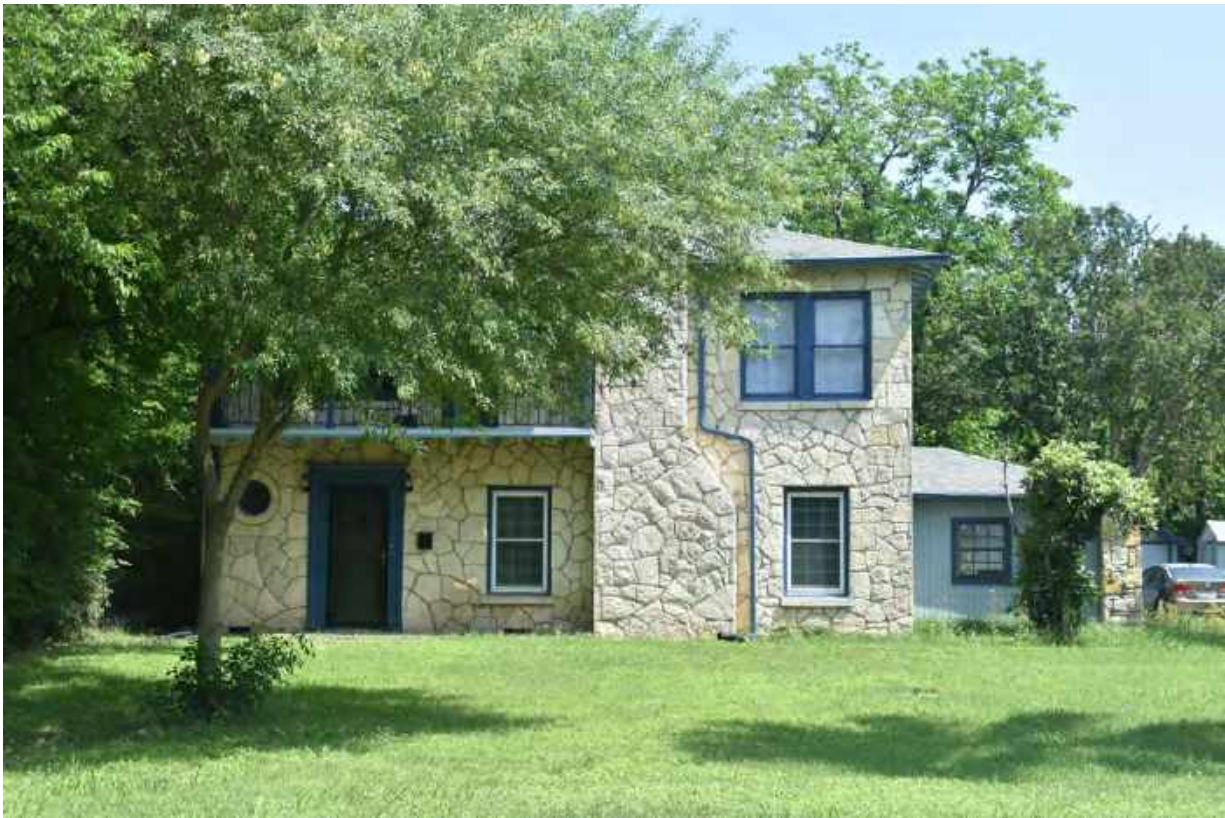
View facing north

Type: Building	Exterior materials: stone wood siding panels	Primary roof type: hipped	Alterations: Porch enclosed Windows replaced – some
Style: Spanish Colonial Revival			
Form: Irregular	Porch: partial-width projecting

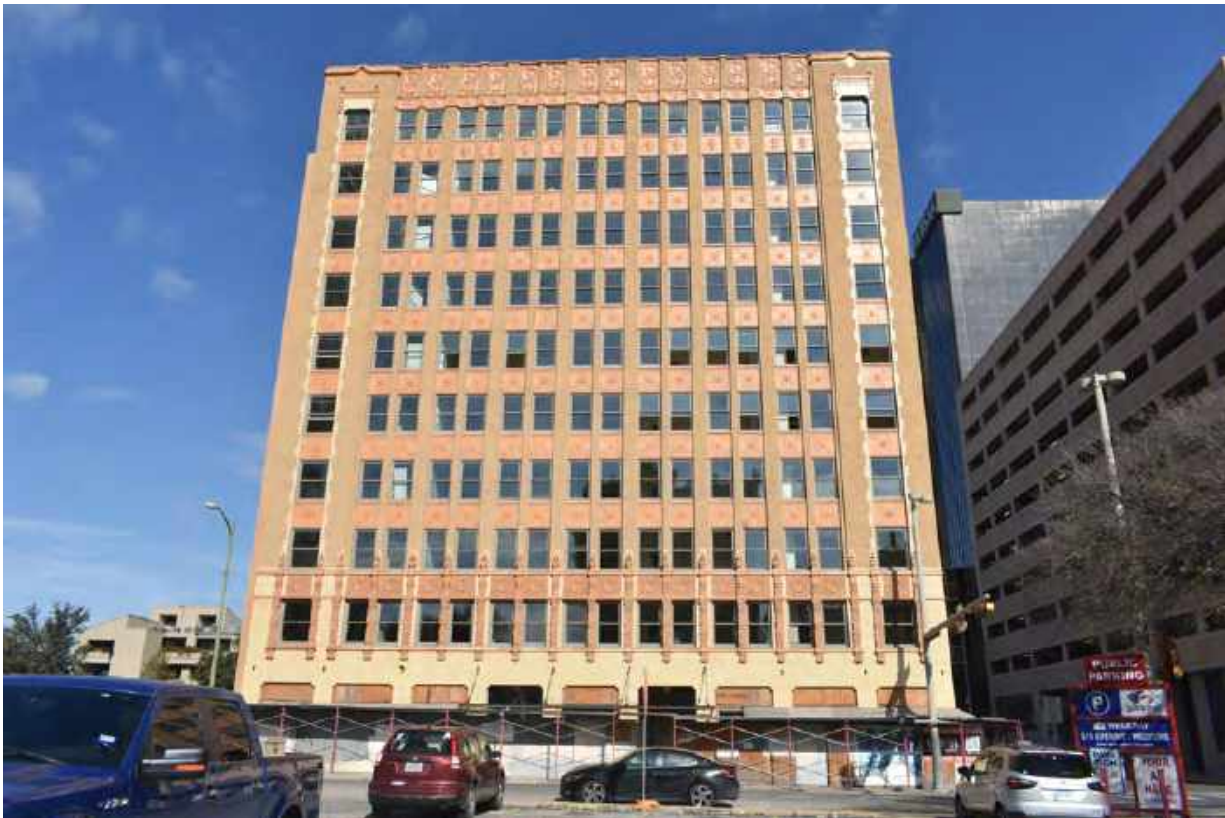
View facing north

Type: Building	Exterior materials: brick stone terra cotta	Primary roof type: flat with parapet	Alterations: Addition to primary/side elevation (west) Window(s) boarded Windows replaced – some Work in progress
Style: Commercial, Spanish Baroque			
Form: Rectangular	Porch: wraparound projecting

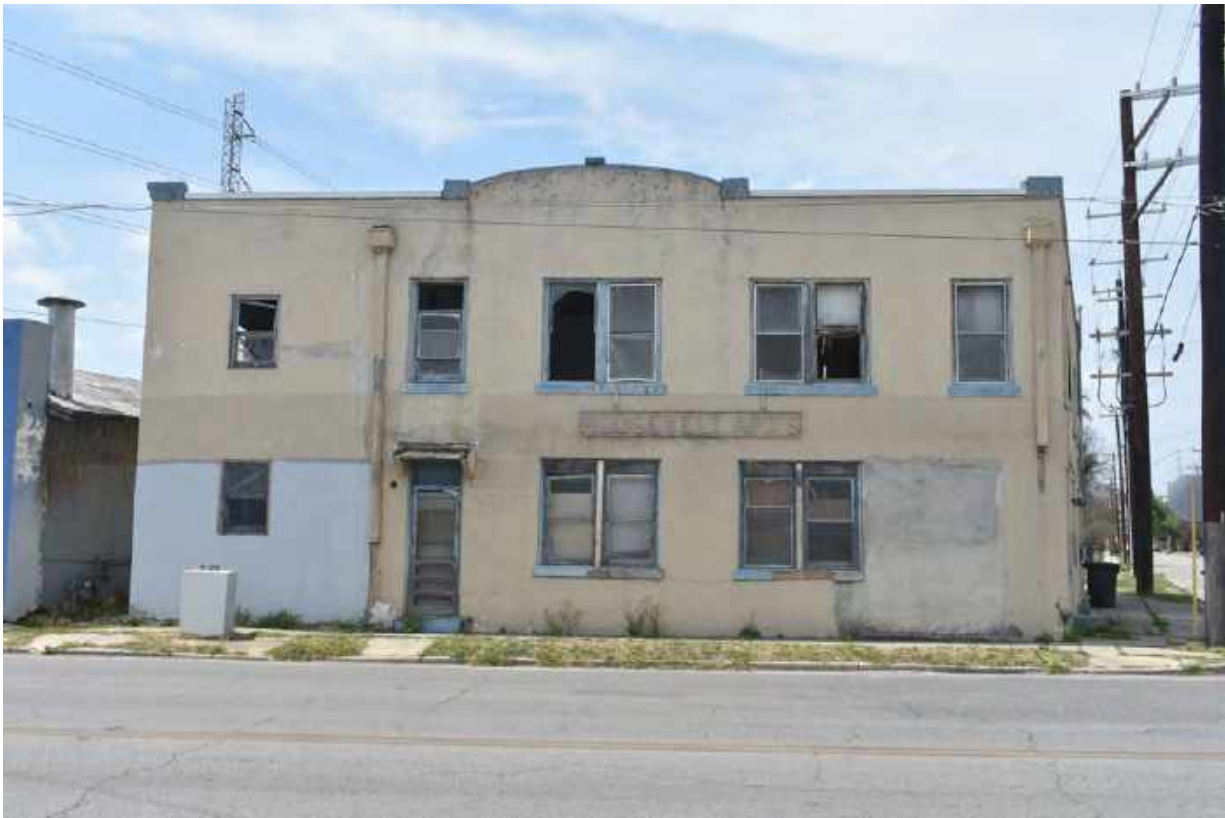
View facing west

Alterations:
Doors replaced
Missing elements
Window opening(s) infilled
Window(s) boarded
Windows replaced – some

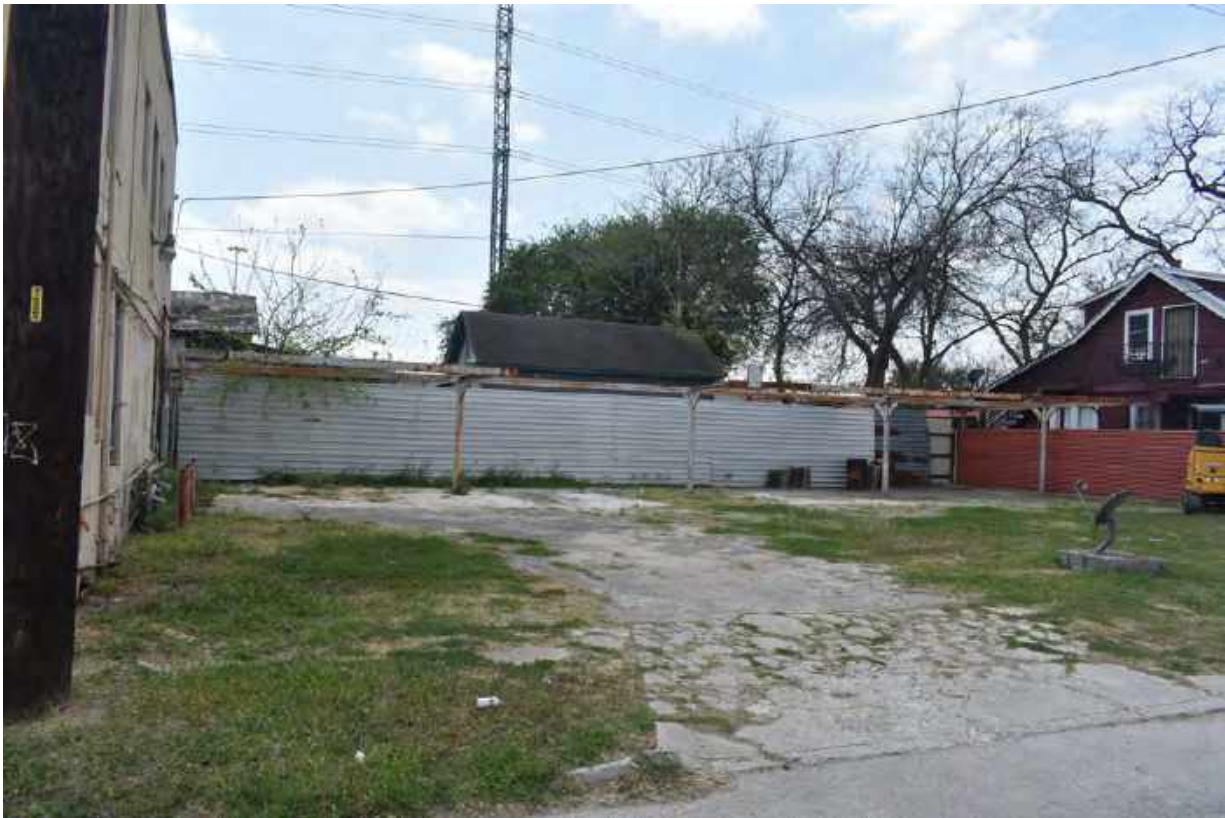
View facing southwest

Type: Structure	Exterior materials: metal	Primary roof type: N/A	Alterations: Missing elements
Style: No style			
Form: Rectangular	Porch: N/A

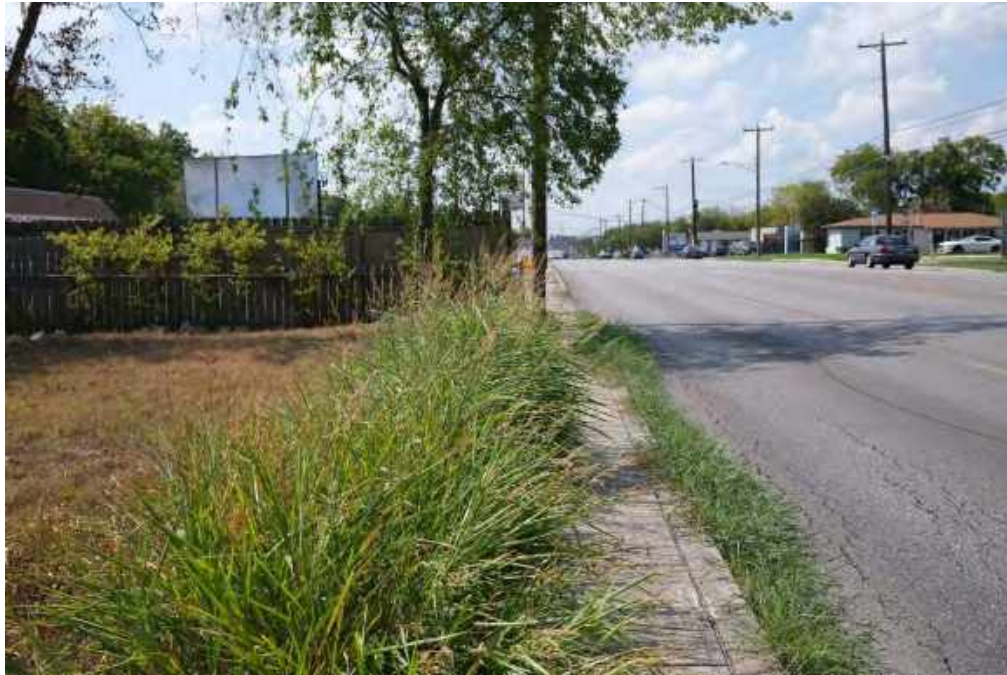
Photograph 1: View from Resource 27 to area of above-ground construction; view facing south.

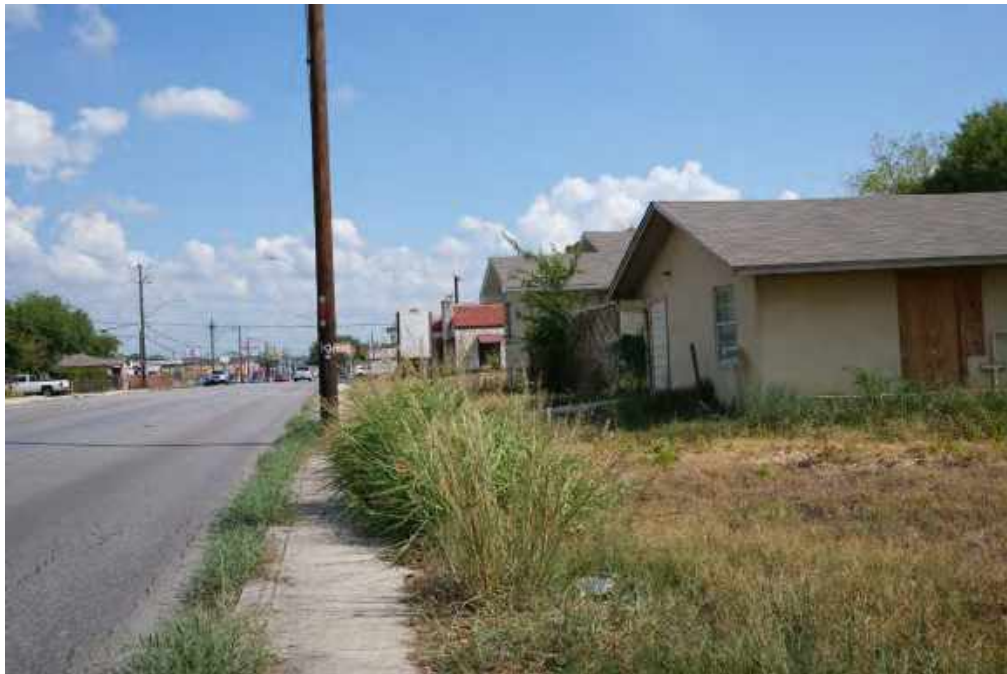
Photograph 2: View from area of above-ground construction to Resource 27: view facing north.

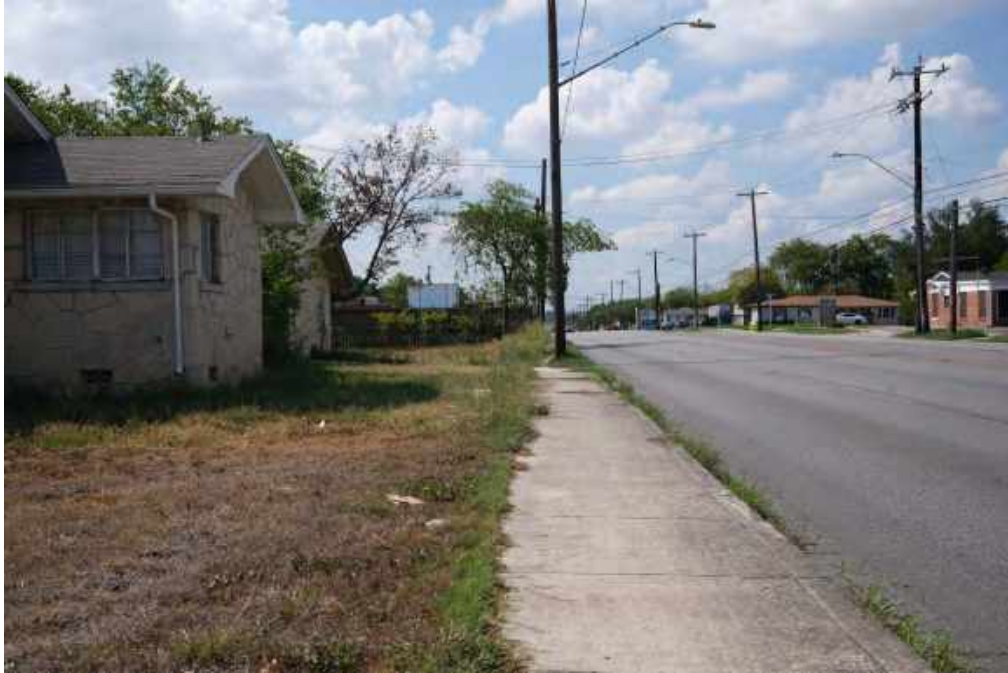
Photograph 3: View encompassing both Resource 27 and area of above-ground construction; view facing south.
