Resource ID: 226A	Parcel ID: 1213123	Year Built: 1889	Year Source: NRHP Nomination Form
Address: 925 S SAINT MARYS ST., SAN ANTONIO, TX		Latitude: 29.414091	County: Bexar
Name: James Butler Bonham Elementary School (Bonham Academy)		Longitude: -98.489459	
Historic Function/Subcategory: Education/School		Indiv. NRHP Eligible? Listed	Effect: No Adverse Effect
Current Function/Subcategory: Education/School		Contributing to NRHP Property/District? Yes

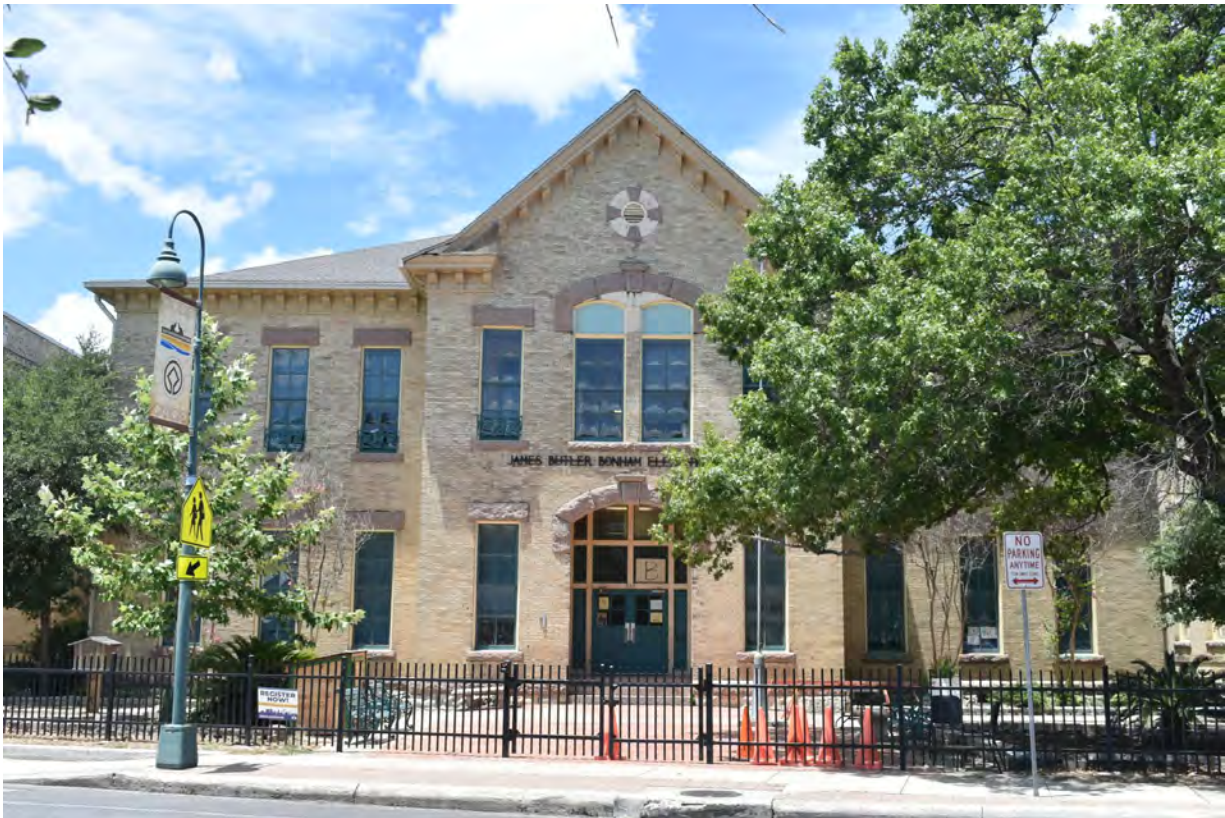
Resource A and nonhistoric Resource B (flagpole, foreground); view facing west.

Type: Building	Exterior materials: brick	Primary roof type: gable-on-hip	Alterations: Rear addition
Style: Victorian			
Form: Rectangular	Porch: stoop integrated

The resource was constructed in 1889 as the James Butler Bonham Elementary School and is individually listed in the NRHP. In addition to this historic-age school building (Resource A), this parcel has three nonhistoric resources (C-E) that are included in this record, and one historic-age flagpole (Resource B) that is described on a separate record.

The resource is individually listed in the NRHP. It is also listed as a contributor to the South Alamo Street-South Saint Mary's Street Historic District. It retains all aspects of integrity. Therefore, its status as an individually listed resource and contributing resource to the South Alamo Street-South Saint Mary's Street Historic District is affirmed.

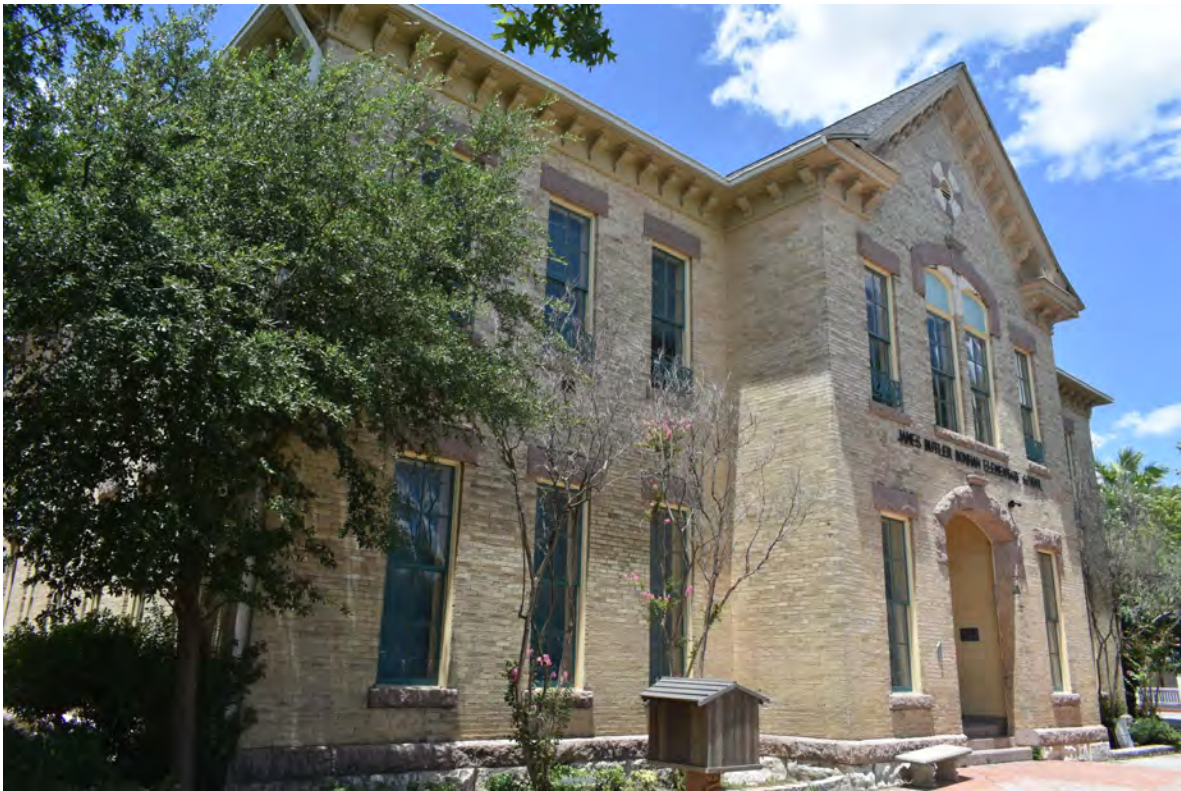
View facing northwest.

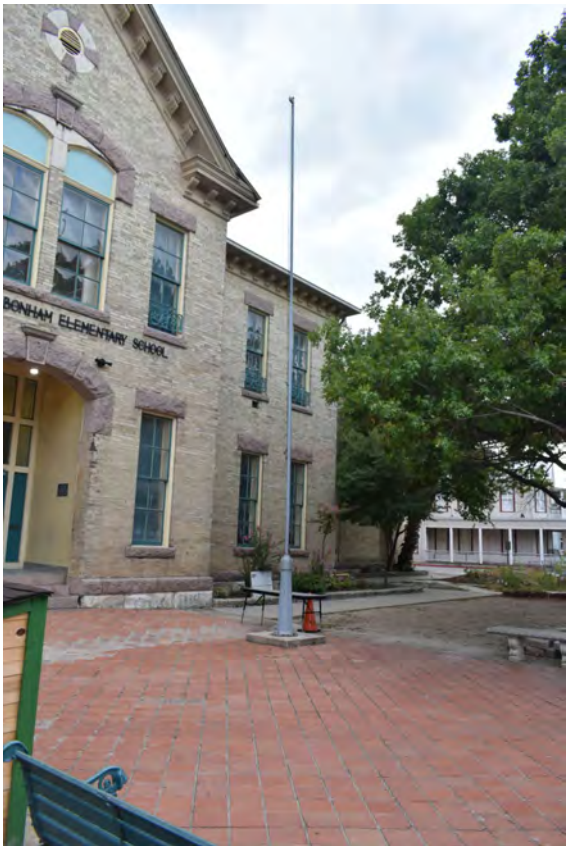
Resource A
(background) and
Resource B
(flagpole,
foreground); view
facing northwest

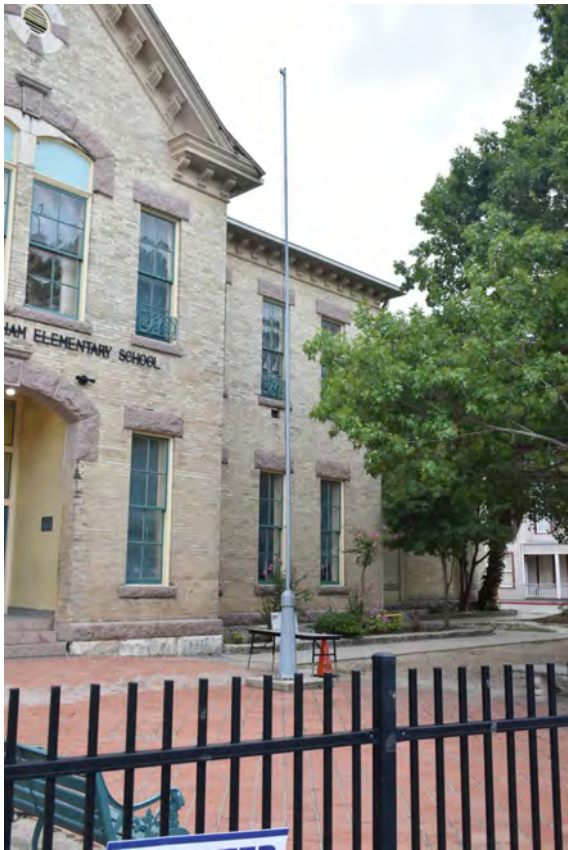
Resource A (background) and
Resource B (flagpole,
foreground); view facing
northwest

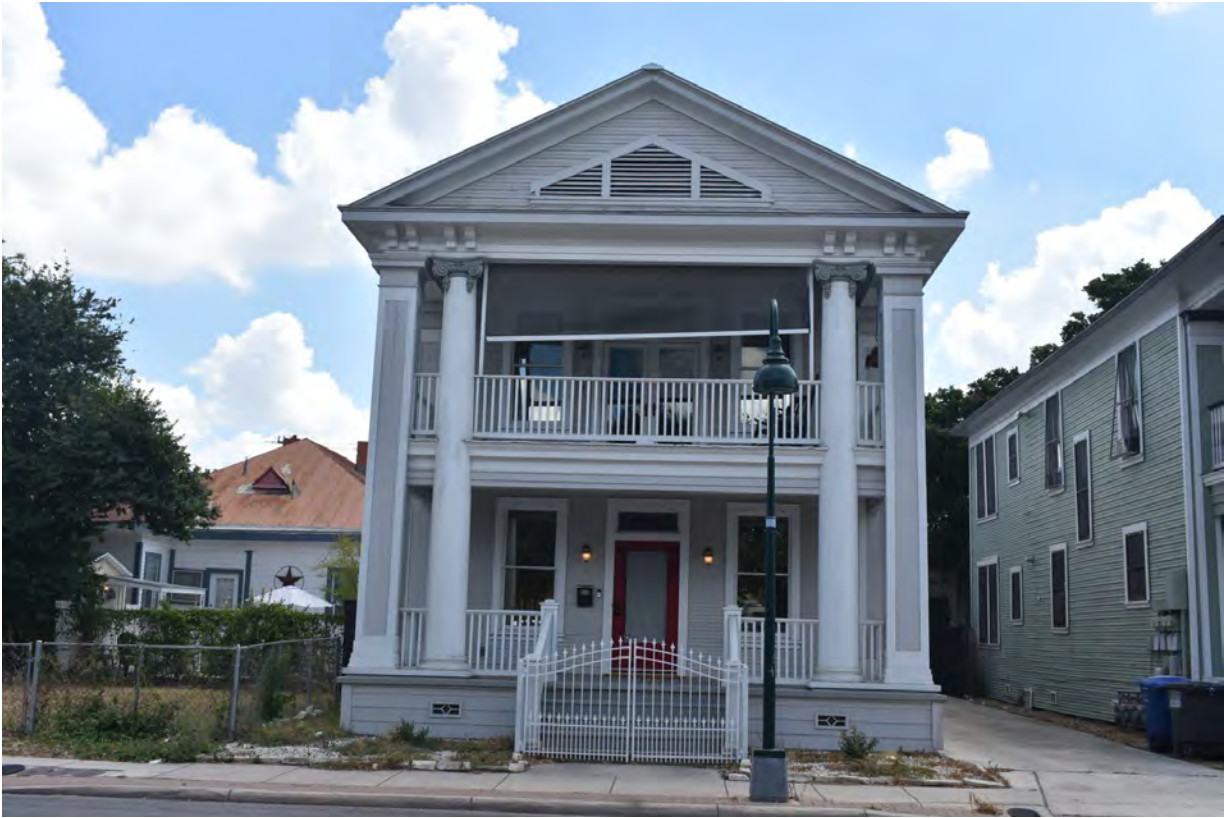
View facing east

Type: Building	Exterior materials: wood siding	Primary roof type: gable, front	Alterations: Doors replaced Porch rails replaced
Style: Neoclassical			
Form: Rectangular	Porch: full-width integrated

This resource does not embody distinctive characteristics of a type, period, or method of construction and it does not represent the work of a master or possess high artistic value. Additionally, no associations were identified linking it to persons or events of historic importance. Material integrity has been diminished by replacement French doors on the second-story porch and added porch railings. Because the building offers neither a local interpretation of a standard design nor an undocumented construction technique, it has limited potential to yield important information. As a result, it is recommended not eligible for the NRHP under Criterion A, B, C, or D. A City of San Antonio Landmark, this resource is located along the commercial corridor along S. St. Mary's-Presa Streets. Although the building has experienced some modifications, the overall design continues to be upheld by its character-defining features. Therefore, this resource is recommended as a contributing resource within a potentially expanded South Alamo Street-South Saint Mary's Street NRHP Historic District.

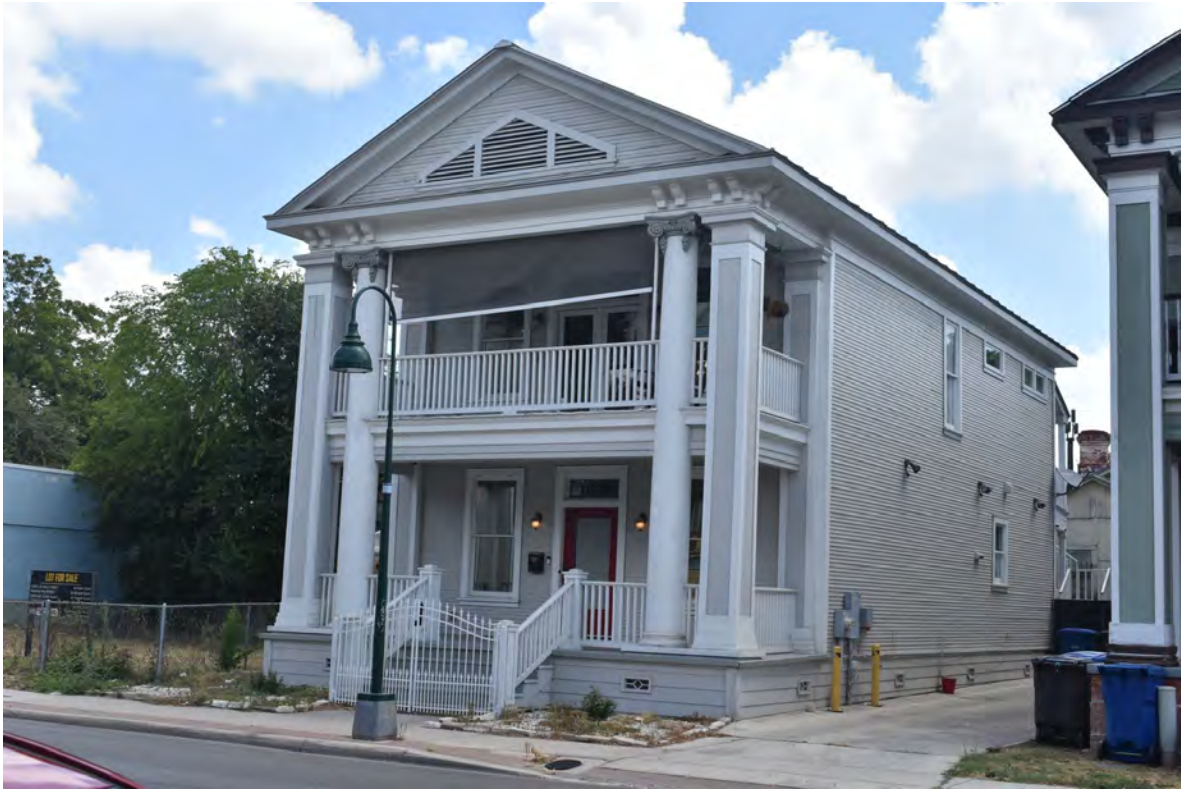
View facing northeast

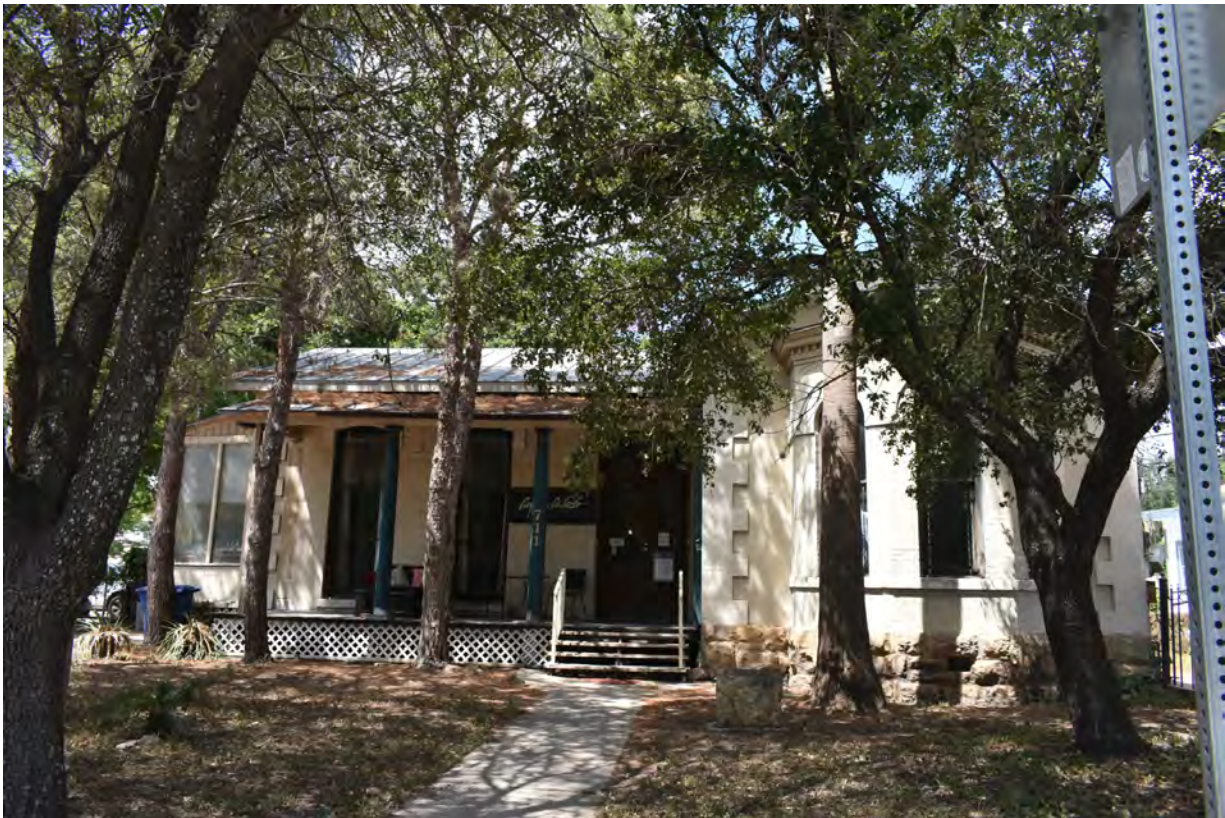
View facing west

Type: Building	Exterior materials: brick	Primary roof type: gable, crossed	Alterations: Addition to rear/side elevation
Style: Italianate	stone	shed	Porch added
Form: Modified L-plan	Porch: partial-width set within ell		Porch altered
			Porch support(s) replaced
			Signage added
			Exterior staircase added

Jeweler Alexander L. Sartor (1855-1915) and his family resided at this ca. 1890 house from 1900 to at least 1910. Sartor previously lived at the Sartor House at 217 King William Street designed by Alfred Giles from 1881 to ca. 1900. Sartor became successful from the family jewelry and watch repair business established by his German-born father also named Alexander in 1845 (Freie Presse Fur Texas 1904). The building changed uses during the 1970s, becoming Howell Hydrocarbons in 1974 (San Antonio Express 1974). Since becoming a commercial space, the building has been used for various salons. The property includes a nonhistoric sign (Resource B) on the front lawn. A photograph of the sign is included in this record.

This resource is located along the commercial corridor along S. St. Mary's-Presa Streets. Although modified, this resource is notable for its association with Alexander L. Sartor. Therefore, this resource is recommended as a contributing resource within a potentially expanded South Alamo Street-South Saint Mary's Street NRHP Historic District.

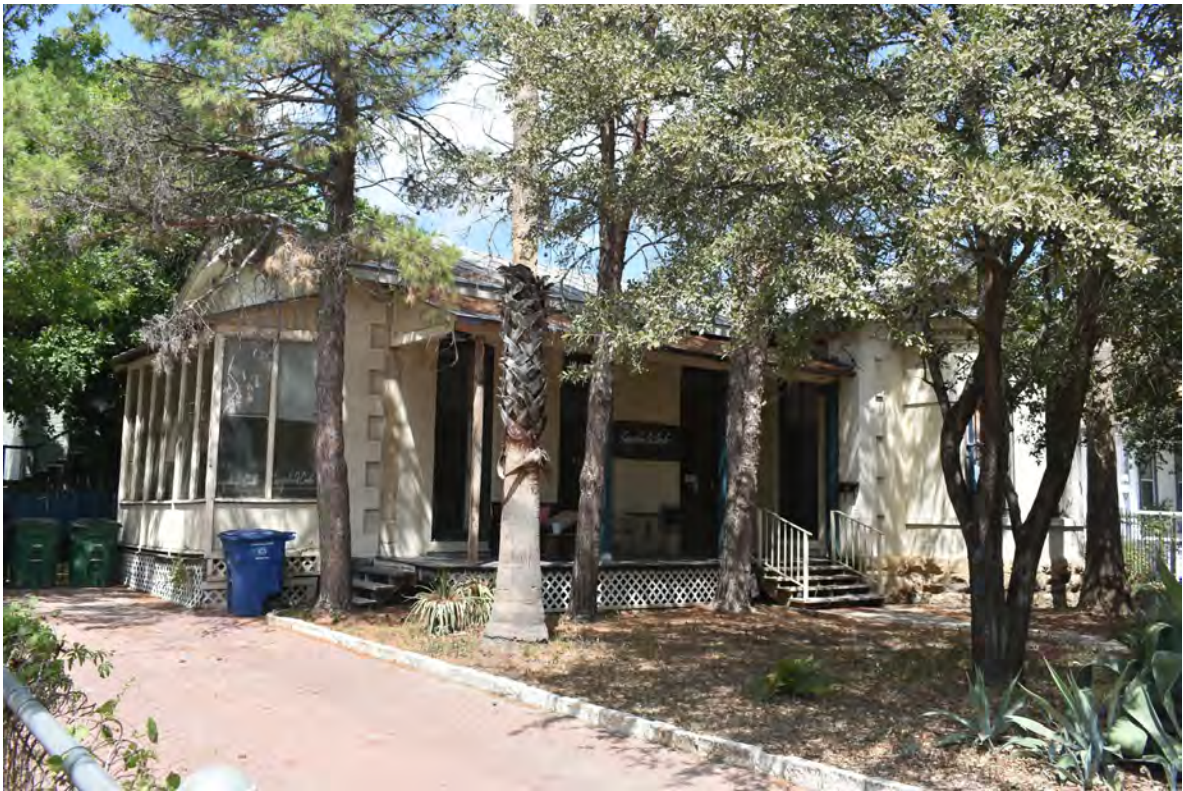
View facing northwest

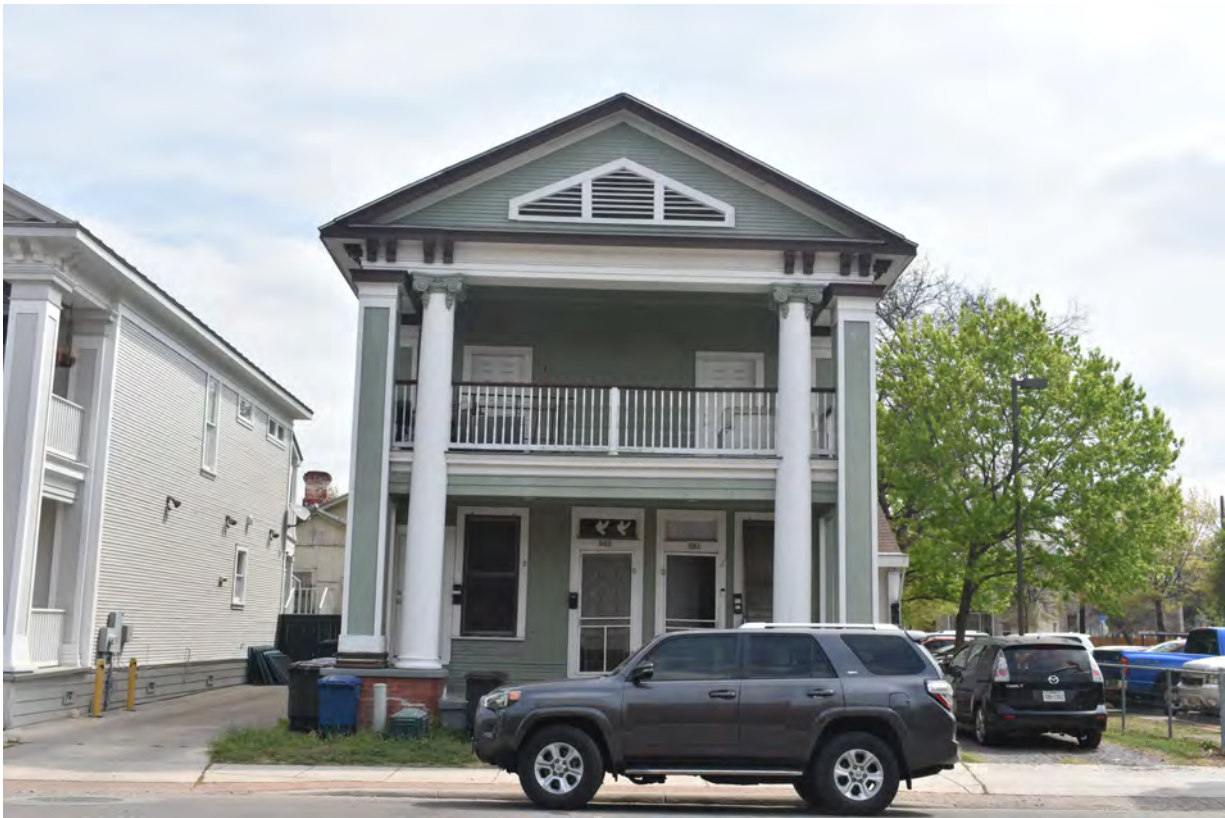
View facing east.

Type: Building	Exterior materials: wood siding	Primary roof type: gable, front	Alterations: Door/entrance added Exterior staircase added Doors replaced Windows replaced – some Addition to primary/side elevation
Style: Neoclassical			
Form: Rectangular	Porch: full-width integrated

This resource is located along the commercial corridor along S. St. Mary's-Presa Streets. This resource is recommended as a contributing resource within a potentially expanded South Alamo Street-South Saint Mary's Street NRHP Historic District.

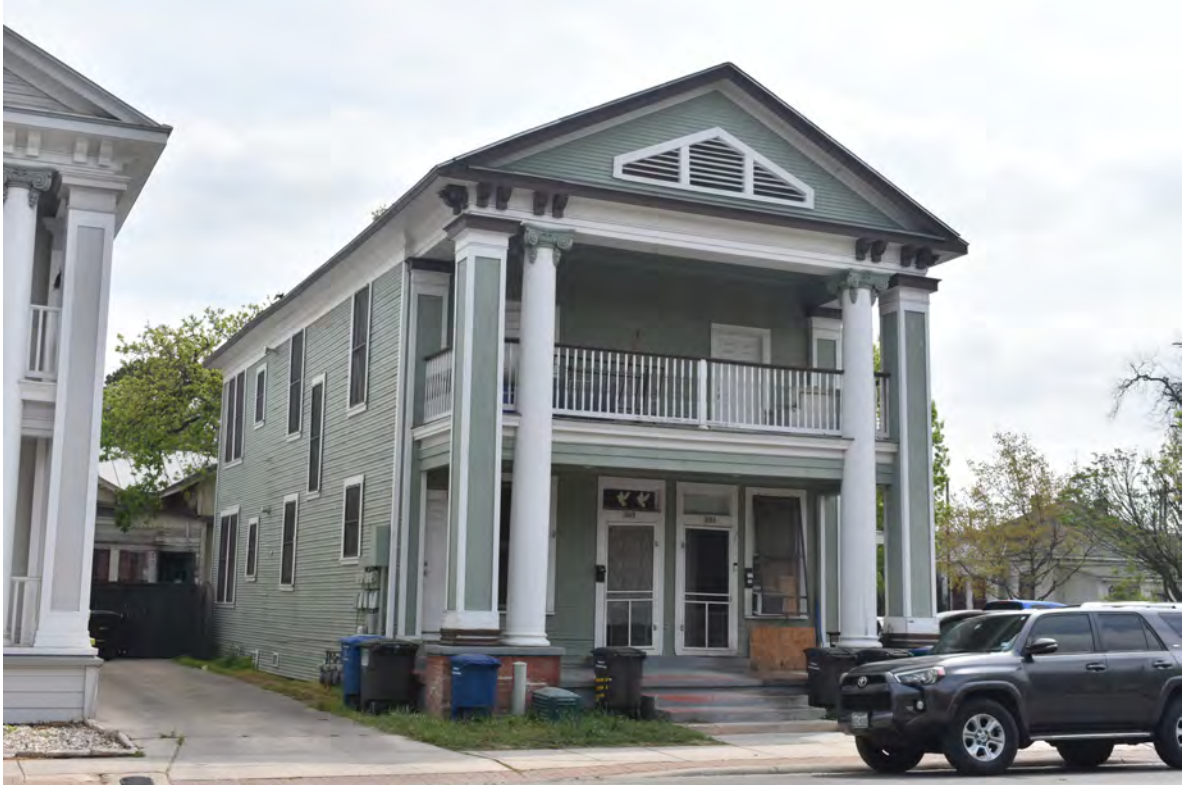
View facing southeast.

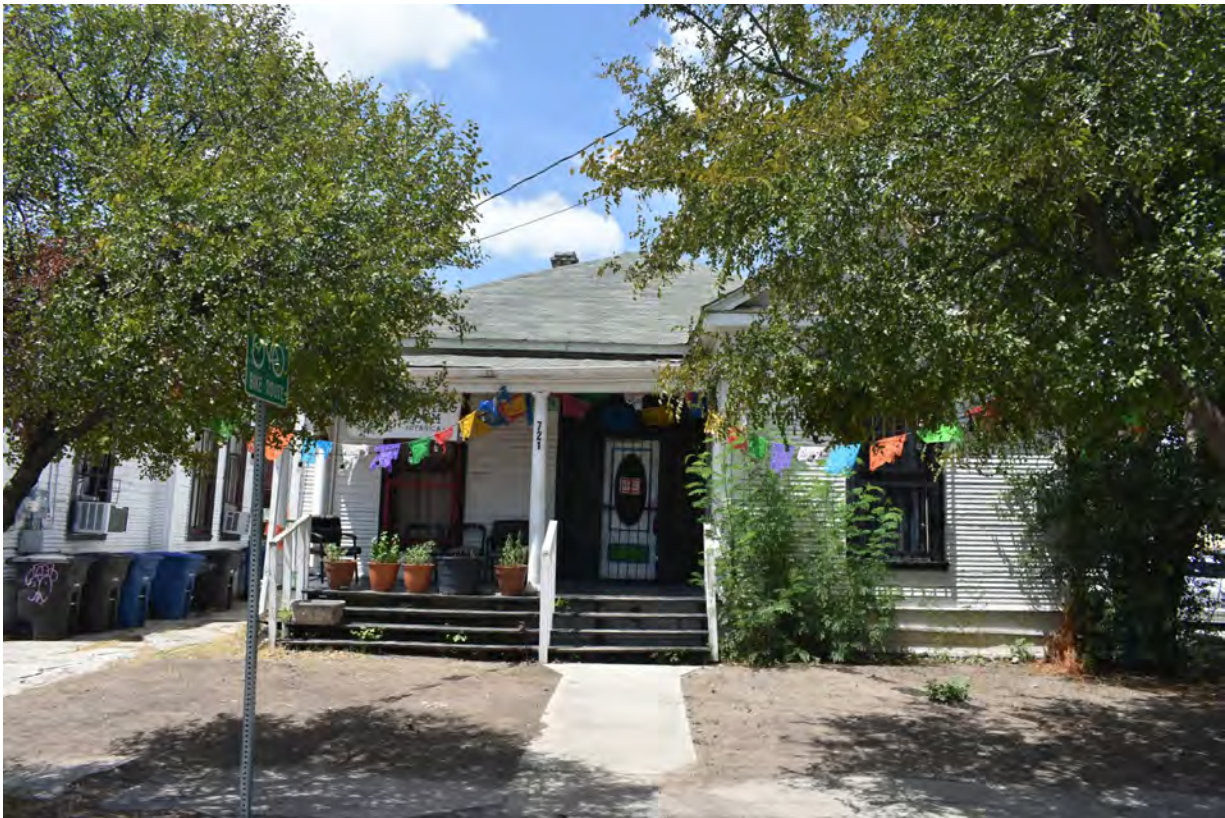
View facing west.

Alterations:
Door (primary) replaced
Stairs replaced
Skirting added

This building does not embody distinctive characteristics of a type, period, or method of construction and it does not represent the work of a master or possess high artistic value. Additionally, no associations were identified linking it to persons or events of historic importance. Furthermore, materials and workmanship integrity have been diminished due to alterations. Because the building offers neither a local interpretation of a standard design nor an undocumented construction technique, it has limited potential to yield important information. As a result, it is recommended not eligible for the NRHP under Criterion A, B, C, or D.

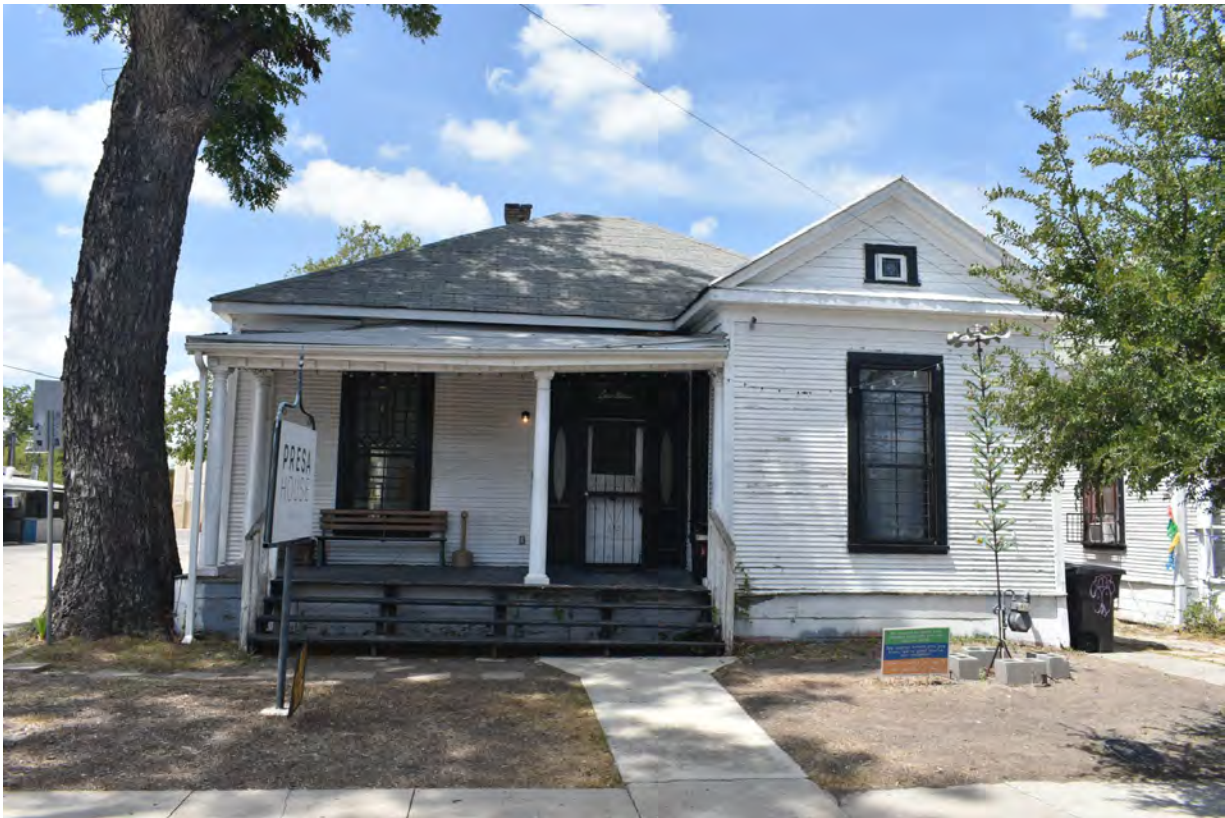
View facing west.

Type: Building	Exterior materials: wood siding	Primary roof type: hipped	Alterations: Addition to rear/side elevation Windows replaced – some Porch stair replaced Skirting added
Style: Folk Victorian			
Form: Rectangular	Porch: partial-width set within ell

This resource does not embody distinctive characteristics of a type, period, or method of construction and it does not represent the work of a master or possess high artistic value. Additionally, no associations were identified linking it to persons or events of historic importance. Furthermore, design, materials, and workmanship integrity have been diminished due to alterations. Because the building offers neither a local interpretation of a standard design nor an undocumented construction technique, it has limited potential to yield important information. As a result, it is recommended not eligible for the NRHP under Criterion A, B, C, or D.

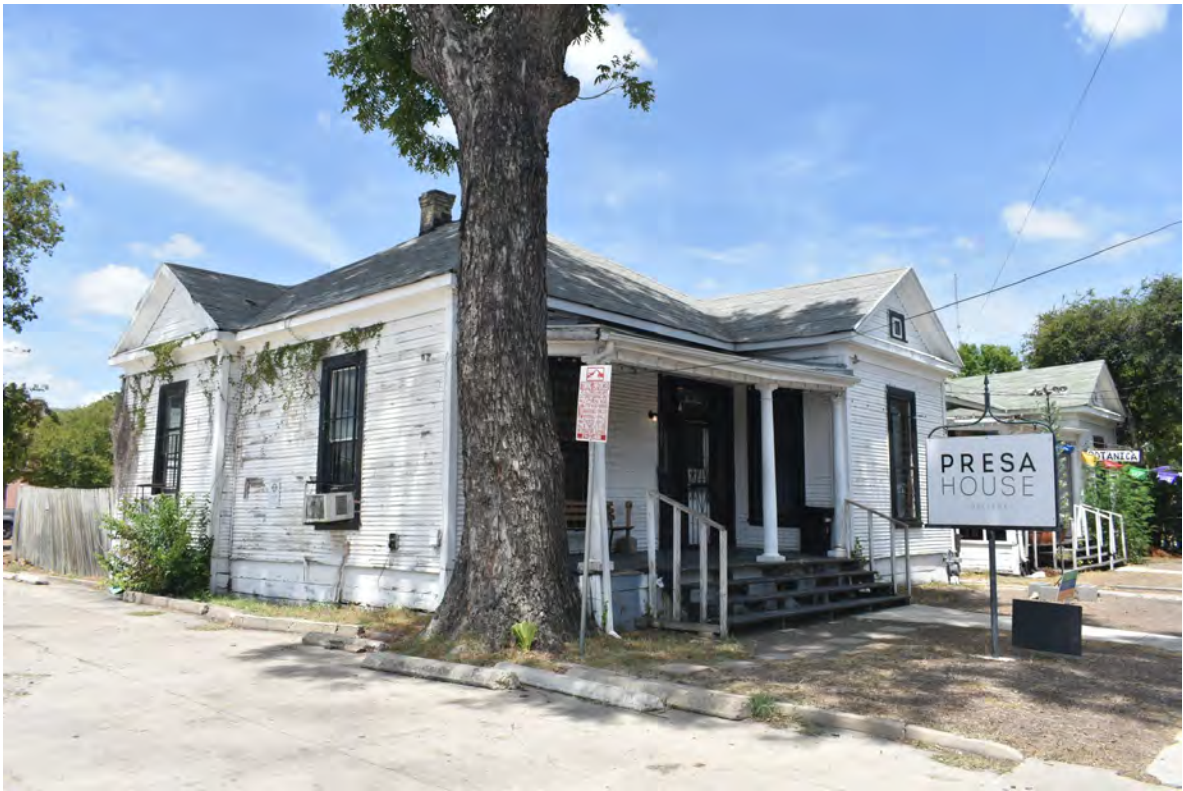
Resource A (center) and
nonhistoric Resource B (right,
sign); view facing northwest.

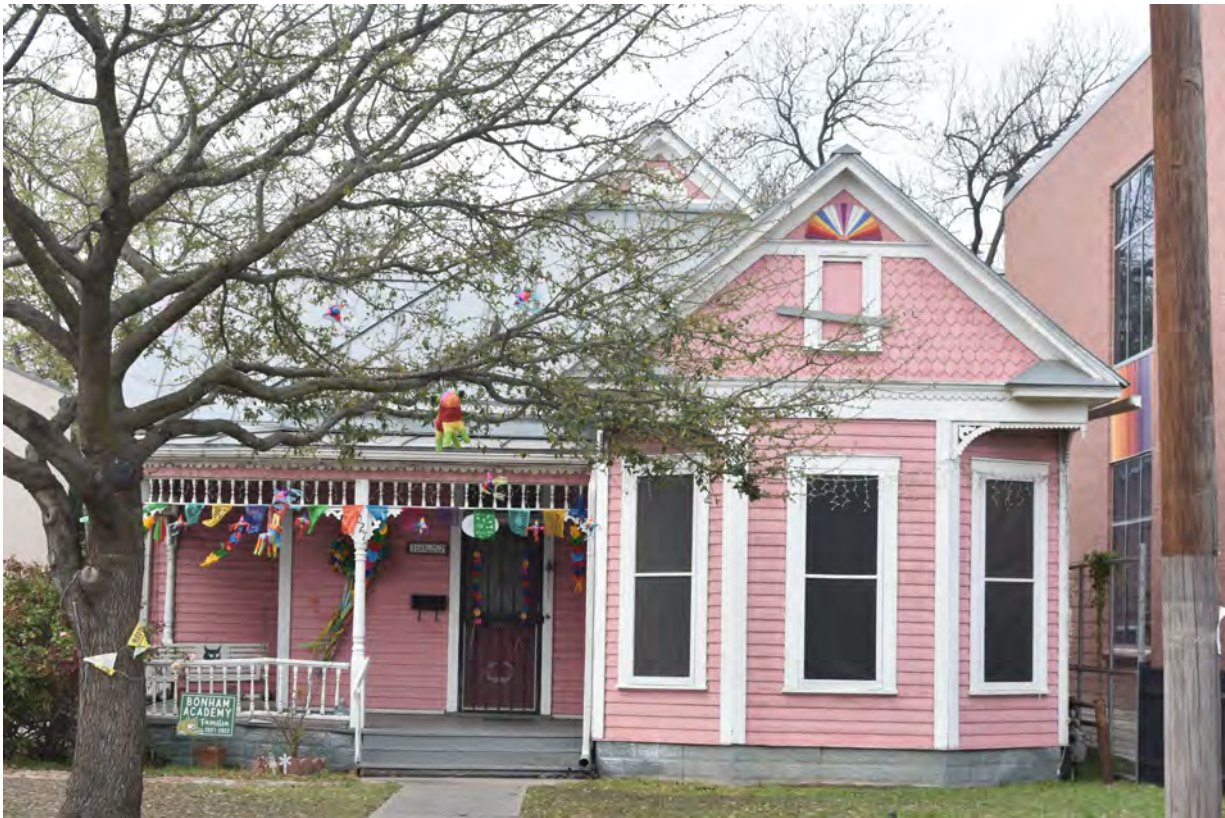
View facing west.

This resource is listed in the National Register of Historic Places as a contributing resource to the South Alamo Street-South Saint Mary's Street NRHP Historic District. Some alterations have occurred including a replaced roof materials, a boarded vent in the gable end, and added decorative elements. These changes diminish the integrity of materials. A large building built north of the residence for Bonham Academy has notably altered the surrounding setting and feeling for the resource. The house retains integrity of location, design, workmanship, and association. Because the building offers neither a local interpretation of a standard design nor an undocumented construction technique, it has limited potential to yield important information. As a result, it is recommended not eligible for the NRHP under Criterion A, B, C, or D.

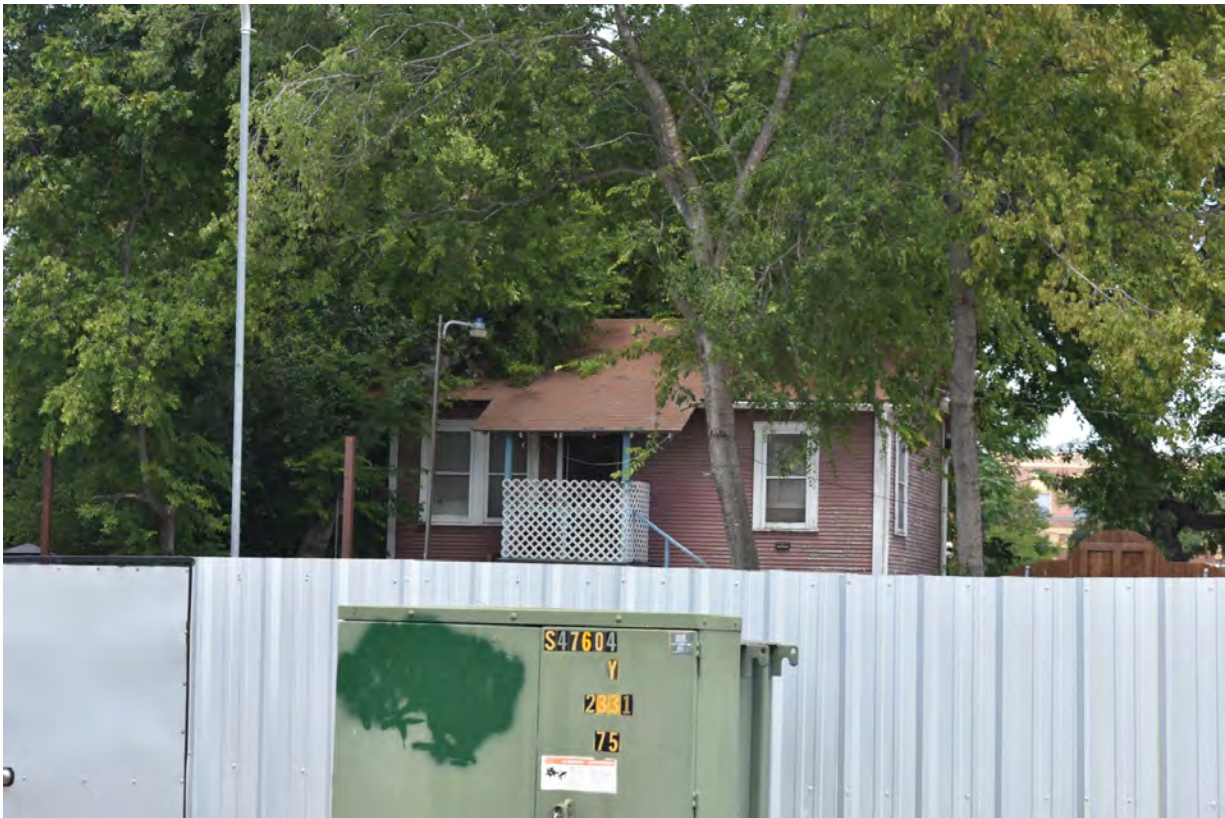
View facing north.

Type: Building	Exterior materials: wood siding	Primary roof type: gable, side	Alterations: Porch enclosed with lattice Porch rails replaced
Style: No style			
Form: Rectangular	Porch: stoop projecting

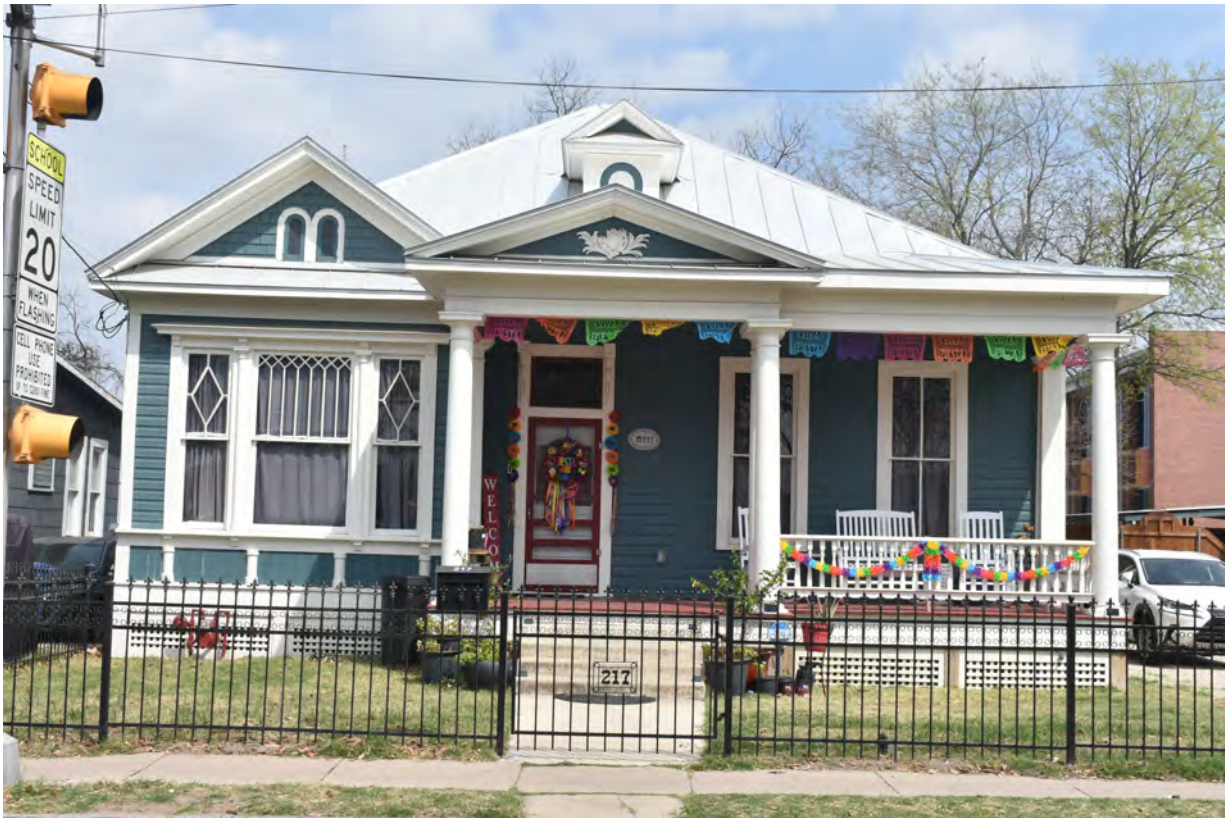
View facing north.

Type: Building	Exterior materials: wood siding wood shingles	Primary roof type: hipped gable, front	Alterations: Roof replaced w/ incomp. materials Vent infilled Decorative elements added
Style: Queen Anne			
Form: Rectangular	Porch: partial-width integrated

This resource is listed in the National Register of Historic Places as a contributing building to the South Alamo Street-South Mary's Street NRHP Historic District and is considered a contributing resource to the City of San Antonio's King William Local Historic District. Although its integrity of materials and workmanship have been diminished by the replacement of the roofing material, the resource retains the majority of the physical features dating from its construction and therefore retains integrity overall. As a result, its contributing status to the South Alamo Street-South Mary's Street NRHP Historic District is affirmed.

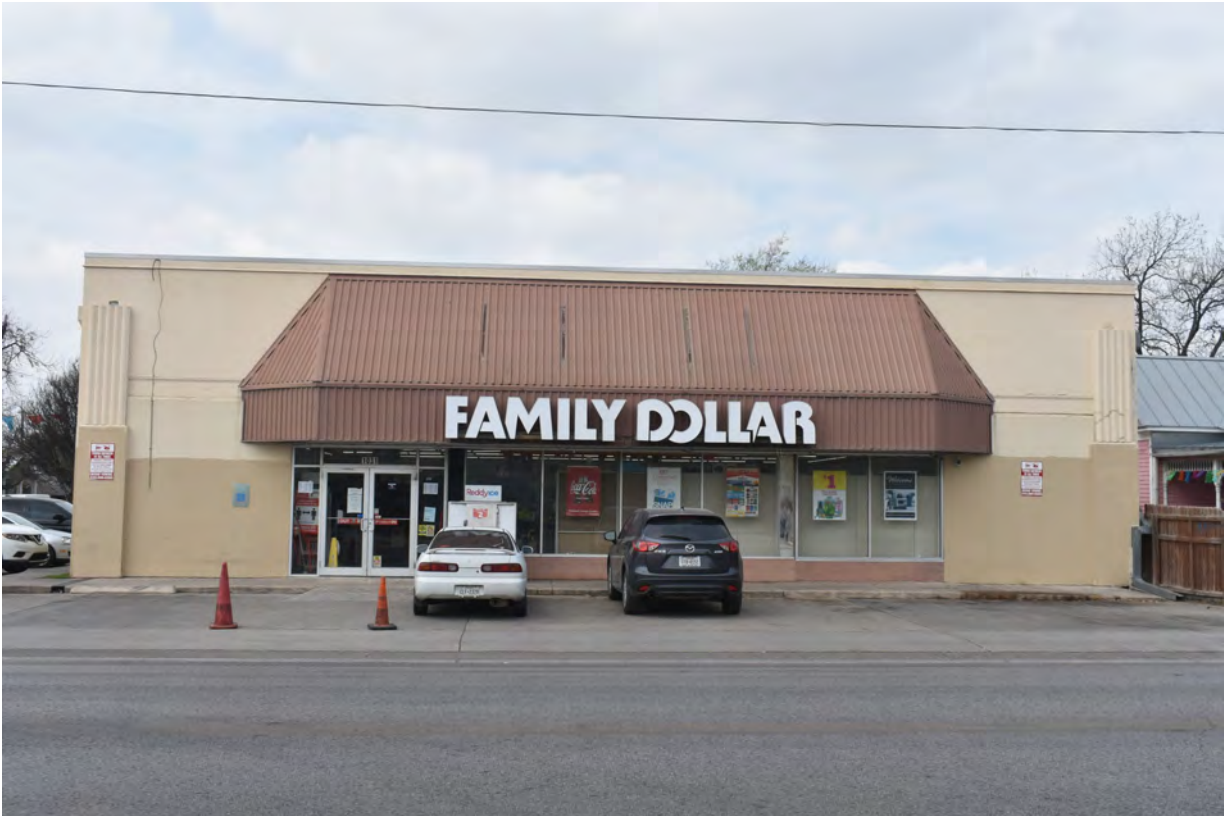
View facing west.

Type: Building	Exterior materials: stucco	Primary roof type: flat	Alterations: Storefront altered/replaced Awning(s) added Door/entrance enclosed
Style: Art Deco			
Form: Rectangular	Porch: partial-width projecting

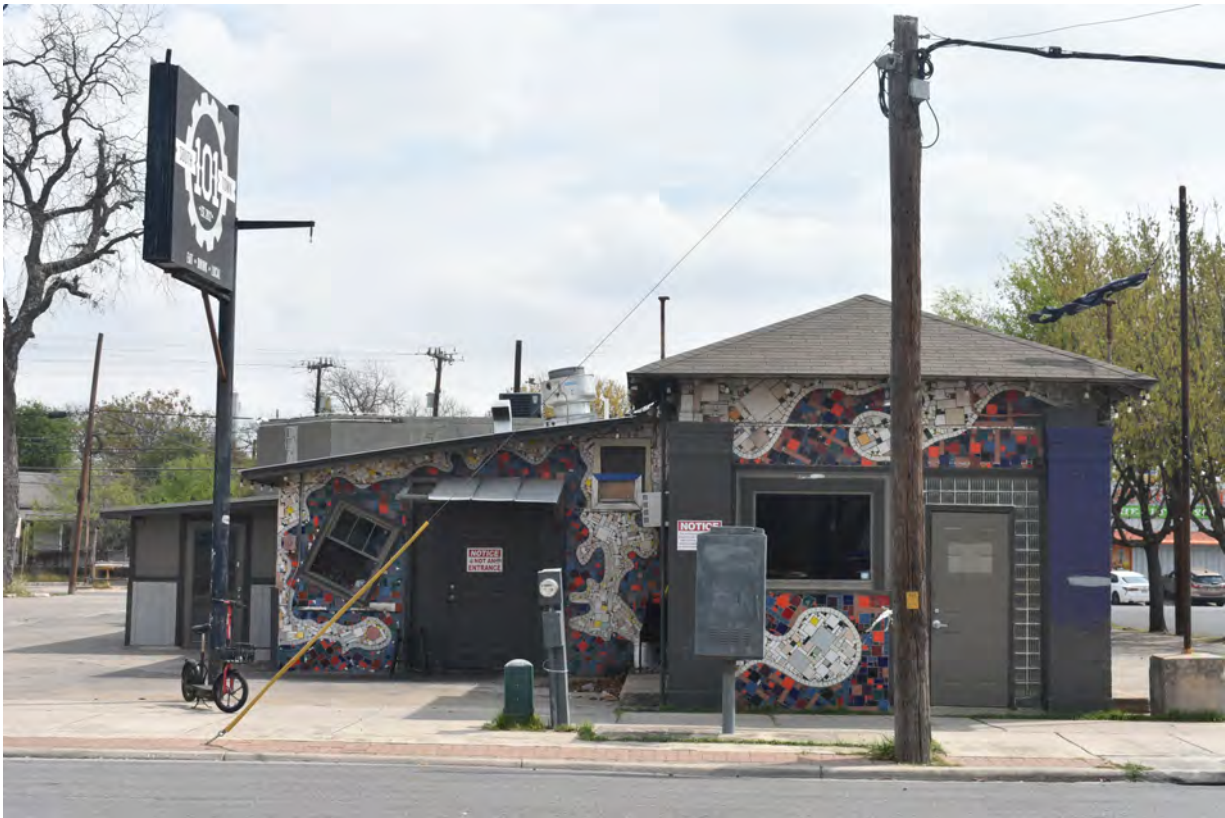
View facing east.

Type: Building	Exterior materials: brick stucco	Primary roof type: flat hipped shed	Alterations: Doors replaced Windows replaced – some Addition to primary/side elevation Brick/stone painted Awning(s) added
Style: No style			
Form: Irregular	Porch: N/A

This resource does not embody distinctive characteristics of a type, period, or method of construction and it does not represent the work of a master or possess high artistic value. Additionally, no associations were identified linking it to persons or events of historic importance. Furthermore, integrity has been diminished as outlined above. Because the building offers neither a local interpretation of a standard design nor an undocumented construction technique, it has limited potential to yield important information. As a result, it is recommended not eligible for the NRHP under Criterion A, B, C, or D.

This resource is located along the commercial corridor along S. St. Mary's-Presa Streets. This resource is recommended as a noncontributing resource within a potentially expanded South Alamo Street-South Saint Mary's Street NRHP Historic District.

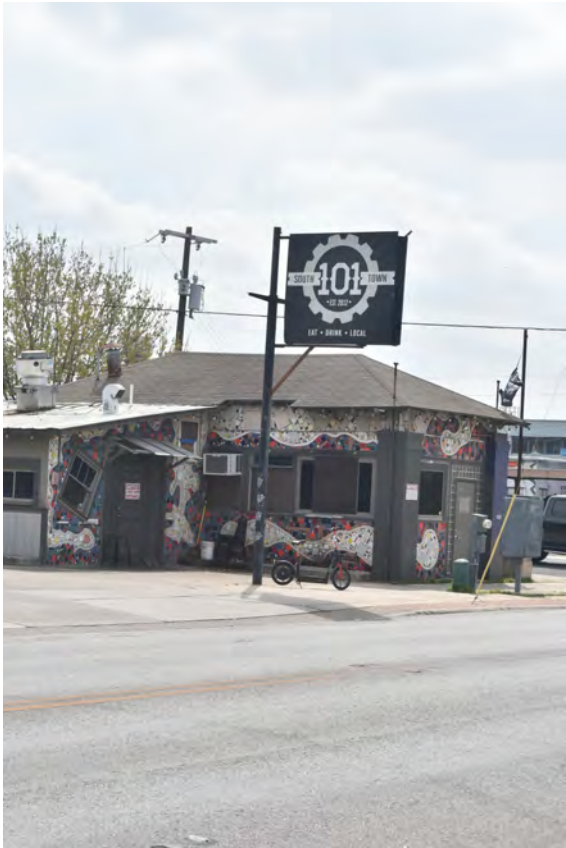
View facing southeast.

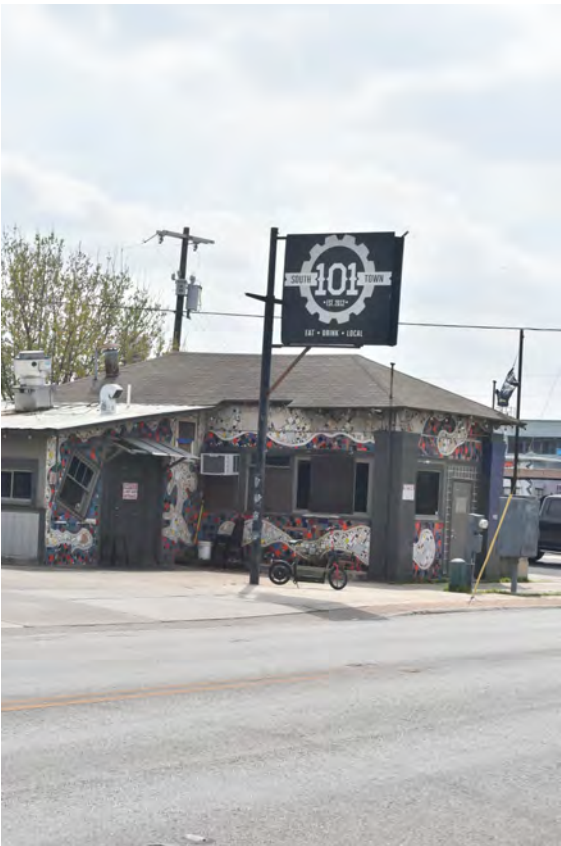
Resource B (sign, foreground) and Resource A (rear); view facing southeast.

Type: Structure	Exterior materials: metal	Primary roof type: N/A	Alterations: Signage replaced
Style: No style			
Form: Sign	Porch: N/A

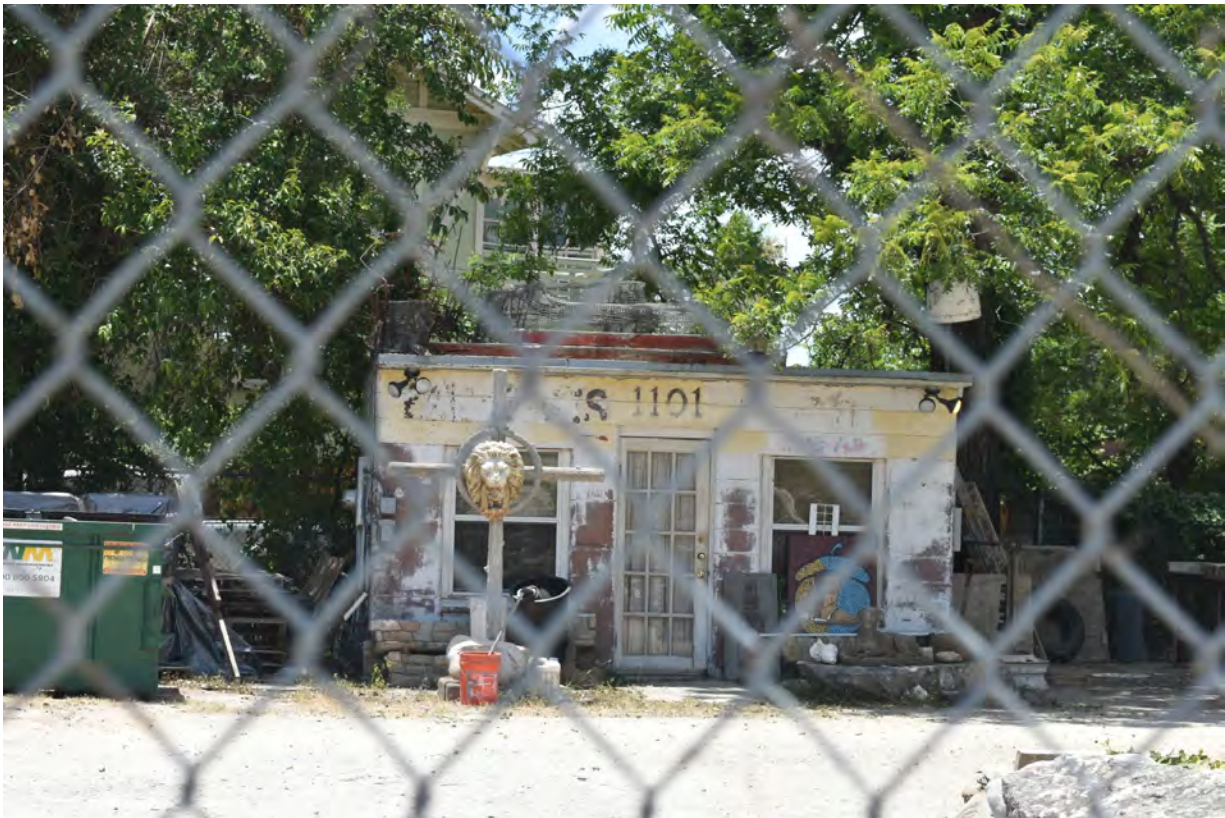
Resource A
(Historic-age);
view facing south

Type: Building	Exterior materials: wood siding	Primary roof type: flat	Alterations: Doors replaced Windows replaced – all visible
Style: No style			
Form: Rectangular	Porch: none

Resources A and B are part of the studio complex operated by Carlos Cortes, a local artist specializing in faux bois and trabaja rustico. Resource A is a historic-age office and Resource B is a nonhistoric metal shed. A photograph of Resource B is included in this record. Since 1924, the Cortes family has created faux bois work with much of their sculptures present throughout San Antonio. Public projects include recent installations along the River Walk, bus stops, and park shelters. The property was formerly a used car dealership in the 1950s. Mueller Motors operated at the site, specializing in Chrysler-Plymouth automobiles (San Antonio Light 1954). Autrey Datsun Sales, a specialist of Japanese vehicles, took over the property during the early 1960s. By 1967, T&L Auto Sales operated at this location (Express and News 1967).

Although the legacy of the Cortes family is interesting and important to the faux bois tradition of San Antonio, the artist has only operated at this property less than fifty years. This resource does not embody distinctive characteristics of a type, period, or method of construction and it does not represent the work of a master or possess high artistic value. Additionally, no associations were identified linking it to persons or events of historic importance. Material integrity of the office building has diminished from the replacement of doors and windows. Because the building offers neither a local interpretation of a standard design nor an undocumented construction technique, it has limited potential to yield important information. As a result, it is recommended not eligible for the NRHP under Criterion A, B, C, or D. The building is a noncontributing resource to the South Alamo Street-South Saint Mary's Street NRHP Historic District but is considered a contributing resource to the City of San Antonio's King William Local Historic District. The building does not retain sufficient historic and physical integrity and its noncontributing status to the South Alamo Street-South Saint Mary's Street NRHP Historic District is affirmed.
