Resource ID: 226A	Parcel ID: 1213123	Year Built: 1889	Year Source: NRHP Nomination Form
Address: 925 S SAINT MARYS ST., SAN ANTONIO, TX		Latitude: 29.414091	County: Bexar
Name: James Butler Bonham Elementary School (Bonham Academy)		Longitude: -98.489459	
Historic Function/Subcategory: Education/School		Indiv. NRHP Eligible? Listed	Effect: No Adverse Effect
Current Function/Subcategory: Education/School		Contributing to NRHP Property/District? Yes

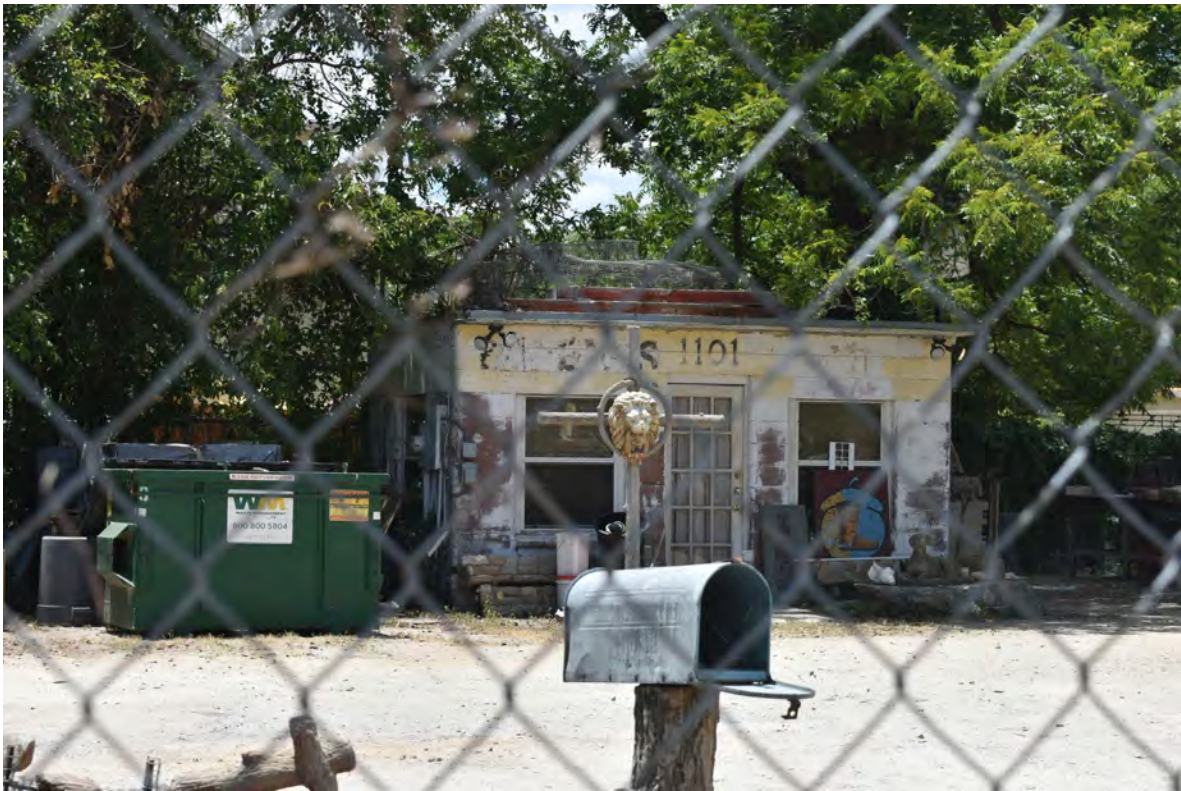
Type: Building	Exterior materials: wood siding	Primary roof type: flat	Alterations: Doors replaced Windows replaced – all visible
Style: No style			
Form: Rectangular	Porch: none

Resource A (Historic-age);
view facing southwest

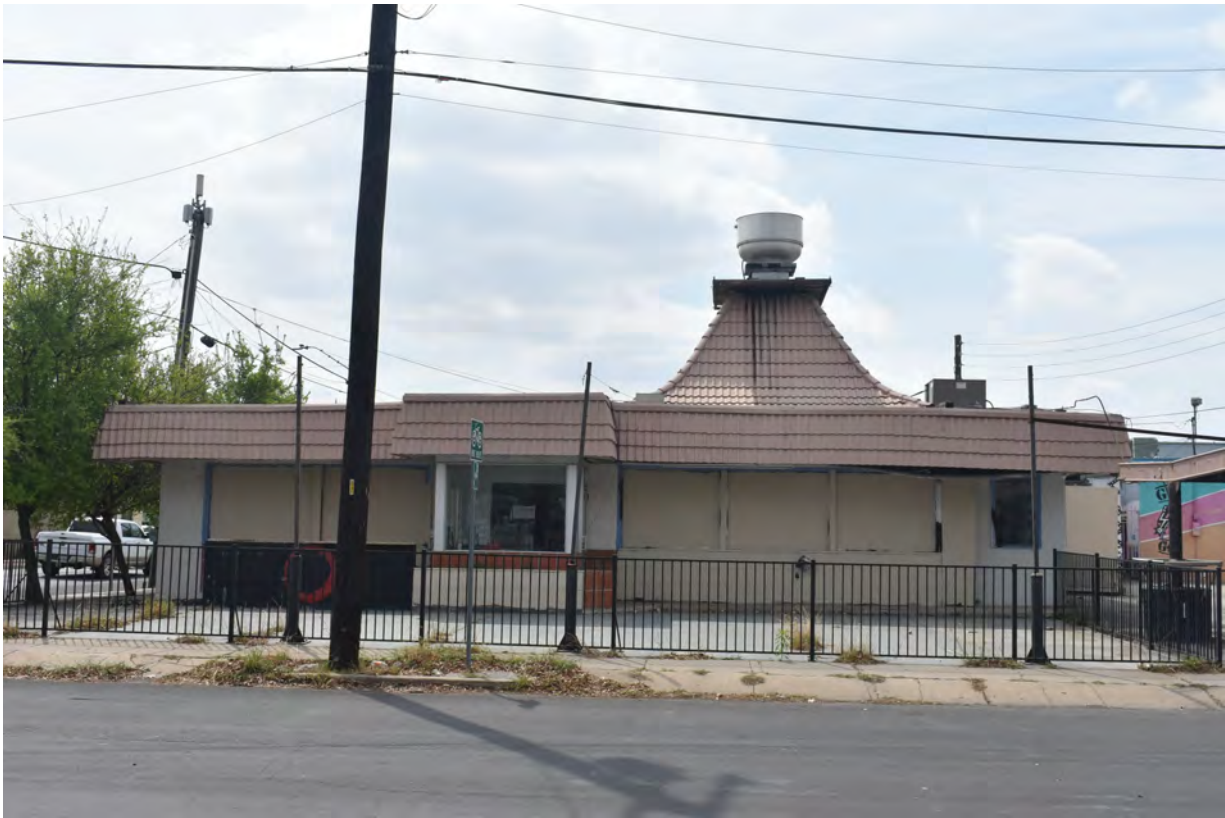
View facing south.

Type:	Building	Exterior materials:	stucco	Primary roof type:	flat	Alterations:	Addition to primary/side elevation
Style:	Exotic Revival, Mid-Cent. Modern	concrete/cinder block		fang zan-jiang-inspired mansard		Door/entrance added	Doors replaced
Form:	Irregular	Porch:	none			Signage removed	Carport removed
						Window opening(s) infilled	Roofline altered/exhaust vent added

This resource is located along the commercial corridor along S. St. Mary's-Presa Streets. This resource is recommended as a noncontributing resource within a potentially expanded South Alamo Street-South Saint Mary's Street NRHP Historic District.

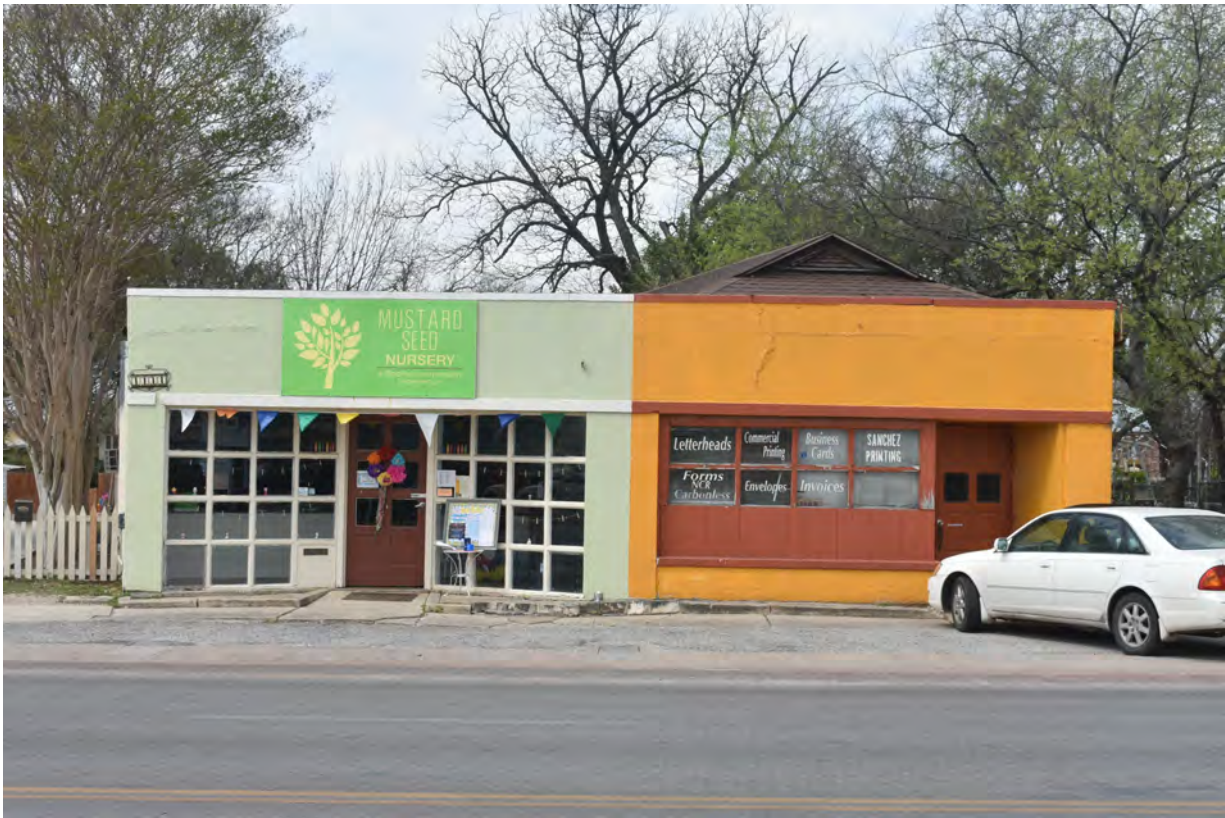
View facing southwest

Type: Building	Exterior materials: stucco processed wood board wood siding brick	Primary roof type: gable-on-hip flat with parapet	Alterations: Completely modified from its original appearance Storefront altered/replaced Signage added
Style: Commercial			
Form: 1-part commercial block	Porch: stoop integrated

This building does not embody distinctive characteristics of a type, period, or method of construction and it does not represent the work of a master or possess high artistic value. Additionally, no associations were identified linking it to persons or events of historic importance. Furthermore, integrity has been irreparably diminished due to extensive modification. Because the building offers neither a local interpretation of a standard design nor an undocumented construction technique, it has limited potential to yield important information. As a result, it is recommended not eligible for the NRHP under Criterion A, B, C, or D.

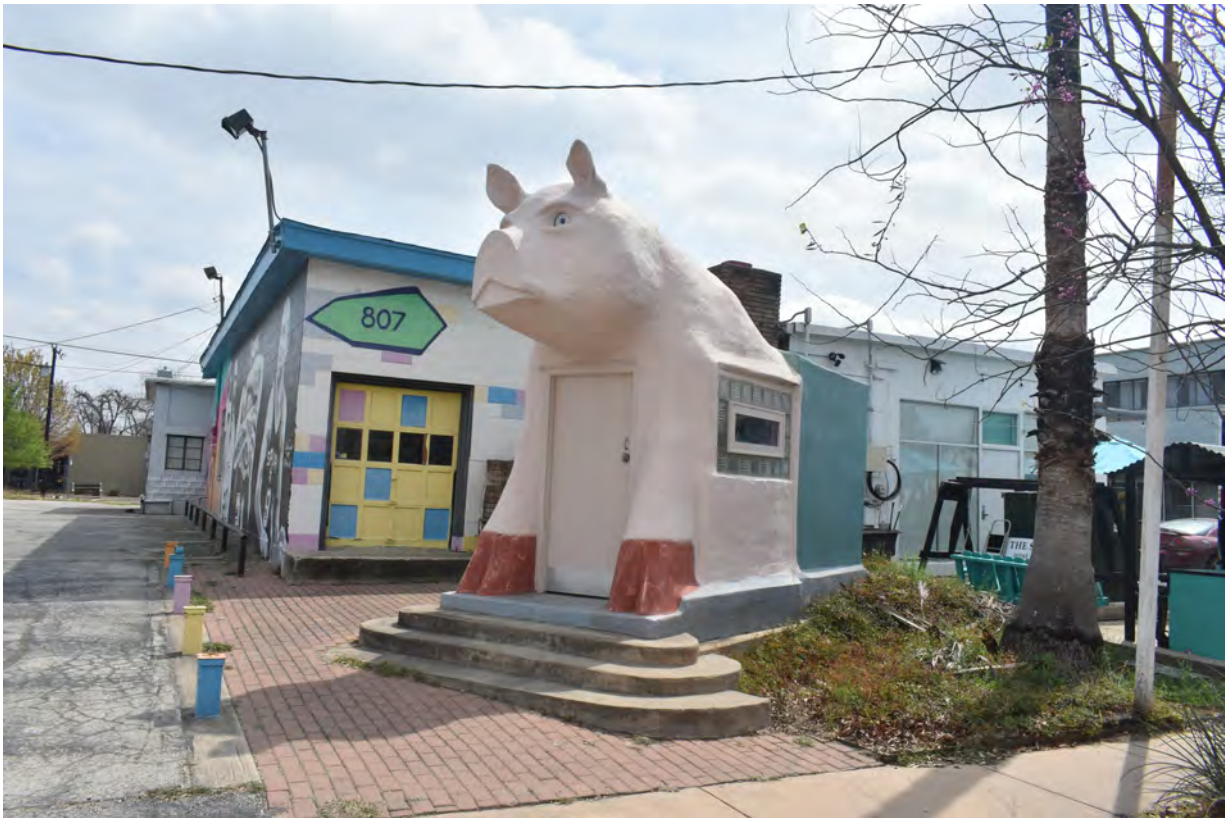
View facing east.

Type: Building	Exterior materials: stucco	Primary roof type: flat	Alterations: Windows replaced – all visible Window opening(s) infilled New foundation constructed
Style: Programmatic/Mimetic	Style: glass block		
Form: Rectangular	Porch: N/A

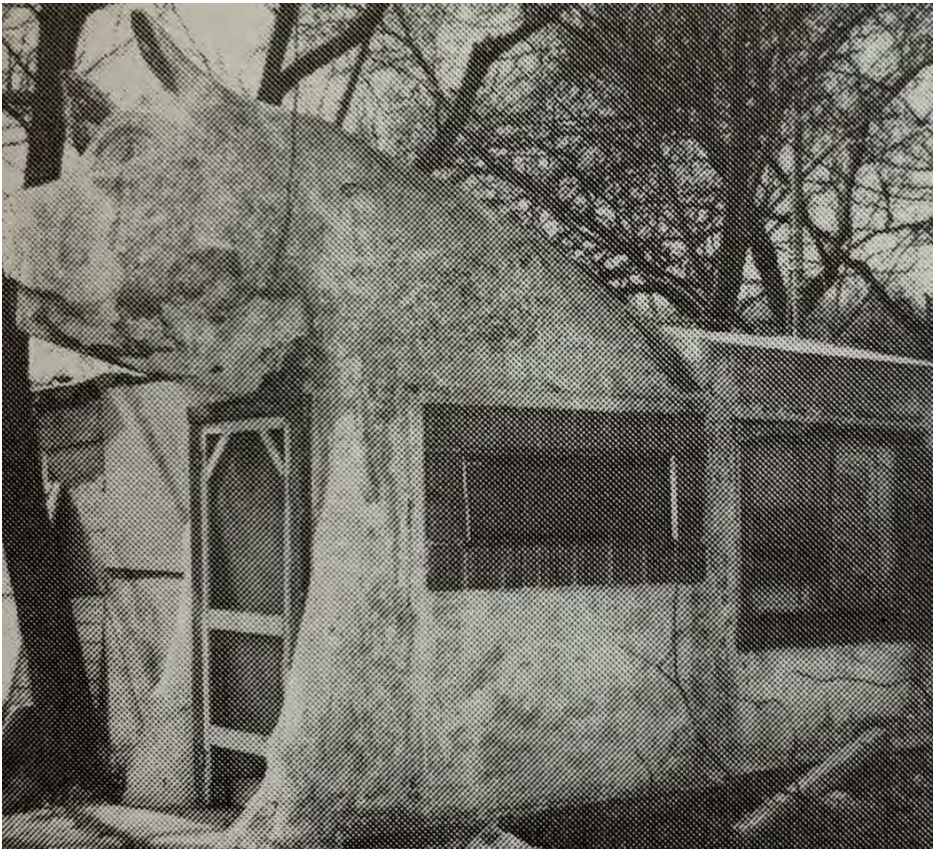
View of resource in ca. 1940
("The Big Pig in San Antonio's
Southtown has a hazy
history," San Antonio Express
News, October 4, 2021).

The Big Pig is recommended individually eligible for listing in the NRHP under Criterion C at the local level of significance in the area of architecture as an exceedingly rare example of programmatic architecture. Regarding Criterion Consideration B, which addresses moved properties, such properties can be historically significant if they still have an orientation, setting, and general environment that are comparable to those of the historic location and that are compatible with the property’s significance (Andrus 1995). As the Big Pig is adjacent to the location of Pig Stand #24, it satisfies the Criterion Consideration. No associations were identified linking the property to persons or events of historic importance. Because the building offers neither a local interpretation of a standard design nor an undocumented construction technique, it has limited potential to yield important information. As a result, it is recommended not eligible for listing in the NRHP under Criterion A, B, or D.

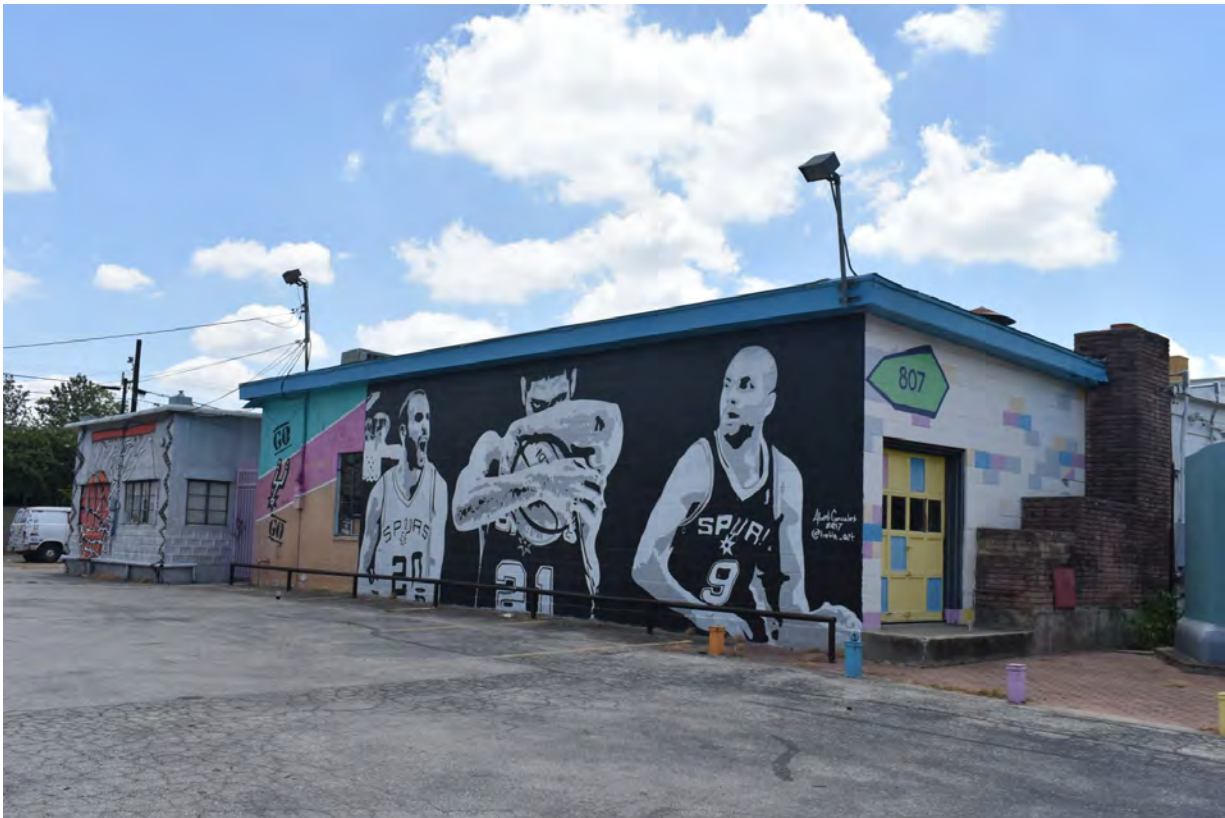
View facing southeast.

Type: Building	Exterior materials: brick stucco	Primary roof type: flat	Alterations: Window opening(s) infilled Doors replaced Brick/stone painted
Style: No style			
Form: Rectangular	Porch: N/A

The resource is not recommended individually eligible for listing in the NRHP under Criterion A, B, C, or D. While it is associated with the Pig Stand restaurant, research did not reveal that they have any significant historic associations with its history. The resources do not embody distinctive characteristics of a type, period, or method of construction and do not represent the work of a master or possess high artistic value. Additionally, no associations were identified linking them to persons of historic importance. Because the building offers neither a local interpretation of a standard design nor an undocumented construction technique, it has limited potential to yield important information.

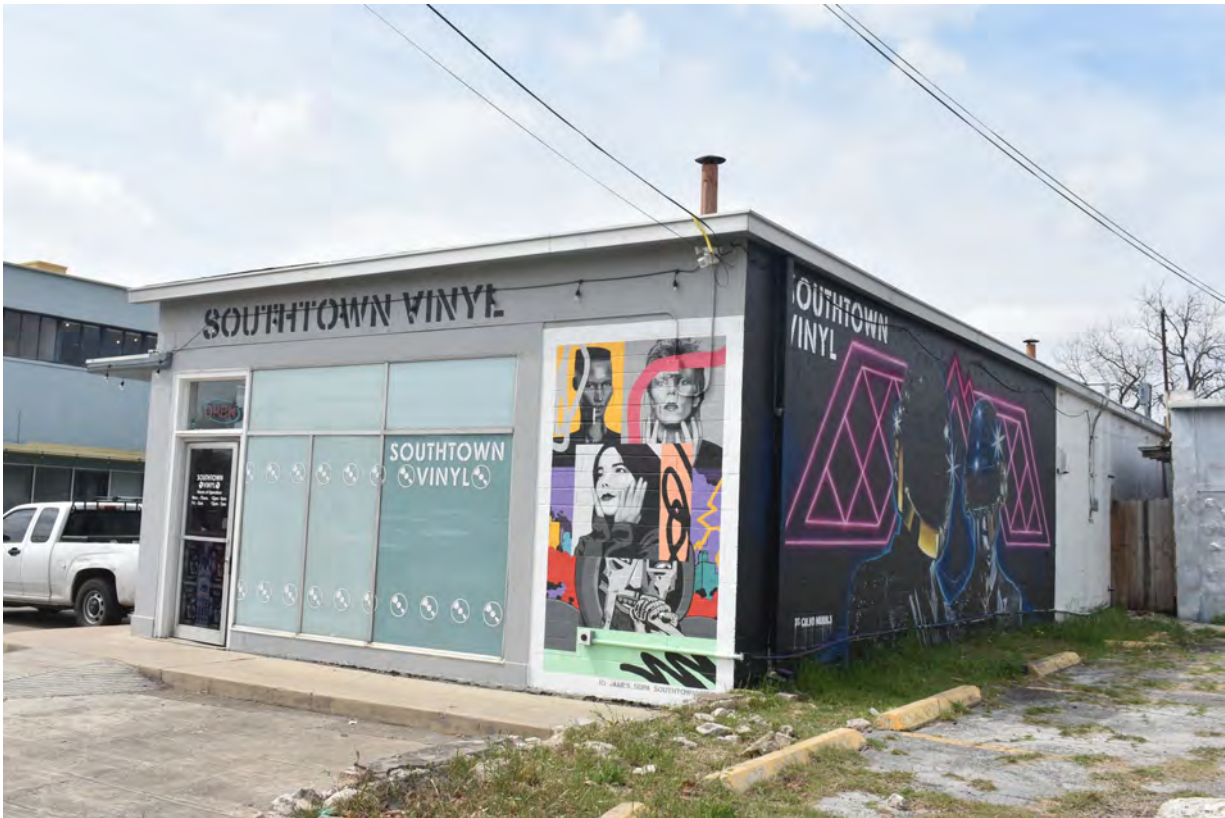
View facing west.

Type: Building	Exterior materials: stucco concrete/cinder block	Primary roof type: flat	Alterations: Storefront altered/replaced Doors replaced
Style: No style			
Form: Rectangular	Porch: full-width projecting

This resource was not found to embody distinctive characteristics of a type, period, or method of construction, represent the work of a master, or possess high artistic value. Additionally, no associations were identified linking it to events or persons of historic importance. Furthermore, integrity has been diminished as outlined above. Because the building offers neither a local interpretation of a standard design nor an undocumented construction technique, it has limited potential to yield important information. As a result, it is recommended not eligible for the NRHP under Criterion A, B, C, or D.

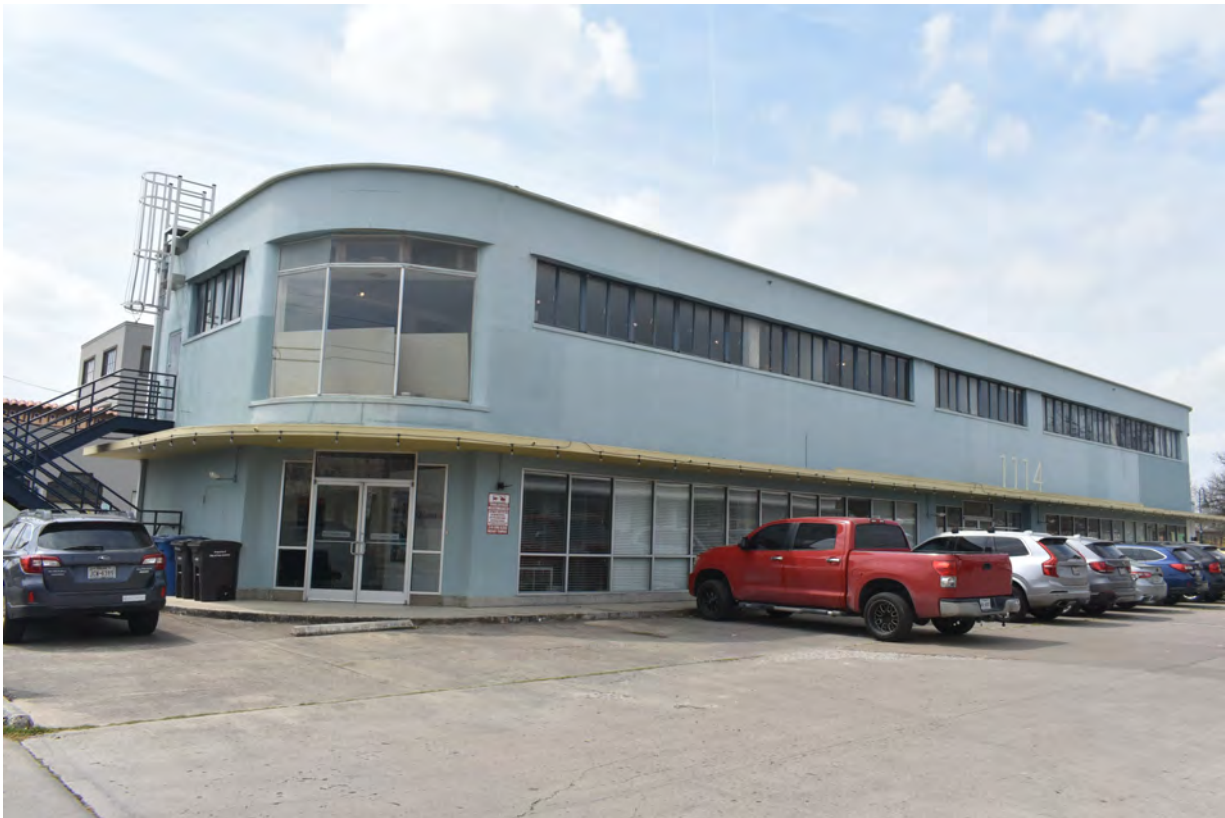
View facing southwest.

Type: Building	Exterior materials: stucco	Primary roof type: flat	Alterations: Storefront altered/replaced Doors replaced
Style: Streamline Moderne			
Form: Rectangular	Porch: wraparound projecting

This resource does not embody distinctive characteristics of a type, period, or method of construction and it does not represent the work of a master or possess high artistic value. Additionally, no associations were identified linking it to persons or events of historic importance. Because the building offers neither a local interpretation of a standard design nor an undocumented construction technique, it has limited potential to yield important information. As a result, it is recommended not eligible for the NRHP under Criterion A, B, C, or D.

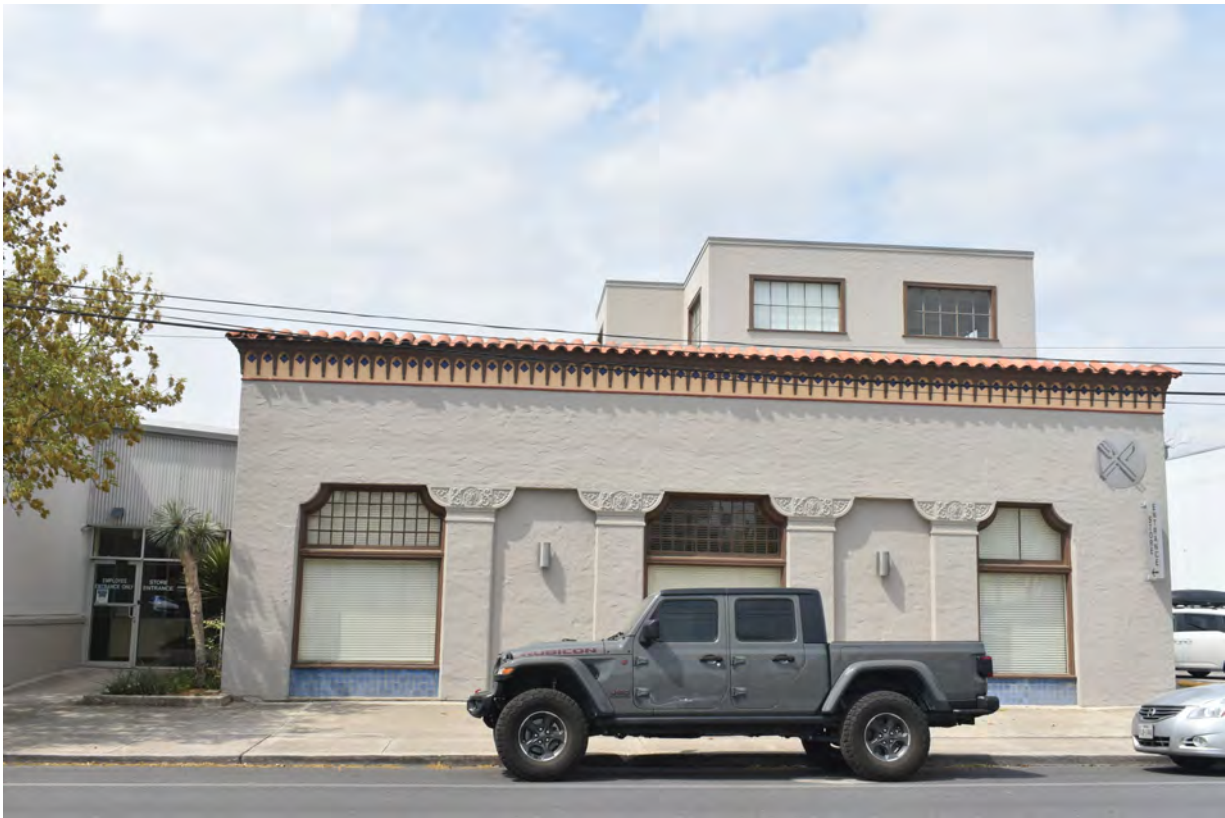
View facing west.

Type: Building	Exterior materials: stucco	Primary roof type: flat	Alterations: Addition to primary/side elevation
Style: Spanish Colonial Revival	metal	with parapet	Windows replaced – some
Form: Irregular	Porch: partial-width projecting		Storefront altered/replaced
			Door/entrance enclosed
			Doors replaced
			Window opening(s) infilled

According to city directories, this resource was constructed as an ice factory and office for the Lone Star Ice, Co. around 1929. The Lone Star Ice, Co. appears to have originally been a subsidiary of the Lone Star Cotton Mill. The Lone Star Cotton Mill was founded in 1921 by Adolphus Busch III following the closure of the Lone Star Brewing Company during Prohibition. The company began manufacturing ice around 1922. By the time the resource was constructed in 1929, the Lone Star Ice, Co. owned and operated 9 factories and 22 retail stores in San Antonio. Their headquarters were located at the former Lone Star Brewing Company factory building at 200 West Jones Avenue. The Lone Star Ice, Co. appears to have later changed its name to the Lone Star Ice and Food and began operating a chain of convenience stores after World War II.

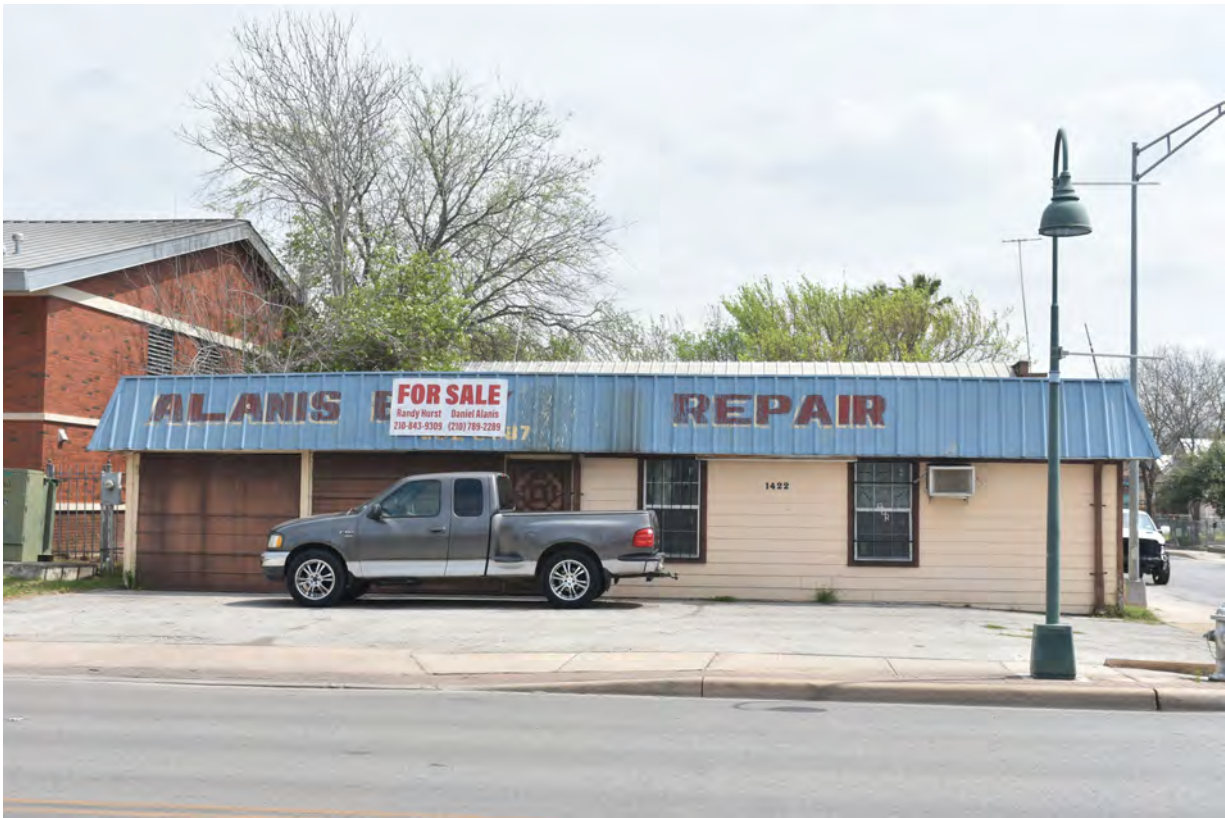
View facing east.

Type: Building	Exterior materials: vinyl siding	Primary roof type: mansard	Alterations: Addition to primary/side elevation
Style: No style	brick	flat	Window opening(s) infilled
Form: Rectangular	aluminum siding	with parapet	Carport removed
	Porch: none		Gas pumps removed
			Signage removed
			Wall cladding replaced
			Garage door(s) replaced

The existing resource is present on the 1951 Sanborn, and is noted as being Minton's Gulf Service gas station (San Antonio Express 1958). It consisted of the brick portion of the building that is located to the east on Florida Street, and originally featured a large canopy that extended west towards S. Saint Mary's Street. A review of historic aerials reveals that the canopy was removed by 1973 and the additions to the east and west of the original portion of the building constructed by 1983. The form of the resource does not match any of those presented in *A Field Guide to Gas Stations in Texas*. Some features are characteristic of Magnolia stations dating from the 1920s and 1930s, such as the brick exterior and stepped parapet, but overall the resource does not appear to align with the design of Gulf gas stations as described in the guide. Visible alterations include the removal of the gas pumps and canopy, construction of two additions to the east and west, removal of original signage, and infilling of window openings.

Based on research conducted at the reconnaissance level, the resource is recommended not eligible under Criterion A. It does not appear to be an early location of a gas station in the area or otherwise significantly associated with overall neighborhood development. No associations with persons significant in our past were identified; therefore, the resource is not recommended eligible under Criterion B. The resource possesses some features that are characteristic of Magnolia gas stations dating from the 1920s and 1930s; however, even if the property's origins as a Magnolia station could be confirmed, the building is not a recognizable example of Magnolia's architectural program. Additionally,, the resource does not represent exemplary engineering techniques, nor was it designed by a noted architect or as a prototype for an oil company or brand. Furthermore, integrity has been diminished as outlined above. For these reasons, the resource is recommended as not individually eligible under Criterion C. Because the building offers neither a local interpretation of a standard design nor an undocumented construction technique, it has limited potential to yield important information. As a result, it is recommended not eligible for

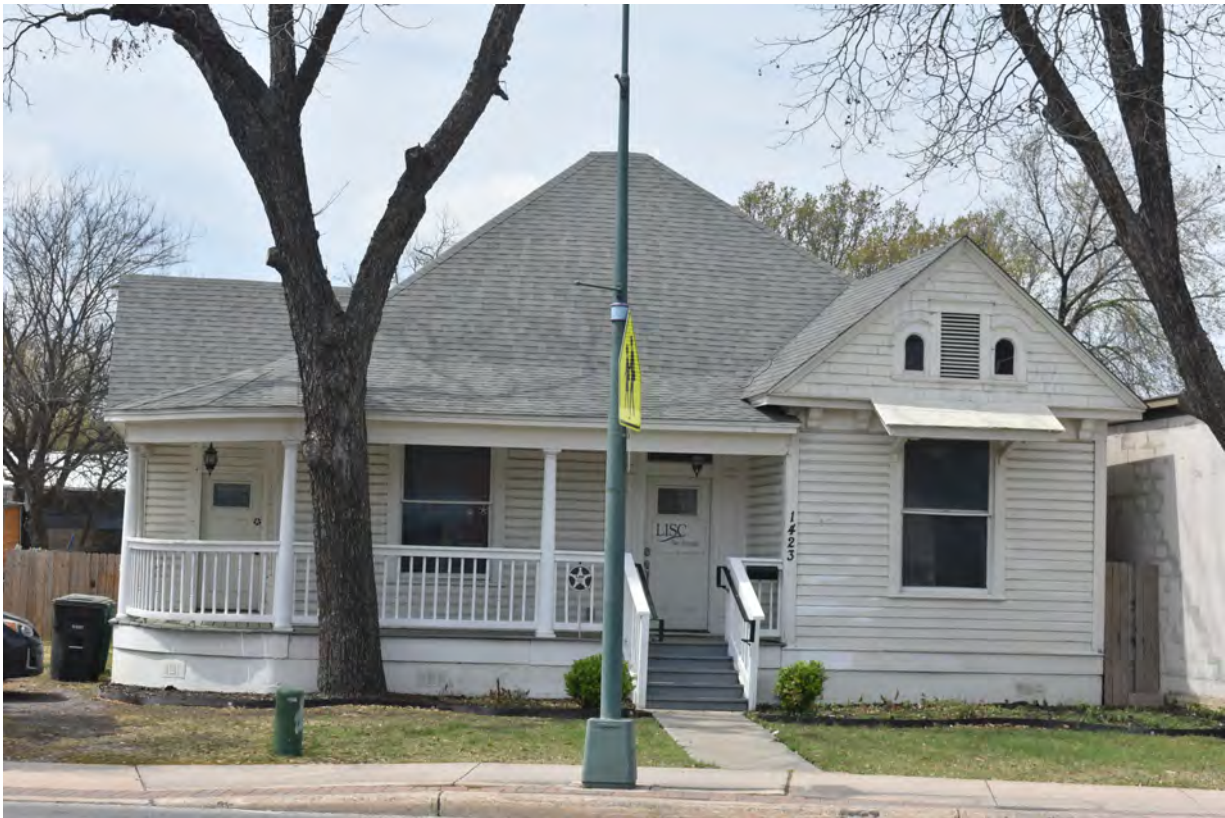
View facing west.

Type: Building	Exterior materials: wood siding	Primary roof type: hipped gable, front	Alterations: Doors replaced Windows replaced – some Sidelights removed Porch altered Porch rails replaced Addition to rear/side elevation
Style: Queen Anne			
Form: L-plan	Porch: wraparound projecting

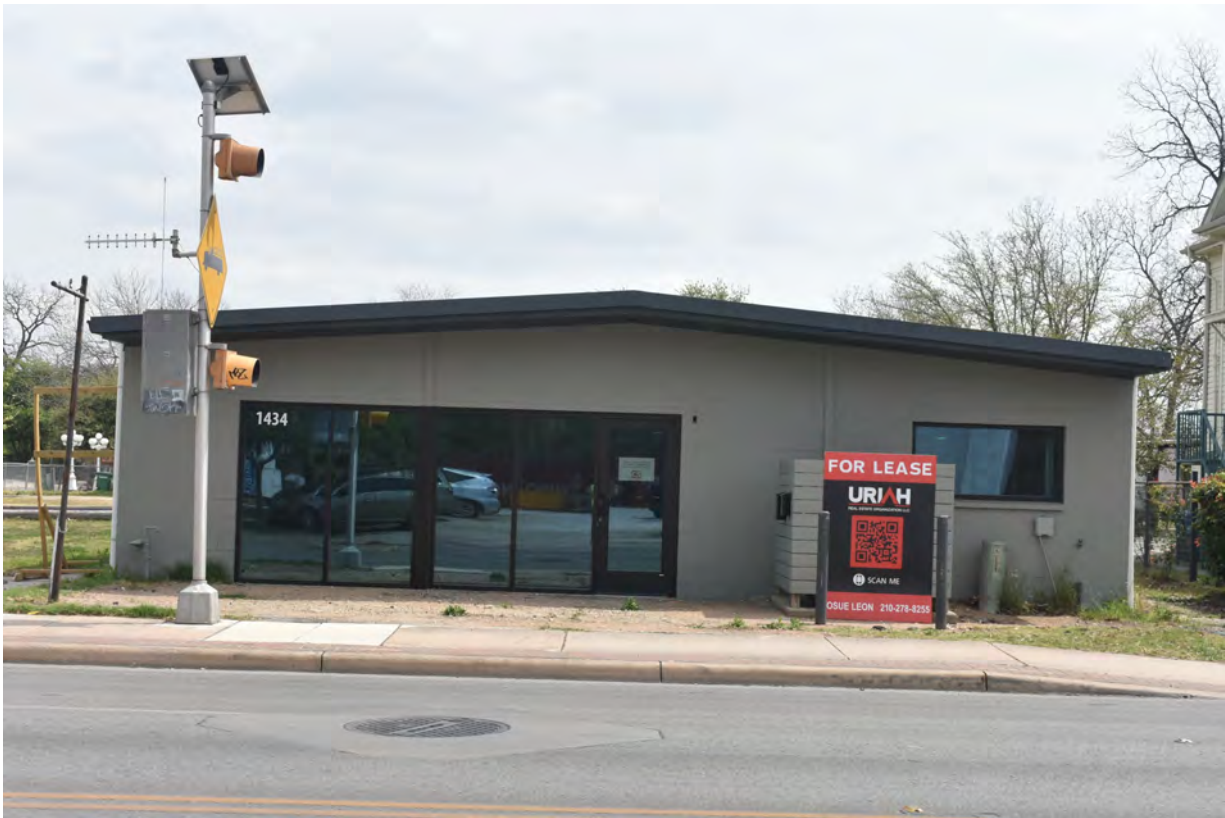
View facing east.

Type: Building	Exterior materials: concrete/cinder block	Primary roof type: gable, front	Alterations: Storefront altered/replaced Windows replaced – all visible
Style: No style			
Form: Rectangular	Porch: N/A

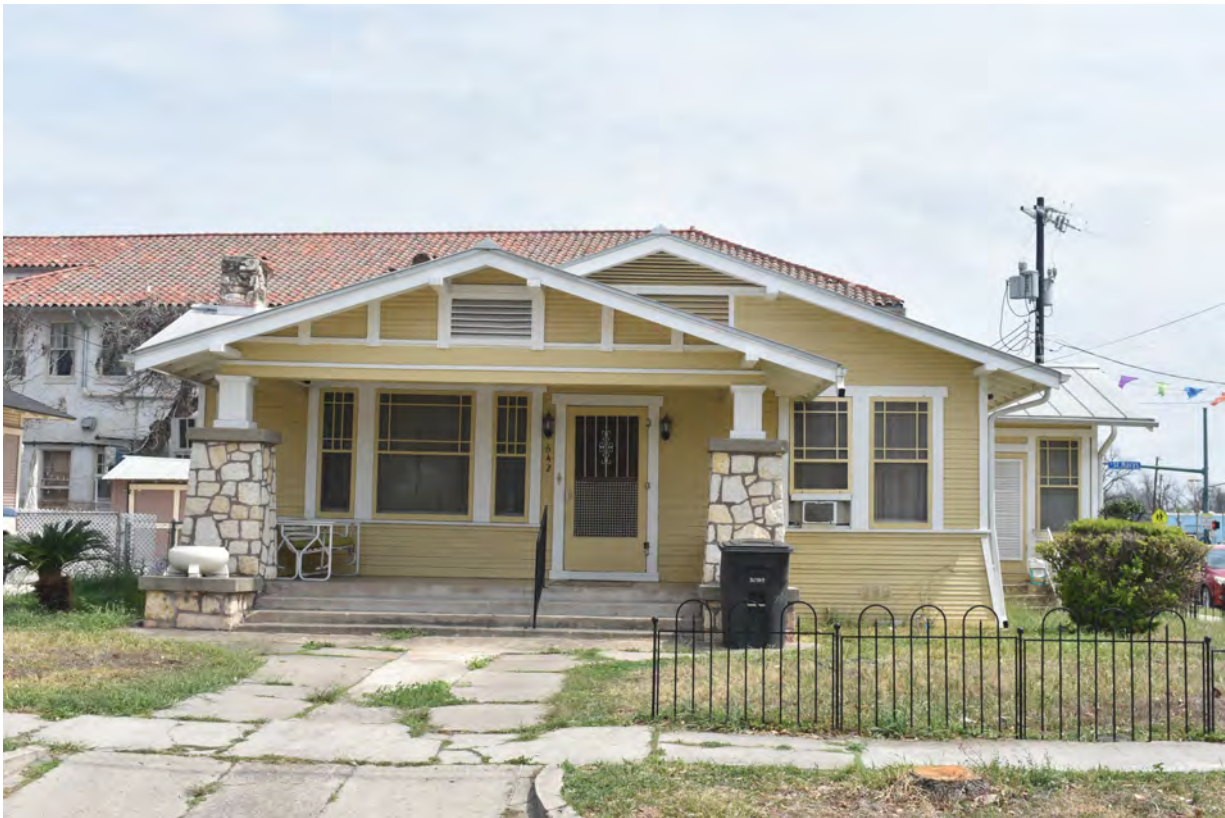
View facing east.

Alterations:
Roof replaced w/ incomp. materials
Addition to rear/side elevation

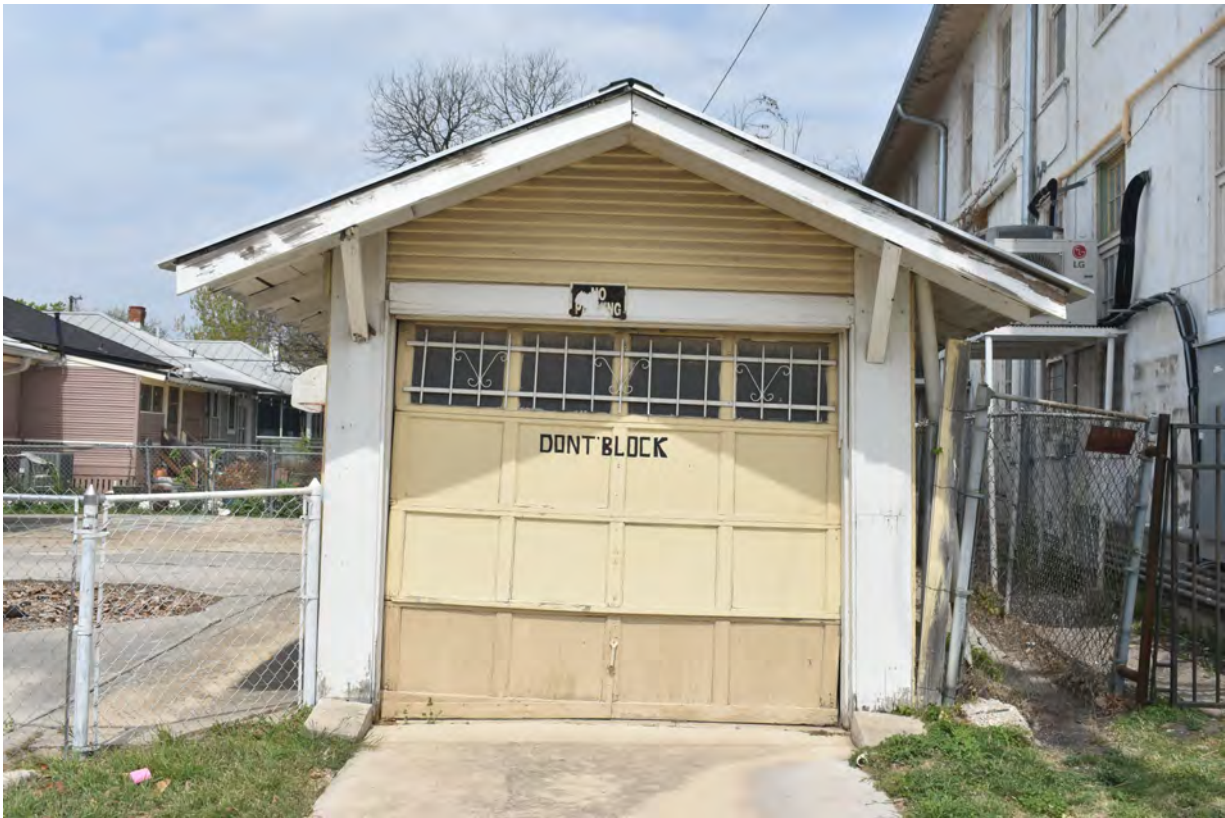
View facing north.

Type: Building	Exterior materials: wood siding	Primary roof type: gable, front	Alterations: Garage door(s) replaced Roof replaced w/ incomp. materials Addition to rear/side elevation
Style: No style			
Form: Rectangular	Porch: N/A

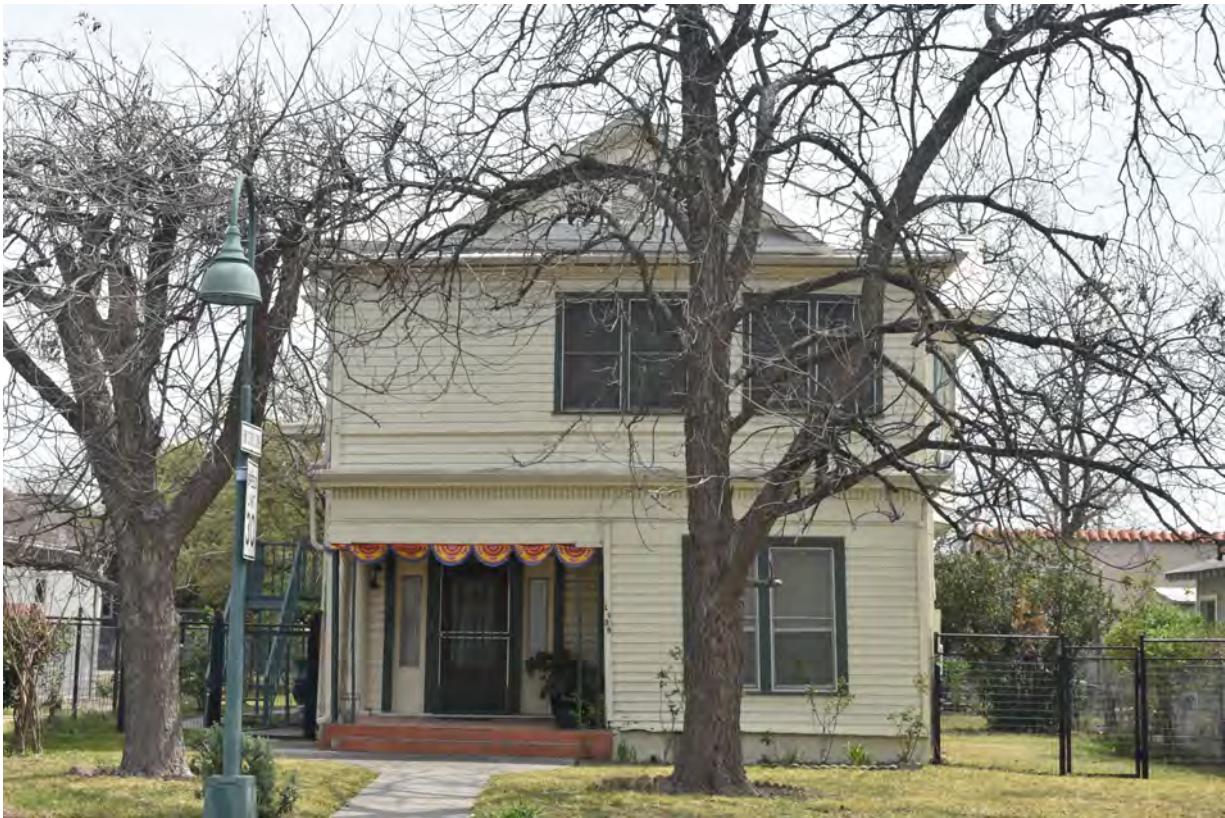
View facing east.

Type: Building	Exterior materials: wood siding	Primary roof type: gable-on-hip gable, front	Alterations: Porch enclosed Porch support(s) and rails replaced Window opening(s) infilled Door/entrance added Exterior staircase added Roof replaced w/ incomp. materials Windows replaced – some
Style: Queen Anne			
Form: Rectangular	Porch: partial-width integrated

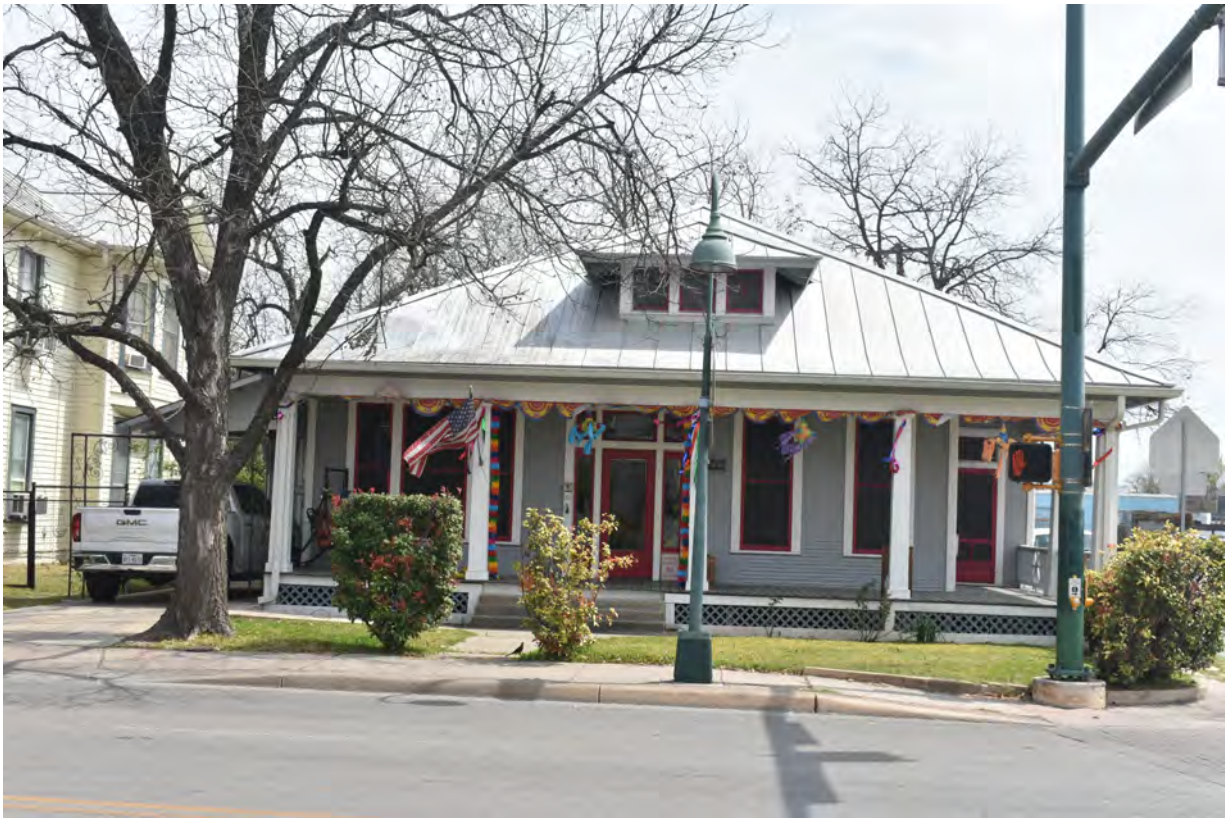
View facing east

Type: Building	Exterior materials: wood siding	Primary roof type: hipped	Alterations: Roof replaced w/ incomp. materials Porch rails removed Carport added Porch added (east elevation)
Style: Folk Victorian			
Form: Rectangular	Porch: wraparound integrated

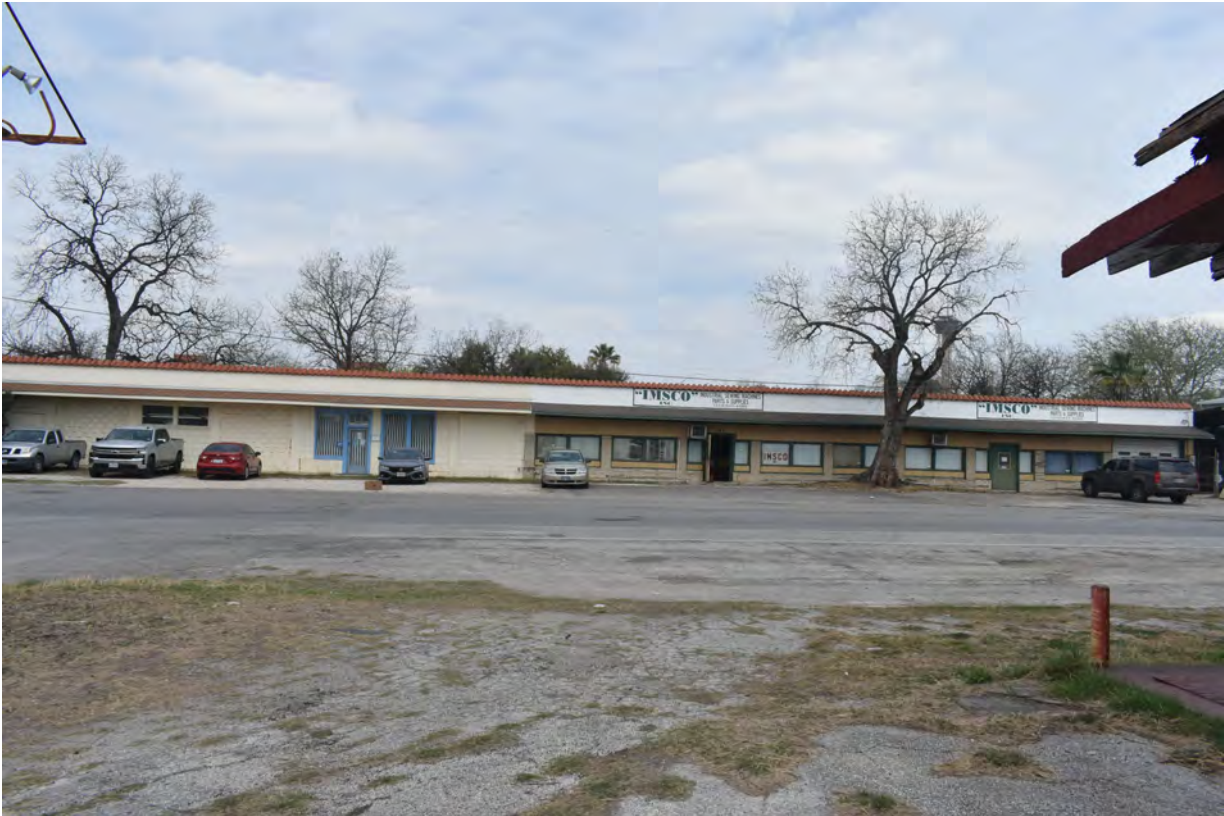
View facing north.

Type: Building	Exterior materials: concrete/cinder block	Primary roof type: flat	Alterations: Completely modified from its original appearance
Style: No style	brick	with parapet	Garage enclosed
Form: Rectangular	Porch: full-width projecting		Garage door(s) replaced
			Windows replaced – all visible
			Storefront altered/replaced

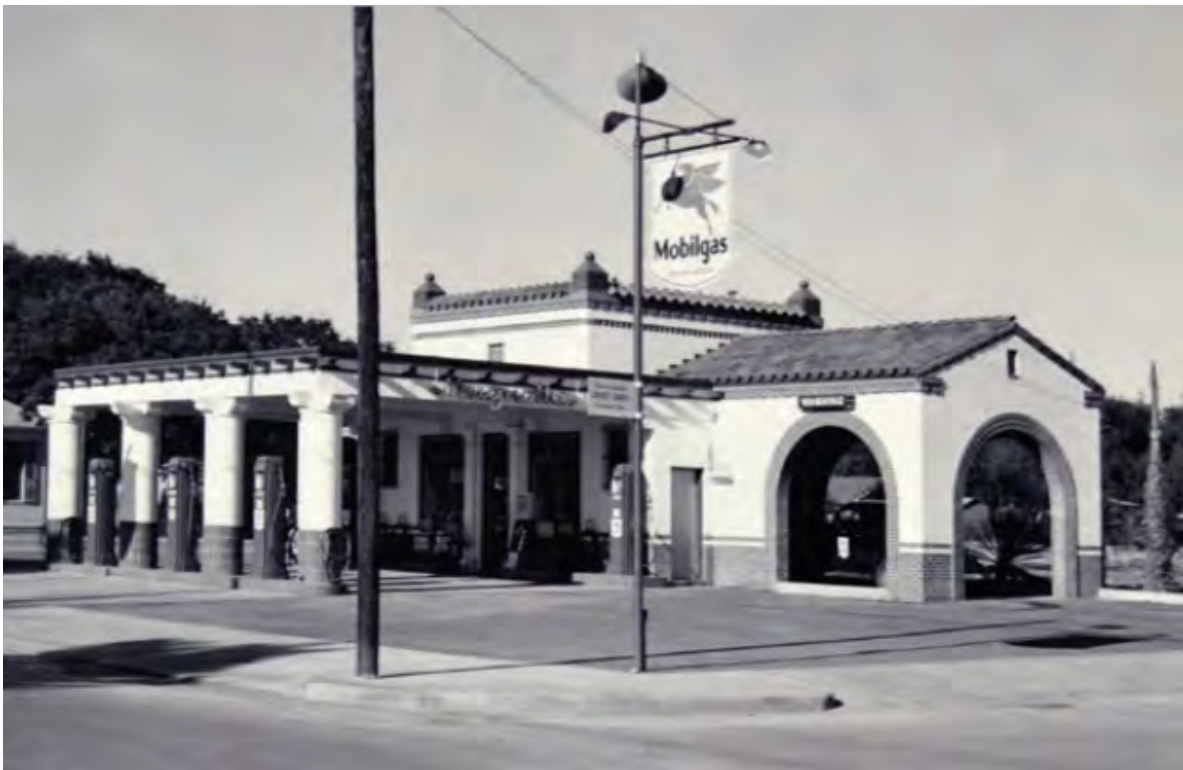
Resource in 1930s prior to alteration into a restaurant (Texas Historical Commission); view facing northeast.

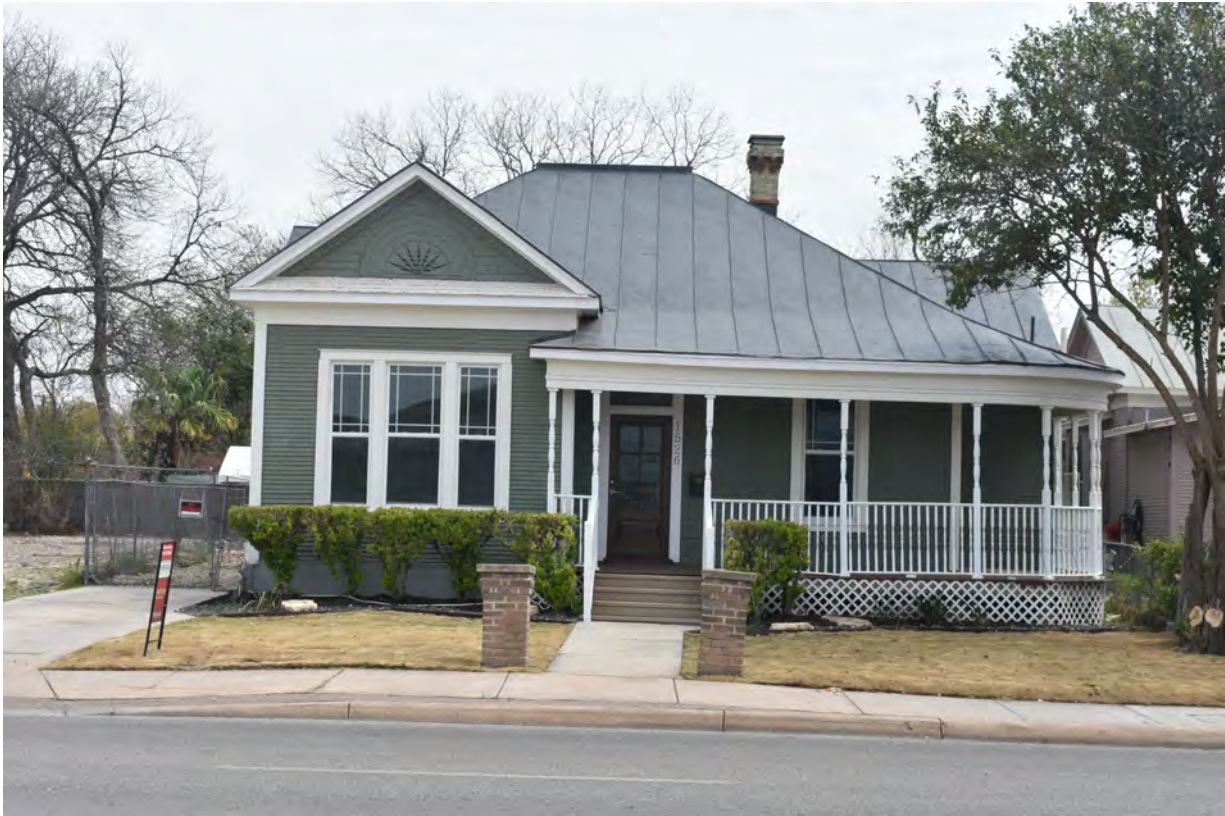
View facing east.

Type: Building	Exterior materials: wood siding	Primary roof type: gable-on-hip	Alterations: Roof replaced w/ incomp. materials Addition to rear/side elevation Doors replaced
Style: Folk Victorian			
Form: Rectangular	Porch: wraparound projecting
