Resource ID: 226A	Parcel ID: 1213123	Year Built: 1889	Year Source: NRHP Nomination Form
Address: 925 S SAINT MARYS ST., SAN ANTONIO, TX		Latitude: 29.414091	County: Bexar
Name: James Butler Bonham Elementary School (Bonham Academy)		Longitude: -98.489459	
Historic Function/Subcategory: Education/School		Indiv. NRHP Eligible? Listed	Effect: No Adverse Effect
Current Function/Subcategory: Education/School		Contributing to NRHP Property/District? Yes

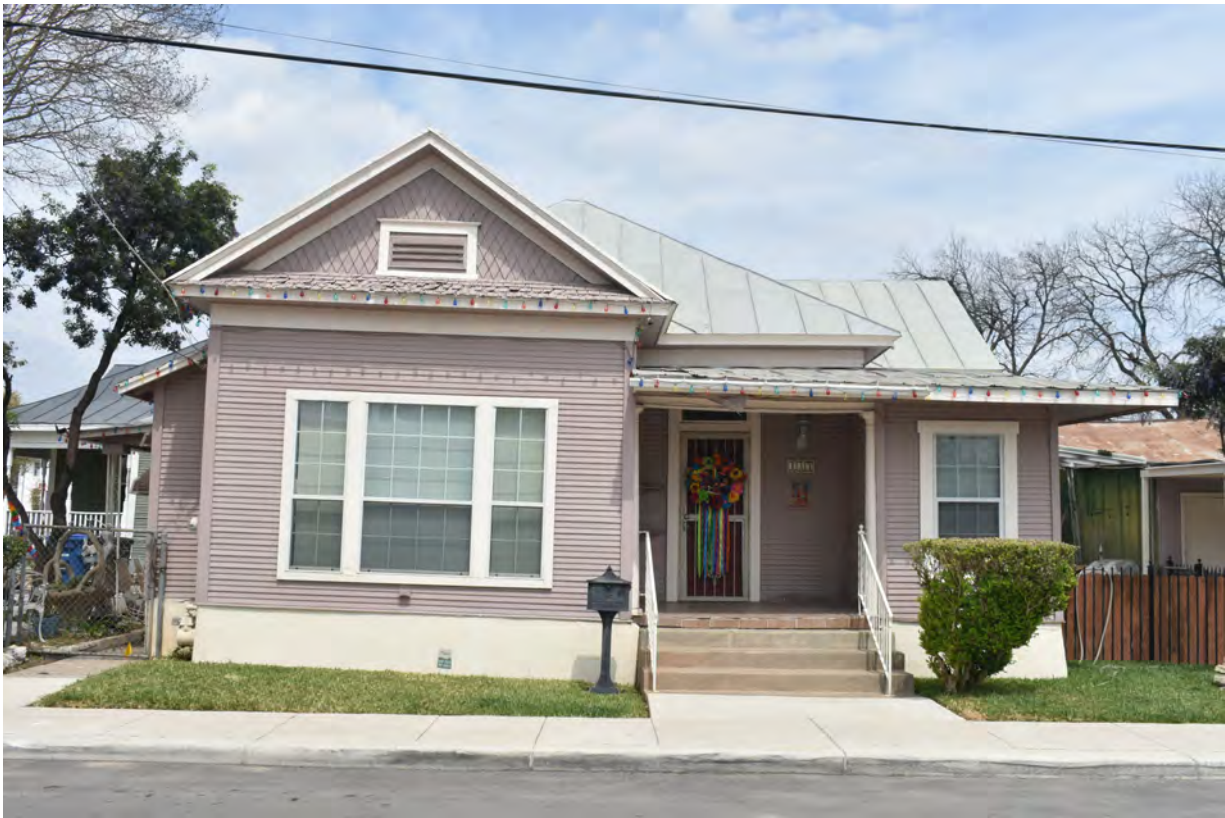
Resource A
(Historic-age);
view facing north.

Type: Building	Exterior materials: wood siding	Primary roof type: gable-on-hip	Alterations: Roof replaced w/ incomp. materials Windows replaced – all visible Entry stairs and railing replaced Door/entrance added Addition to rear/side elevation Awning(s) added
Style: Folk Victorian			
Form: Rectangular	Porch: partial-width integrated

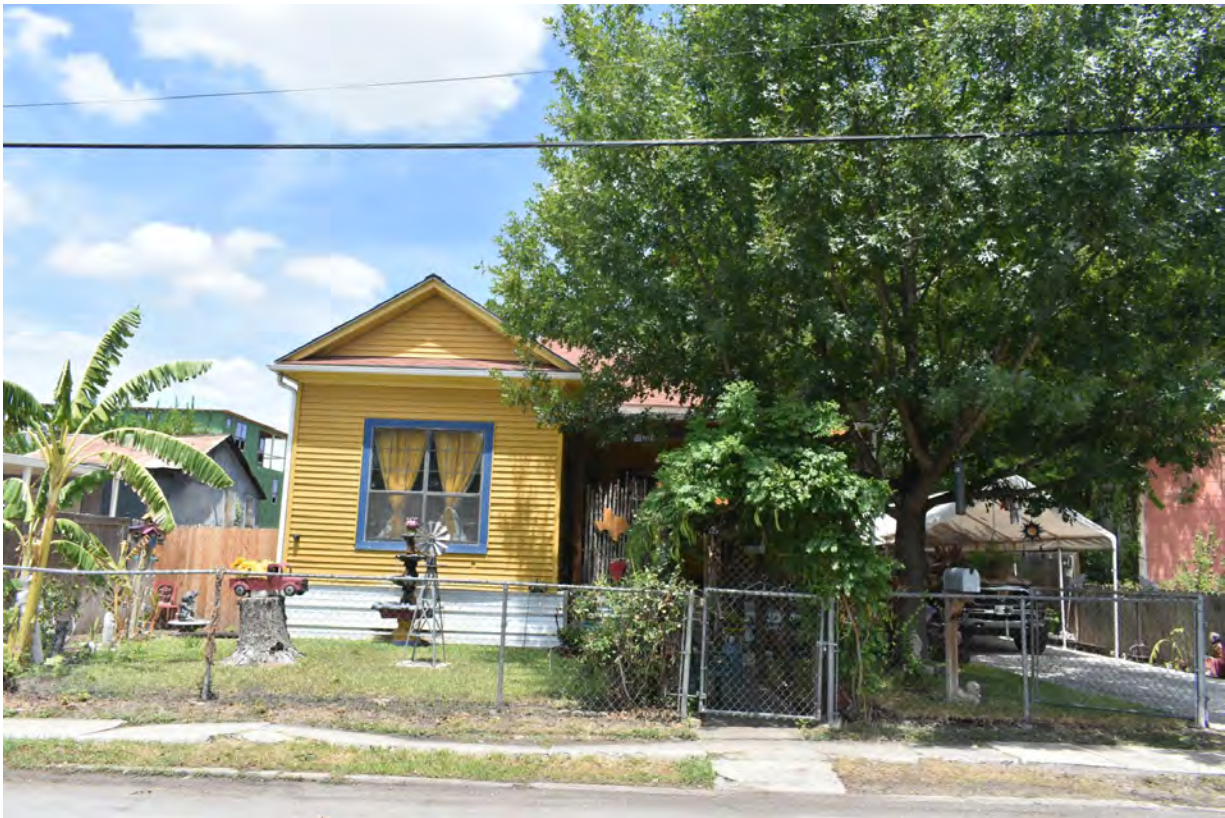
View facing northwest.

Type: Building	Exterior materials: vinyl siding	Primary roof type: hipped	Alterations: Windows replaced – all visible Porch rails replaced Metal skirting added Addition to rear/side elevation
Style: Folk Victorian			
Form: Rectangular	Porch: partial-width set within ell

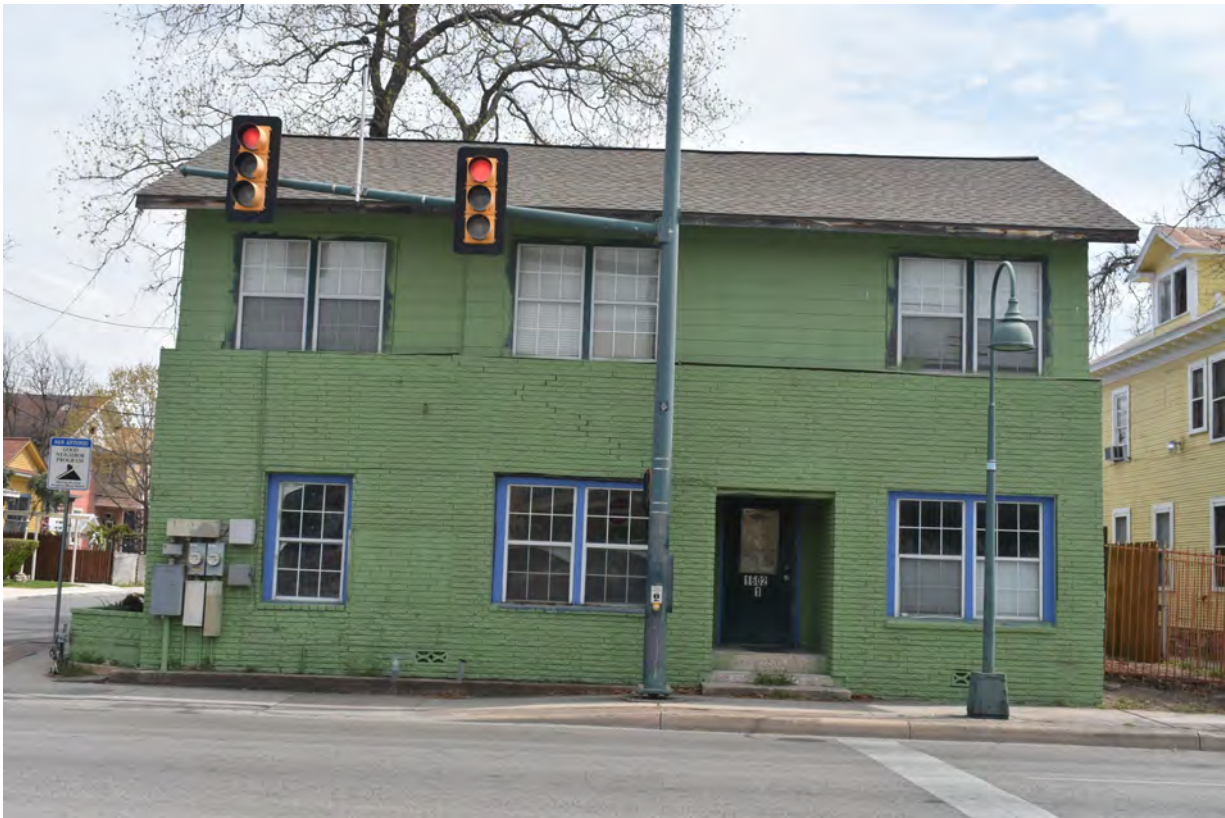
View Resource A facing east.

Type: Building	Exterior materials: vinyl siding brick	Primary roof type: gable, side	Alterations: Windows replaced – all visible Window opening(s) infilled Doors replaced Addition to upper story
Style: No style			
Form: Rectangular	Porch: stoop integrated

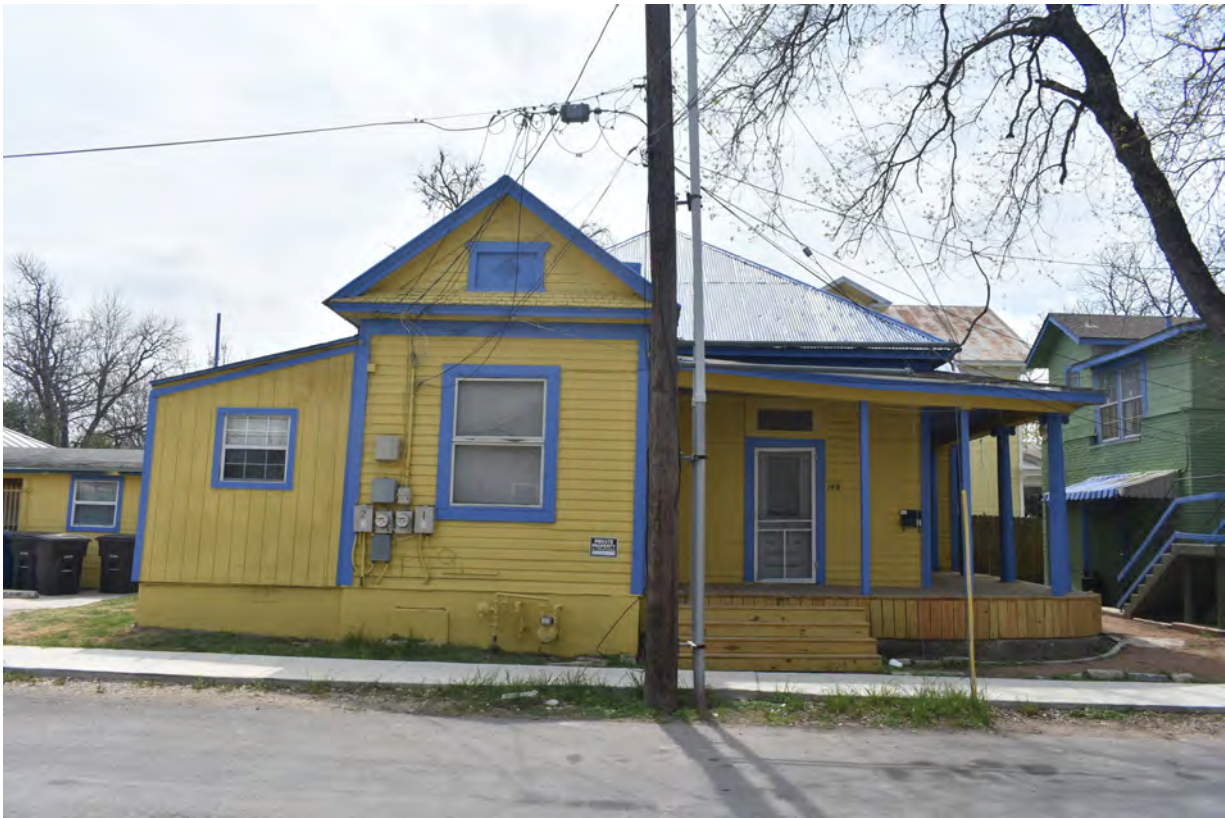
View facing south.

Type: Building	Exterior materials: vinyl siding brick	Primary roof type: gable-on-hip	Alterations: Wall cladding replaced Roof replaced w/ incomp. materials Window opening(s) infilled Door/entrance added Porch rails replaced Porch support(s) replaced Windows replaced – all visible Relocated
Style: Folk Victorian			
Form: Rectangular	Porch: N/A

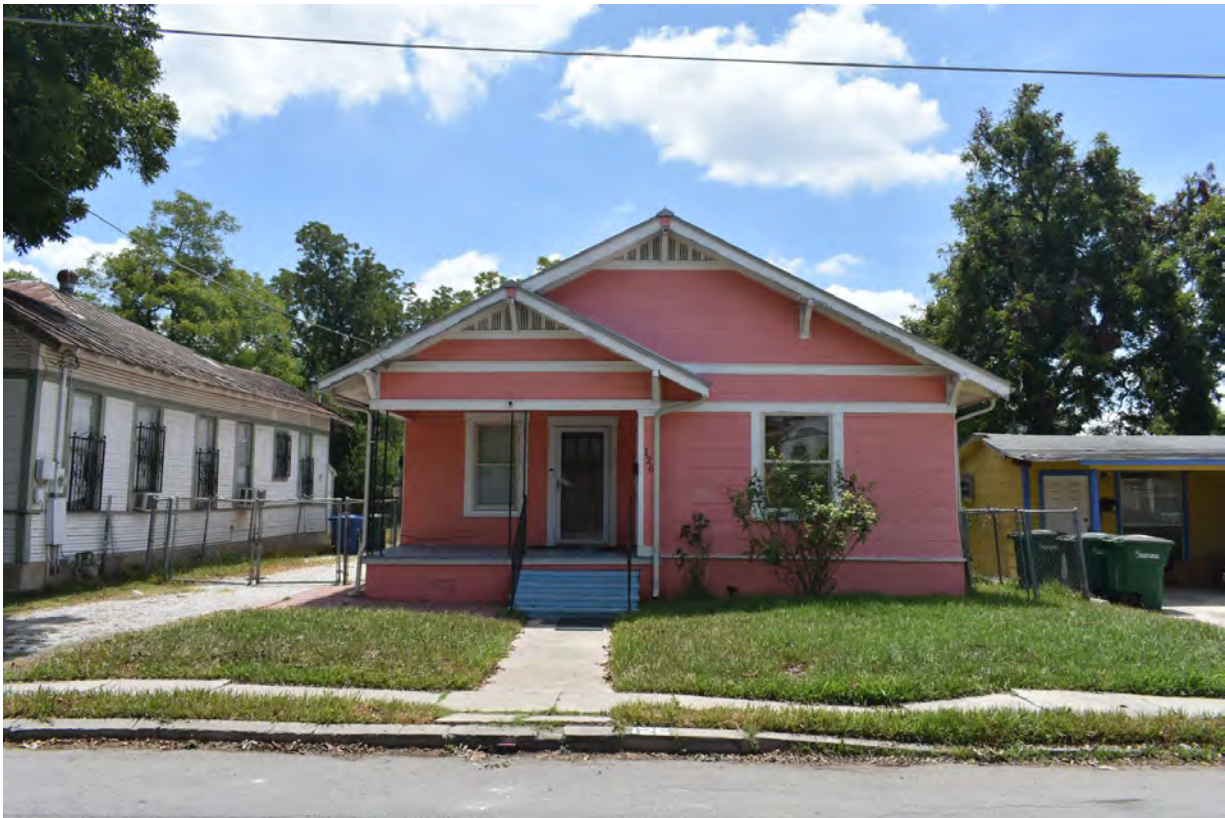
View facing southeast.

Type: Building	Exterior materials: asbestos	Primary roof type: gable, front	Alterations: Windows replaced – all visible Porch support(s) replaced Door (primary) replaced
Style: Craftsman			
Form: Bungalow	Porch: partial-width projecting

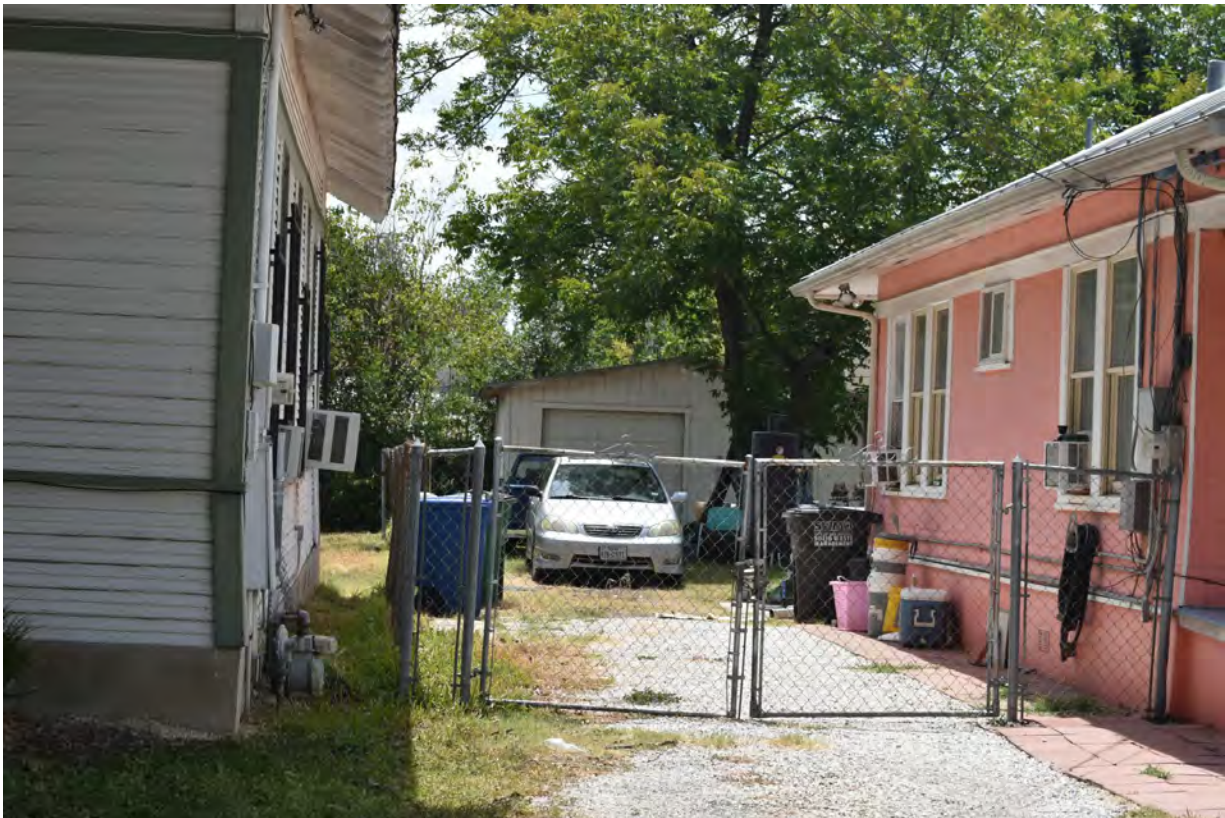
View facing south.

Type: Building	Exterior materials: wood siding panels	Primary roof type: gable, front	Alterations: Garage door(s) replaced
Style: No style			
Form: Rectangular	Porch: N/A

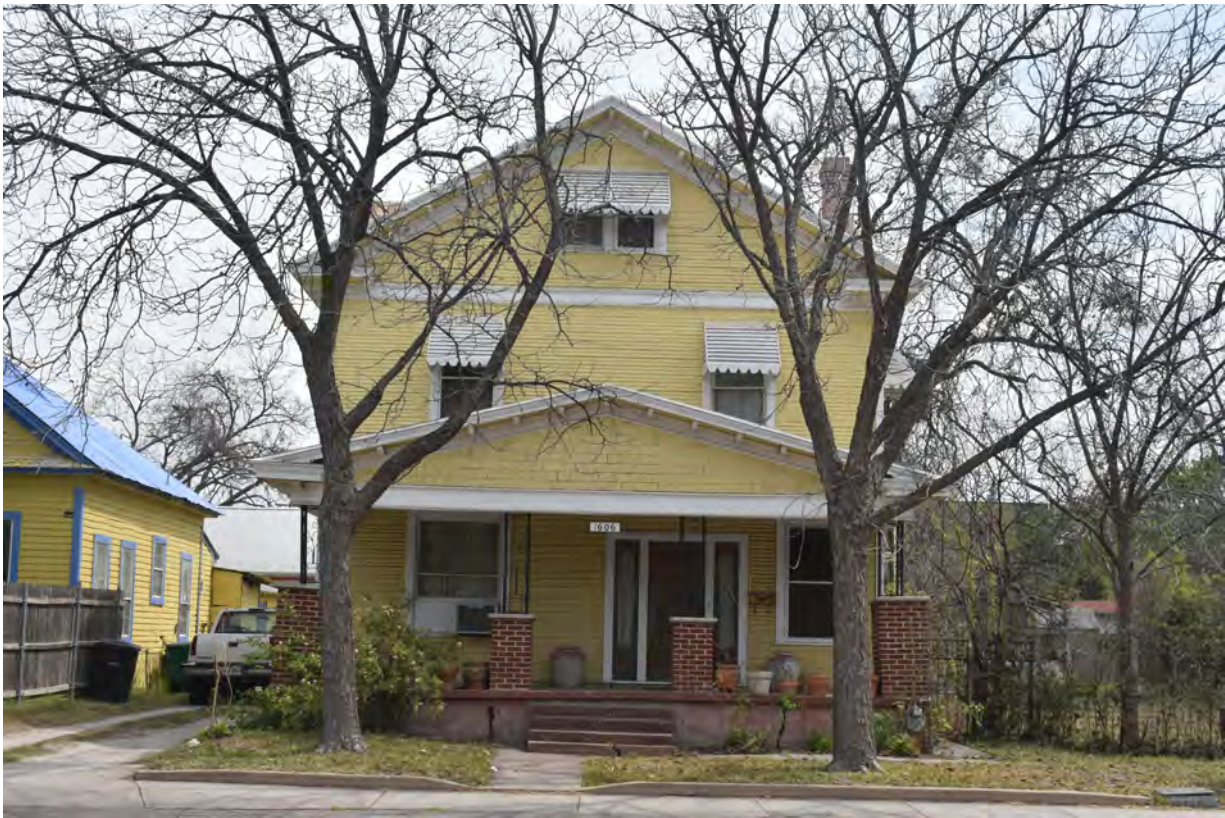
View facing east.

Type: Building	Exterior materials: wood siding wood shingles	Primary roof type: gable, front	Alterations: Awning(s) added Porch support(s) and rails replaced Window opening(s) infilled Glazing replaced at door (primary)
Style: Colonial Revival			
Form: Rectangular	Porch: full-width projecting

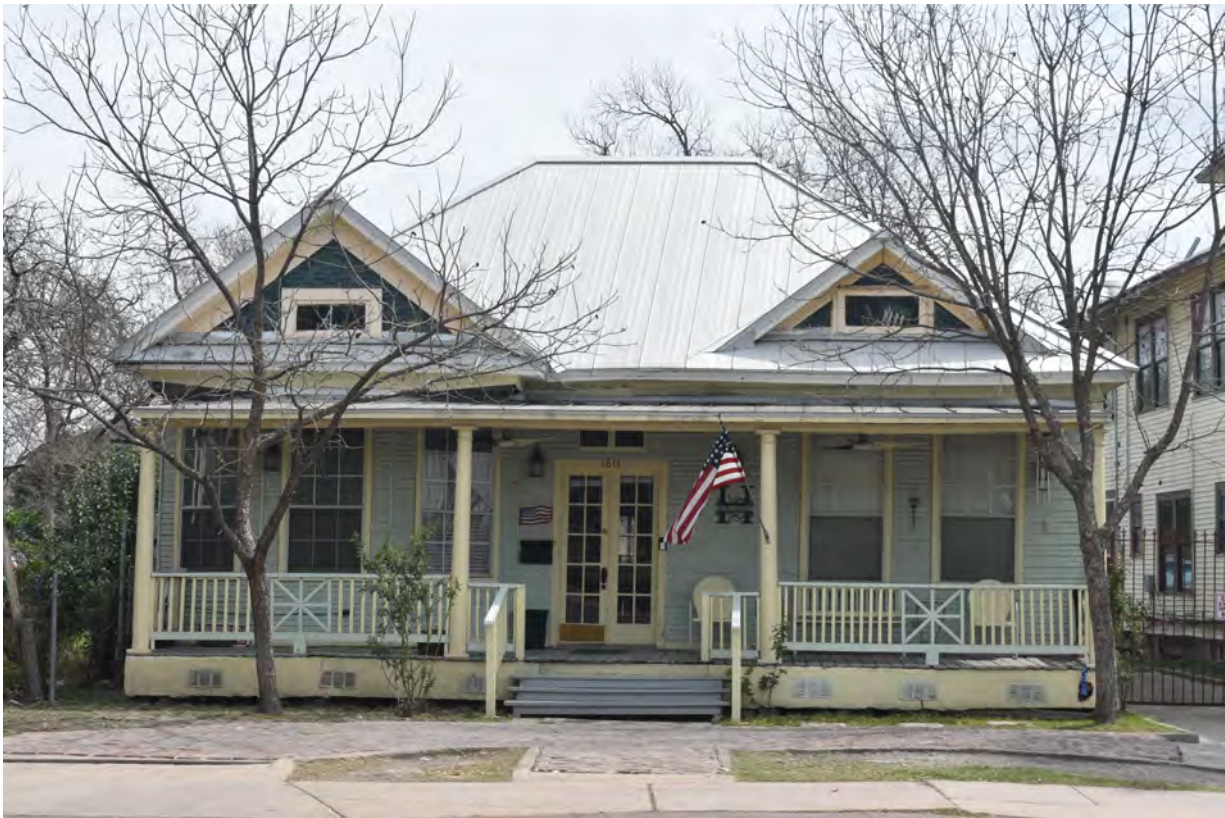
View facing east.

Type: Building	Exterior materials: wood siding	Primary roof type: gable-on-hip	Alterations: Door (primary) replaced Windows replaced – all visible
Style: Folk Victorian			
Form: Rectangular	Porch: full-width projecting

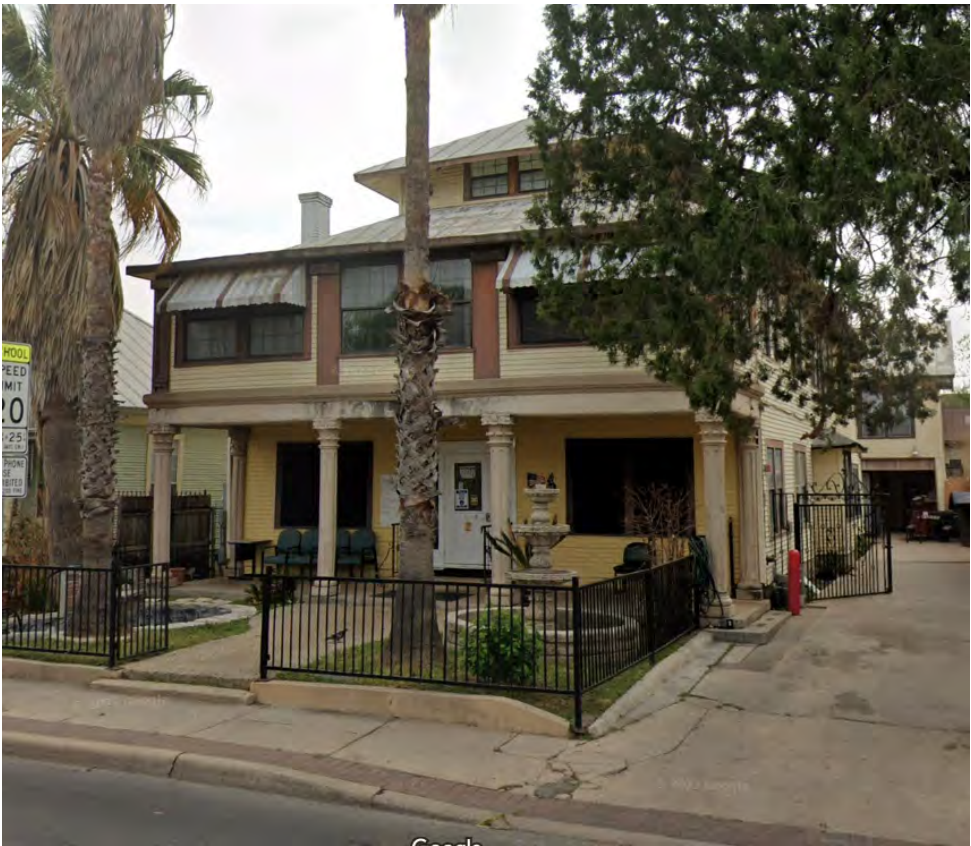
View facing east.

Type: Building	Exterior materials: wood siding vinyl siding	Primary roof type: hipped	Alterations: Additions have doubled the building's size Windows replaced – all visible Roof replaced w/ incomp. materials Door (primary) replaced Wall cladding replaced - some Porch enclosed
Style: No style			
Form: Irregular	Porch: full-width integrated

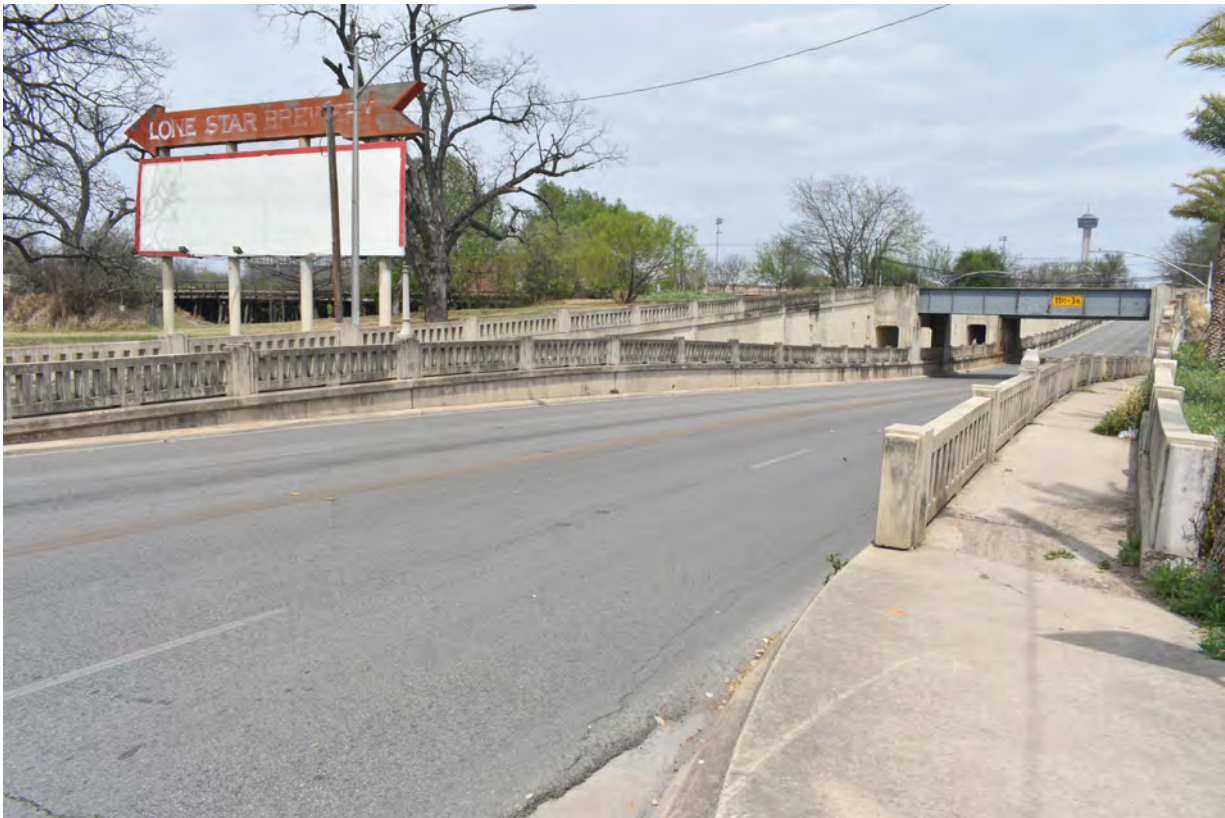
View facing north;
note the south
overpass (inactive)
on right.

Type: Structure	Exterior materials: concrete	Primary roof type: N/A	Alterations: Missing lamps/lamp posts Damage to balustrade
Style: Art Deco	metal		
Form: Bridge	Porch: N/A

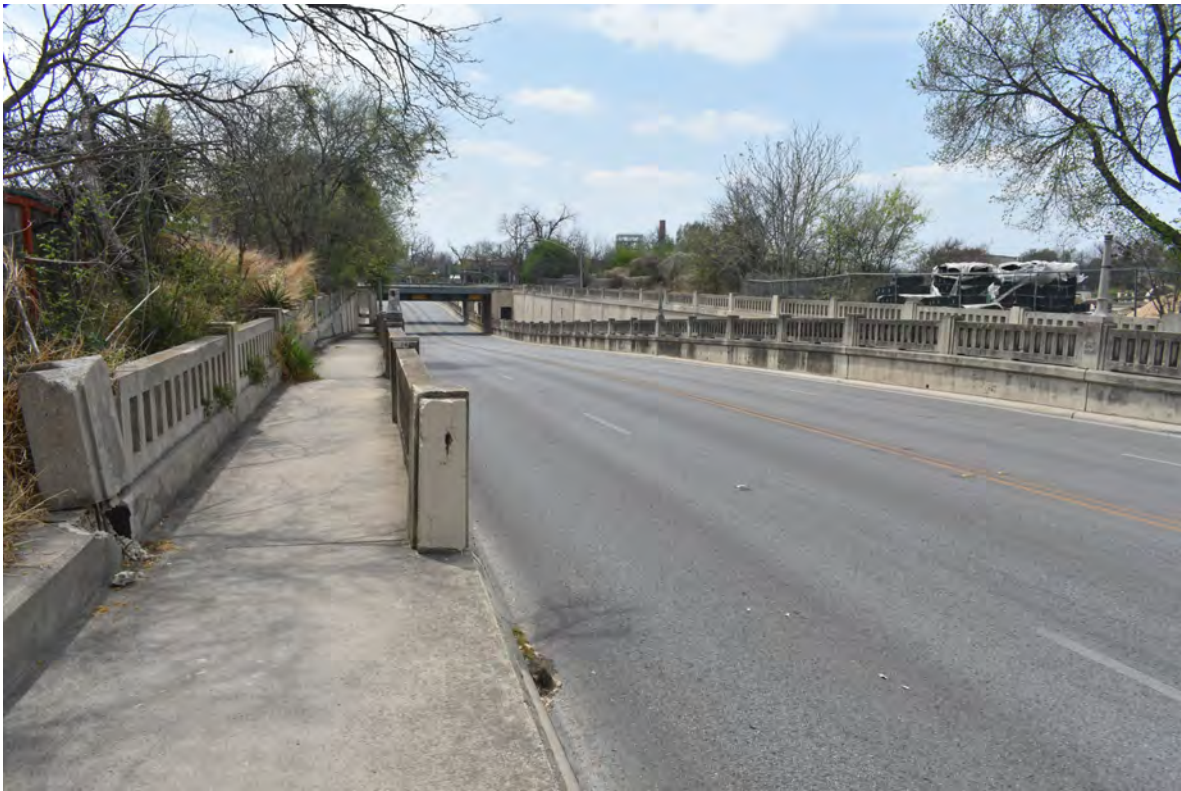
View facing southwest; note the north (active) overpass on left.

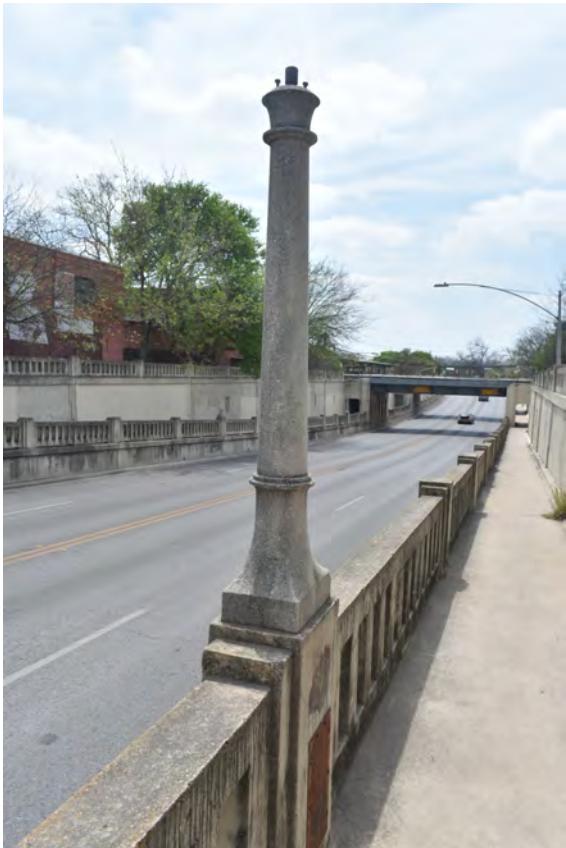
Lamp detail; view facing south.

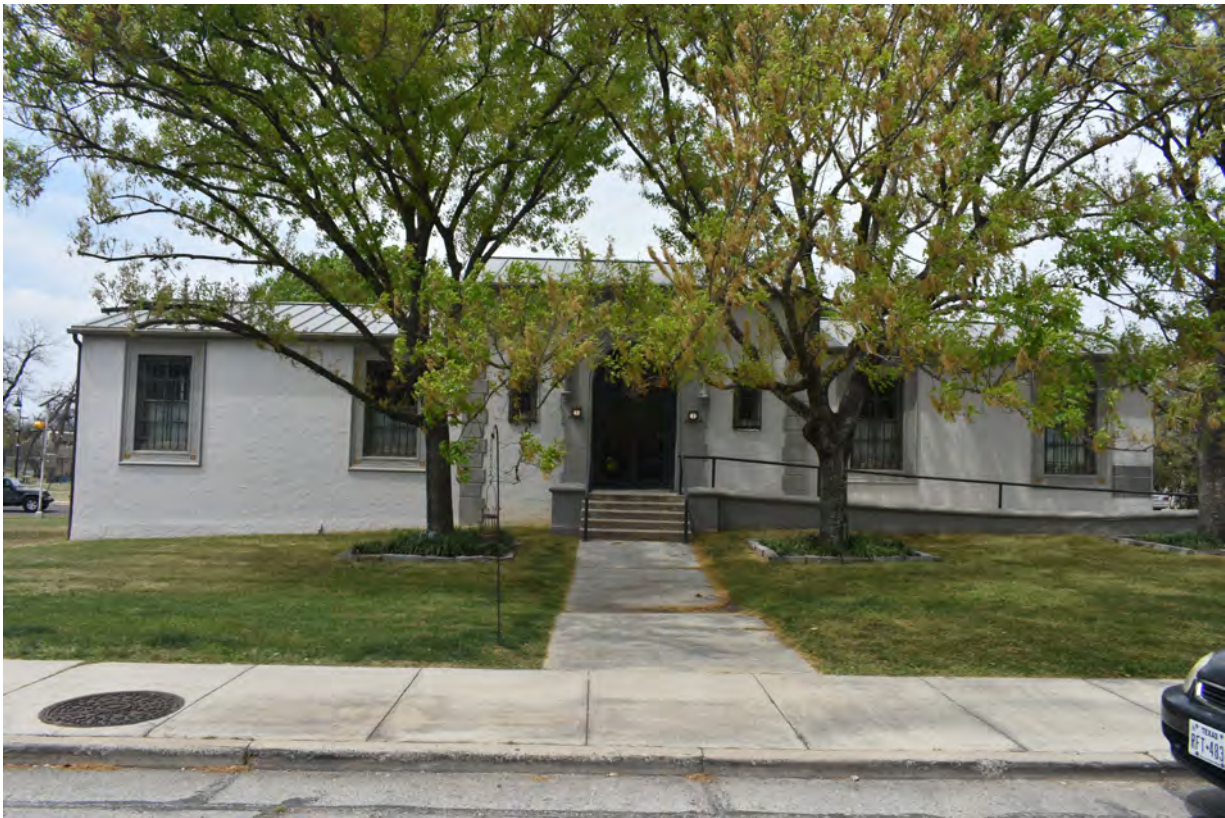
View facing west.

Type: Building	Exterior materials: stucco	Primary roof type: gable, crossed	Alterations: Roof replaced w/ incomp. materials Doors replaced Addition to rear/side elevation
Style: Neoclassical			
Form: T-plan	Porch: stoop projecting

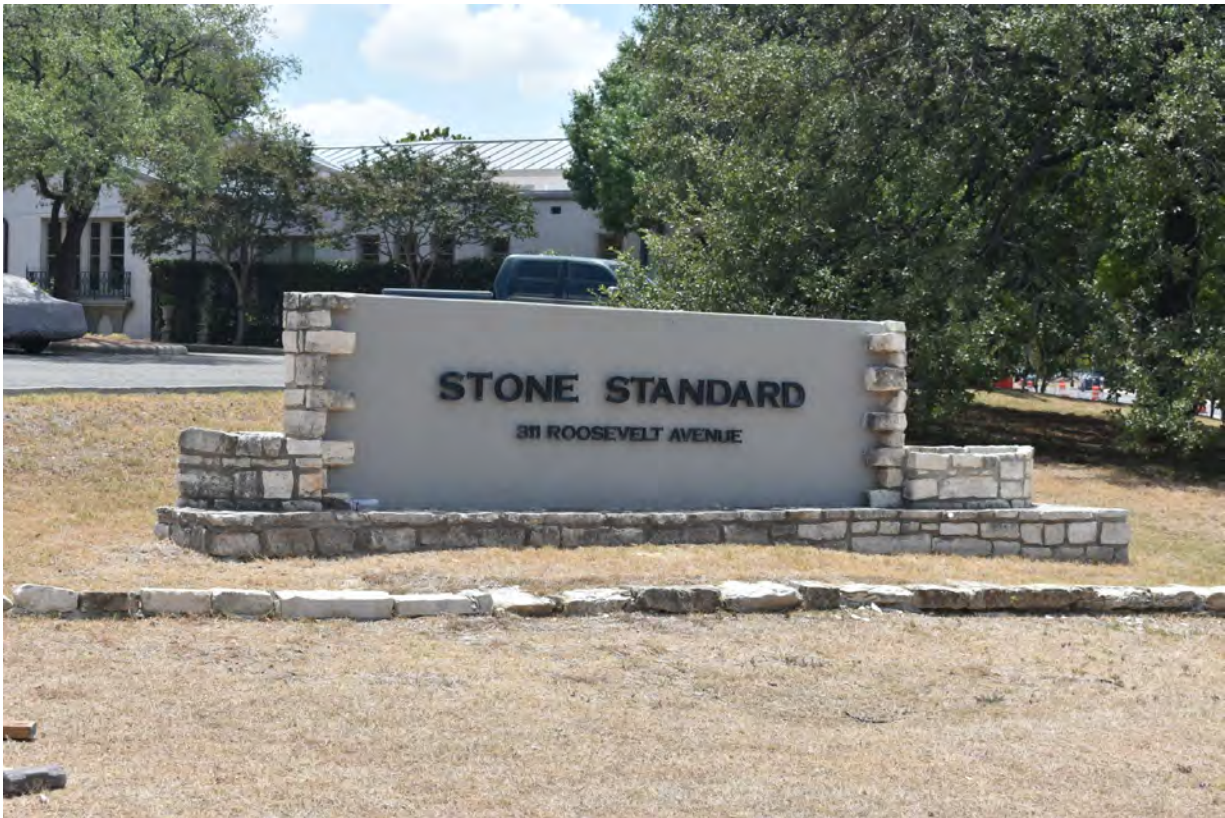
View facing southeast.

Type: Structure	Exterior materials: stone stucco	Primary roof type: N/A	Alterations: Signage changed
Style: Rustic			
Form: Rectangular	Porch: N/A

This sign does not embody distinctive characteristics of a type, period, or method of construction and it does not represent the work of a master or possess high artistic value. Additionally, no associations were identified linking it to persons or events of historic importance. Because the building offers neither a local interpretation of a standard design nor an undocumented construction technique, it has limited potential to yield important information. As a result, it is recommended not eligible for the NRHP under Criterion A, B, C, or D.

The sign is recommended a non-contributing resource to Resource A, the Roosevelt Park Public Library.

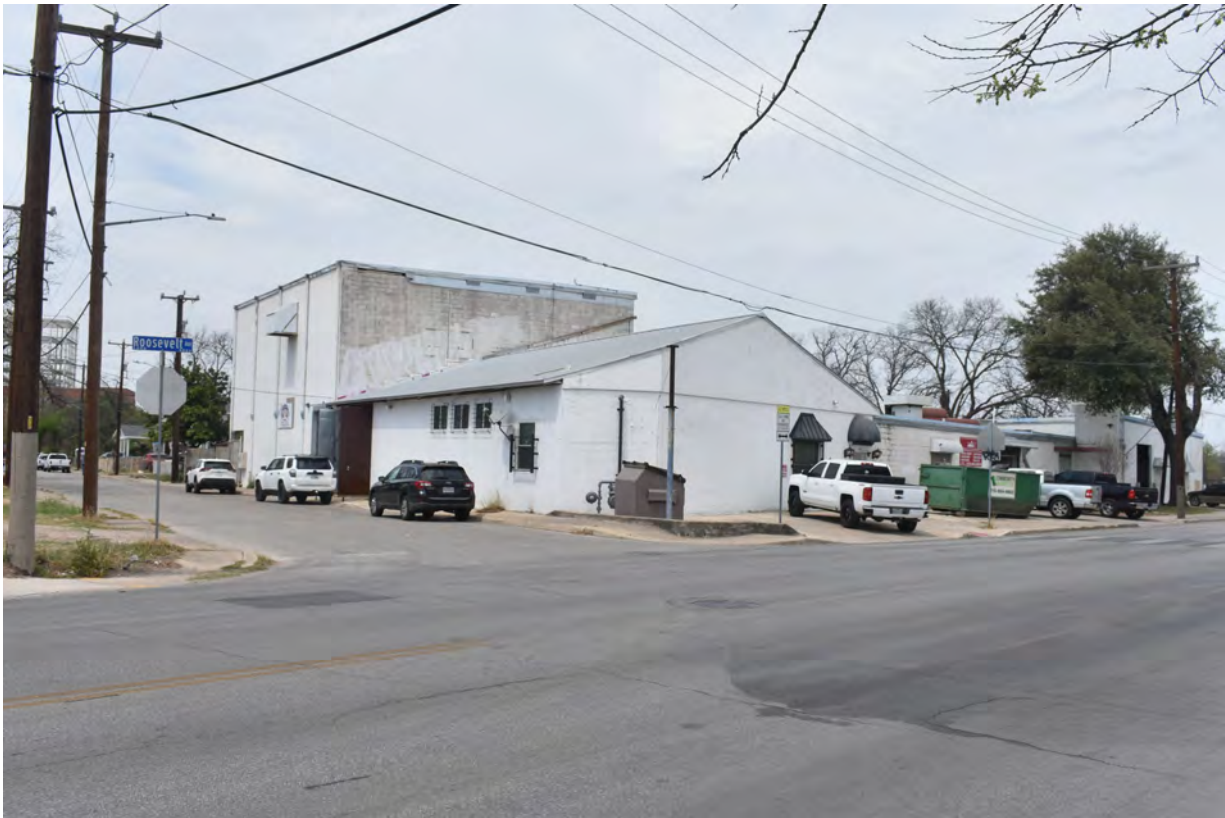
View facing northwest.

Type: Building	Exterior materials: concrete/cinder block stucco	Primary roof type: gable, front flat	Alterations: Door (primary) replaced Windows replaced – some Addition to rear/side elevation Roofline altered Window opening(s) infilled/added Garage enclosed Awning(s) added
Style: No style			
Form: Irregular	Porch: stoop projecting

There is a building at this location on a 1955 aerial that has a similar rectangular footprint to the portion of the existing resource at the corner of Roosevelt Ave and Yellowstone Ave; however, this building has a flat roof rather than the existing gabled roof. This is likely the same building pictured at this location on the 1951 Sanborn. Sometime around 1963, the resource was likely altered. The flat roof was replaced with the existing gable roof, and a large one-to-two-story addition constructed to the north and west, surrounding the original portion of the building on two sides. A newspaper search reveals that this building was occupied by the Guess Towel and Uniform company beginning in the late 1950s through at least the early 1970s (San Antonio Express 1957, 1976).

This resource does not embody distinctive characteristics of a type, period, or method of construction and it does not represent the work of a master or possess high artistic value. Additionally, no associations were identified linking it to persons or events of historic importance. Furthermore, integrity has been diminished as outlined above. Because the building offers neither a local interpretation of a standard design nor an undocumented construction technique, it has limited potential to yield important information. As a result, it is recommended not eligible for the NRHP under Criterion A, B, C, or D.

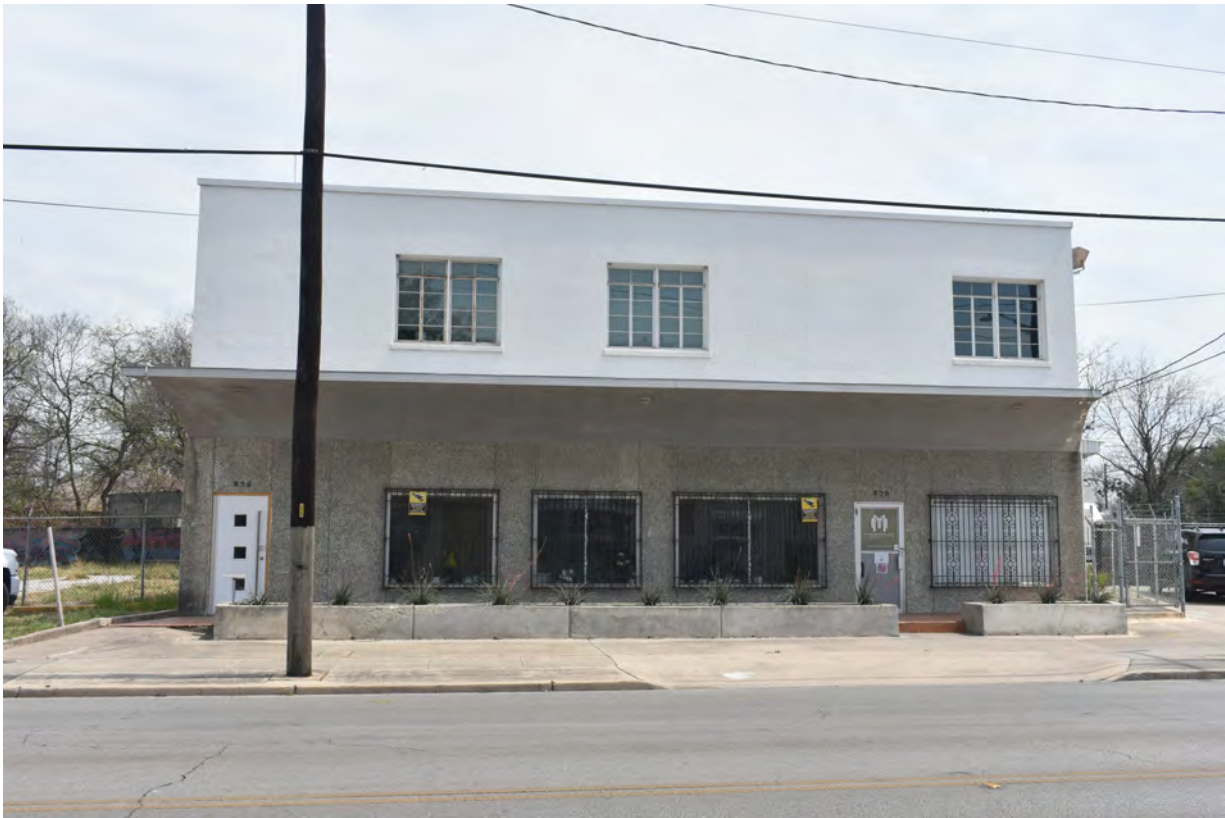
View facing east.

Type: Building	Exterior materials: stucco	Primary roof type: flat	Alterations: Doors replaced
Style: International	aggregate concrete panels	with parapet	Windows added (south elevation)
Form: Rectangular	Porch: full-width projecting

This resource does not embody distinctive characteristics of a type, period, or method of construction and it does not represent the work of a master or possess high artistic value. Additionally, no associations were identified linking it to persons or events of historic importance. As a result, it is recommended not individually eligible for listing in the NRHP under Criterion A, B, or C.

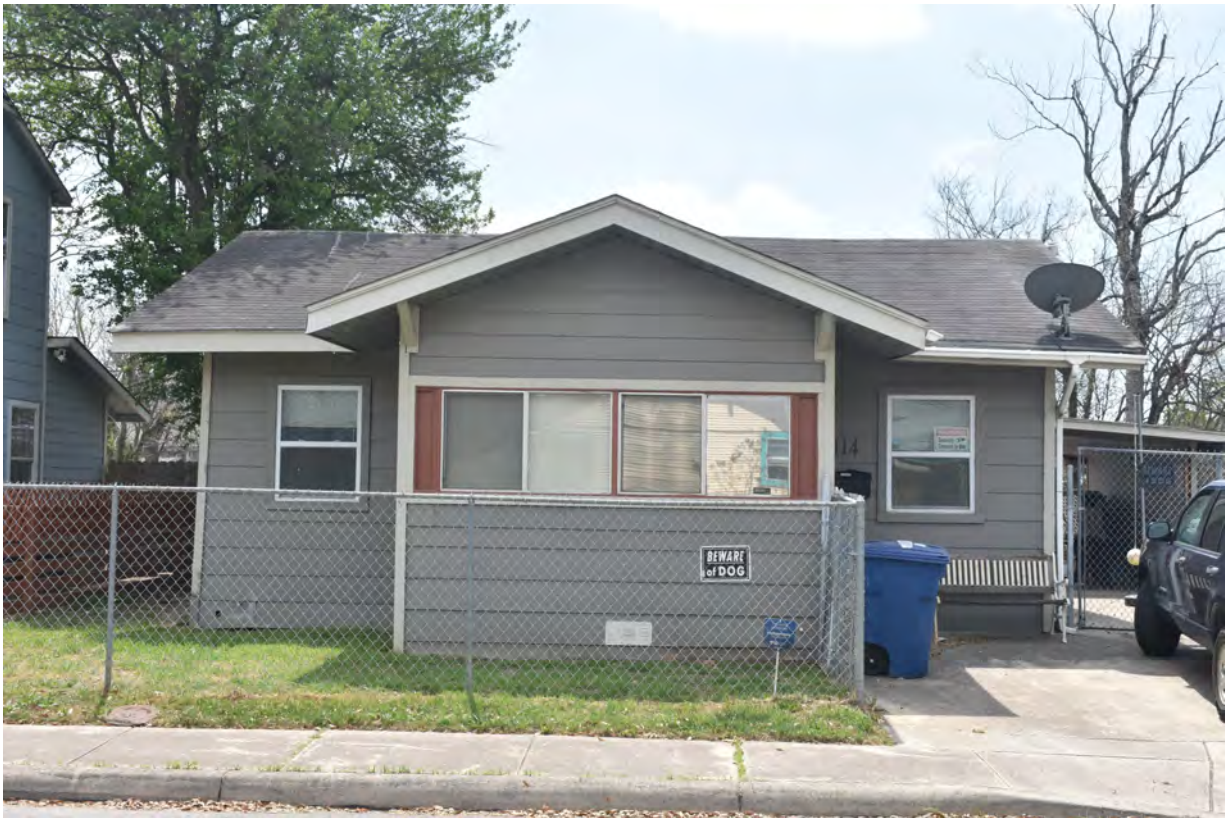
View facing south.

Type: Building	Exterior materials: wood siding	Primary roof type: gable, crossed	Alterations: Completely modified from its original appearance Wall cladding replaced Windows replaced – all visible Parapet altered or removed Doors replaced Porch enclosed
Style: Craftsman			
Form: Bungalow	Porch: N/A

This resource was constructed sometime between 1904 and 1912 and does not represent a very early period of residential development in this area of San Antonio. Properties associated with early residential development were generally constructed between the 1870s and 1890s. Examples of such properties can be found in the neighboring King William National Register Historic District and South Alamo Street-South Saint Mary's Street National Register Historic District. The resource is instead associated with the ongoing trend in residential development in this neighborhood and has no significant associations linking it to events or trends of historic importance. The resource is also a highly altered example of a Craftsman-style residential building. Because the property's integrity has been impacted by alterations undertaken after its construction, it no longer embodies the distinctive characteristics that would make it significant as an example of the style and does not demonstrate any innovative, important, or outstanding design features. Additionally, no associations were identified linking it to persons of historic importance. Because the building offers neither a local interpretation of a standard design nor an undocumented construction technique, it has limited potential to yield important information. As a result, it is recommended not eligible for the NRHP under Criterion A, B, C, or D.

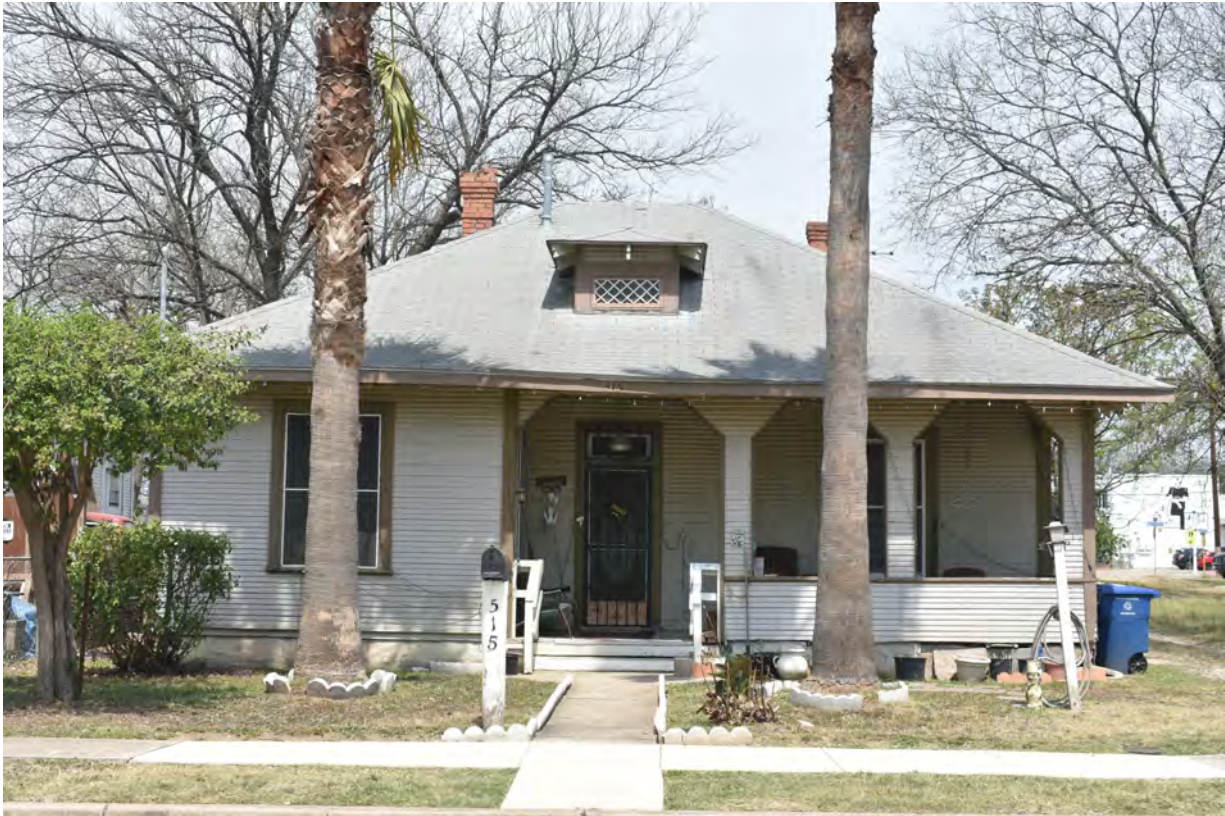
View facing north.

Type: Building	Exterior materials: wood siding	Primary roof type: hipped	Alterations: Wall cladding replaced Awning(s) added at rear Porch support(s) and rails replaced Chimney removed
Style: Craftsman			
Form: Bungalow	Porch: partial-width integrated

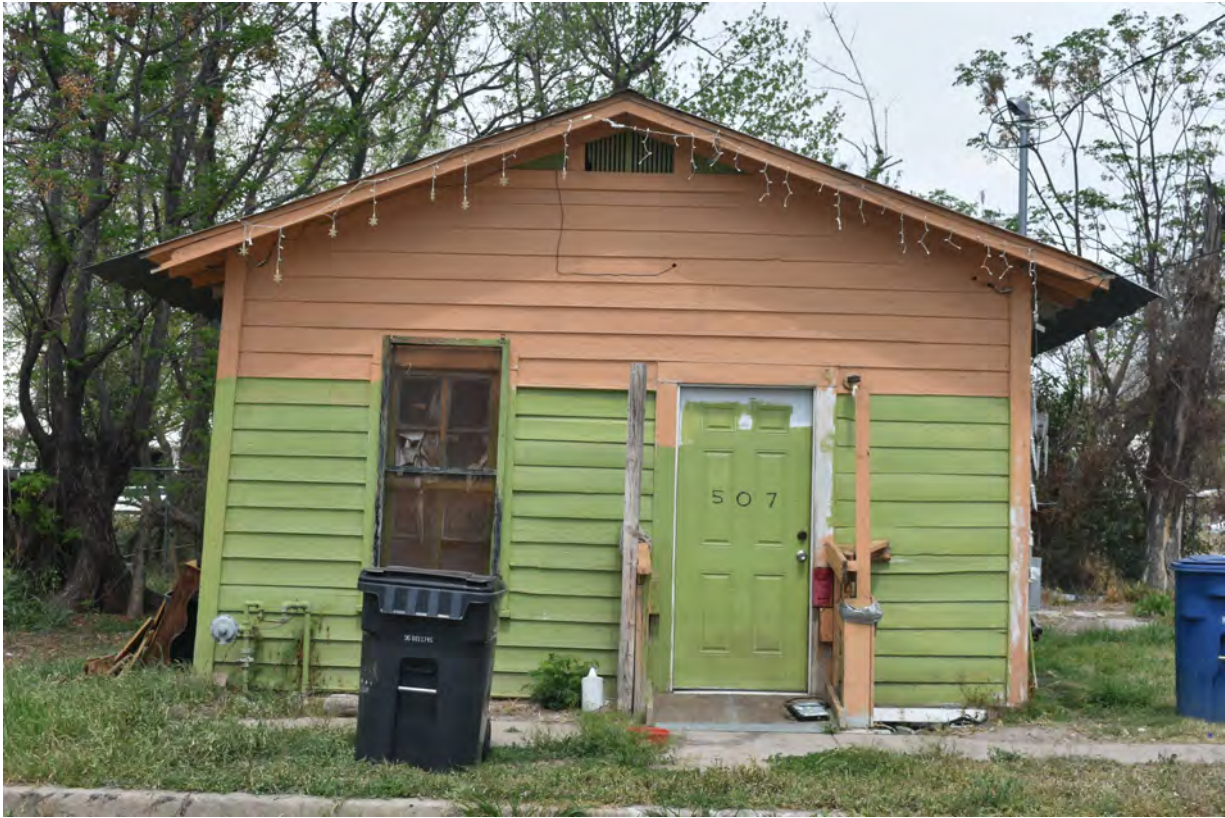
View facing north.

Type: Building	Exterior materials: wood siding	Primary roof type: gable, front	Alterations: Door (primary) replaced Awning on primary elevation removed Window(s) boarded Porch enclosed/rear addition
Style: No style			
Form: Rectangular	Porch: none

This resource does not embody distinctive characteristics of a type, period, or method of construction and it does not represent the work of a master or possess high artistic value. Additionally, no associations were identified linking it to persons or events of historic importance. Furthermore, integrity has been diminished as outlined above. Because the building offers neither a local interpretation of a standard design nor an undocumented construction technique, it has limited potential to yield important information. As a result, it is recommended not eligible for the NRHP under Criterion A, B, C, or D.

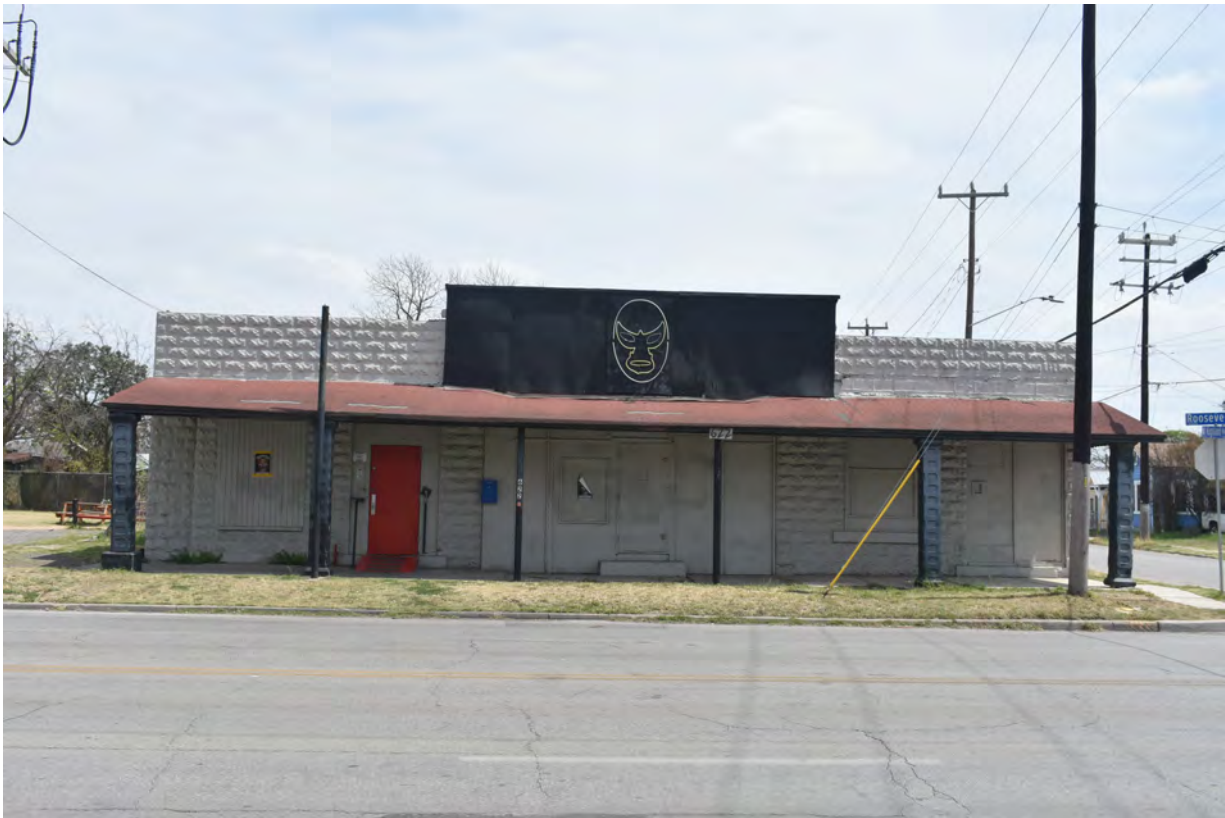
View facing east.

Type: Building	Exterior materials: brick	Primary roof type: gable, front flat	Alterations: Completely modified from its original appearance Storefront altered/replaced Wall cladding replaced - some Windows replaced – all visible Doors replaced
Style: No style			
Form: Rectangular	Porch: N/A

This resource is utilitarian in nature. It was not found to embody distinctive characteristics of a type, period, or method of construction, represent the work of a master, or possess high artistic value. Additionally, no associations were identified linking it to events or persons of historic importance. Furthermore, integrity has been diminished as outlined above. Because the building offers neither a local interpretation of a standard design nor an undocumented construction technique, it has limited potential to yield important information. As a result, it is recommended not eligible for the NRHP under Criterion A, B, C, or D.
