Resource ID: 226A	Parcel ID: 1213123	Year Built: 1889	Year Source: NRHP Nomination Form
Address: 925 S SAINT MARYS ST., SAN ANTONIO, TX		Latitude: 29.414091	County: Bexar
Name: James Butler Bonham Elementary School (Bonham Academy)		Longitude: -98.489459	
Historic Function/Subcategory: Education/School		Indiv. NRHP Eligible? Listed	Effect: No Adverse Effect
Current Function/Subcategory: Education/School		Contributing to NRHP Property/District? Yes

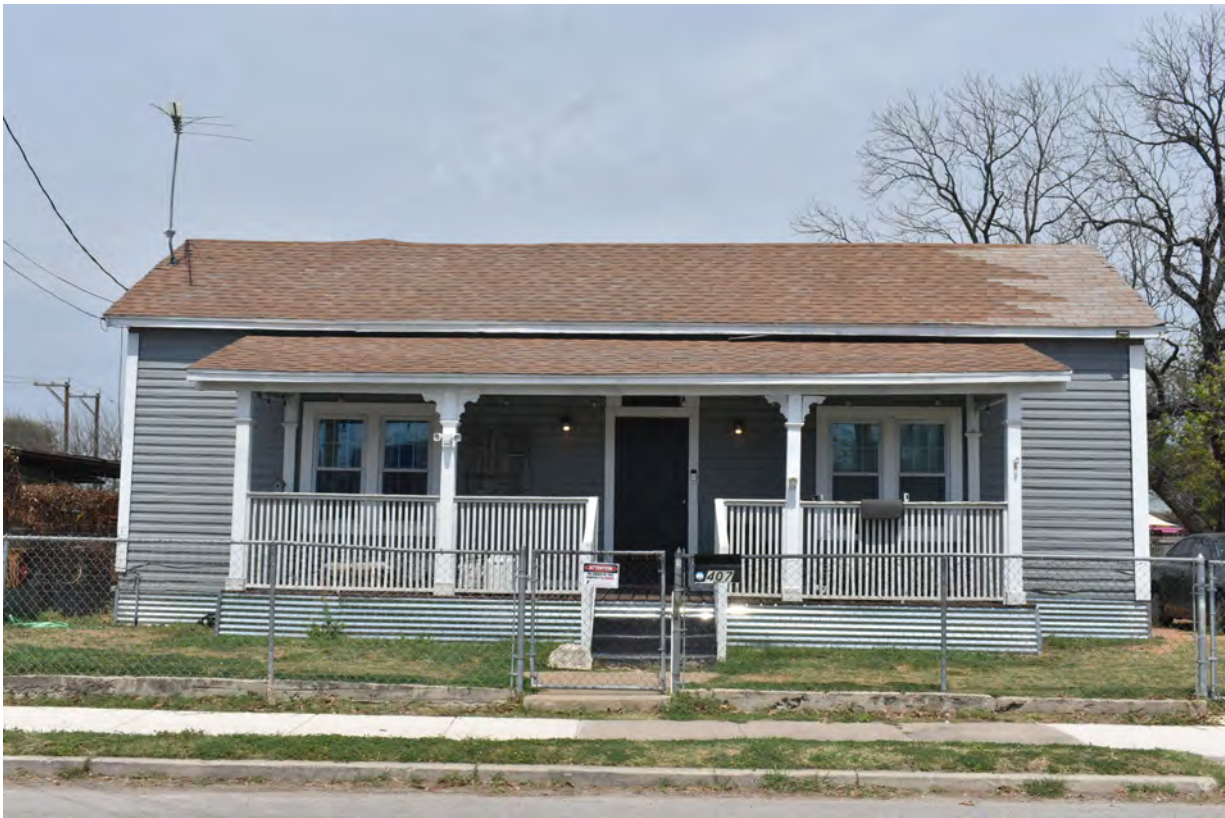
View facing north.

Type: Building	Exterior materials: wood siding	Primary roof type: gable, crossed	Alterations: Windows replaced – all visible Porch rails replaced Doors replaced Addition to rear/side elevation
Style: Folk Victorian			
Form: L-plan	Porch: partial-width projecting

This resource was constructed sometime between 1904 and 1912 and does not represent a very early period of residential development in this area of San Antonio. Properties associated with early residential development were generally constructed between the 1870s and 1890s. Examples of such properties can be found in the neighboring King William National Register Historic District and South Alamo Street-South Saint Mary's Street National Register Historic District. The resource is instead associated with the ongoing trend in residential development in this neighborhood and has no significant associations linking it to events or trends of historic importance. The resource is also a highly altered example of a Folk Victorian residential building. Because the property's integrity has been impacted by alterations undertaken after its construction, it no longer embodies the distinctive characteristics that would make it significant as an example of the style and does not demonstrate any innovative, important, or outstanding design features. Additionally, no associations were identified linking it to persons of historic importance. Because the building offers neither a local interpretation of a standard design nor an undocumented construction technique, it has limited potential to yield important information. As a result, it is recommended not eligible for the NRHP under Criterion A, B, C, or D.

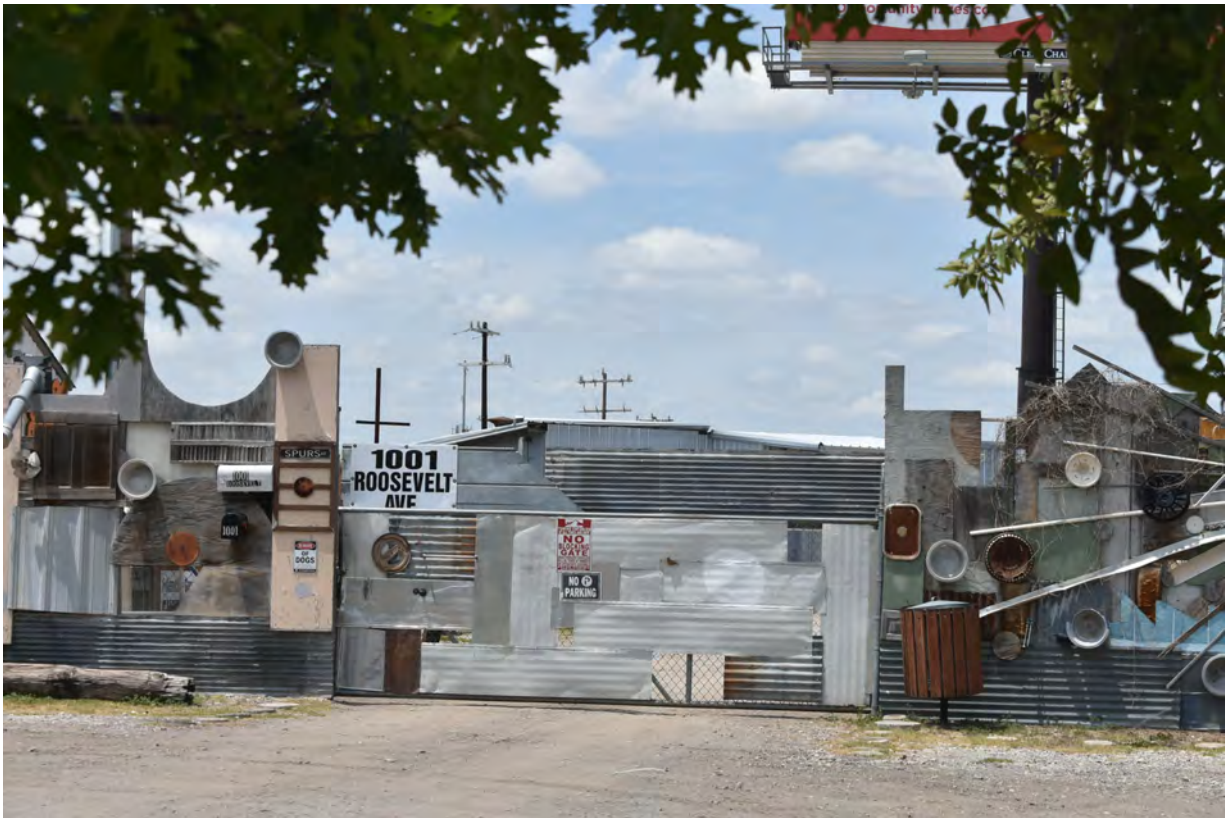
Resource A roof visible above fence (nonhistoric Resource G); view facing west.

Type: Building	Exterior materials: metal	Primary roof type: shed	Alterations: Garage door(s) replaced Wall cladding replaced Windows added
Style: No style			
Form: Rectangular	Porch: partial-width projecting

This resource does not embody distinctive characteristics of a type, period, or method of construction and it does not represent the work of a master or possess high artistic value. Additionally, no associations were identified linking it to persons or events of historic importance. Furthermore, integrity has been diminished based on material alterations of added windows, replaced wall cladding, and replaced garage doors. Because the building offers neither a local interpretation of a standard design nor an undocumented construction technique, it has limited potential to yield important information. As a result, it is recommended not eligible for the NRHP under Criterion A, B, C, or D.

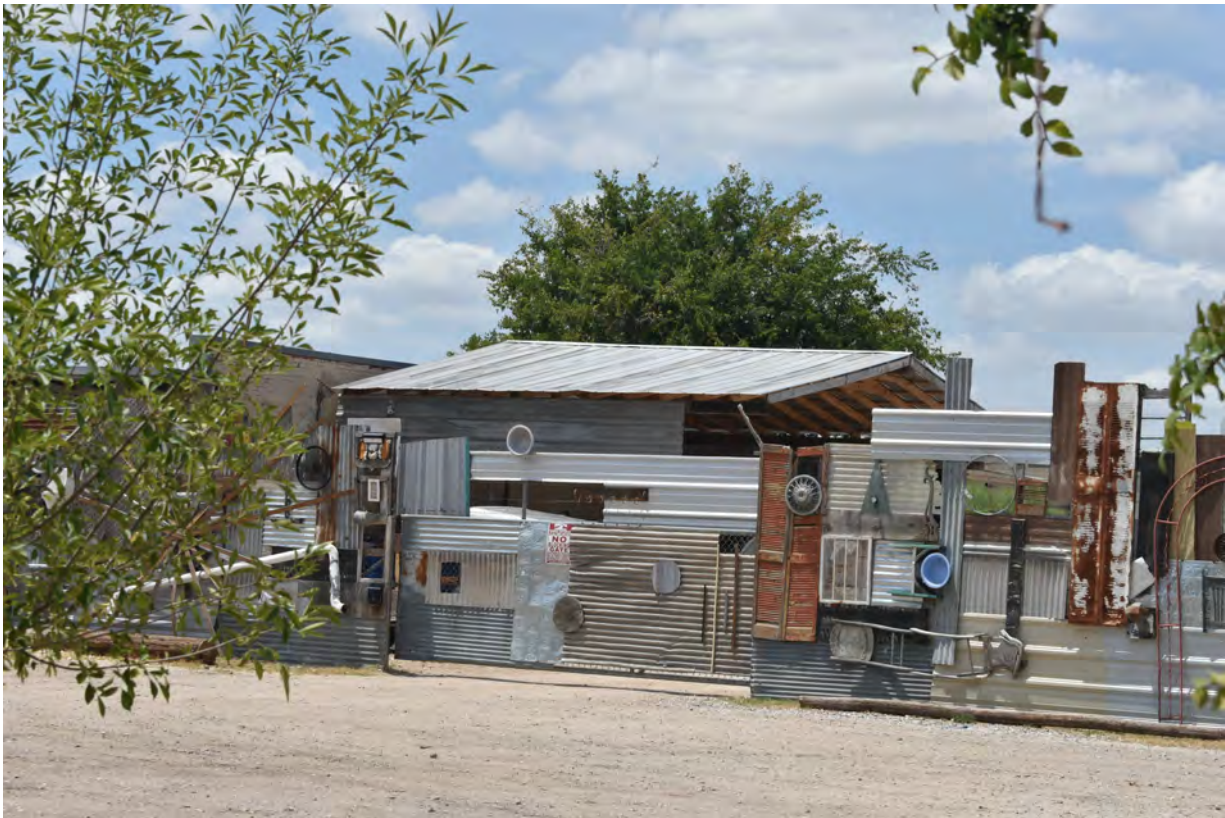
Resource B roof visible above fence (nonhistoric Resource G); view facing southwest.

Though it possesses integrity, this resource was not found to embody distinctive characteristics of a type, period, or method of construction, represent the work of a master, or possess high artistic value. Additionally, no associations were identified linking it to events or persons of historic importance. Because the building offers neither a local interpretation of a standard design nor an undocumented construction technique, it has limited potential to yield important information. As a result, it is recommended not eligible for the NRHP under Criterion A, B, C, or D.

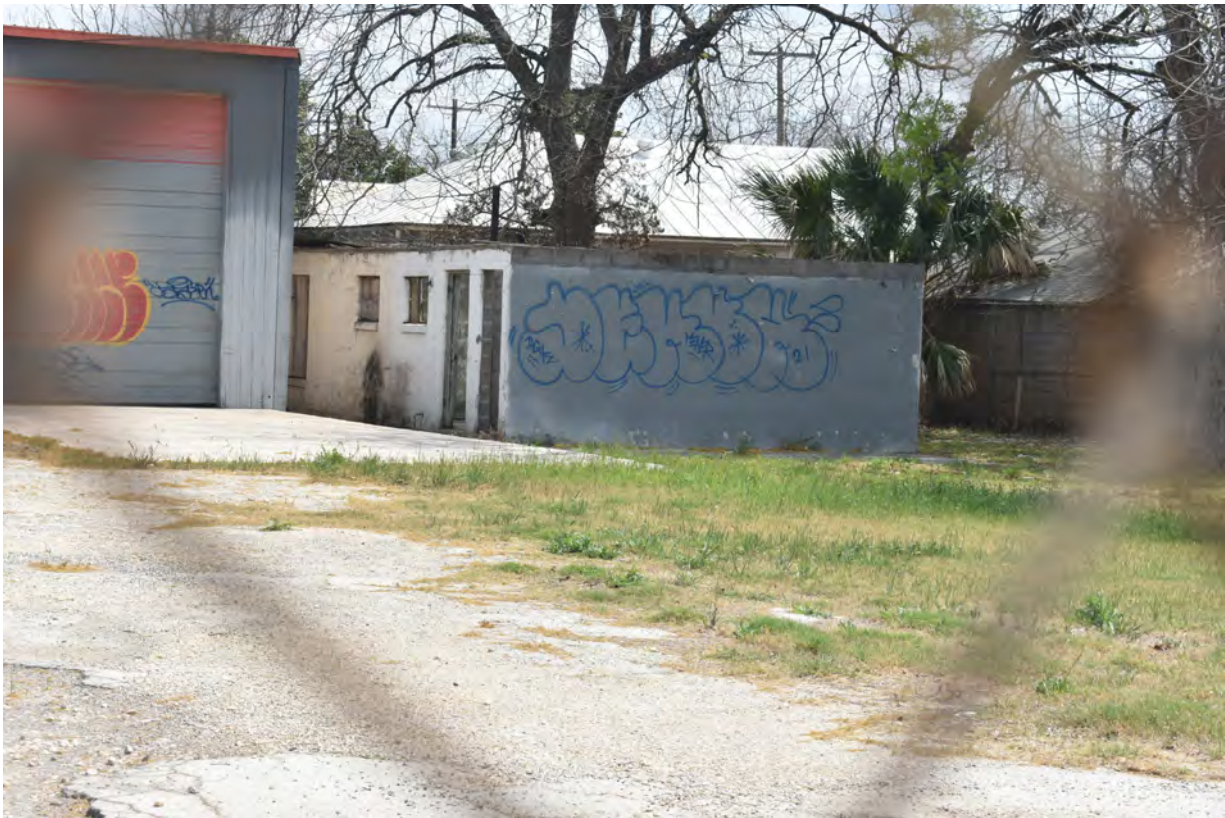
View facing east

Type: Building	Exterior materials: concrete/cinder block stucco	Primary roof type: flat (roof missing)	Alterations: Missing elements Graffiti Window(s) boarded
Style: No style			
Form: Rectangular	Porch: N/A

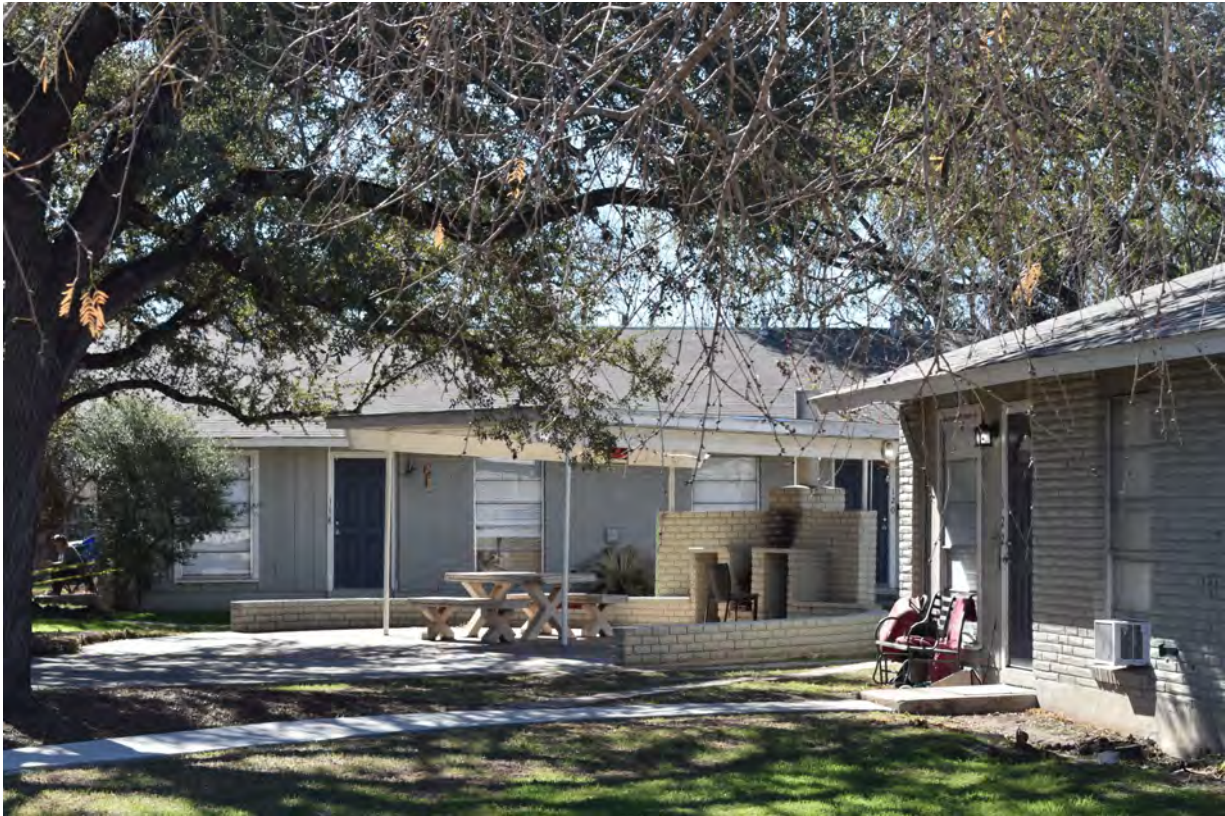
View facing south
(background)

Type: Building	Exterior materials: brick wood siding panels	Primary roof type: gable, side	Alterations: Doors replaced Brick/stone painted
Style: Ranch			
Form: Rectangular	Porch: none

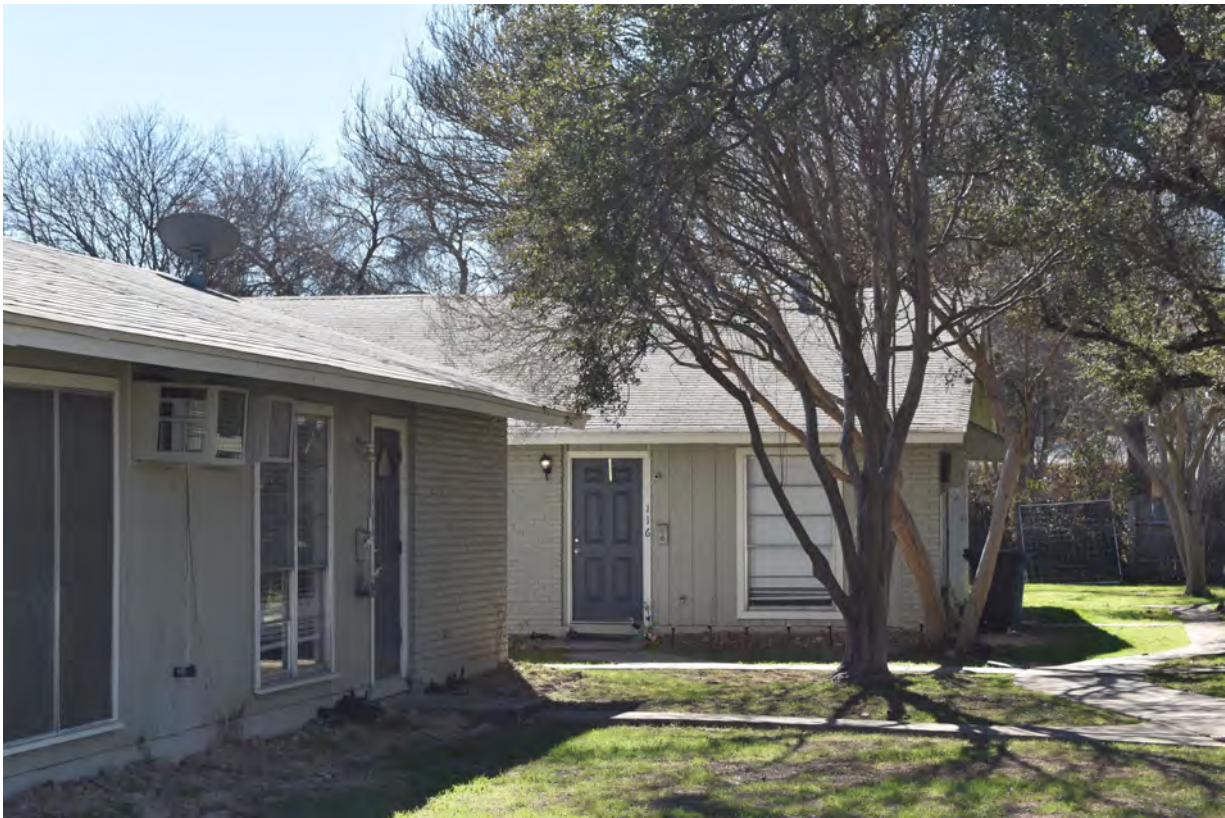
View facing south

Alterations:
Doors replaced
Brick/stone painted

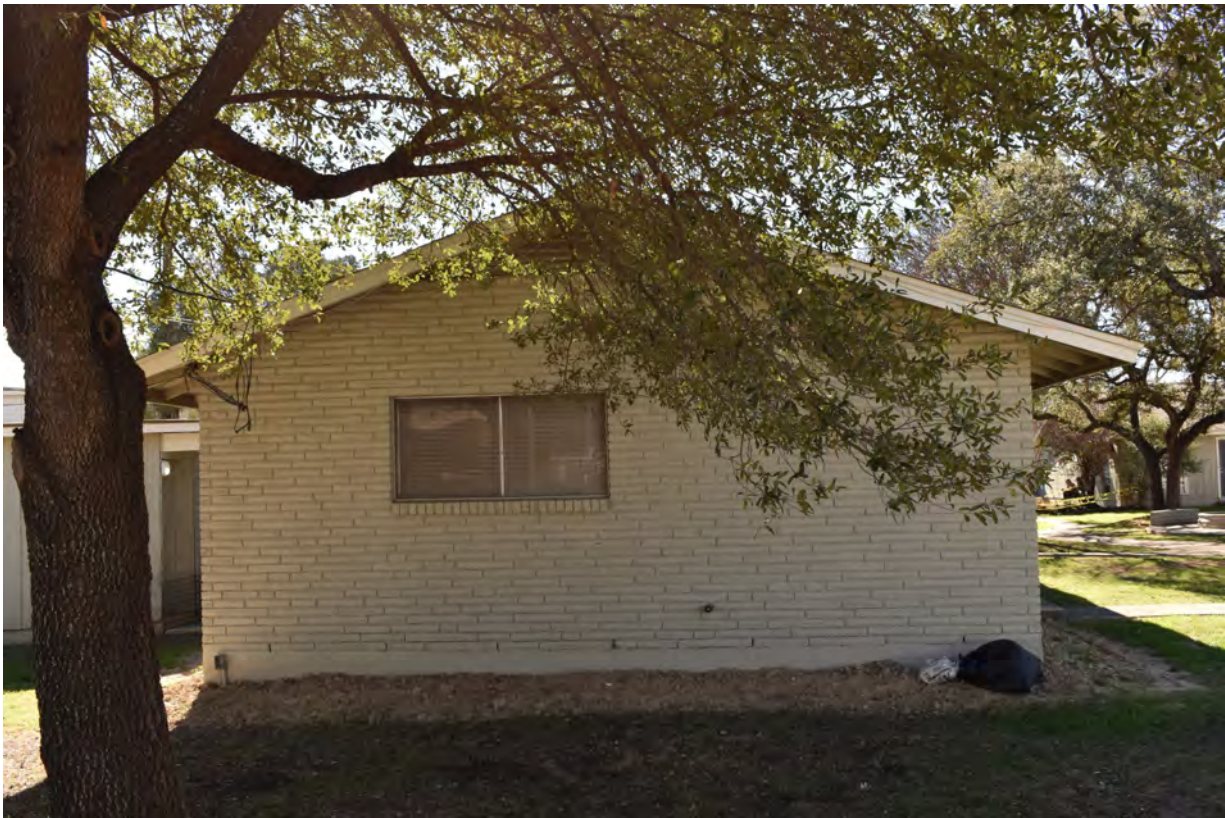
View facing south

Type: Building	Exterior materials: brick wood siding panels	Primary roof type: gable, side	Alterations: Doors replaced Brick/stone painted
Style: Ranch			
Form: Rectangular	Porch: none

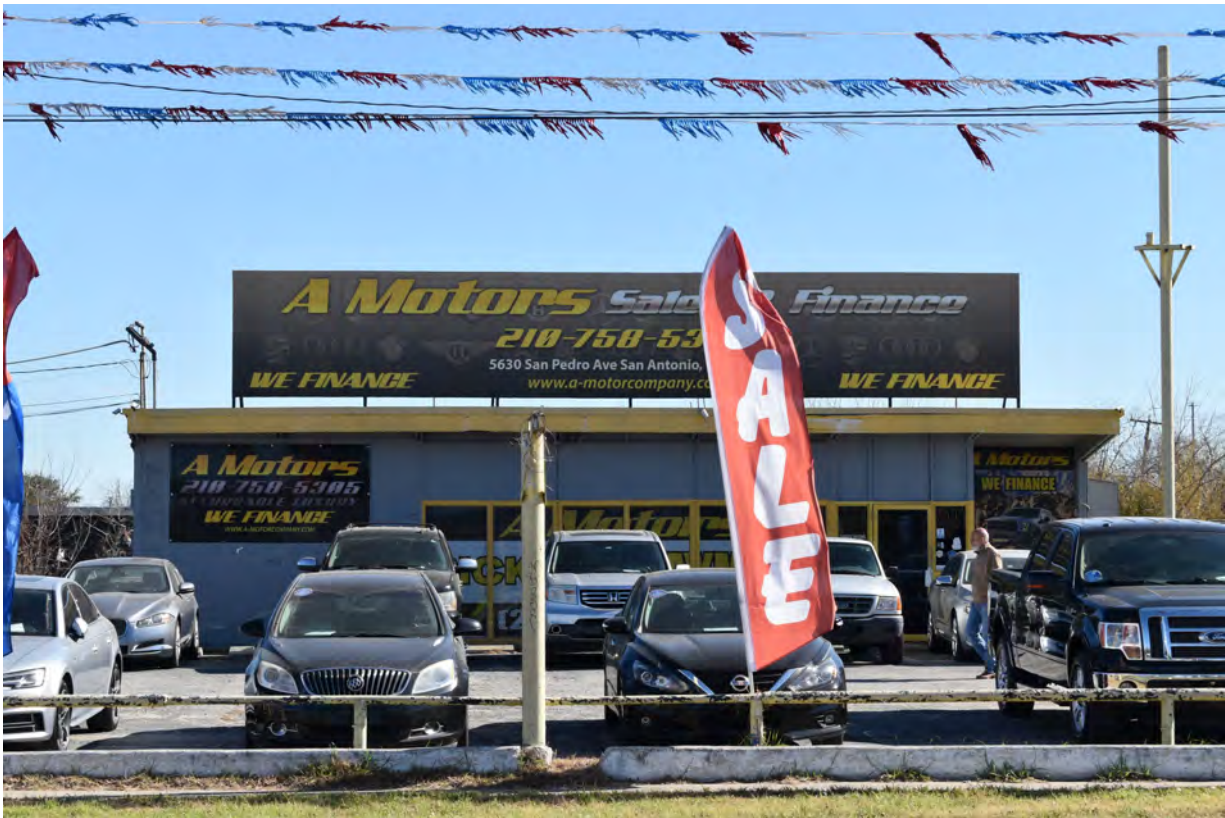
View facing east

Type: Building	Exterior materials: brick	Primary roof type: shed	Alterations: Addition to primary/side elevation
Style: No style	concrete/cinder block	flat	Brick/stone painted
Form: Irregular	stucco		Signage added
	Porch: stoop		Window opening(s) infilled
	integrated		Windows replaced – some

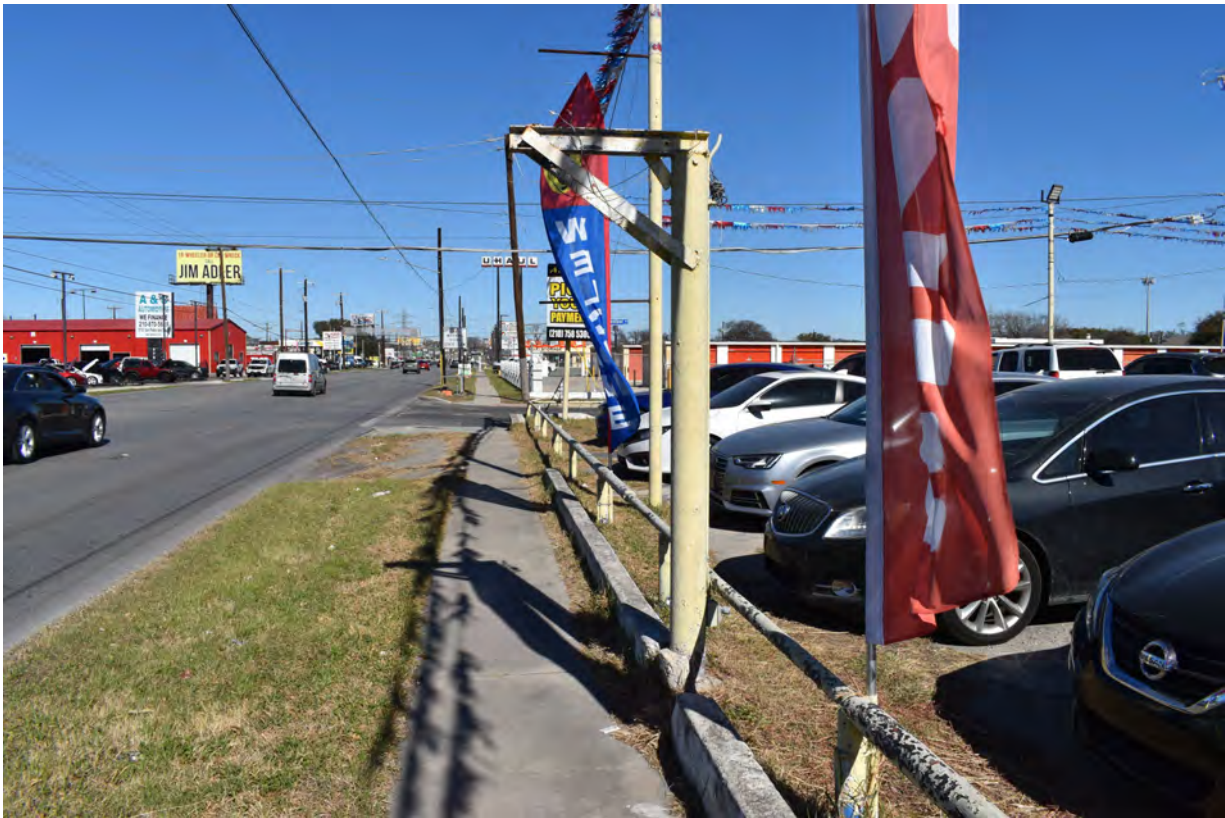
View facing north

Type: Object	Exterior materials: metal	Primary roof type: N/A	Alterations: Missing elements
Style: No style			
Form: Sign	Porch: N/A

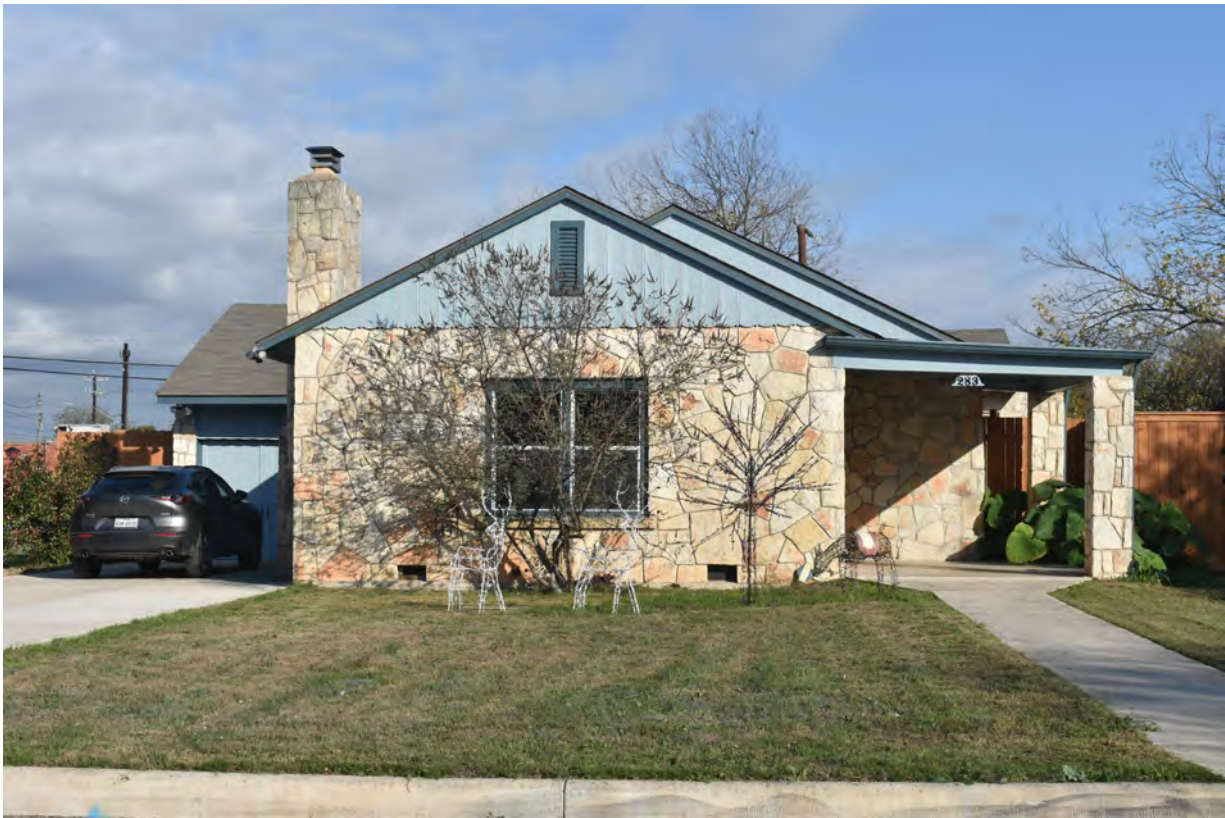
Resource A
(Historic-age);
view facing north

Type: Building	Exterior materials: stone	Primary roof type: gable, front	Alterations: Door/entrance enclosed
Style: Minimal Traditional	wood siding panels		Garage door(s) replaced
Form: Irregular	Porch: partial-width projecting		Rafters covered
			Window opening(s) infilled
			Windows replaced – all visible

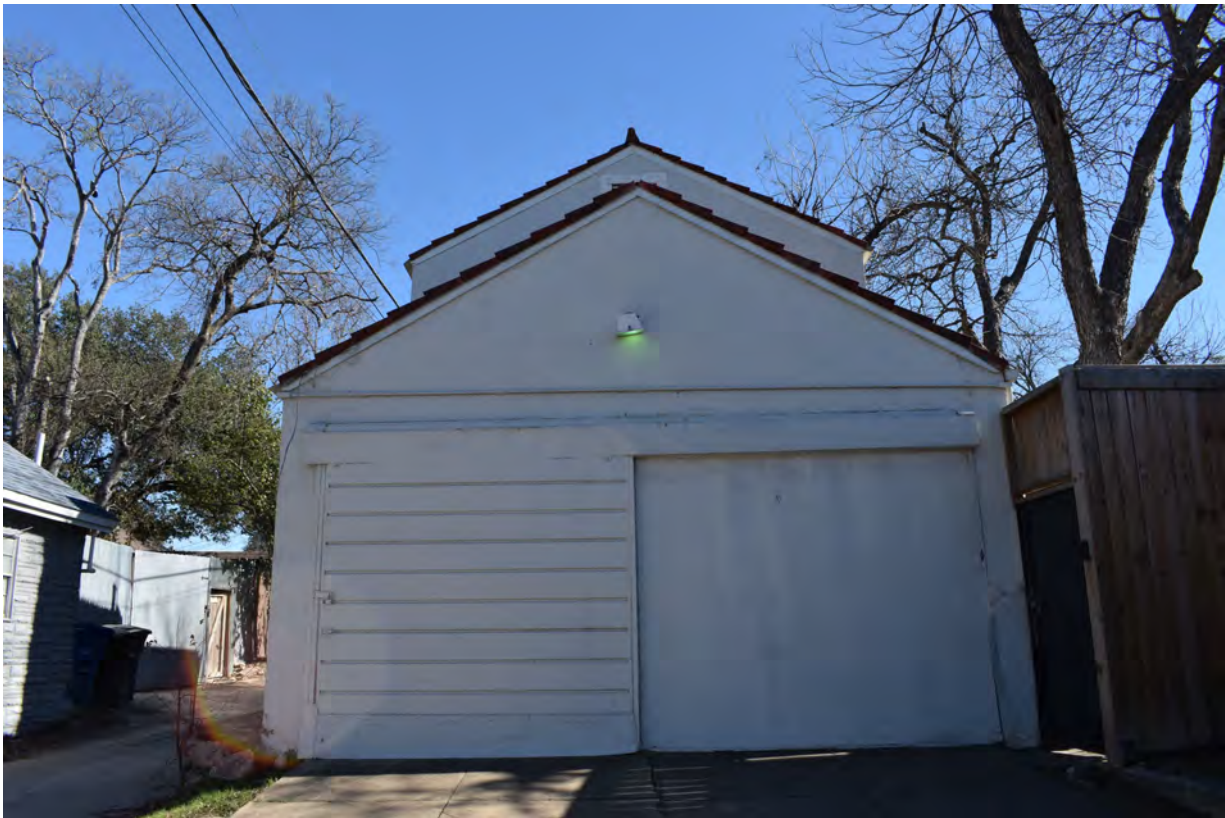
View facing east

Alterations:
Garage door(s) replaced
Door (secondary) replaced
Windows replaced – all visible

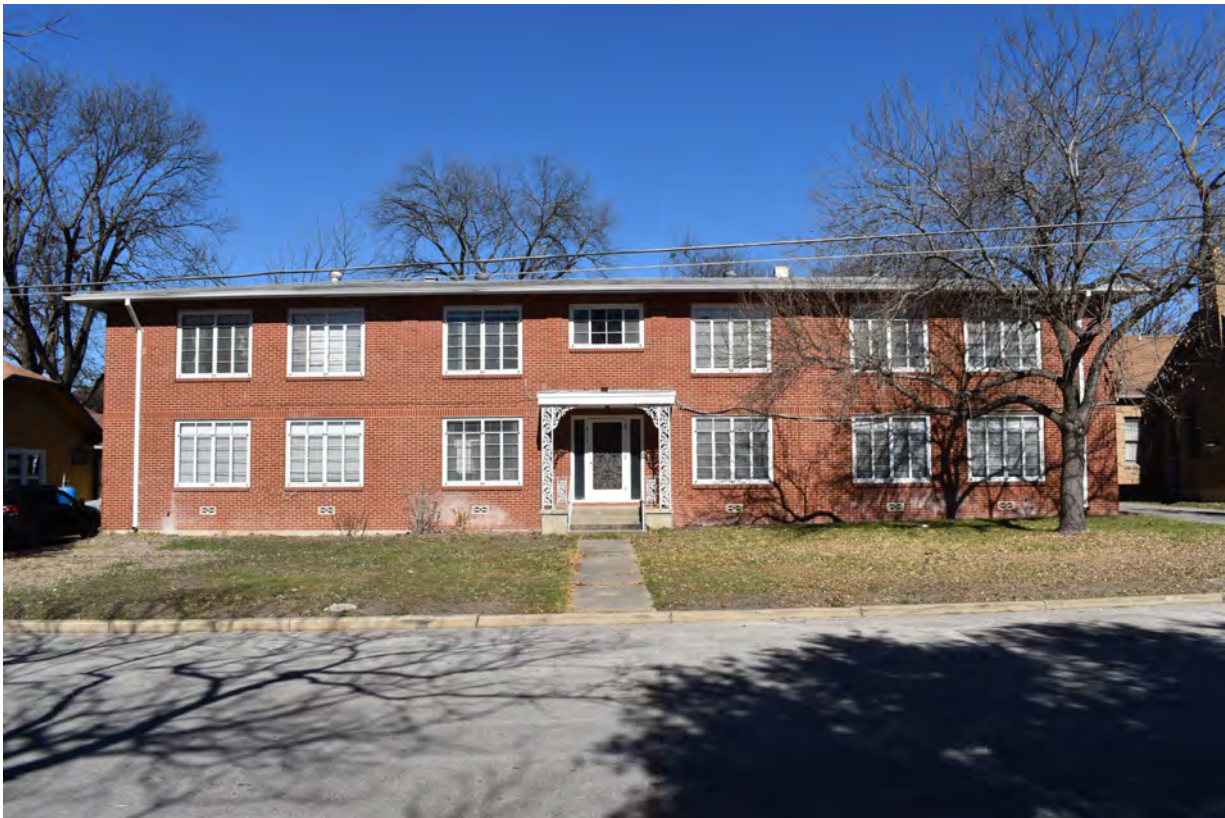
View facing north

Alterations:
Windows replaced – some (rear)

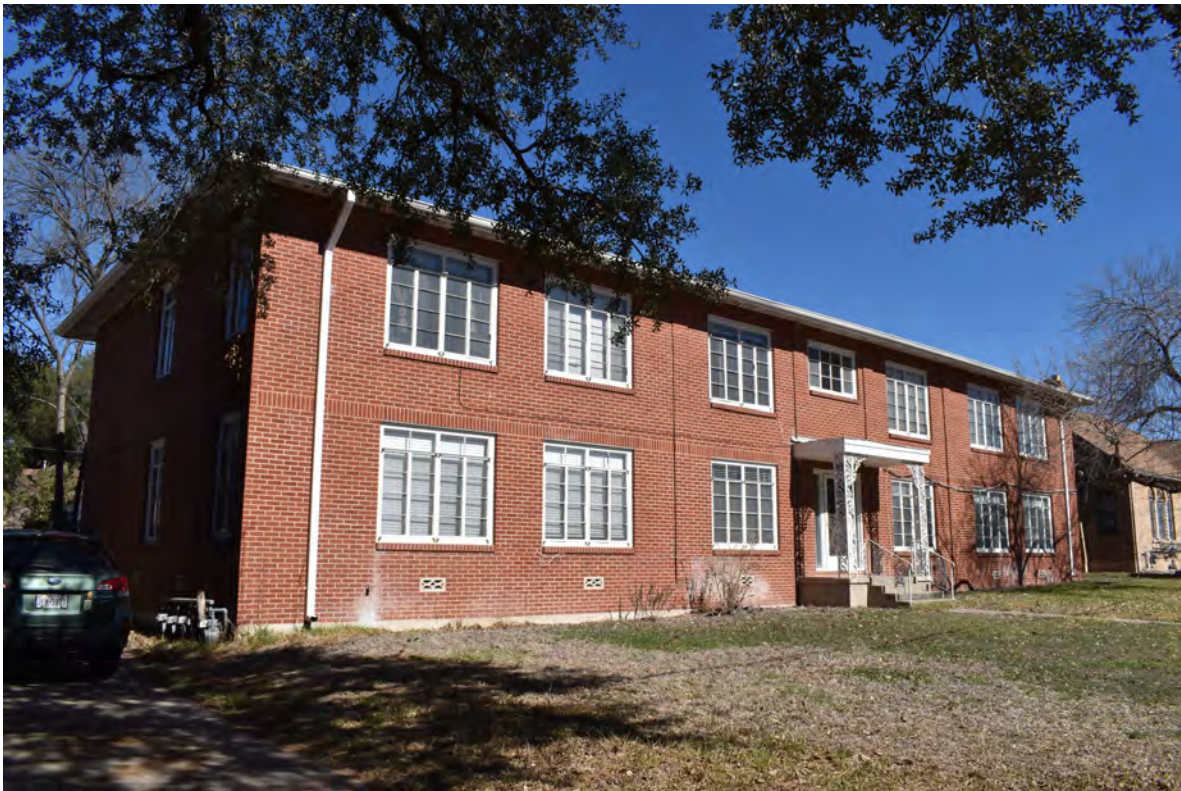
View facing northeast

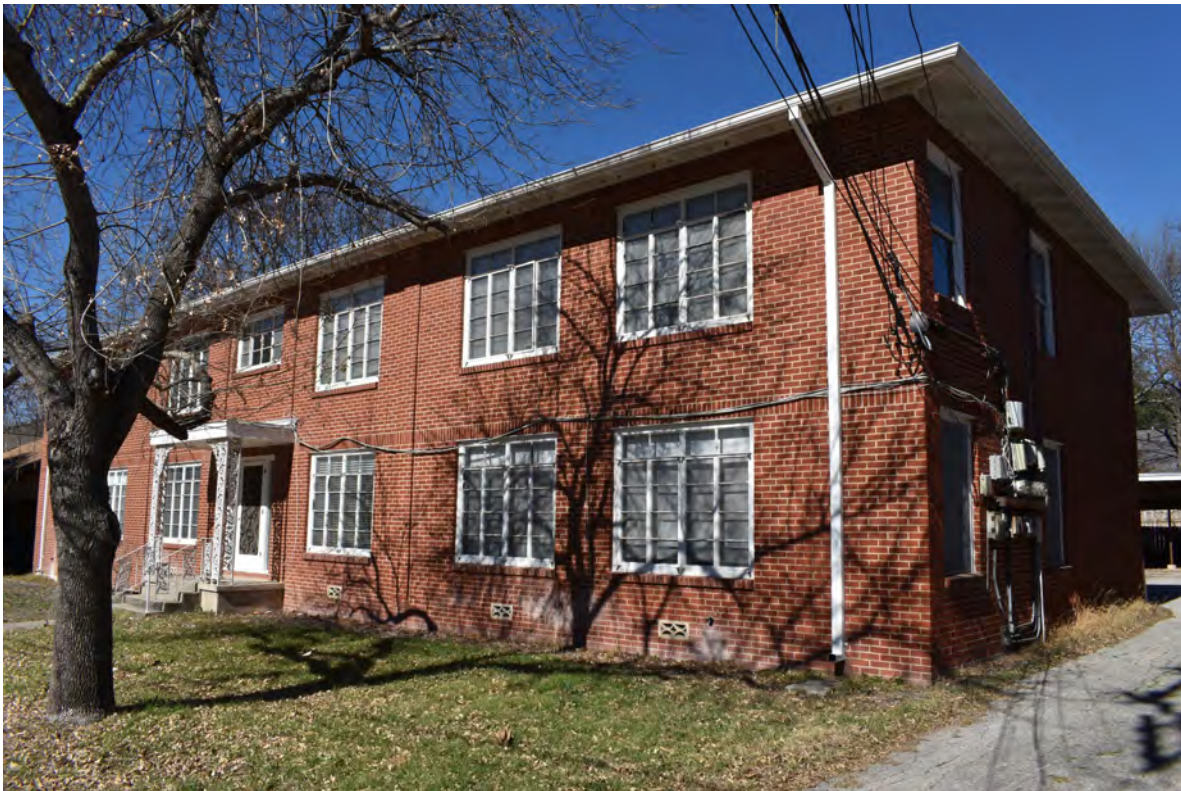
View facing northwest

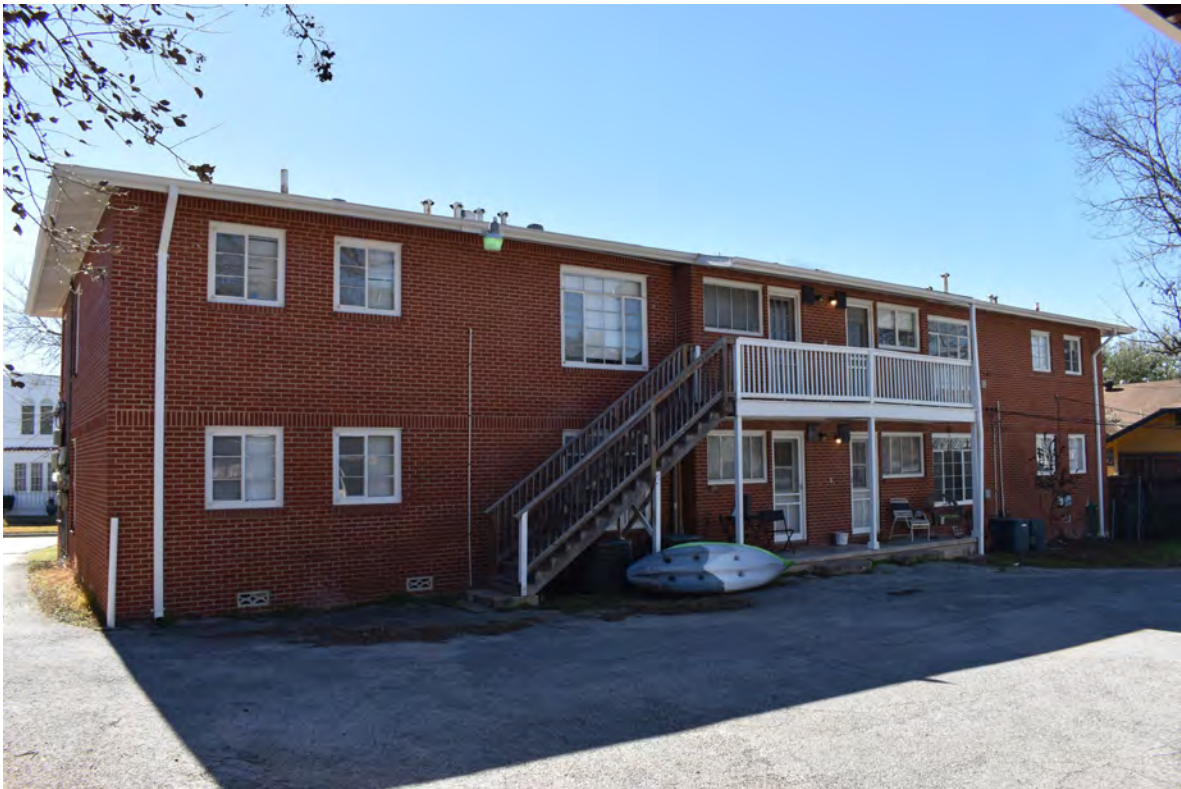
View facing southeast

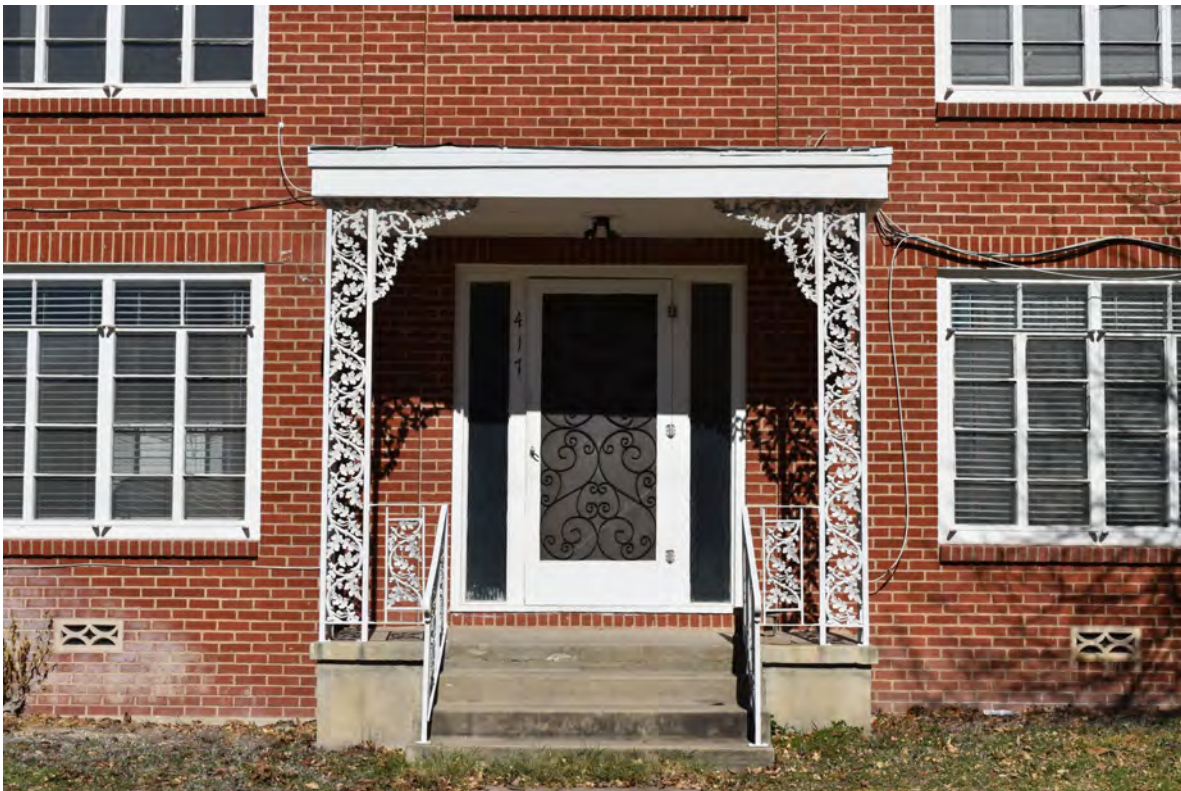
Entrance detail; view facing north

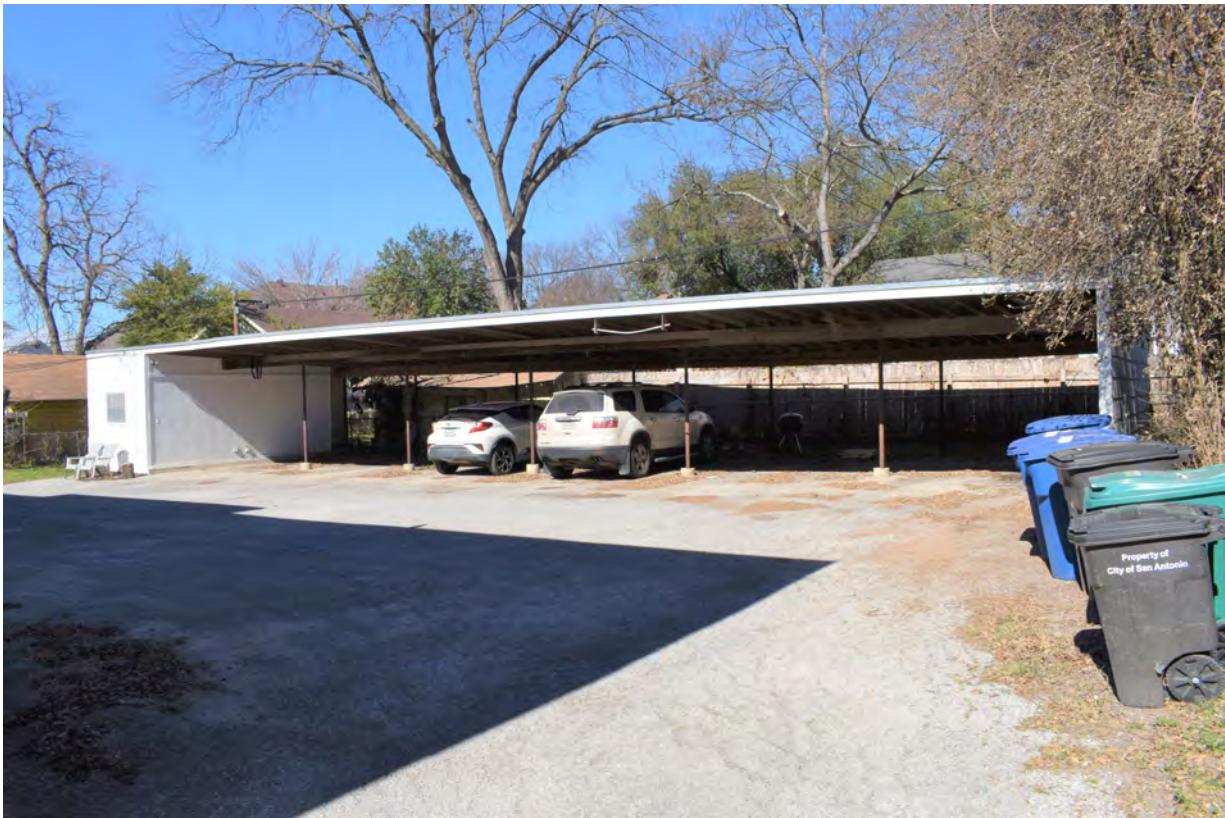
View facing northwest

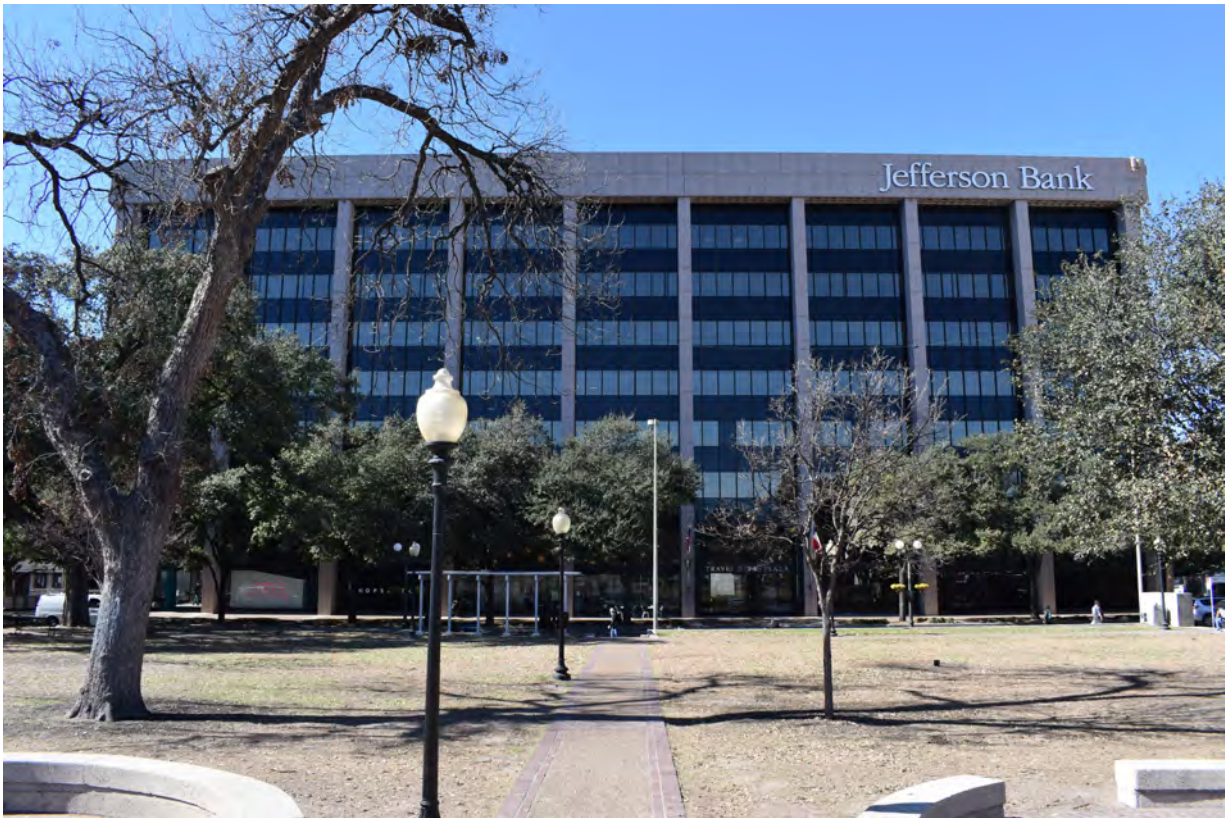
Resource A
(Historic-age);
view facing west

Travis Park Plaza is a seven story building home to Jefferson Bank, Hopscotch Gallery, and a number of other businesses. Built in 1970 as Travis Park West, the New Formalist building was designed by architect Harwood K. Smith (1913-2002) (San Antonio Express 1970; The Dallas Morning News 2002). The design incorporates pink granite mined from Burnet County and bronze cermaic glass, and includes an underground passageway to the attached parking garage to the west (San Antonio Express 1970). The building's original tenants included First National Bank and San Antonio Loan & Trust Company. Jefferson Bank currently occupies the majority of the building, and manages a drive-through on its west elevation. The complex includes the historic-age building and attached parking garage, joined by a banking drive-through (Resource A), a nonhistoric standalone sign for Jefferson Bank (Resource B), and two nonhistoric granite benches on the west

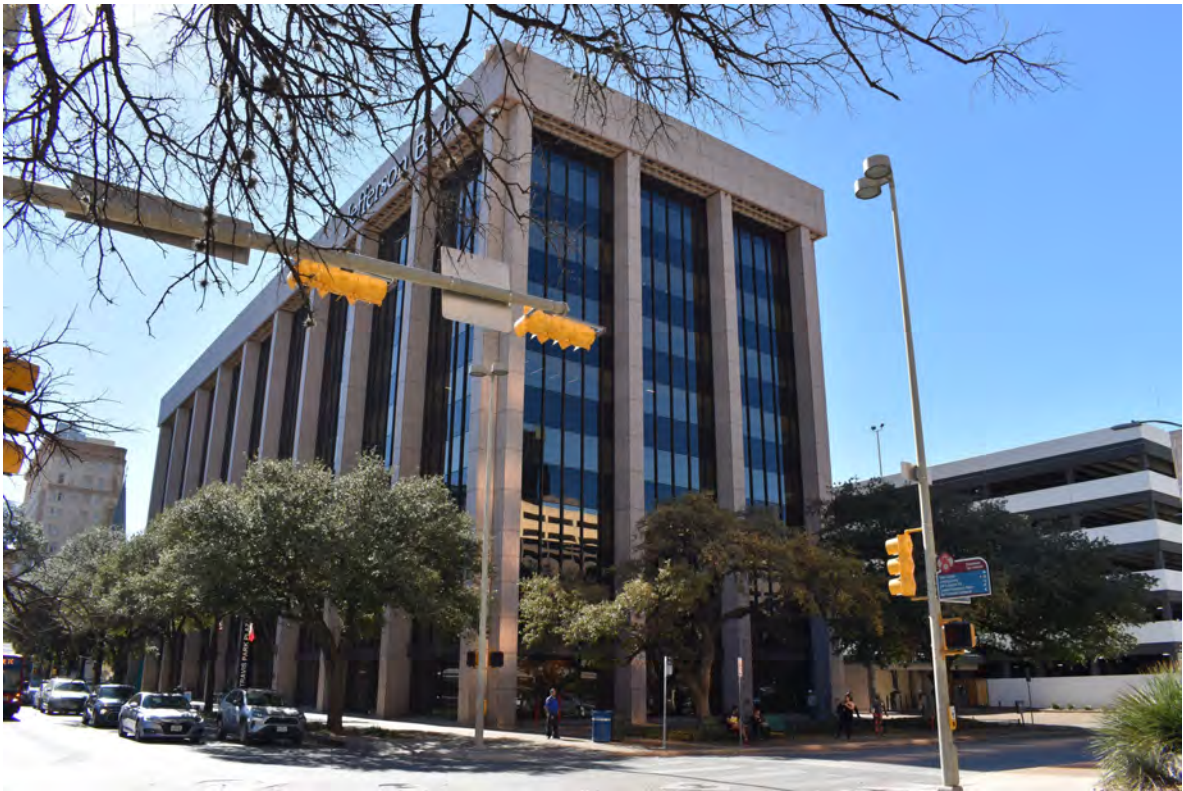
Resource A (Historic-age);
view facing southwest

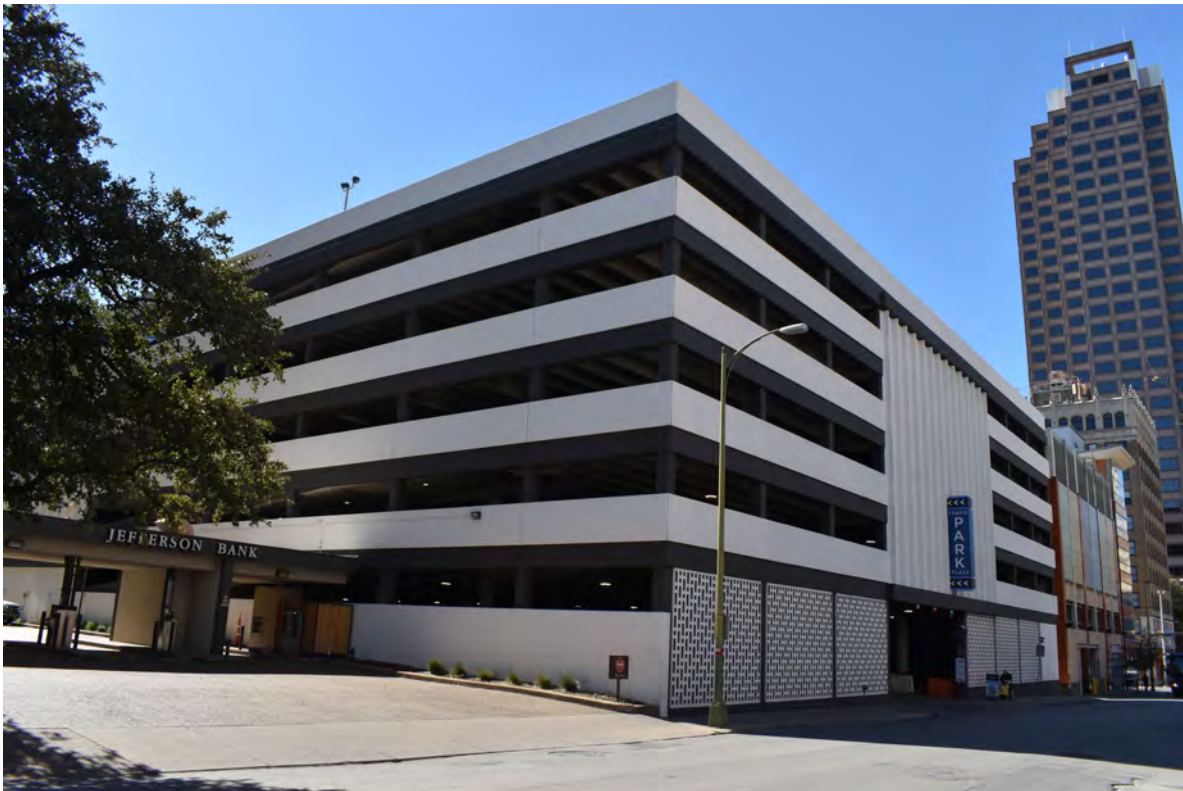
Resource A (Historic-age)
parking garage; view facing
southwest

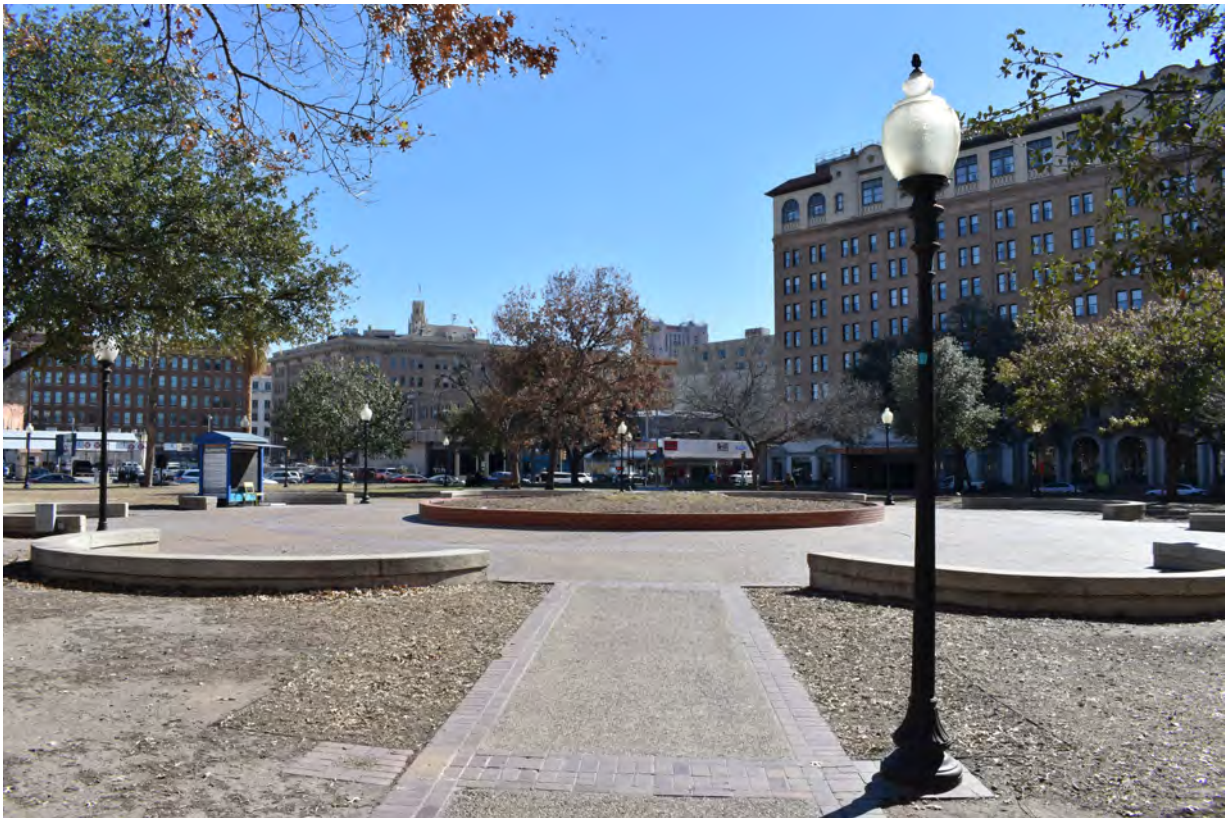
Resource A
(Historic-age);
view facing
southeast

The park has experienced design changes with its restoration in 1993 and Confederate monument removal in 2017. These changes inhibit the park from being recommended individually eligible for the NRHP. Despite its alterations, the park remains significant for its association with the development of San Antonio. The park is a contributing resource to the San Antonio Downtown and River Walk NRHP Historic District. The property retains sufficient historic and physical integrity and its contributing status is affirmed.
