Resource ID: 226A	Parcel ID: 1213123	Year Built: 1889	Year Source: NRHP Nomination Form
Address: 925 S SAINT MARYS ST., SAN ANTONIO, TX		Latitude: 29.414091	County: Bexar
Name: James Butler Bonham Elementary School (Bonham Academy)		Longitude: -98.489459	
Historic Function/Subcategory: Education/School		Indiv. NRHP Eligible? Listed	Effect: No Adverse Effect
Current Function/Subcategory: Education/School		Contributing to NRHP Property/District? Yes

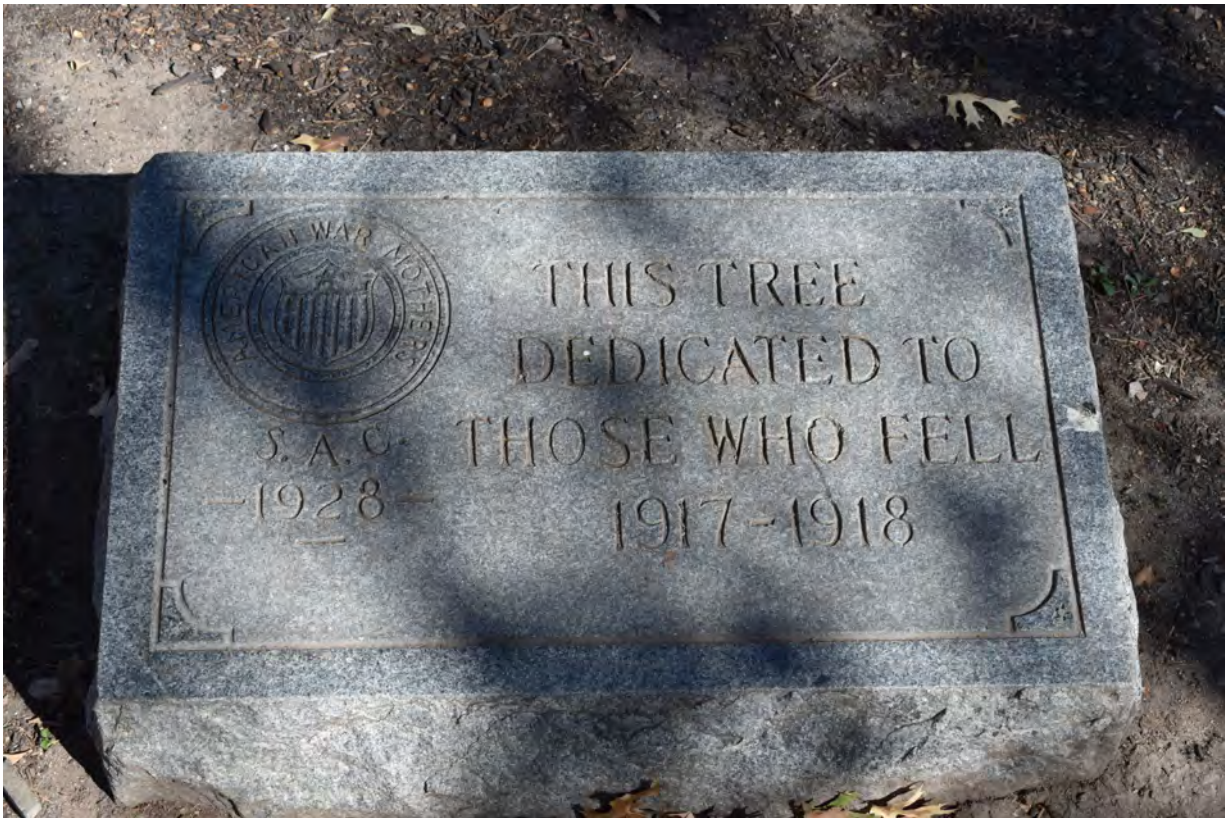
View facing northeast

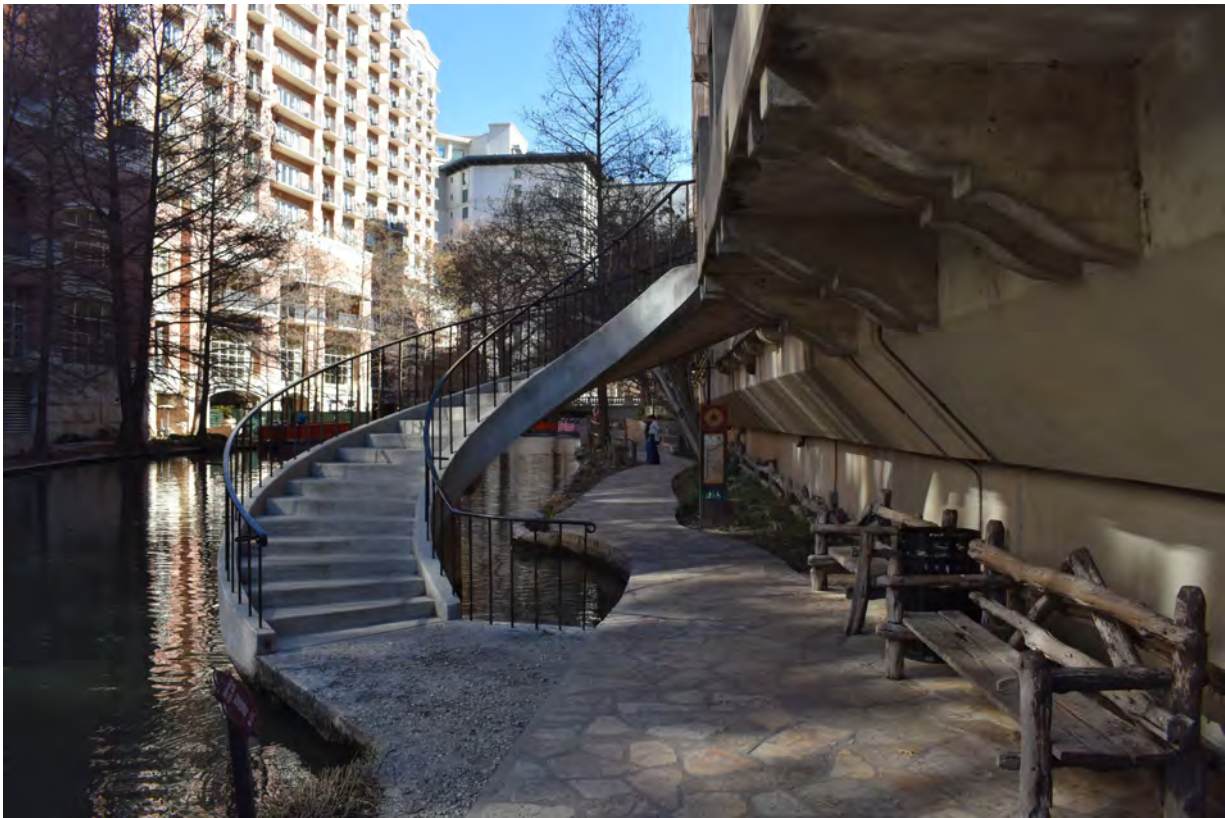
Staircase at Saint Mary's Street; view facing east

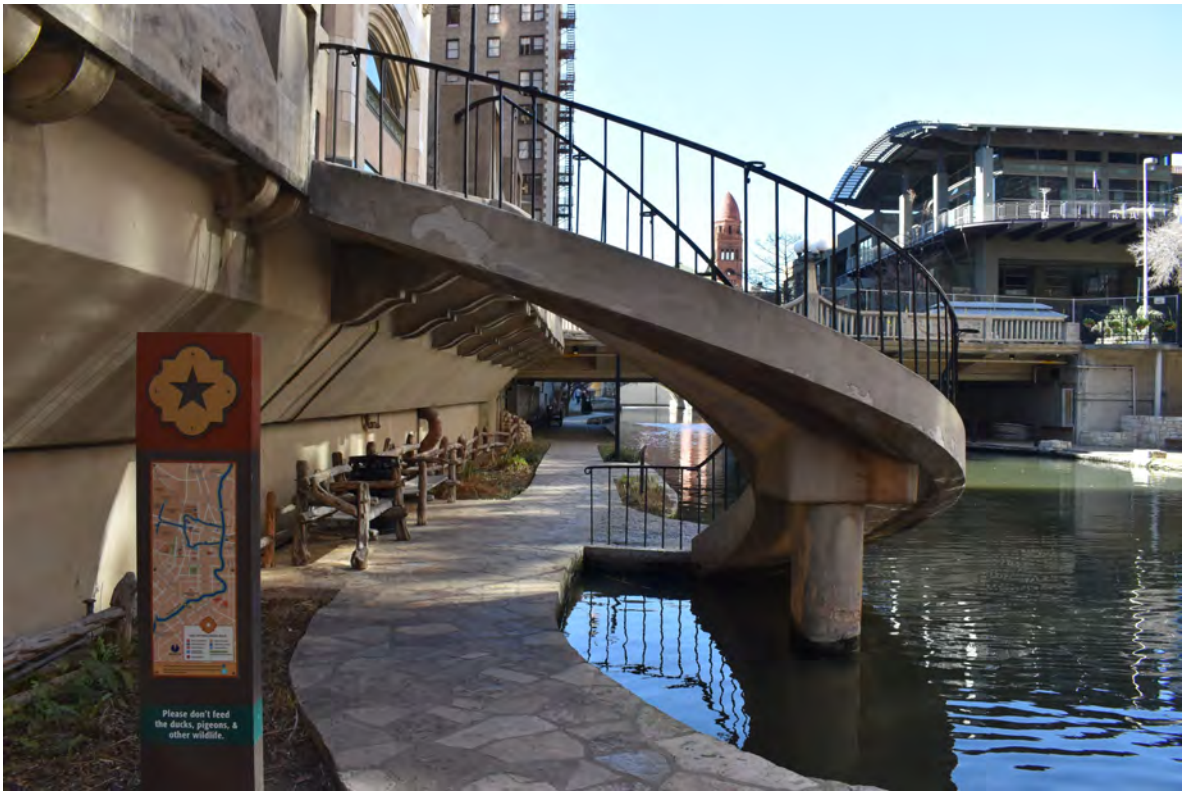
Staircase at Saint Mary's Street; view facing west

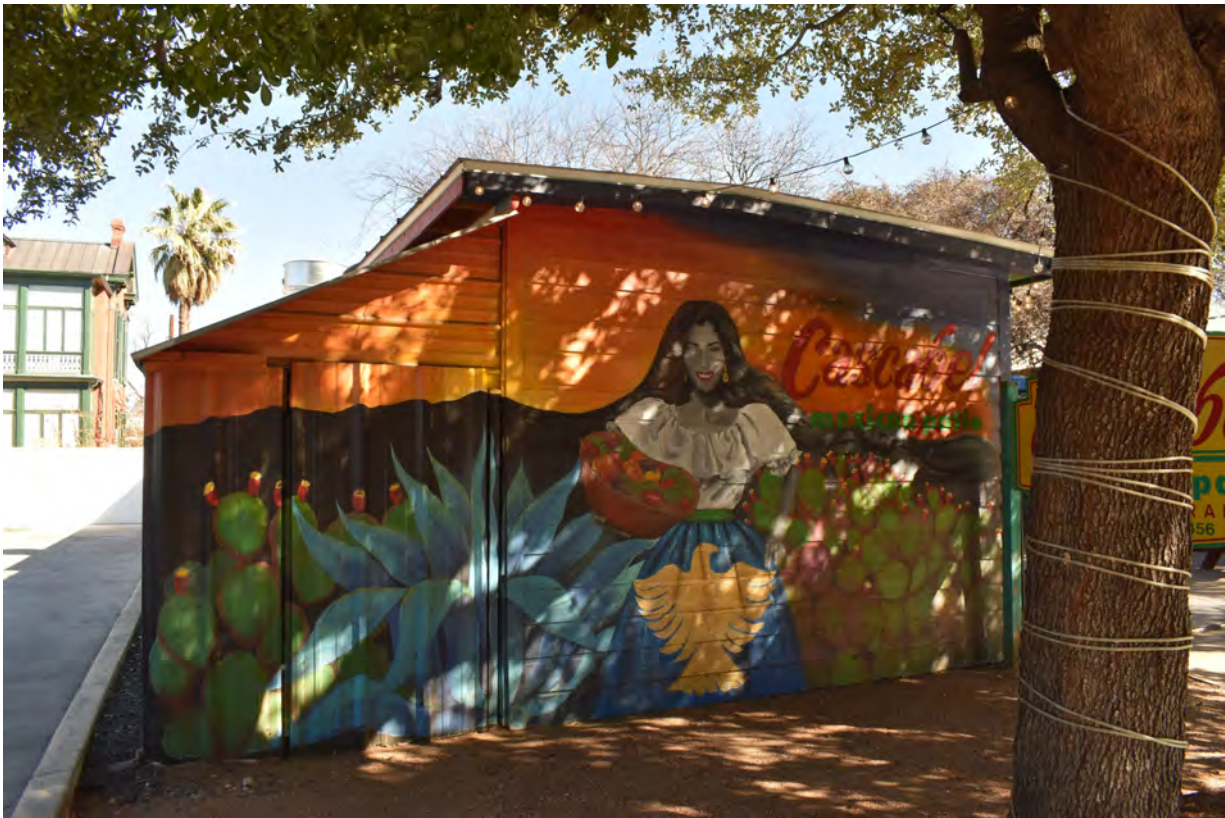
Resource A
(Historic-age);
view facing east

Type: Building	Exterior materials: wood siding panels metal	Primary roof type: shed	Alterations: Addition to primary/side elevation Wall cladding replaced - some
Style: No style			
Form: Irregular	Porch: partial-width integrated

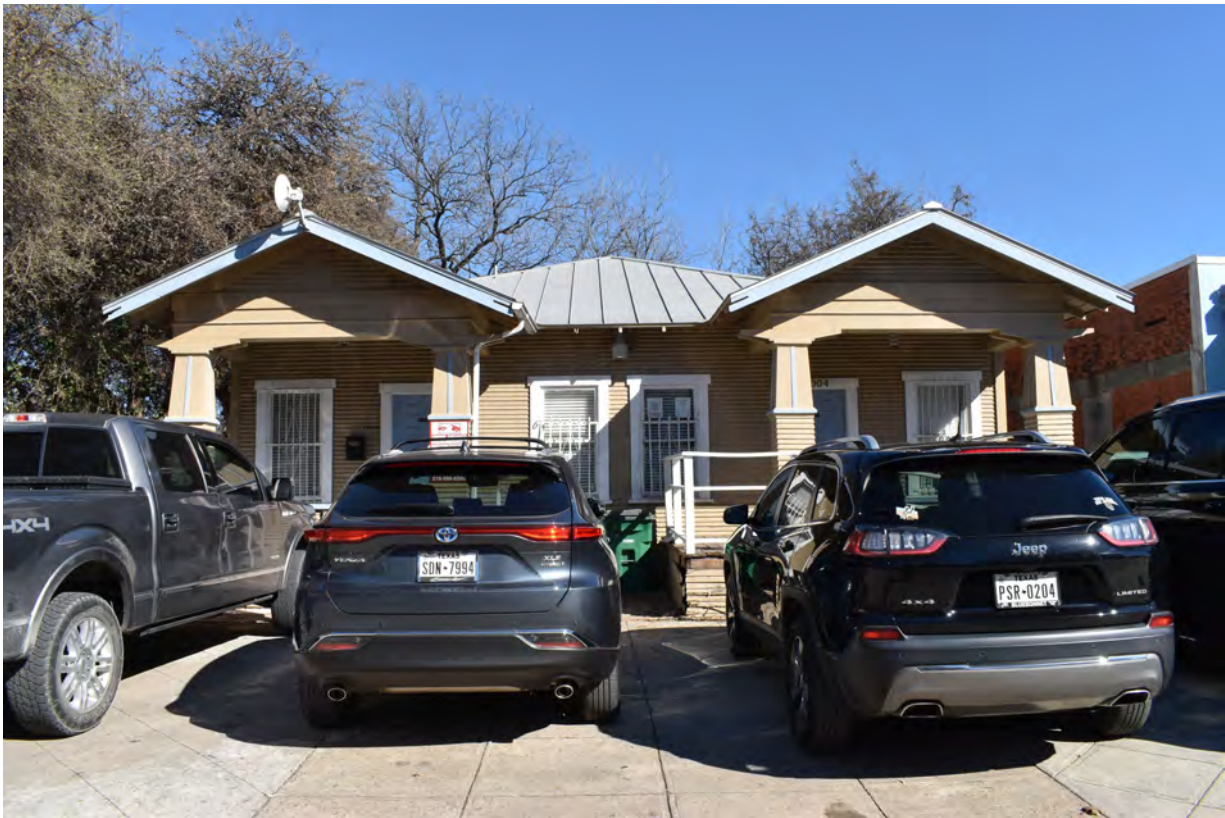
Resource A
(Historic-age);
view facing
northeast

Alterations:
Doors replaced
Ramp added

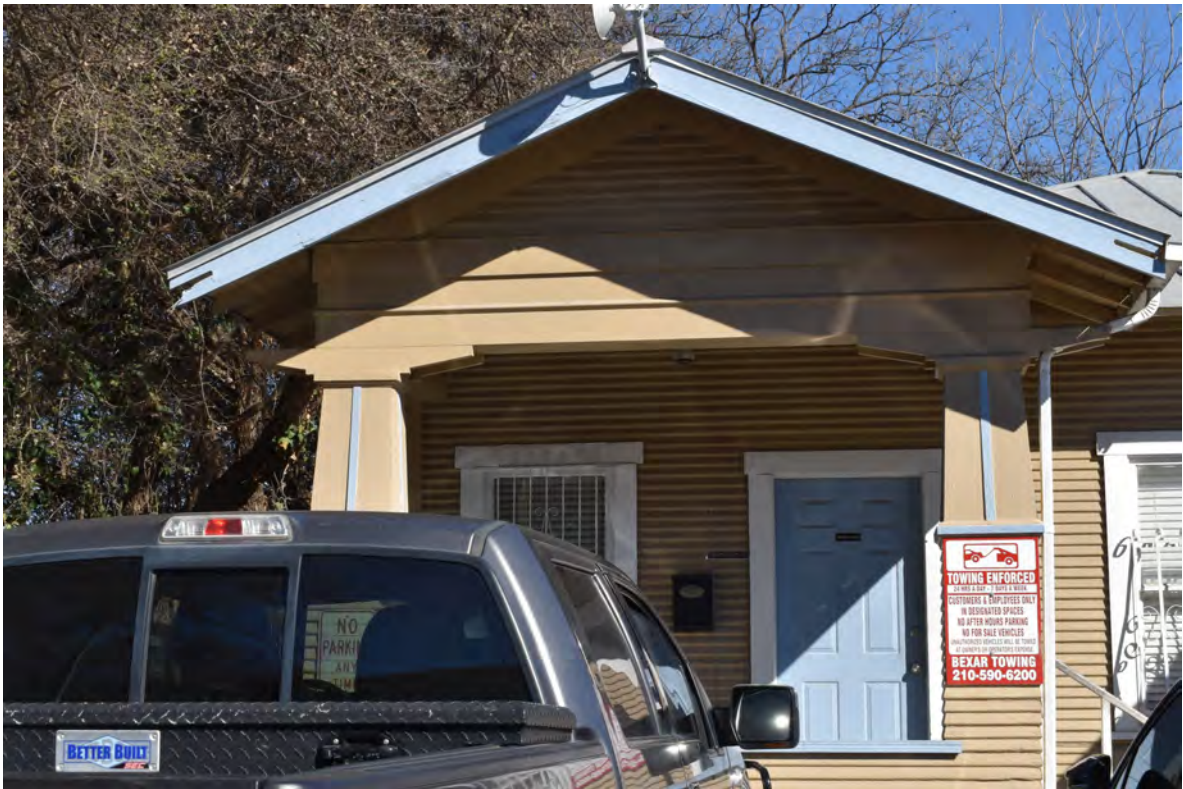
Resource A (Historic-age)
entrance detail; view facing
northeast

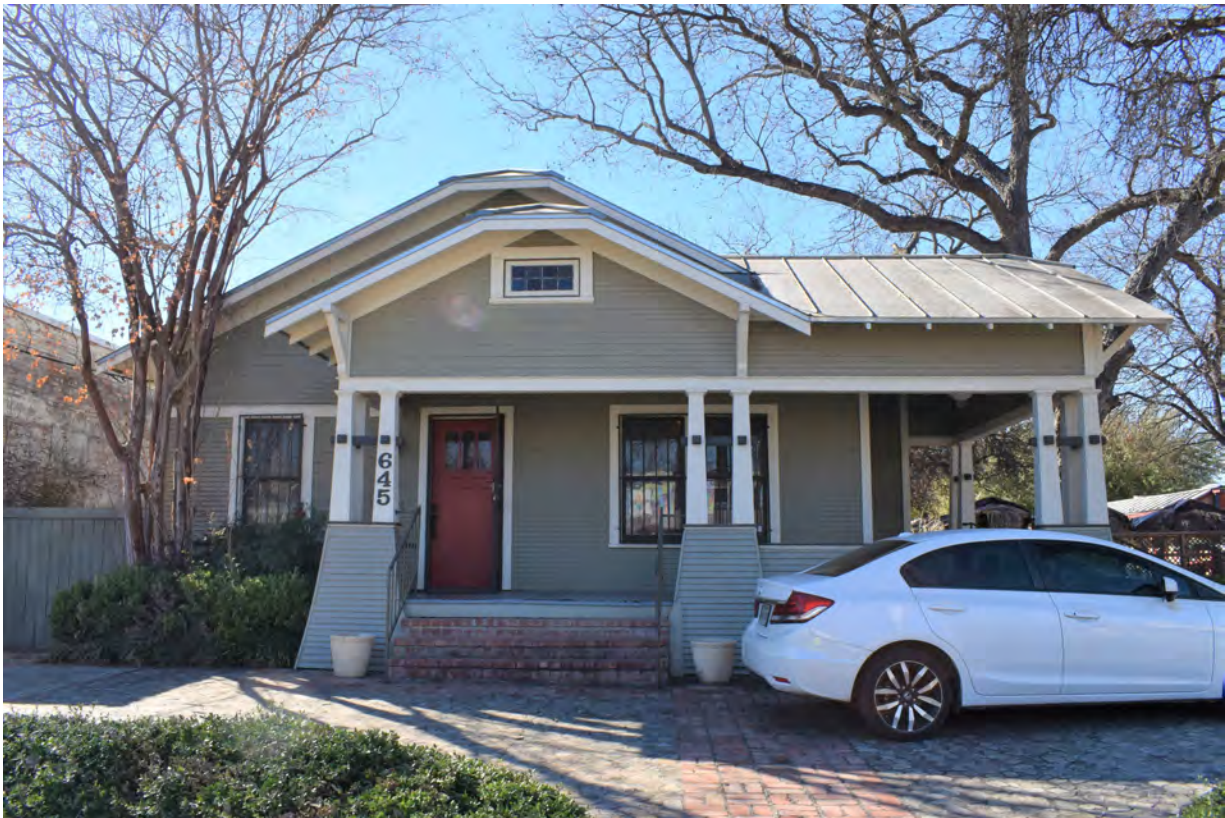
Resource A
(Historic-age);
view facing
southwest

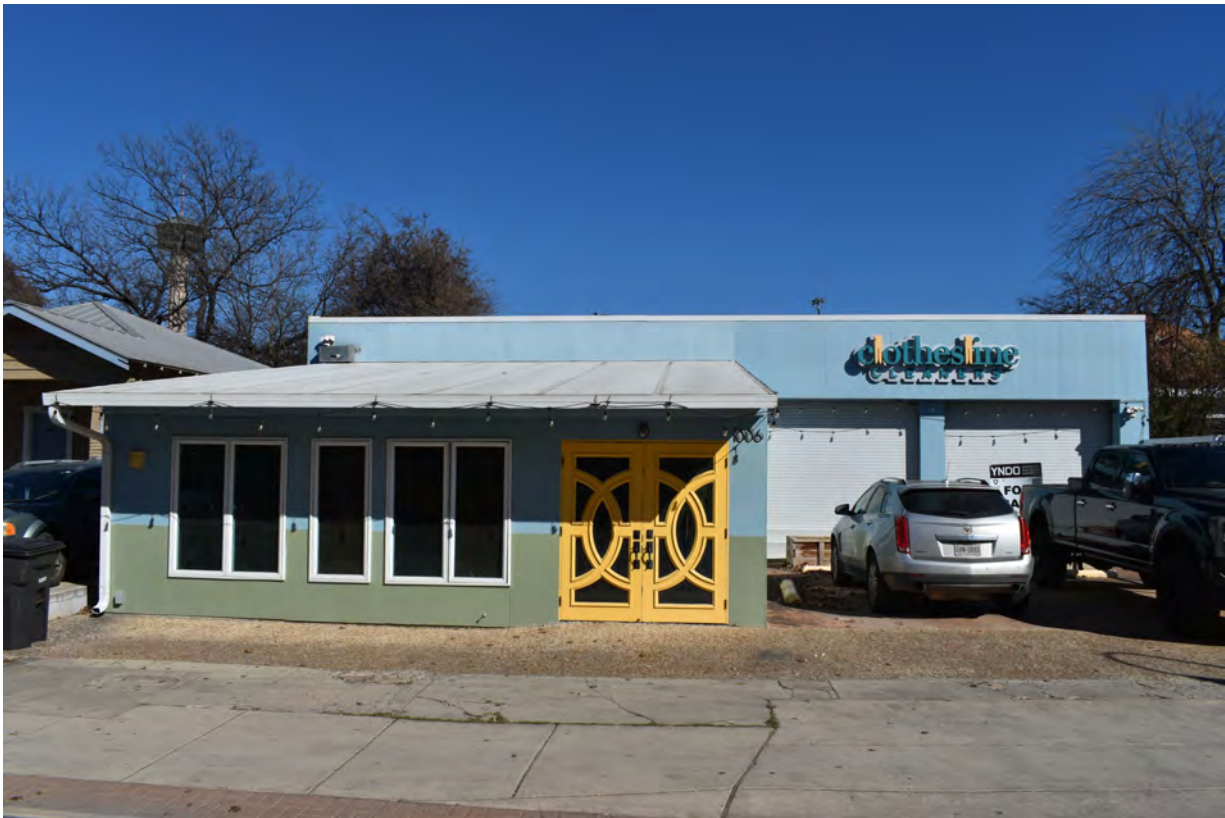
View facing northeast

Type: Building	Exterior materials: stucco	Primary roof type: flat shed	Alterations: Addition to primary elevation Garage door(s) replaced Porch added (rear) Signage added
Style: No style			
Form: Irregular	Porch: none

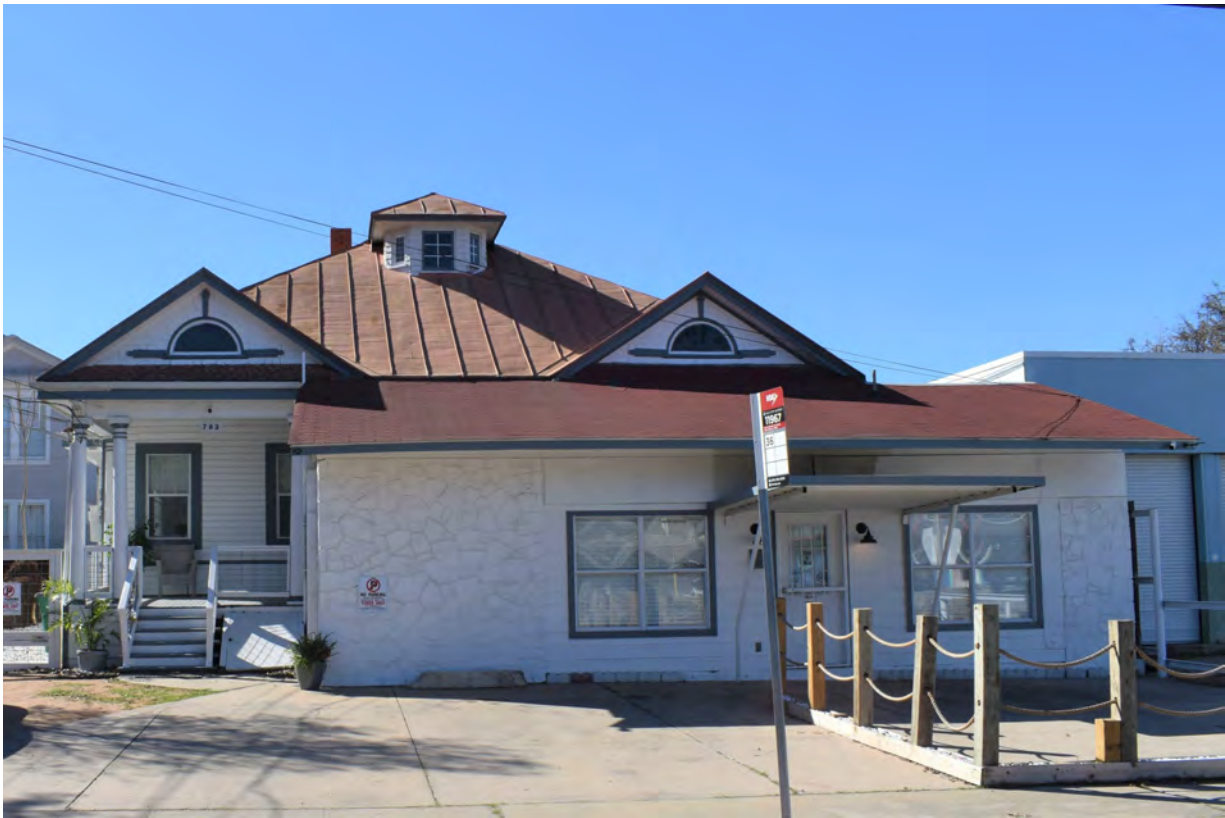
View facing southwest

Type: Building	Exterior materials: wood siding stone	Primary roof type: hipped	Alterations: Addition to primary elevation Addition to rear/side elevation Doors replaced Porch altered Porch enclosed Wall cladding replaced - some Windows replaced – all visible
Style: Queen Anne			
Form: Irregular	Porch: partial-width projecting

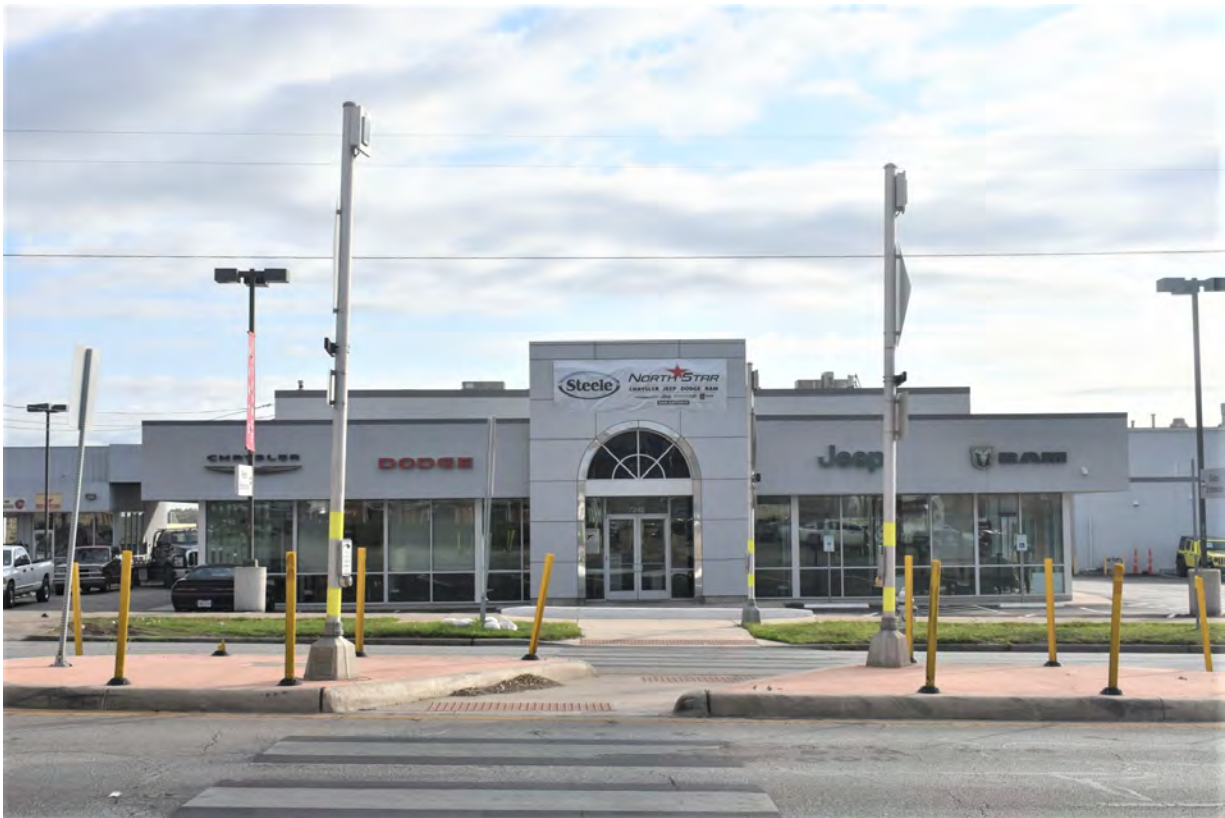
Resource A
(Historic-age);
view facing east

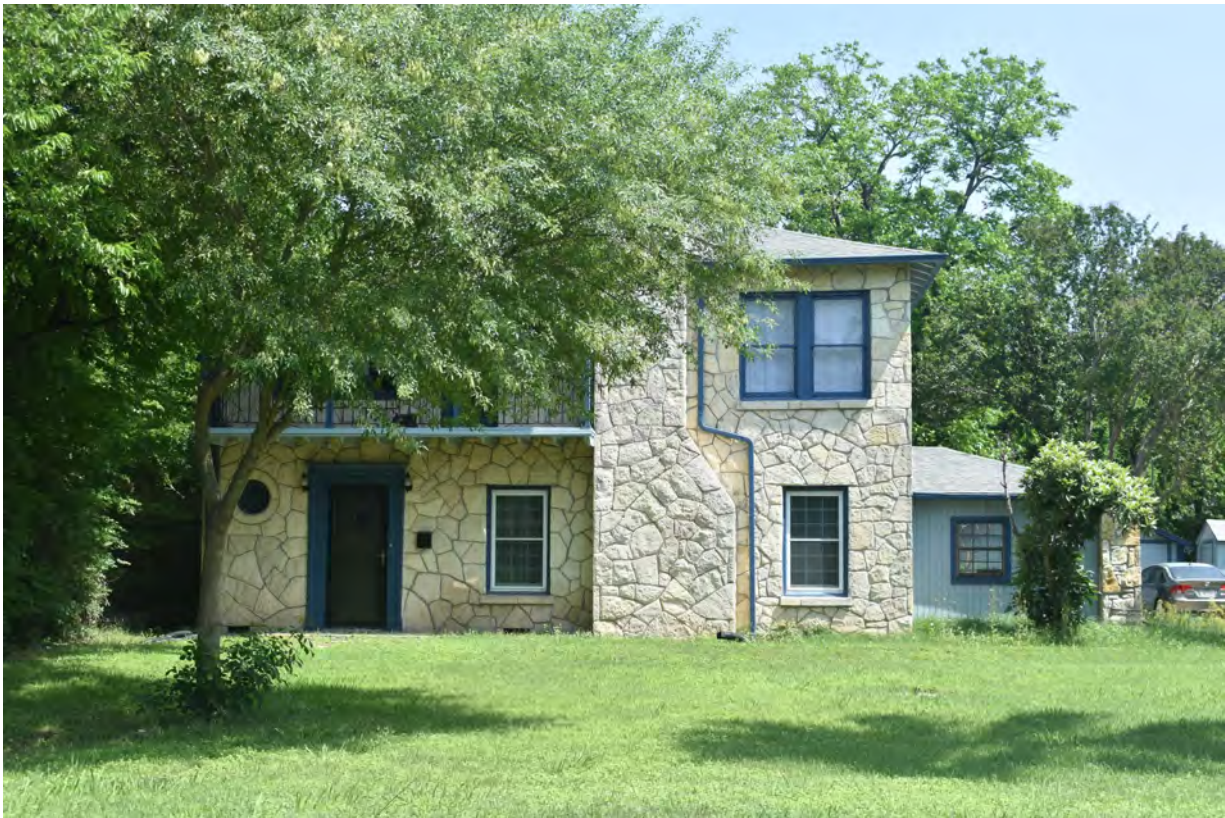
Resource ID: 301A **Parcel ID:** 431200 **Year Built:** 1938 **Year Source:** CAD

View facing north

Alterations:
Porch enclosed
Windows replaced – some

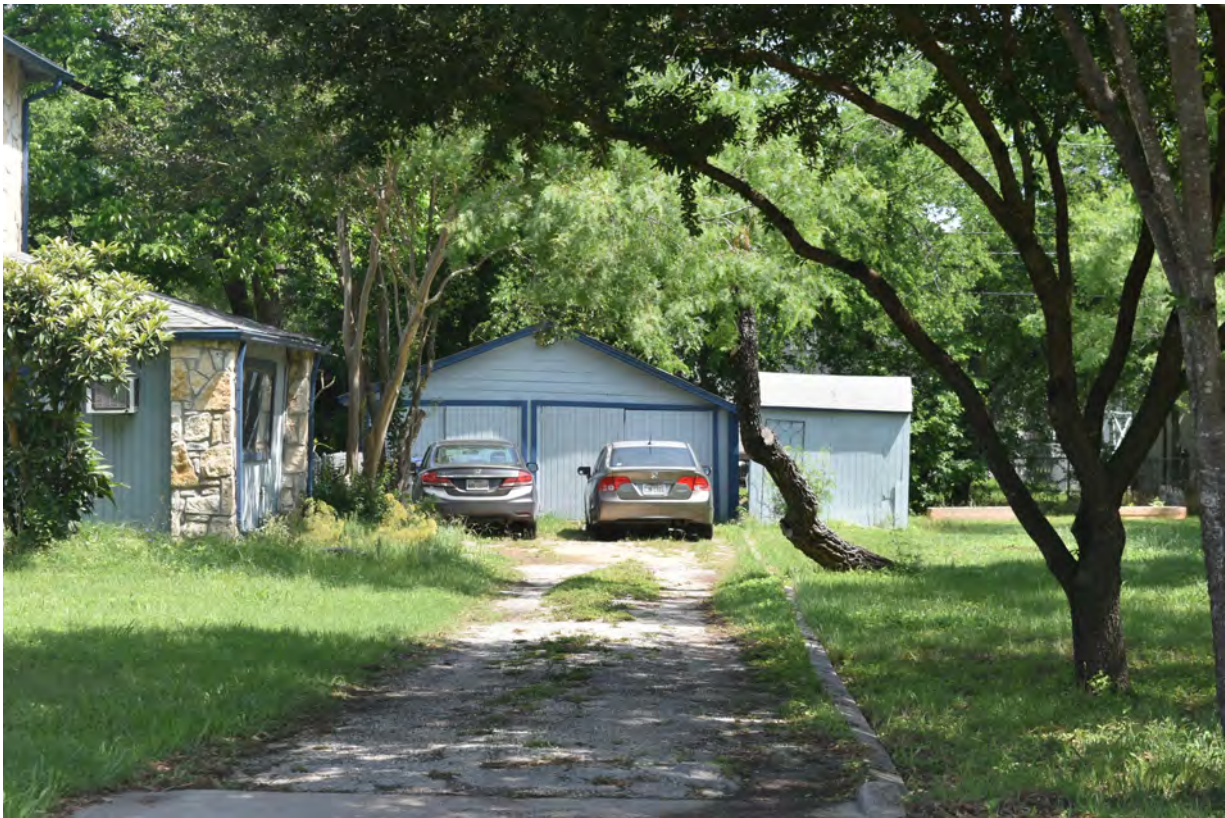
Resource ID: 301B **Parcel ID:** 431200 **Year Built:** ca. 1938 **Year Source:** Estimate

View facing north

Type: Building	Exterior materials: wood siding	Primary roof type: gable, front	Alterations: Garage door(s) replaced
Style: No style			
Form: Rectangular	Porch: N/A

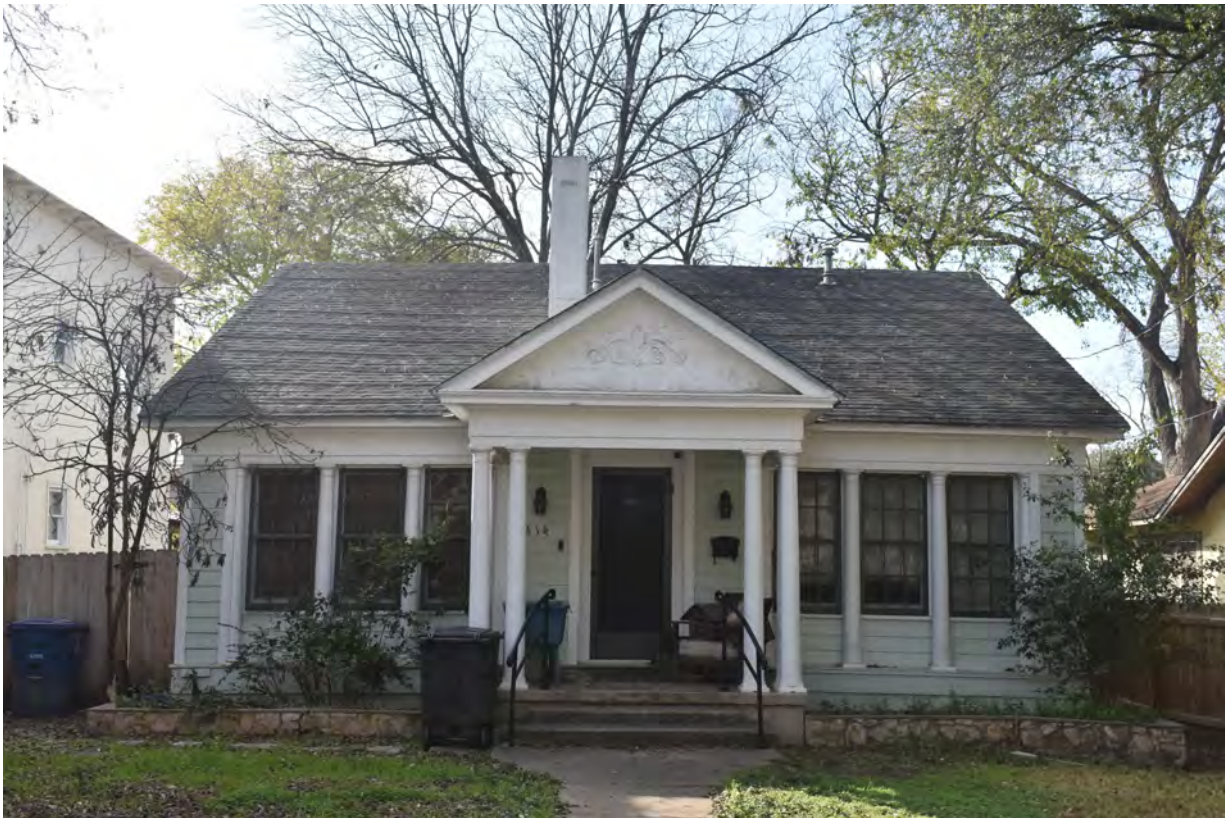
Resource ID: 302

View facing south

Type: Building	Exterior materials: engineered wood siding	Primary roof type: gable, side	Alterations: Wall cladding replaced
Style: Colonial Revival			
Form: Rectangular	Porch: partial-width projecting

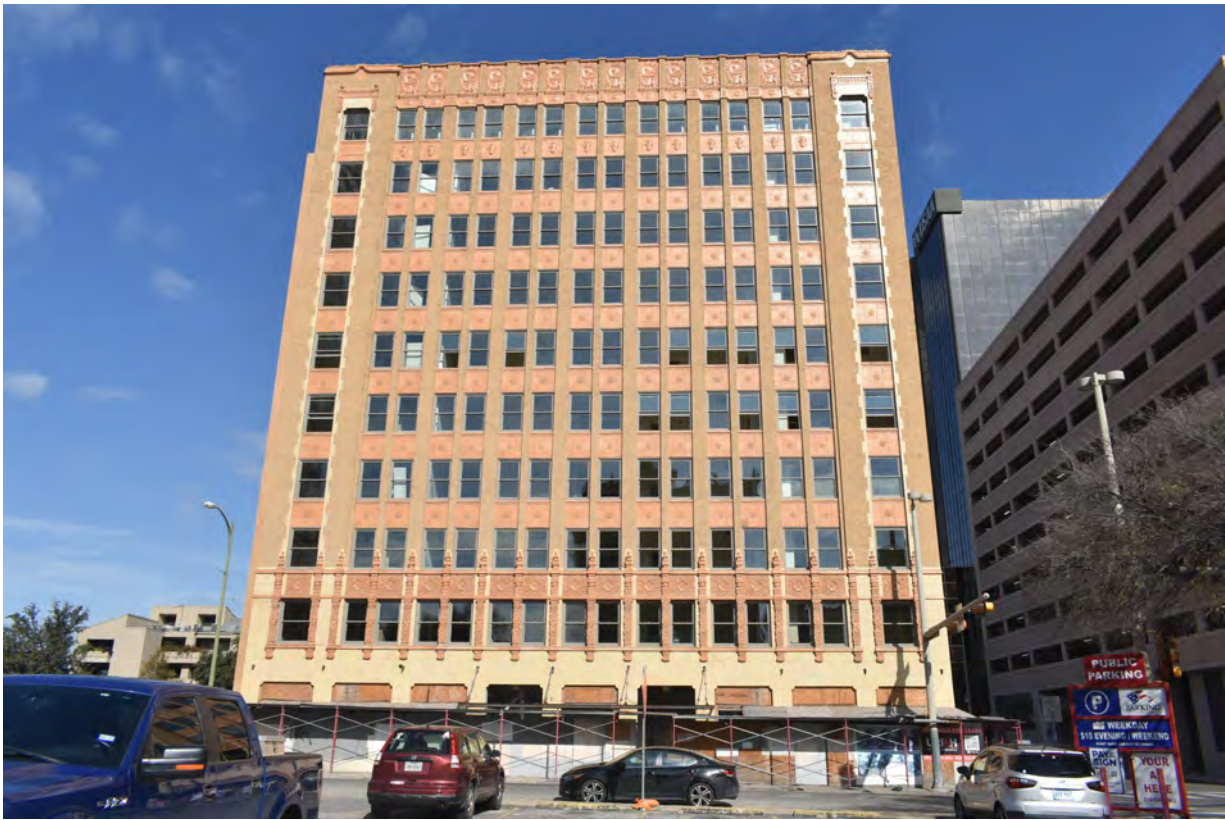
Resource ID: 303

View facing north

Type: Building	Exterior materials: brick stone terra cotta	Primary roof type: flat with parapet	Alterations: Addition to primary/side elevation (west) Window(s) boarded Windows replaced – some Work in progress
Style: Commercial, Spanish Baroque			
Form: Rectangular	Porch: wraparound projecting

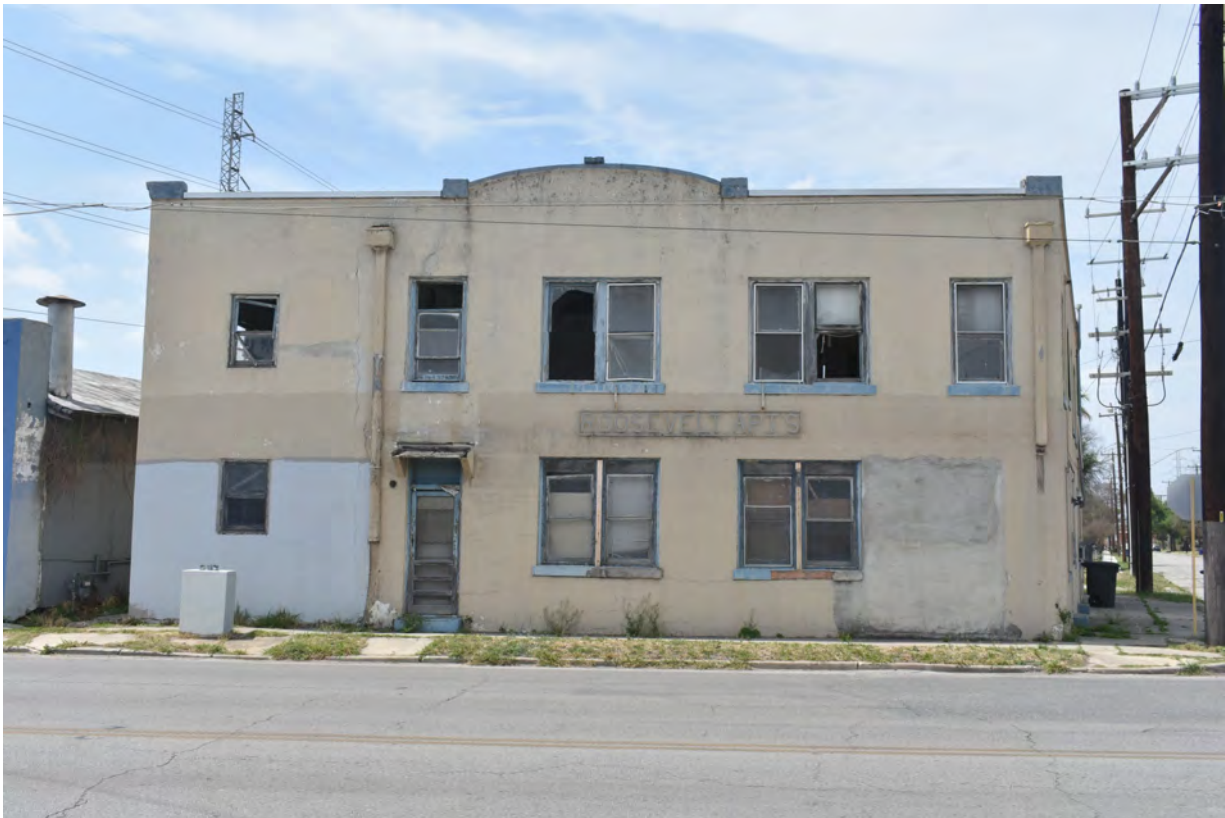
View facing west

Type: Building	Exterior materials: stucco	Primary roof type: flat with parapet	Alterations: Doors replaced Missing elements Window opening(s) infilled Window(s) boarded Windows replaced – some
Style: Mission Revival			
Form: Rectangular	Porch: partial-width projecting

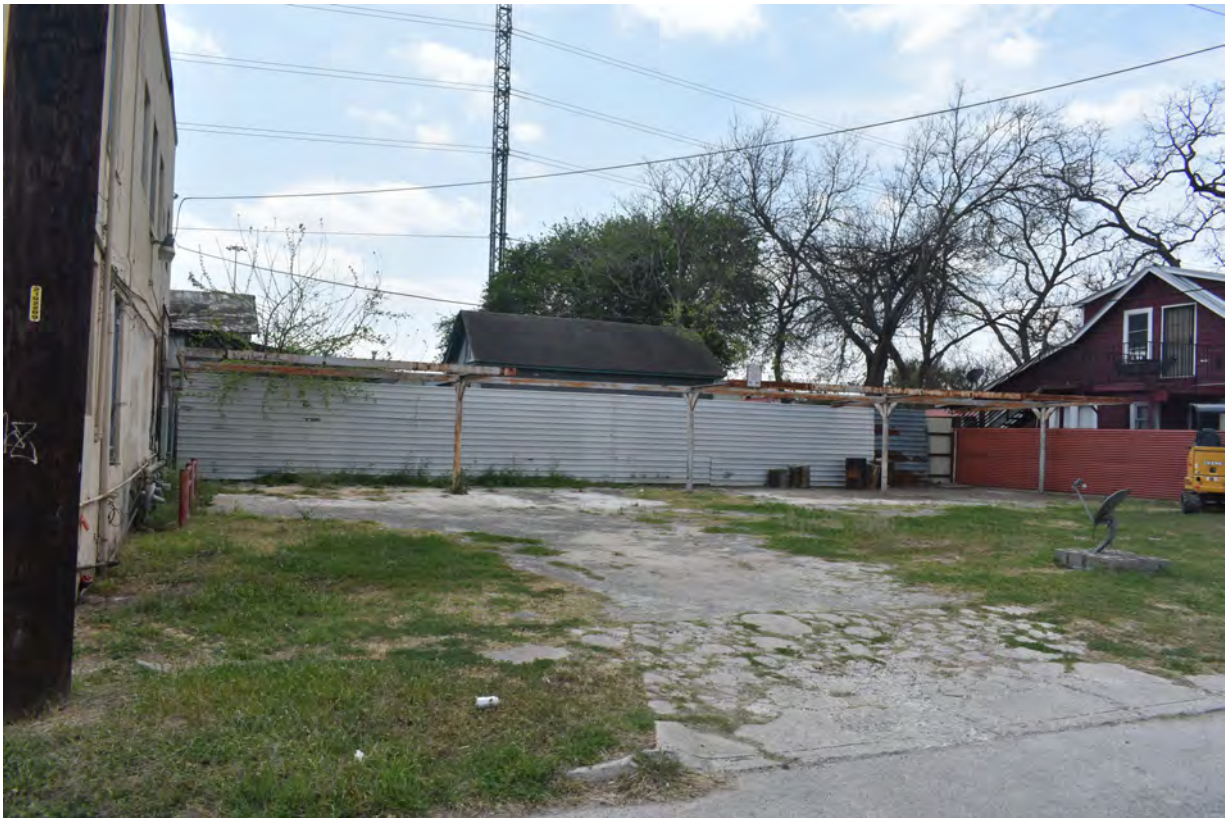
View facing southwest

Type: Structure	Exterior materials: metal	Primary roof type: N/A	Alterations: Missing elements
Style: No style			
Form: Rectangular	Porch: N/A
