PHASE I ENVIRONMENTAL SITE ASSESSMENT

ADVANCED RAPID TRANSIT (ART) EAST/WEST CORRIDOR PROJECT

September 2025 (Version 4)

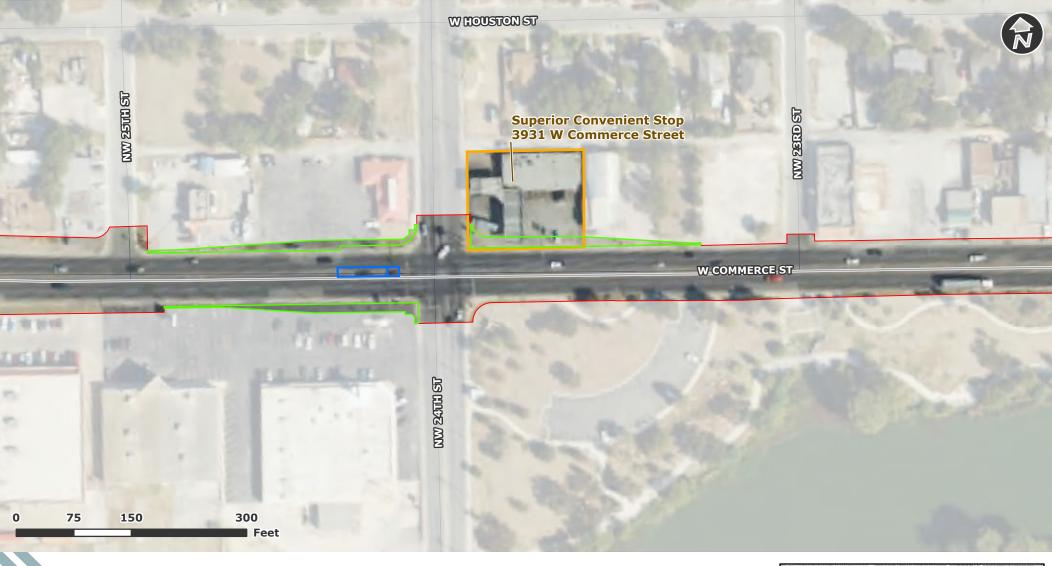
Hazardous Materials Sites Potential Sites of Concern - Aerial Map

Appendix G includes maps of these five sites. Detailed discussions of these sites are provided in **Sections 4** and **5** of the report.

Maps of the properties listed above are provided in **Appendix G.** Further assessment of environmental conditions, including additional research and, if necessary, Phase II investigations, should be conducted to evaluate and address any potential environmental concerns associated with these properties.
